Concept Knitting.(Extension)

Tilargati, Sataish Bazar, Tongi, Gazipur

12 February 2024

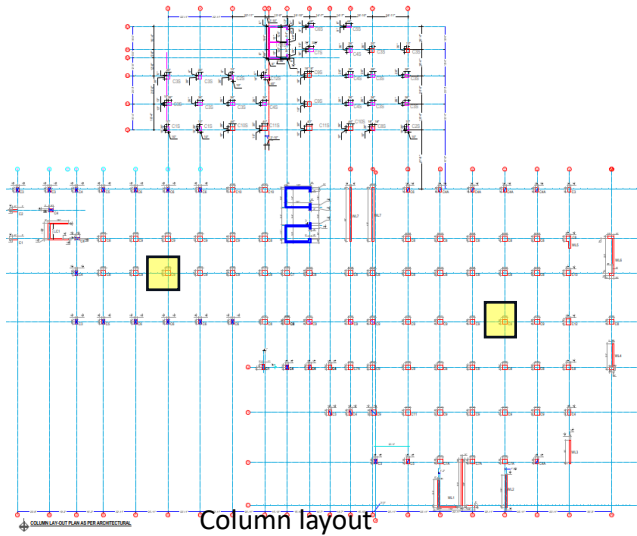
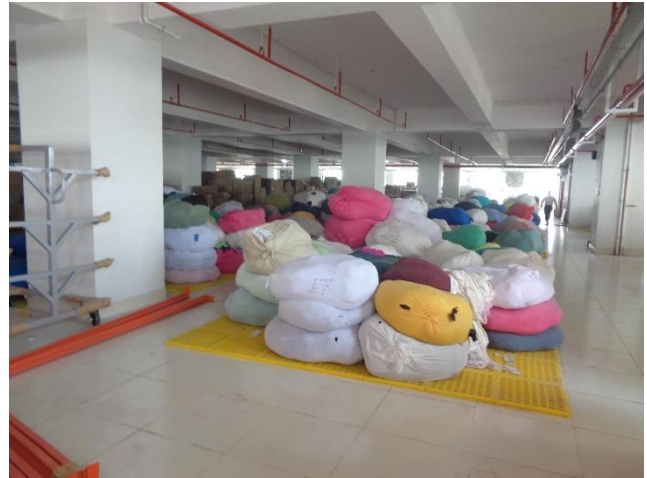
Typical floor loading

Observation-1: Stress in the column above normal design limit (New Garments Building).

Description: The cursory calculation indicates that the column is stressed above the normal design limit at the marked location considering the floor live load as per the provided load plan (6 kPa for the typical floor and roof). We have considered minimum concrete strength based on aggregate type due to inadequate number of concrete cylinder test reports and rebar strength 500 MPa from the available rebar test report. The building engineer is required to review design and column stresses based on in-situ concrete strength at the marked location. Also, produce and actively manage load management plans.

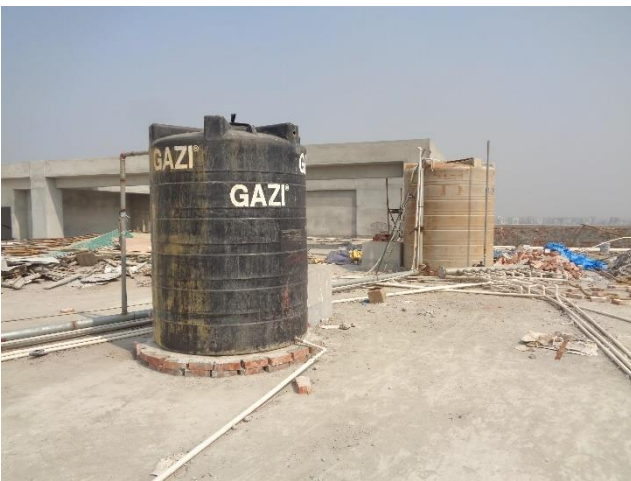
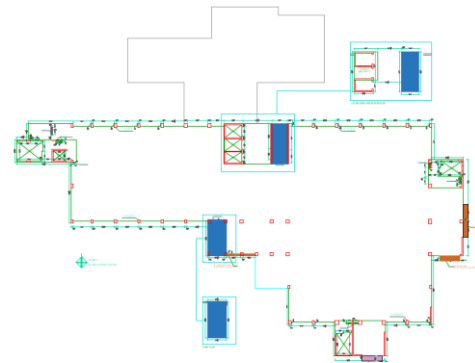
Observation-2: Missing information in as-built drawing. (New Garments Building).

Description: An undocumented plastic water tank was found on the roof slab. The building engineer is required to update the as-built drawing and consider it in the design check.

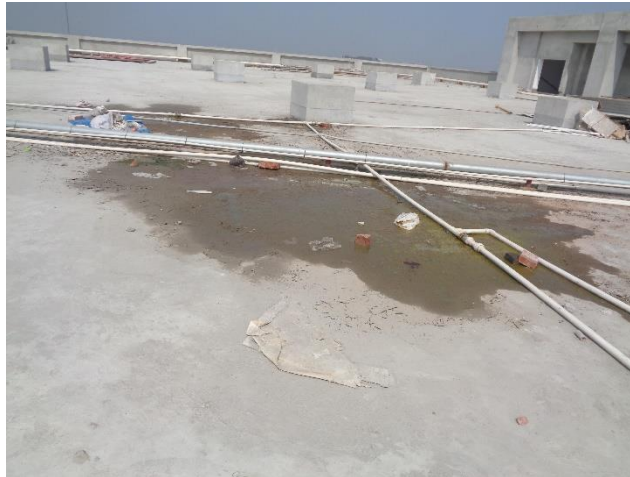
Observation-3: Stagnant water on the roof slab. (New Garments Building).

Description: Stagnant water on the roof slab. The building engineer is required to improve the drainage system on the roof slab.

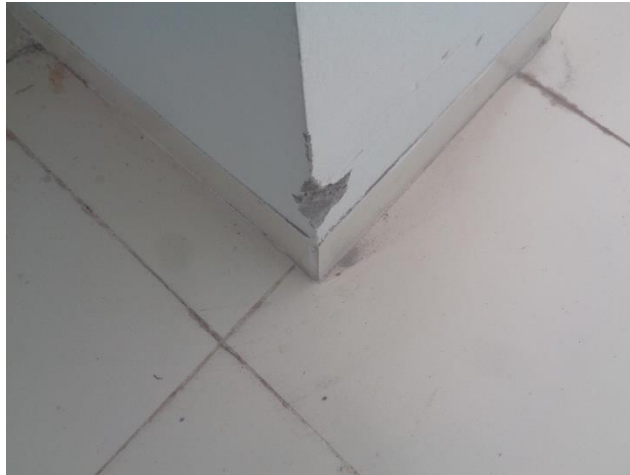
Observation-4: Column surface was found damaged due to the trolley impact. (New Garments Building).

Description: Column surface was found damaged due to the trolley impact. The building engineer is required to repair the damaged column and provide adequate barriers to avoid trolley impact.

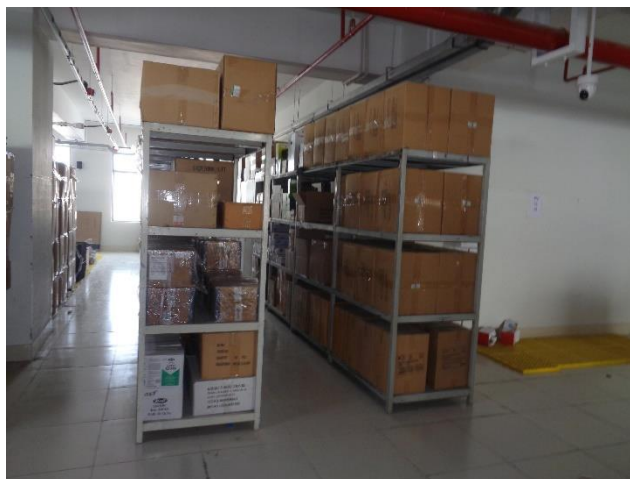
Observation-5: Nonstructural storage racks found not anchored/braced (New Garments Building).

Description: Nonstructural storage racks found not anchored/braced. The building engineer is required to anchor/brace all nonstructural elements within the factory.

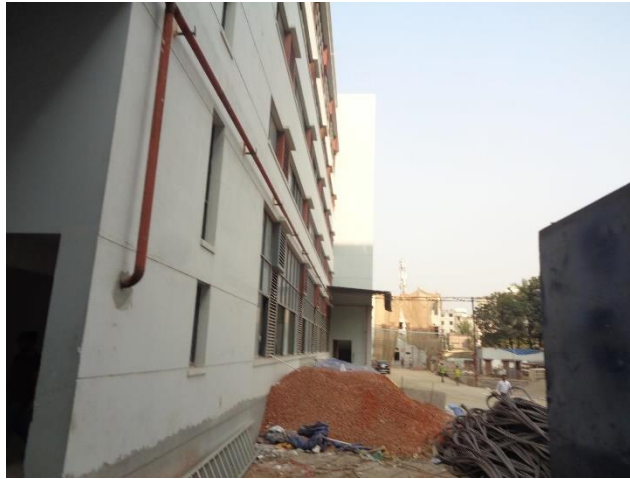
Observation-6: Lack of design report (Utility Building)

Description: As per 1.9.1 (BNBC Part-6), every structure should have a design report. At the time of inspection, only as-built structural drawings were available but no design report was available. The building engineer is required to prepare a design report as per 1.9.1 (BNBC Part-6).

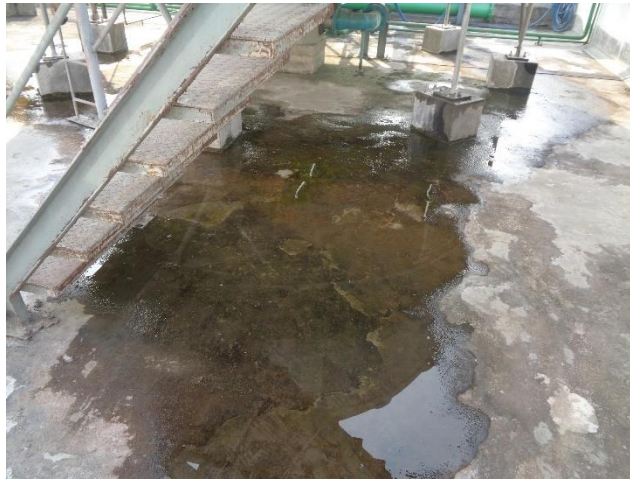
Observation-7: Stagnant water on the roof slab. (Utility Building).

Description: Stagnant water on the roof slab. The building engineer is required to improve the drainage system on the roof slab.

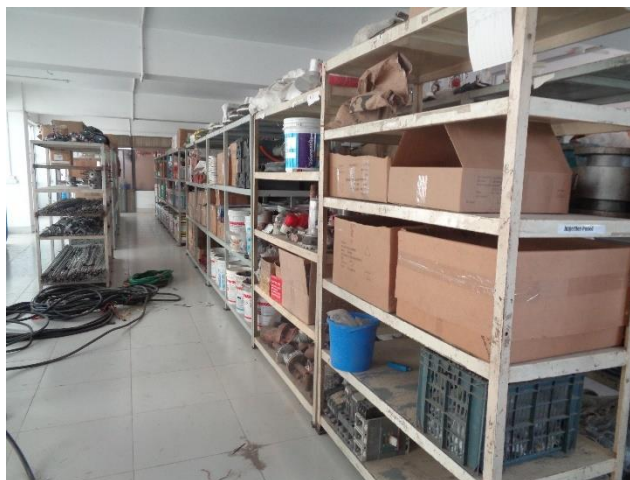
Observation-8: Nonstructural storage racks found not anchored/braced (Utility Building).

Description: Nonstructural storage racks found not anchored/braced. The building engineer is required to anchor/brace all nonstructural elements within the factory.
