# Pioneer Knitwears (BD) Ltd. (Section-2) (Extension)

Jamirdia, Habirbari, Valuka, Mymensingh-2240.

23 November 2023

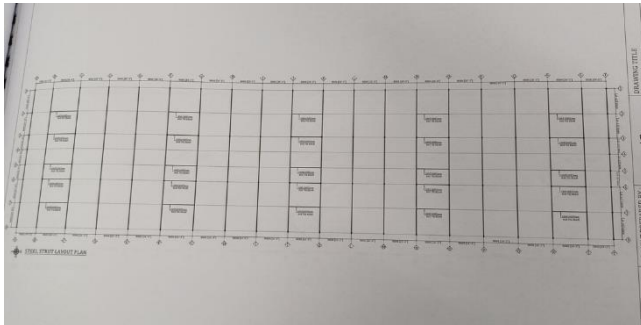
Strut Layout

**Observation-01:** Lack of information and mismatch in as-built drawing. (Linking Floor-C&D)

**Description:** No connection details were found in the provided as-built drawings. The building engineer is required to survey the structure and prepare accurate as-built drawings.

| Serial | Observation | Action Plan | Timeline |
|---|---|---|---|
| 1 | Lack of information and mismatch in as-built drawing. (Linking Floor-C&D) | The building engineer is required to survey the structure and prepare accurate as-built drawings. | within 6 weeks |

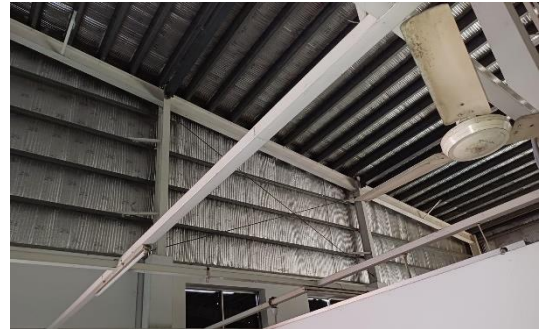
Compression strut on end bay

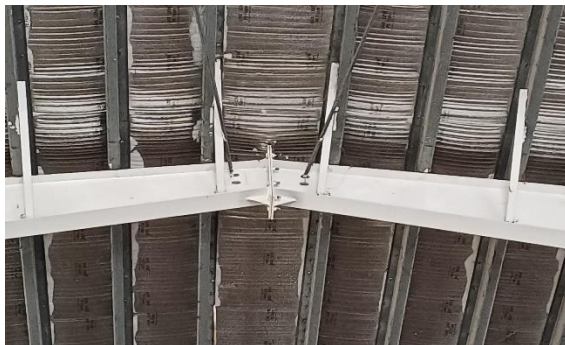
Strut Layout

**Observation-02:** Incomplete lateral stability system. (Linking Floor-C&D)

**Description:** No compression strut was found along the ridge lines of the long direction. Also, other strut members were found to be discontinued along the long direction. So lateral stability in the long direction is incomplete. The building engineer is required to check the stability system of the existing structure.

| Serial | Observation | Action Plan | Timeline |
|---|---|---|---|
| 2 | Incomplete lateral stability system. (Linking Floor-C&D) | The building engineer is required to check the lateral stability of the structure. | within 6 weeks |
| 3 | Incomplete lateral stability system. (Linking Floor-C&D) | Carry out remediation work if required. | within 6 months |

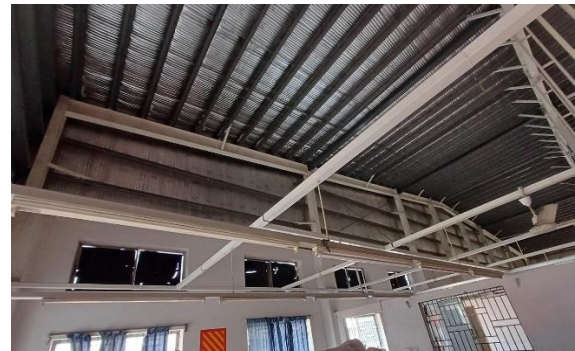
Compression strut on end bay

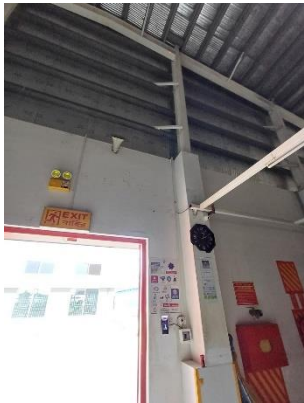
Incline column at East

**Description:** An inclined steel column was found on the East side of the shed. The stability of the distorted columns and related elements need to be checked.

| Serial | Observation | Action Plan | Timeline |
|---|---|---|---|
| 4 | Inclined steel column. (Linking Floor-C&D) | The building engineer is required to review the design of the distorted steel column considering the as-built condition of the column. | within 6 weeks |
| 5 | Inclined steel column. (Linking Floor-C&D) | Carry out remedial works (if any) after being reviewed by RSC. | within 6 months |

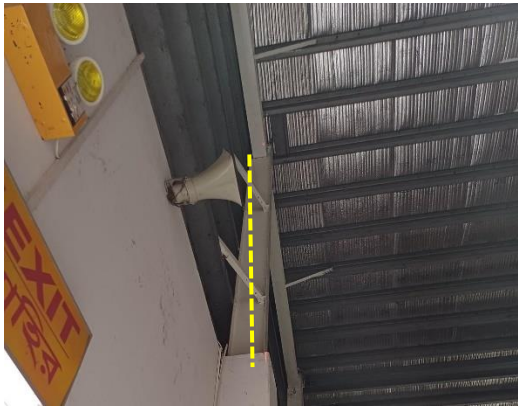
Incline steel column

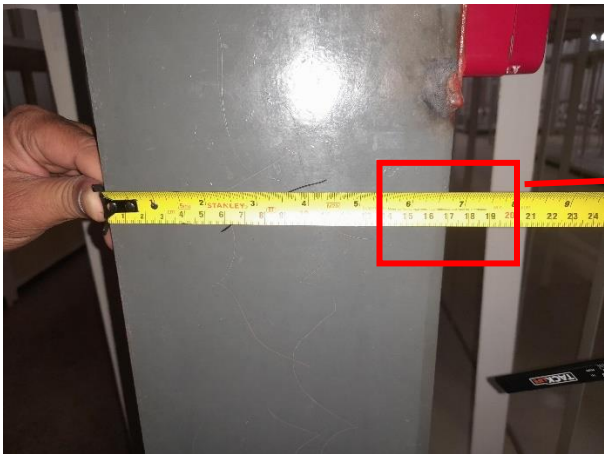
SC1 column flange measured 168 mm

**Description:** During the inspection, the SC1 column flange was measured 168 mm in grid J/6 instead of 200 mm which was shown in provided as-built structural drawing. The building engineer is required to survey the full structure and produce accurate as-built drawings.

| Serial | Observation | Action Plan | Timeline |
|---|---|---|---|
| 9 | Discrepancies in as-built drawing. (Yarn Go-down) | The building engineer is required to survey the structure and prepare accurate as-built drawings. | within 6 weeks |

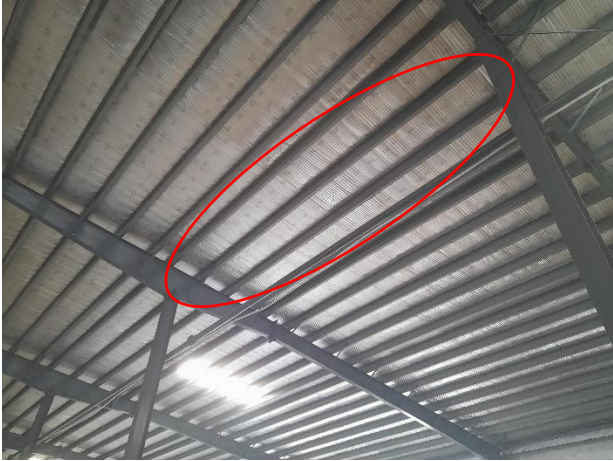
Missing compression strut

**Description of observation:** Portal frame is provided along the short direction. Any compression member along a long direction with any lateral or horizontal bracing was not available. Building engineer is required to check the lateral stability of the structure.

| Serial | Observation | Action Plan | Timeline |
|---|---|---|---|
| 10 | Lack of lateral stability system. (Yarn Go-down) | The building engineer is required to check the lateral stability of the structure. | within 6 weeks |
| 11 | Lack of lateral stability system. (Yarn Go-down) | Carry out remediation work if required. | within 6 months |

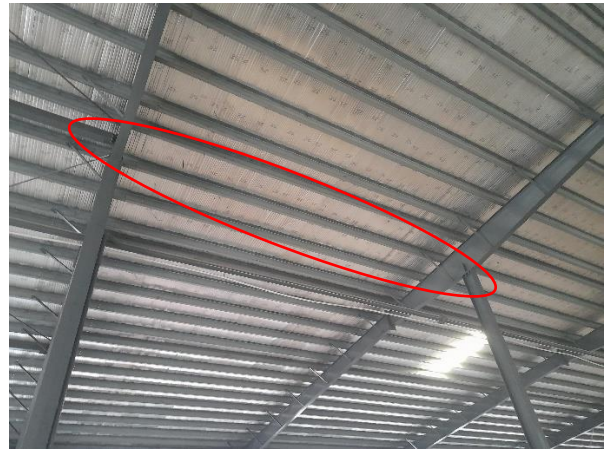
No vertical or Horizontal bracing

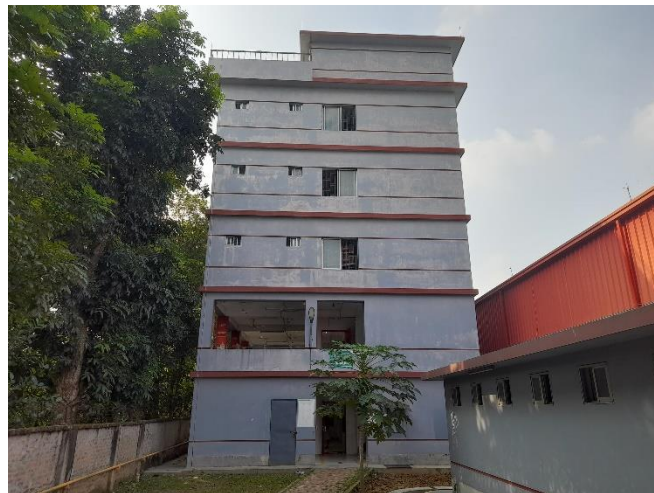
**Observation-6: Lack of design report (Canteen-2).**

During inspection, the design report was not available on site. The building engineer is required to prepare a design report based on in-situ material strength & software-based analysis and submit it to RSC for review.

| Serial | Observation | Action Plan | Timeline |
|---|---|---|---|
| 13 | Lack of design report. (Canteen-2) | Building engineer is required to prepare the design documents including a design report, and a set of structural drawings in compliance with section 1.9.1.1 and section 1.9.1.2, part-6 of BNBC and submit it to RSC for review. | within 6 weeks |
| 14 | Lack of design report. (Canteen-2) | Carry out remedial works (if any) after review by RSC. | within 6 months |

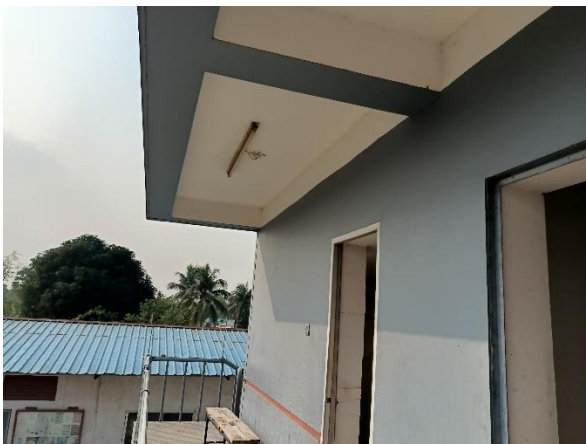
Cantilever Beam

**Description:** Cantilever beams were not shown in the beam layout. Also, no drawings were found for the external steel stairs. The building engineer is required to survey the structure and prepare accurate as-built drawings.

| Serial | Observation | Action Plan | Timeline |
|---|---|---|---|
| 8 | Incomplete as-built drawing. (Security Building-02) | The building engineer is required to survey the structure and prepare accurate as-built drawings. | within 6 weeks |

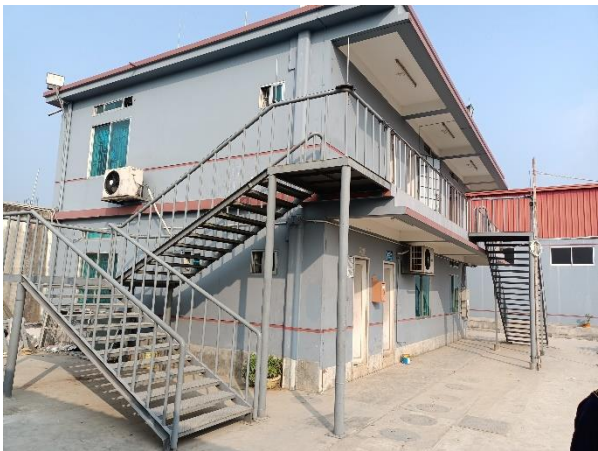
External steel stair

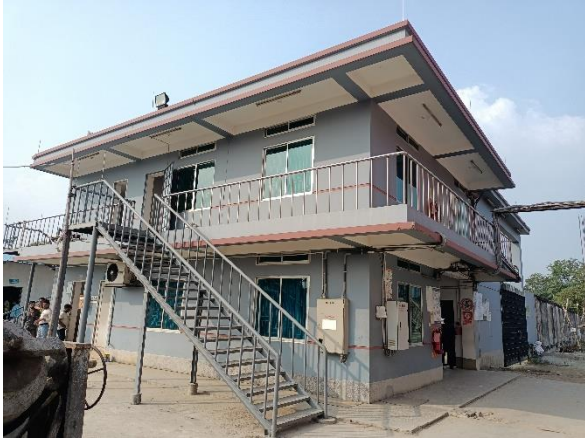
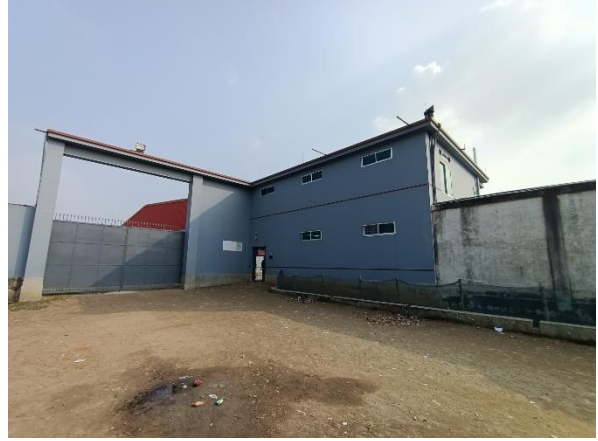
Security Building-02

**Observation-09:** Lack of design report. (Security Building-02)

**Description:** As per BNBC, every building or structure designed shall have its design documents prepared following the provision of Section 1.9.1. The design document shall include a design report, and a set of structural drawings, which shall be prepared in compliance with section 1.9.1.1 and section 1.9.1.2, part 6 of BNBC.

| Serial | Observation | Action Plan | Timeline |
|---|---|---|---|
| 6 | Lack of design report. (Security Building-02) | Building engineer is required to prepare the design documents including a design report, and a set of structural drawings in compliance with section 1.9.1.1 and section 1.9.1.2, part-6 of BNBC and submit it to RSC for review. | within 6 weeks |
| 7 | Lack of design report. (Security Building-02) | Carry out remedial works (if any) after review by RSC. | within 6 months |

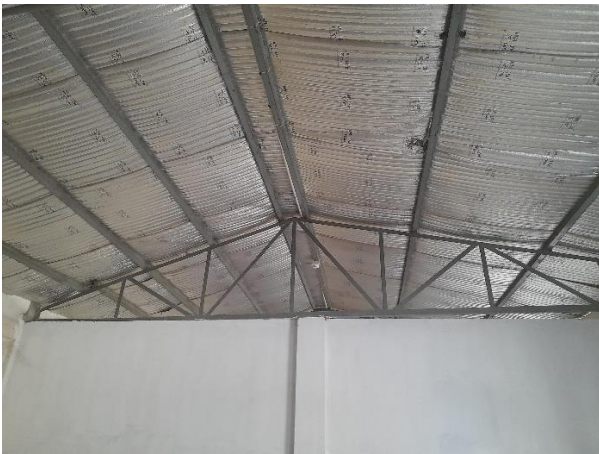
Civil Godown

**Description of observation:** Truss frame and rafter are provided along the short direction. Any compression member along a long direction with any lateral or horizontal bracing was not available. Building engineer is required to check the lateral stability of these structures.

| Serial | Observation | Action Plan | Timeline |
|---|---|---|---|
| 16 | Lack of Lateral Stability. (Civil Godown) | The building engineer is required to check the lateral stability of the structure. | within 6 weeks |

| 17 | Lack of Lateral Stability. (Civil Godown) | Carry out remediation work if required. | within 6 months |

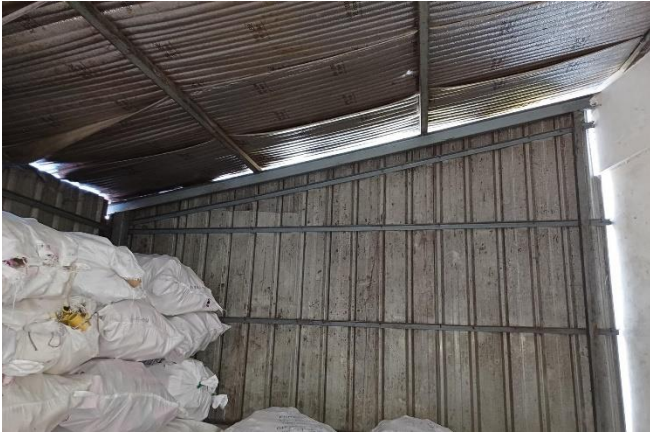
Steel angle connection with steel column

**Description:** Connection details of steel angles were not found in the provided as-built drawings. The building engineer is required to survey the structure and prepare accurate as-built drawings.

| Serial | Observation | Action Plan | Timeline |
|---|---|---|---|
| 12 | Lack of information in as-built drawing. (Scrab Godown) | The building engineer is required to survey the structure and prepare accurate as-built drawings. | within 6 months |

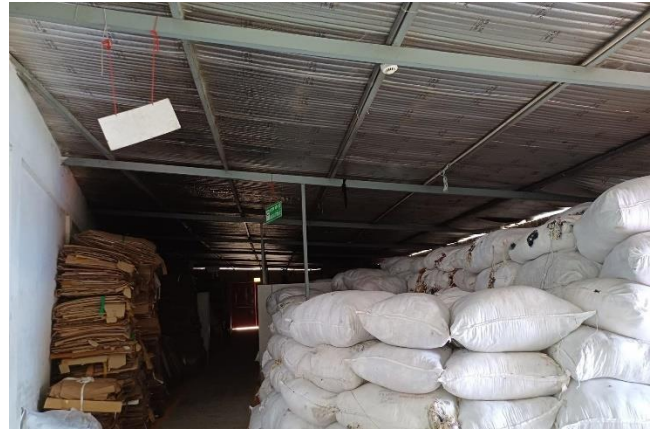
Steel angle connection with brick wall

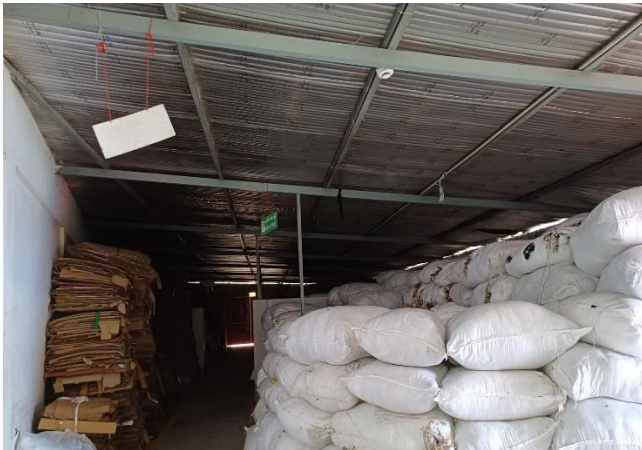
Steel column

**Description:** Apparently inadequate steel columns and connections were observed on the lightweight roof of the single-storied Sheds. The building engineer checks the connection adequacy of the lightweight roof against the uplift pressure of the wind.

| 24 | Apparently inadequate steel columns and connections. (Scrab Godown) | The building engineer is required to check member adequacy and the connection of the steel roof for the uplift pressure of the wind. | within 6 weeks |
| 25 | Apparently inadequate steel columns and connections. (Scrab Godown) | Carry out remediation work if required. | within 6 months |

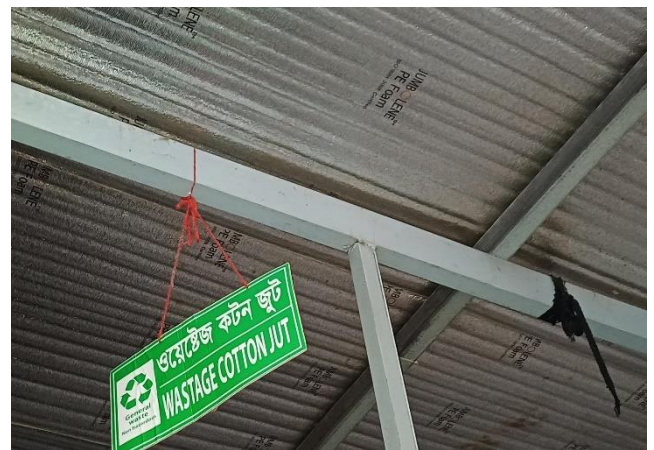
Apparently inadequate connection

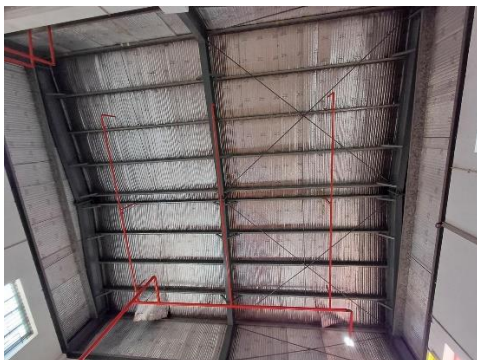
Roof framing with compression strut

**Description:** No compression strut was found along the East-west direction. The building engineer is required to check the stability system of the existing structure.

| 26 | Incomplete lateral stability system. (Fire Pump House) | The building engineer is required to check the lateral stability of the structure. | within 6 weeks |
| 27 | Incomplete lateral stability system. (Fire Pump House) | Carry out remediation work if required. | within 6 months |
