# Chaity Composite Ltd. (Extension 2)

Chotto Shilmondi, Tripurdi, Sonargaon, Narayanganj

22 February 2024

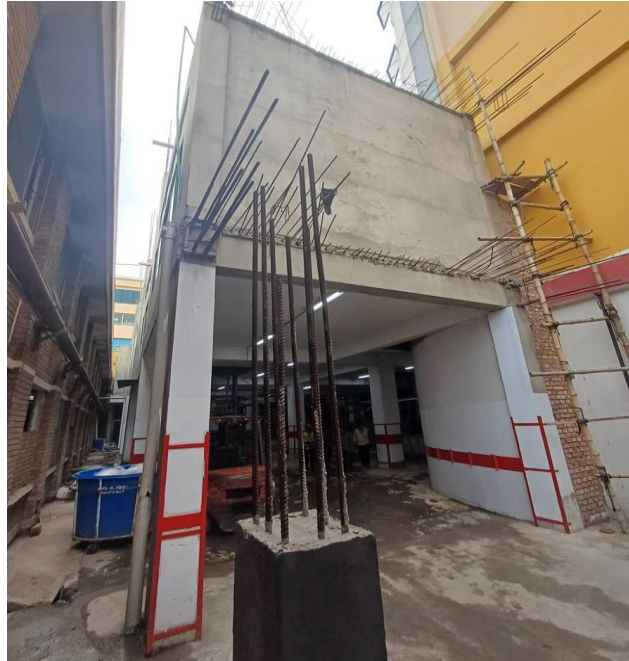
**Observation-1:** Absence of design report (Building 01).

**Description:** During the inspection, the design report was not available for Building 1. The building engineer is required to prepare a design report following BNBC (part-6, section 1.9.1) and submit it to RSC for review.

| Observation | Action Plan | Timeline |
|---|---|---|
| Absence of design report (Building 01). | The building engineer is required to prepare a design report following BNBC (part-6, section 1.9.1) and submit it to RSC for review. | within 6 weeks |
| | Implement remediation work if required. | within 6 months |

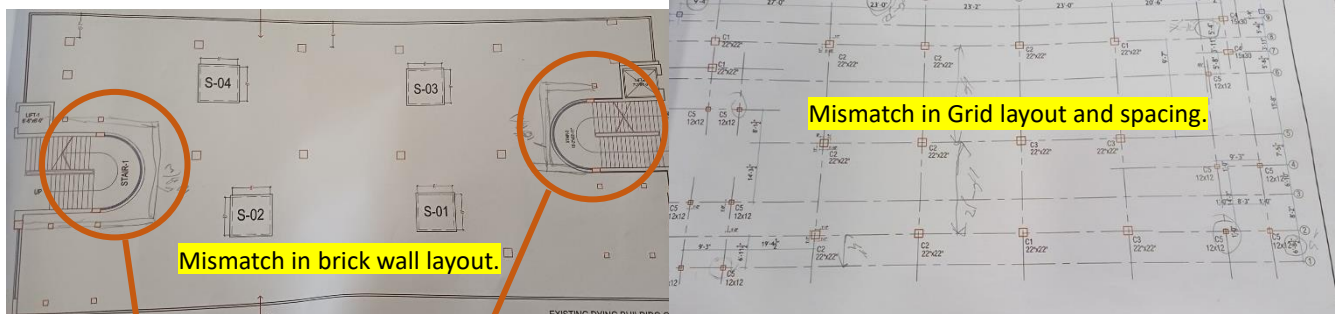
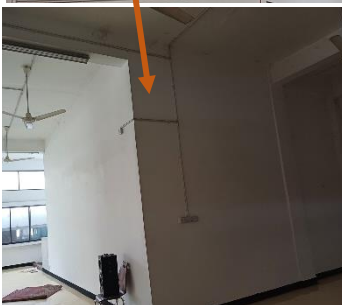
Brick wall was observed in marked position at 1<sup>st</sup> floor level which was not shown in as built drawing.

Mismatch was observed in column grid spacing. Cantilever portion at side was observed 2.4m instead of 1.62m.

**Description:** During the inspection, discrepancies were observed between the as-built drawing and

the on-site condition. Mismatches are shown above. The building engineer is required to survey the whole structure and update the drawing reflecting on-site conditions.

| Observation | Action Plan | Timeline |
|---|---|---|
| Discrepancies in as-built drawings (Building 01). | The building engineer is required to survey the whole structure and update the drawing reflecting on-site conditions. | within 6 weeks |

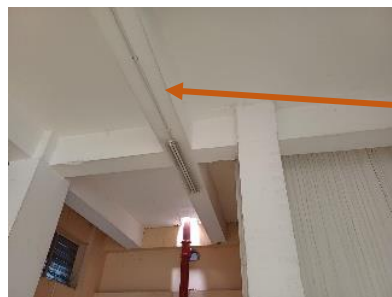
Beam is not passing through column. Also, edge beam is found missing.

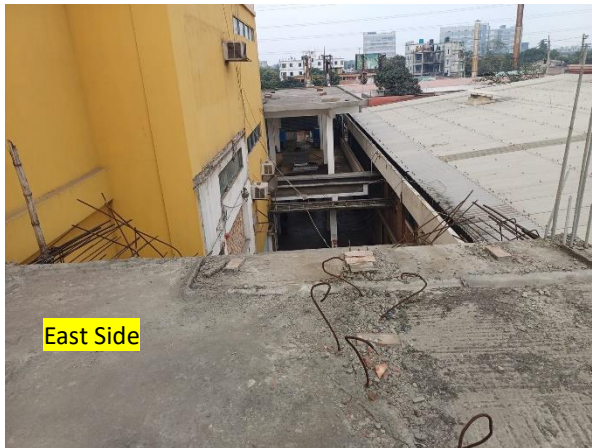
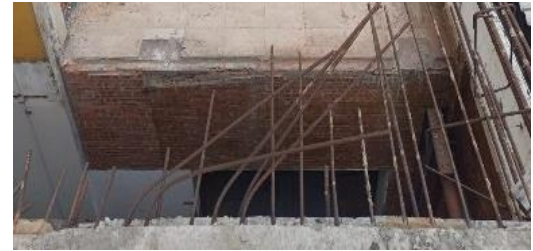
**Observation-3:** Lack of fall protection (Building 01).

Incomplete Slab construction.

**Description:** A falling hazard was observed on the roof of the 1<sup>st</sup> floor, especially at the East and south side of the building. The building engineer is required to protect against falling hazards appropriately.

| Observation | Action Plan | Timeline |
|---|---|---|
| Lack of fall protection (Building 01). | The building engineer is required to protect against falling hazards in the appropriate manner. | within 6 weeks |

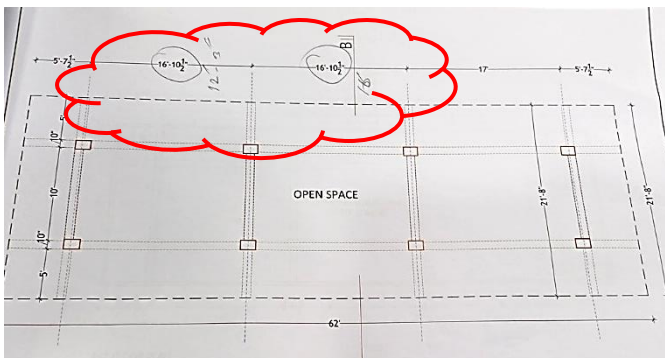
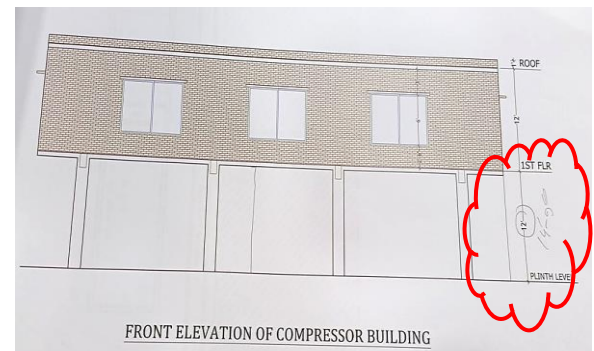
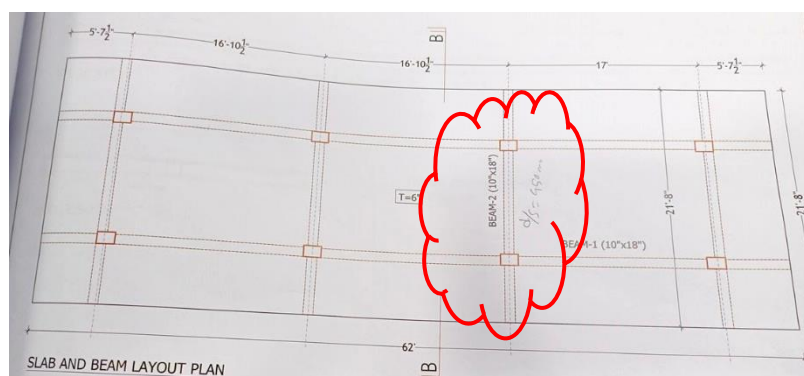
**Observation 4:** Mismatch in as-built drawings. (Building-02)

**Description:** Mismatches were found in as-built drawing of grid spacing, floor height & beam sizes. During inspection, beam size found 10X24" instead of 10X18" and ground floor height found 14'9" instead of 12'. The building engineer is required to revise the as-built drawing as per actual site condition.

| Observation | Action Plan | Timeline |
|---|---|---|
| Mismatch in as-built drawings. (Building-02) | The building engineer is required to revise the as-built drawing as per the actual site condition. | within 6 weeks |

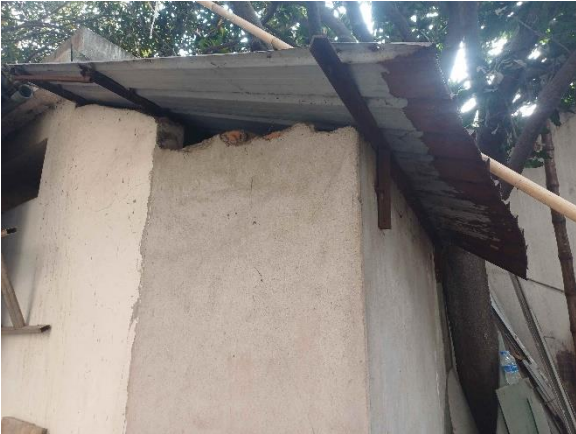
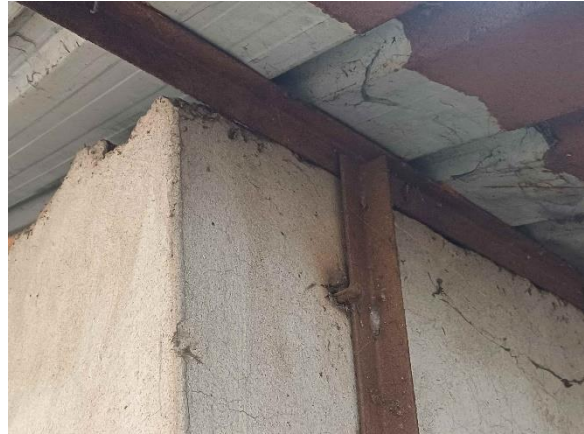
### Observation 5: Corrosion on steel members (Building-06)

**Description:** Corrosion was found on steel members at several locations. The building engineer is required to remove corrosion and provide rust-proof paint on steel members.

| Observation | Action Plan | Timeline |
|---|---|---|
| Corrosion on steel members (Building-06) | The building engineer is required to remove corrosion and provide rust-proof paint on steel members. | within 6 weeks |

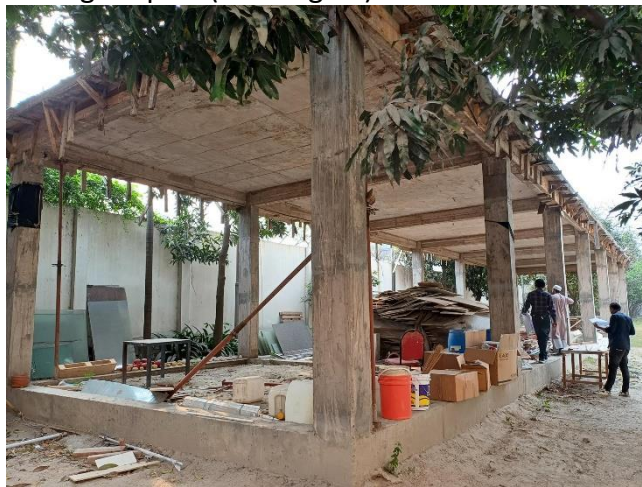
### Observation-6: Absence of design report (Building 07).

**Description:** During the inspection, the design report was not available for Building 7. The building engineer is required to prepare a design report following BNBC (part-6, section 1.9.1) and submit it to RSC for review.

| Observation | Action Plan | Timeline |
|---|---|---|
| Absence of design report (Building 07). | The building engineer is required to prepare a design report following BNBC (part-6, section 1.9.1) and submit it to RSC for review. | within 6 weeks |
| | Implement remediation work if required. | within 6 months |

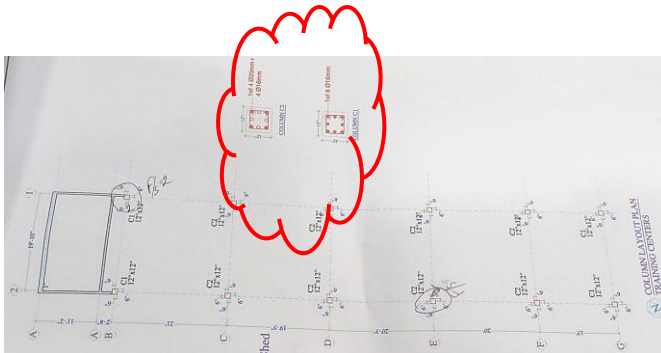
6-Nos rebar found instead  
of 8-Nos bar

**Description:** Mismatches were found in the as-built drawing of column rebar and no details of roof steel members were found. During inspection, 6-nos column rebar was found instead of 8-nos rebar. The building engineer is required to revise the as-built drawing as per the actual site condition.

| Observation | Action Plan | Timeline |
|---|---|---|
| Mismatch in as-built drawings. (Building-08) | The building engineer is required to revise the as-built drawing as per the actual site condition. | within 6 weeks |

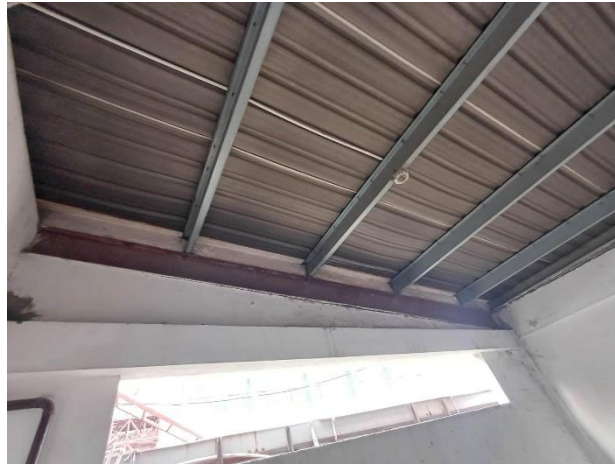
**Observation -8:** Lack of lateral stability (Building-08)

No load transfer media at long-direction

**Description:** No Load transfer media was found along the long-direction. The building engineer is required to perform an Engineering Assessment (EA) to check the lateral stability of the structure.

| Observation | Action Plan | Timeline |
|---|---|---|
| Lack of lateral stability (Building-08) | The building engineer is required to perform Engineering Assessment (EA) to check the lateral stability of the structure. | within 6 weeks |
| | Carry out the suggested remedial works if required. | within 6 months |

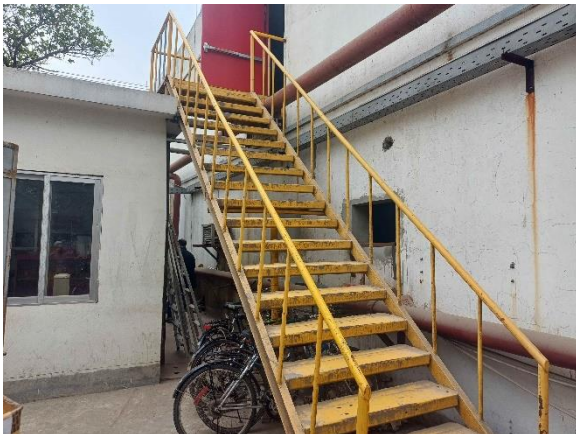
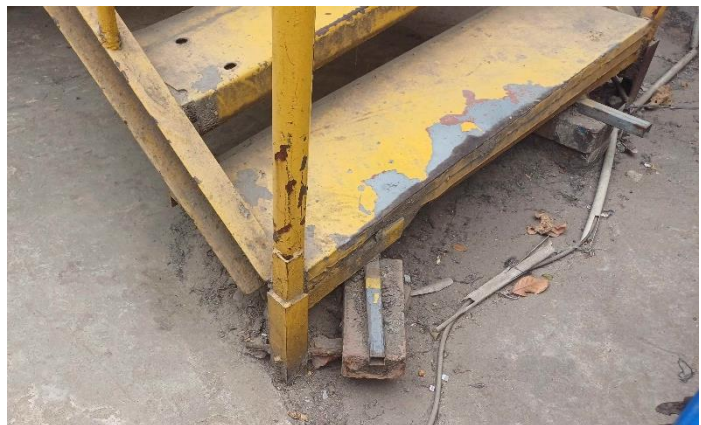
**Observation -9:** Apparently non-engineered steel stair. (Building-08)

Apparently non-engineered steel stair

**Description:** The stability system of the steel stair and its connections are apparently non-engineered. The building engineer is required to suggest a proper action plan to make the structure adequate and prepare necessary design documents accordingly.

| Observation | Action Plan | Timeline |
|---|---|---|
| Apparently non-engineered steel stair. (Building-08) | The building engineer is required to suggest a proper action plan to make the structure adequate and prepare necessary design documents accordingly. | within 6 weeks |
| | Carry out the suggested remedial works if required. | within 6 months |

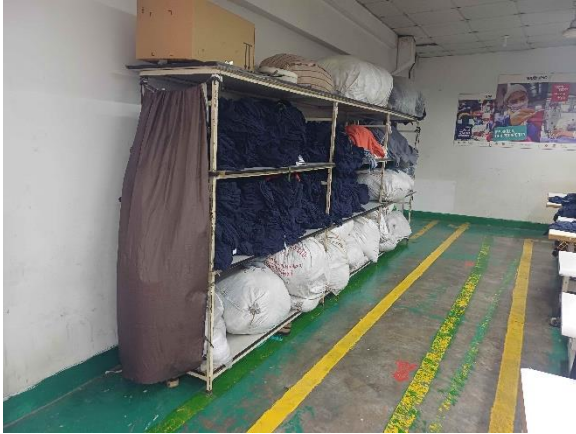
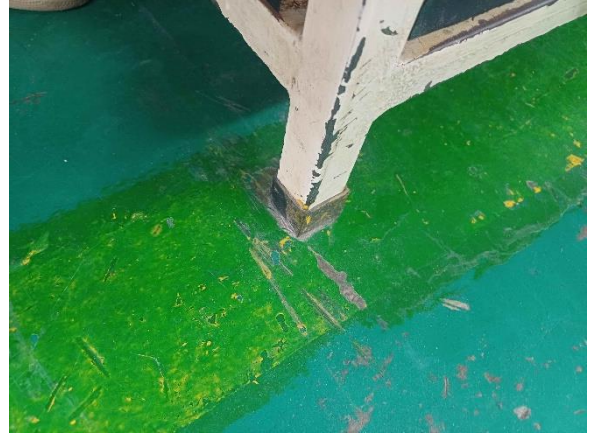
**Observation -10: Unbraced storage racks (Building-08)**

Unbraced storage racks

**Description:** Storage racks at several locations were found unbraced. The building engineer is required to brace/anchor all the non-structural elements including the storage racks.

| Observation | Action Plan | Timeline |
|---|---|---|
| Unbraced storage racks (Building-08) | The building engineer is required to brace/anchor all the non-structural elements including the storage racks. | within 6 weeks |

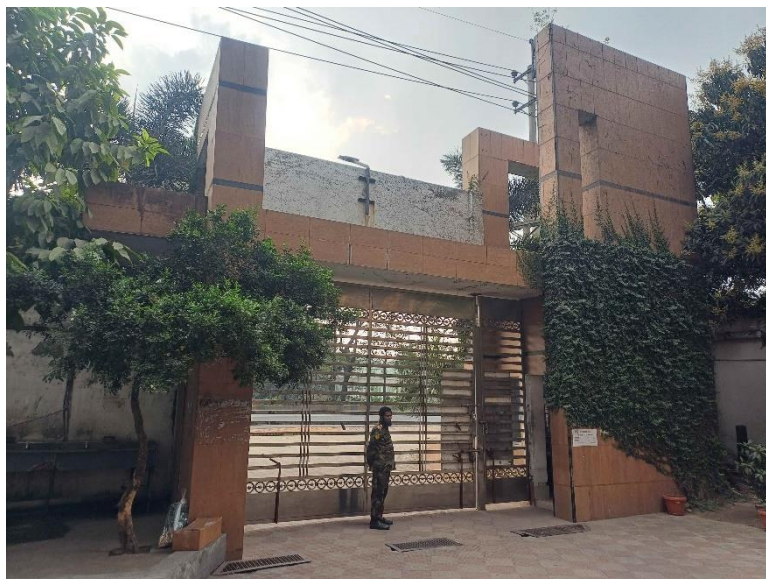
**Observation -11: Lack of as-built drawing (Building-09)**

**Description:** During inspection, only as-built architectural drawing was found but no as-built structural drawing was found at site. The building engineer is required to prepare a set of as-built structural drawing as per actual site condition and keep on site for verification.

| Observation | Action Plan | Timeline |
|---|---|---|
| Lack of as-built drawing (Building-09) | The building engineer is required to prepare a set of as-built structural drawings as per actual site conditions and keep on-site for verification. | within 6 weeks |

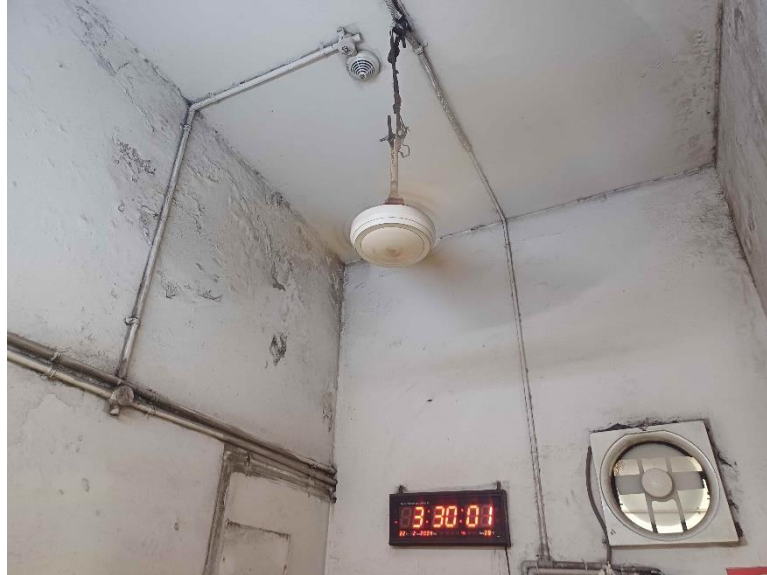
**Observation -12:** Dampness at interior wall (Building-09)

Dampness at the interior wall

**Description:** During the inspection, Dampness was observed at the interior wall surface. The building engineer is required to remove dampness and repair the wall accordingly.

| Observation | Action Plan | Timeline |
|---|---|---|
| Dampness at interior wall (Building-09) | The building engineer is required to remove dampness and repair the wall accordingly. | within 6 weeks |

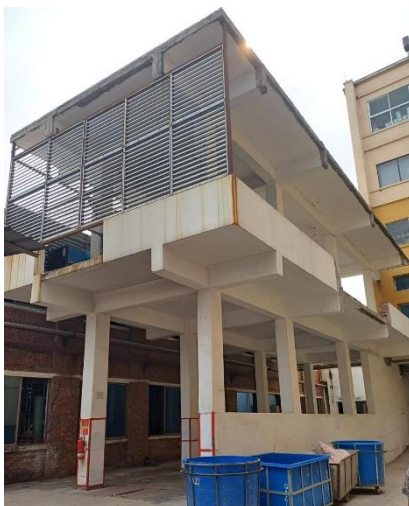
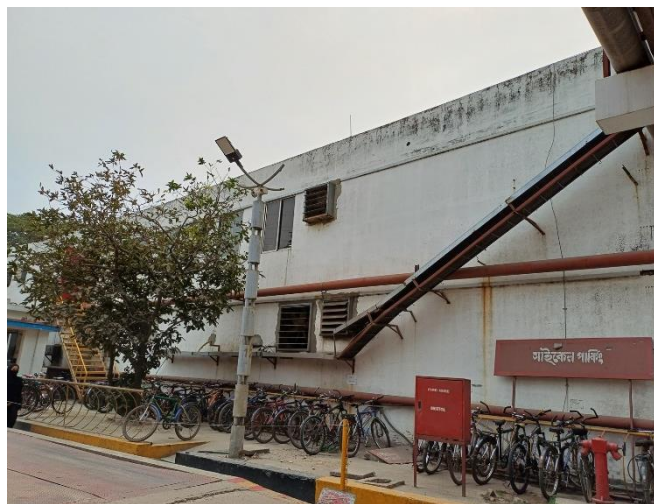
**Observation -13:** Lack of Building Permit (Building-2 to Building-9)

**Description:** During the inspection, no permit drawings were found except for Building-1. The building engineer is required to collect the permit drawings for all buildings from the concerned authority.

| Observation | Action Plan | Timeline |
|---|---|---|
| Lack of Building Permit (Building-2 to Building-9) | The building engineer is required to collect the permit drawings for all buildings from the concerned authority. | within 6 months |
