# Refat Garments Ltd (Extension 2)

144,147,148 Narashingpur, Ashulia, Savar, Dhaka.

20 February 2024

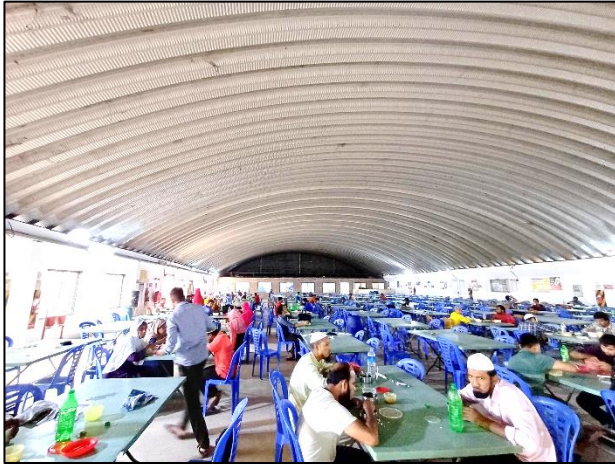
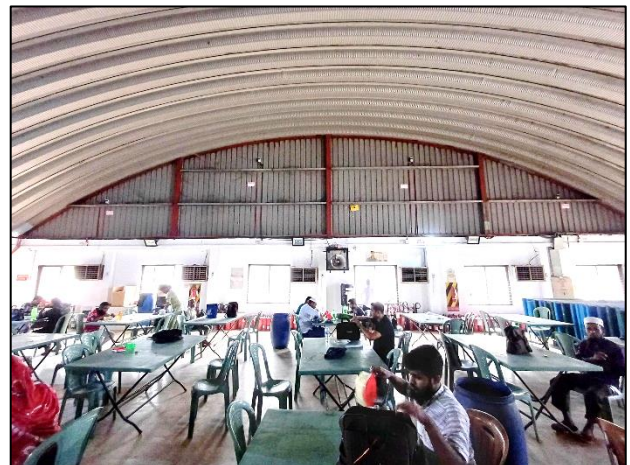
### Observation-01: Lack of roof lateral stability. (Dining & Printing)

**Description:** Lack of lateral stability system (absence of load transfer media) & improper connections were observed in the structure. The building engineer is required to check the stability of the structure and suggest proper remedial actions accordingly.

| Observation | Action Plan | Timeline |
|--|---|---|
| Lack of roof lateral stability. (Dining & Printing) | The building engineer is required to check the stability of the roof shed & revise the design report accordingly. | within 6 weeks |
| | Carry out remediation work if required. | within 6 months |

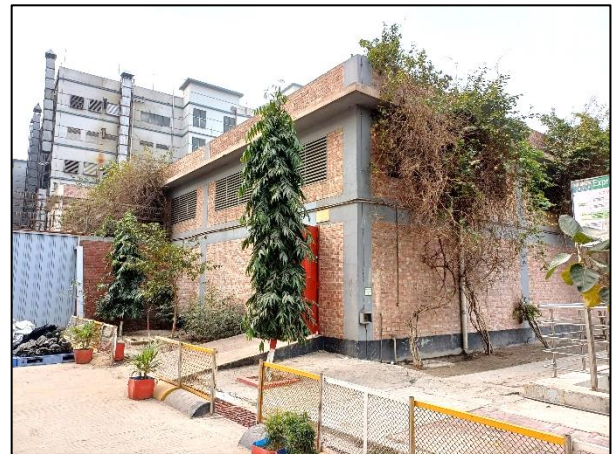
### Observation-02: Absence of concrete compressive strength test result. (Chemical Store)

**Description:** In the design report, the compressive strength of concrete was considered as 3500 psi for column, footing, beam & slab etc. However, no concrete compressive strength test result was available onsite. The building engineer is required to verify in-situ material strength by taking a minimum adequate number of concrete cores and review the analysis & design report.

| Observation | Action Plan | Timeline |
|--|---|---|
| Absence of concrete compressive strength test result. (Chemical Store) | Verify in situ concrete strength (100mm dia. cores from 4 columns) from the lower tier of the building. | within 6 weeks |
| | The building engineer is required to revise the design report for the concrete strength and submit it to RSC for review. | within 6 weeks |
| | Carry out suggested remedial works if required. | within 6 months |

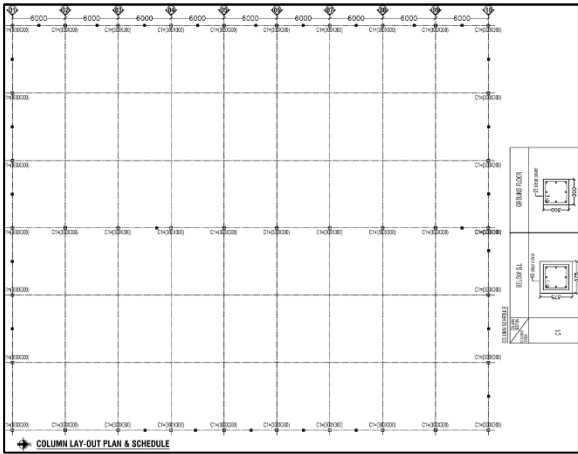
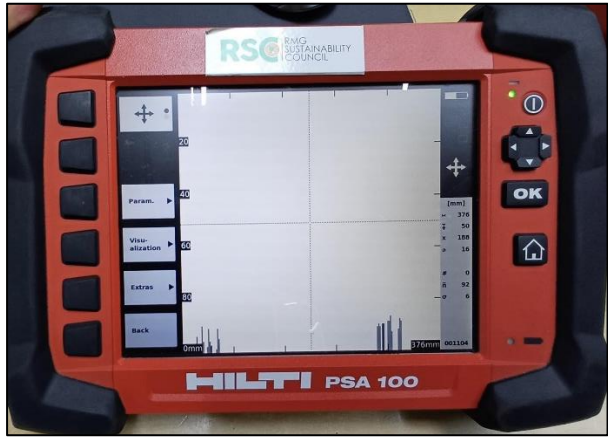
**Observation-03: Inconsistency in as-built drawing. (Chemical Store)**

**Description:** During the inspection, in the C-1 (300X300) column, 6 nos. rebar was found instead of 8 nos. rebar. The building engineer is required to survey the whole structure & update the as-built drawing.

| Observation | Action Plan | Timeline |
|--|---|---|
| Inconsistency in as-built drawing (Chemical Store) | The building engineer is required to survey the whole structure & update the as-built drawing. | within 6 weeks |

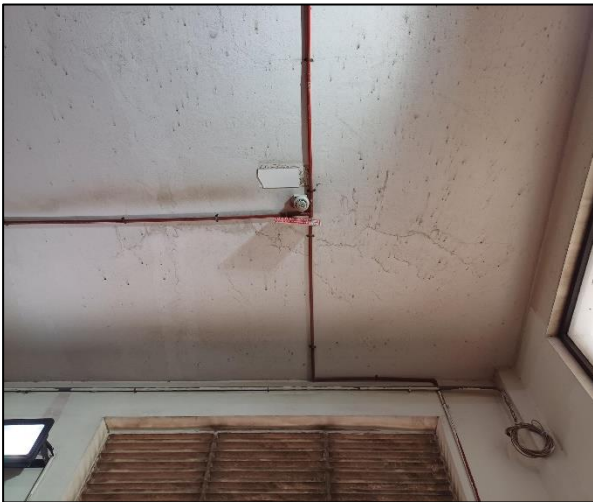
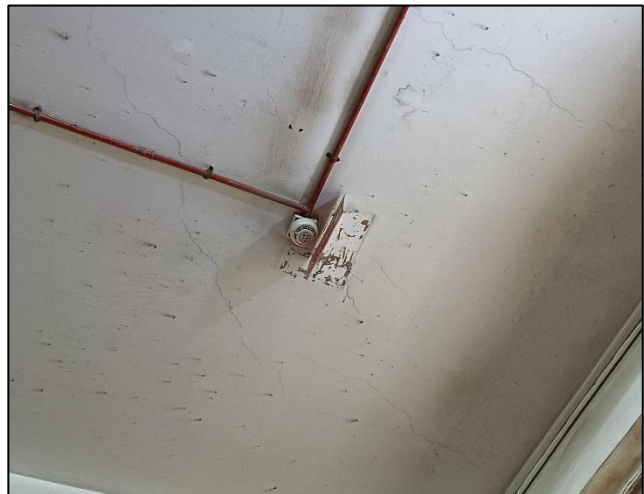
**Observation-04: Crack was found on the slab soffit. (Chemical Store)**

**Description:** During the inspection, a crack was found on the slab soffit of the chemical store building. The building engineer is required to investigate the reason for cracks & repair as per the investigation report.

| Observation | Action Plan | Timeline |
|--|---|---|
| Crack was found on the slab soffit. (Chemical Store) | The building engineer is required to investigate the reason for cracks & repair as per the investigation report. | within 6 months |

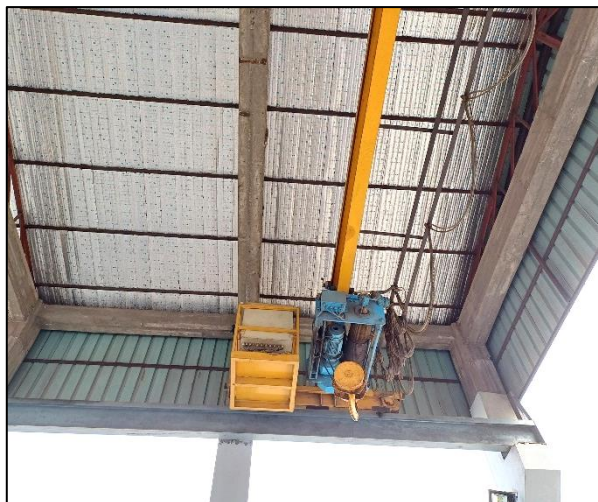
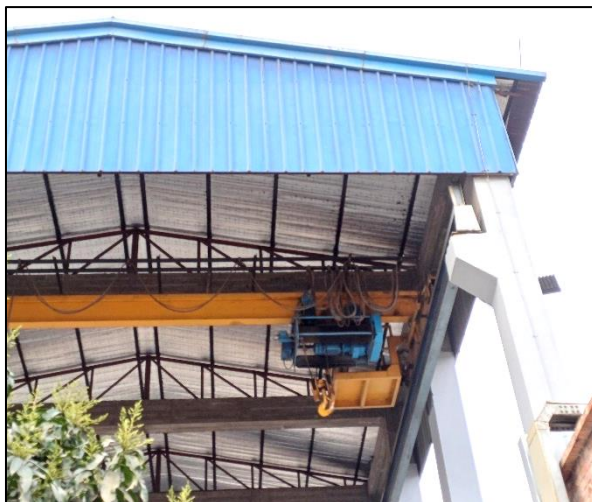
**Observation-05:** Adequacy of gantry girder, corbel and columns for overhead crane need to be checked (ETP Large).

**Description:** In the design report, no adequacy check of gantry girder, corbel and columns for overhead crane have been found. The building engineer is required to incorporate the adequacy check of gantry girder, corbel and columns for overhead crane in design report.

| Observation | Action Plan | Timeline |
|--|---|---|
| Adequacy of gantry girder, corbel and columns for overhead crane need to be checked (ETP Large). | The building engineer is required to incorporate the adequacy check of gantry girder, corbel and columns for overhead crane in design report. | within 6 weeks |
| | Carry out suggested remedial works if required. | within 6 months |

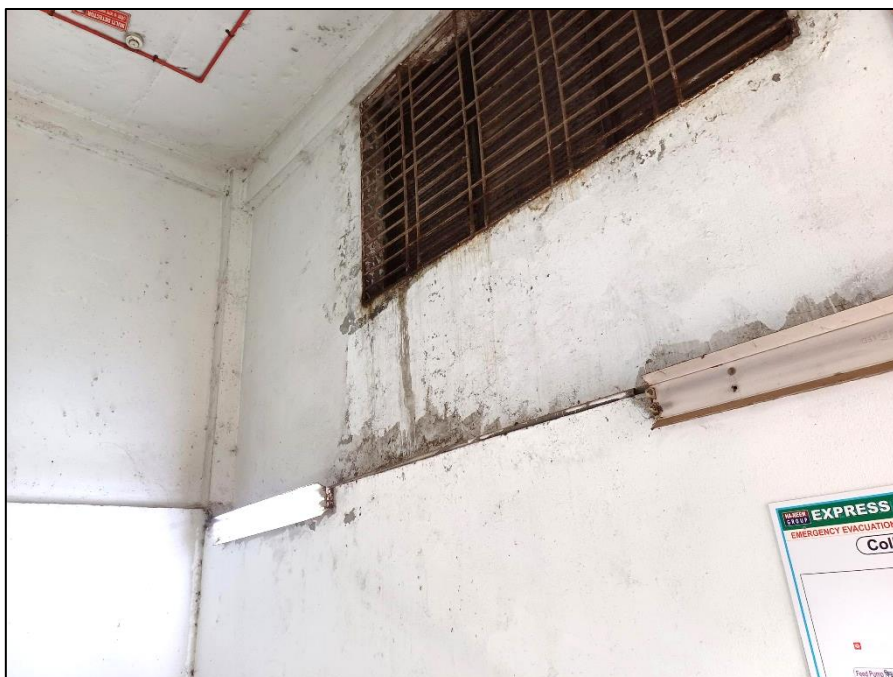
**Observation-06:** Dampness was found on the brick wall. (ETP Large)

**Description:** During the inspection, dampness was found on some brick walls in ETP. The building engineer is required to repair dampness with a suitable method.

| Observation | Action Plan | Timeline |
|--|---|---|
| Dampness was found on the brick wall. (ETP Large) | The building engineer is required to repair the dampness with a suitable method. | within 6 months |

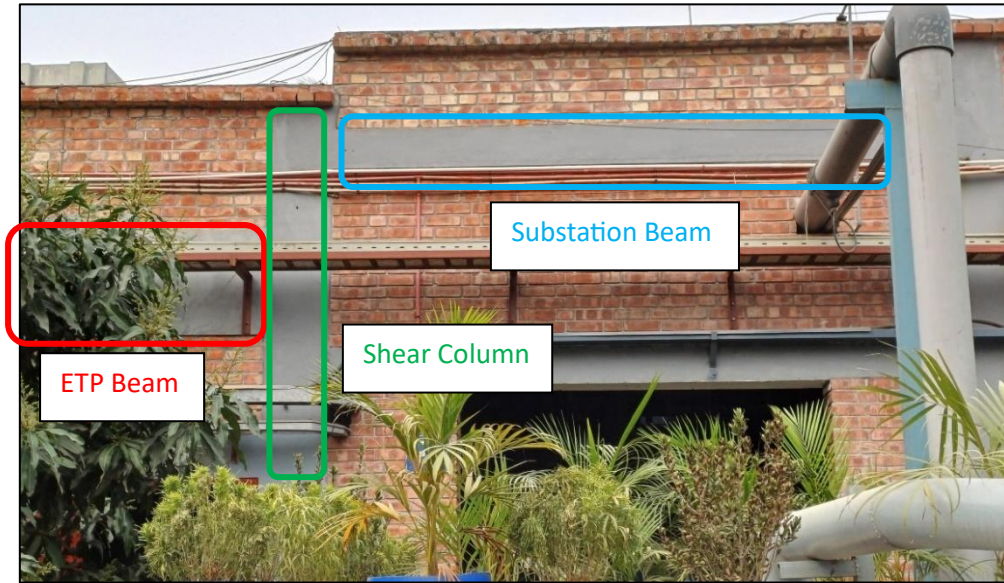
**Observation-07:** ETP Large & ETP Substation building are structurally connected.

**Description:** During the inspection, the ETP large & ETP substation was found structurally connected. However, in the design report, these two structures were analyzed separately. The building engineer is required to revise the design report considering these two structures as one structure.

| Observation | Action Plan | Timeline |
|--|---|---|
| ETP Large & ETP Substation building are structurally connected. | The building engineer is required to revise the design report considering these two structures as one structure | within 6 weeks |
| | Carry out suggested remedial works if required. | within 6 months |

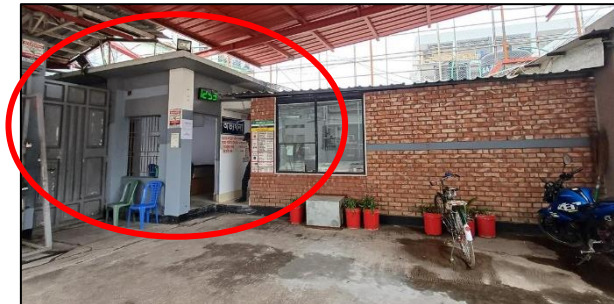
**Observation-08:** Lack of as-built documents for the RC part of the Guard Room.

**Description:** During the inspection, as-built documents for the RC part of the Guard Room were not available.

| Lack of as-built documents for the RC part (Guard Room) | The building engineer is required to survey the structure and prepare as-built documents. | within 6 weeks |

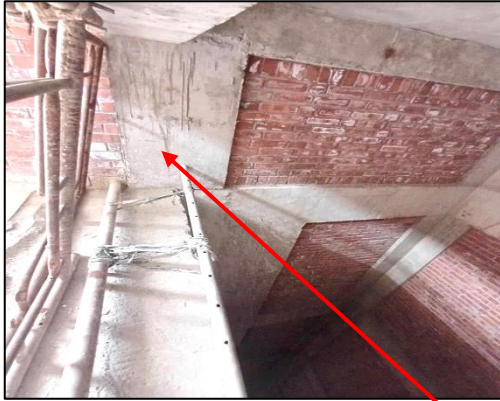
Column size reduced above roof level  
12'X56" to 12" X24"

**Description:** The size of 4 columns below the lift machine room and overhead water tank has been reduced from the roof level. 100 mm thick buildup was found on the 1st floor which was not incorporated in as-built drawing & design report. Mismatch found in concrete compressive strength between as-built drawing and design report (For column: 4500 psi in design report but 4000 psi in drawing, for beam & slab: 3500 psi in design report but 3000 psi in drawing). Live load was mentioned in the design report but no load plan was available during inspection.

The building engineer is required to revise the as-built drawing as per onsite condition, produce the load plan as per BNBC minimum requirement, update the design report as per the revised as-built drawing and load plan and submit all documents to RSC for review.

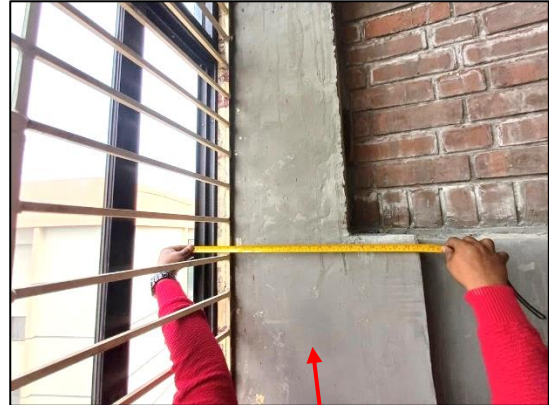
Column size reduced above the roof  
15'X24" to 15' X18"

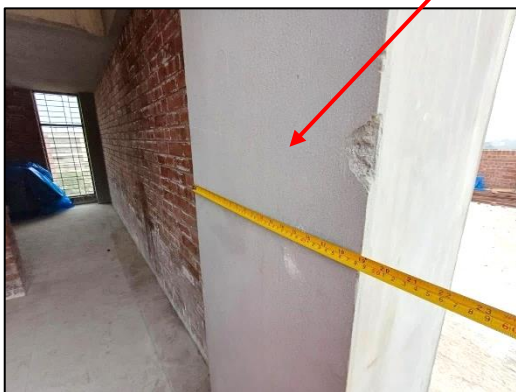
Column size reduced above the roof  
18'X36" to 18" X18"

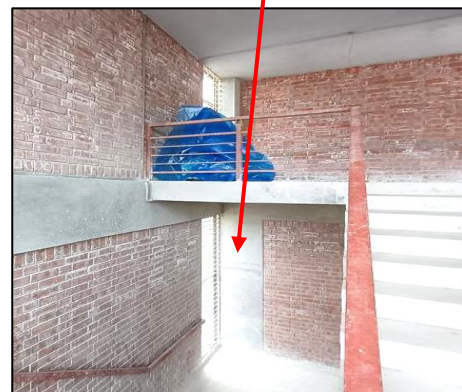
Column size reduced above the roof  
18'X36" to 18" X18"

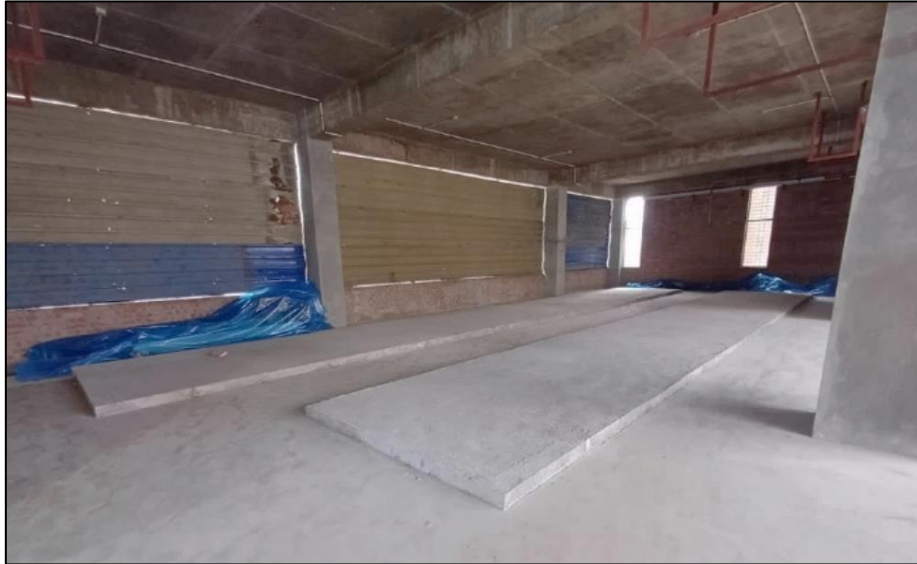
100 mm thick build-up at 1<sup>st</sup> floor is not shown in the drawing or not incorporated in the design report

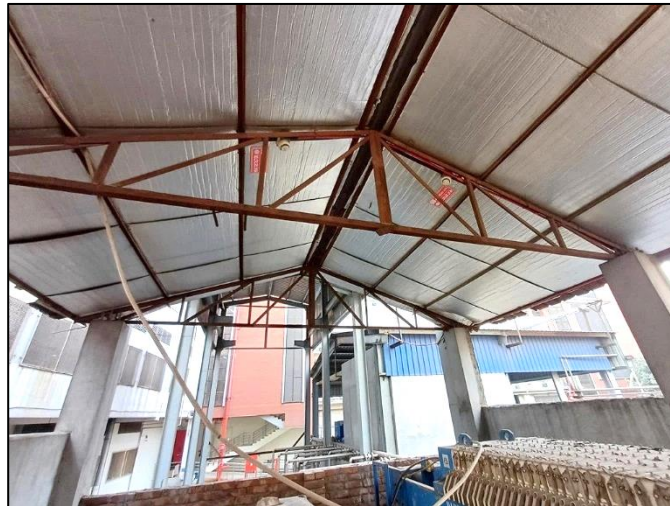
**Observation-10:** Lack of lateral stability system [Shed 1, ETP small (Old)].

**Description:** Truss action was observed in the short direction. No compression strut or load transfer media was observed in the long direction. The building engineer is required to check the lateral stability of the shed and submit it to the RSC review.

| Lack of lateral stability system [Shed 1, ETP small (Old)]. | Building engineer is required to check the lateral stability of the shed and submit it to the RSC review. | within 6 weeks |
| | Carry out remedial work where required. | within 6 months |

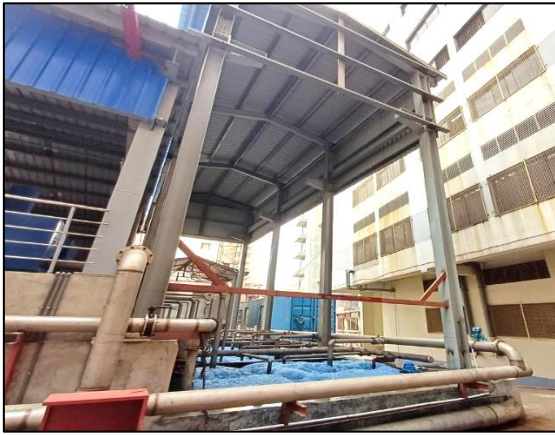
No bracing (Shed 2)

**Description:** The portal frame was observed in the short direction. No bracing (Shed 2 & 3) and no compression strut along the eave (Shed 3) were observed in the long direction. The building engineer is required to check the lateral stability of the sheds as part of the Engineering Assessment (EA).

| Apparently lack of lateral stability system [Shed 2 & 3, ETP small (Old)]. | Building engineer is required to check the lateral stability of the shed and submit it to the RSC review. | within 6 weeks |
| | Carry out remedial work where required. | within 6 months |

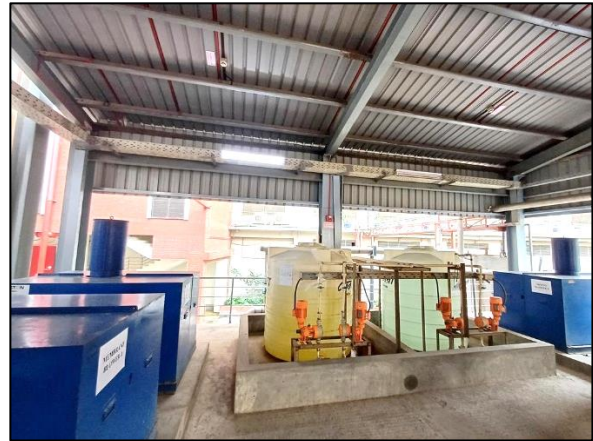
No bracing and no compression strut along eave (Shed 3)

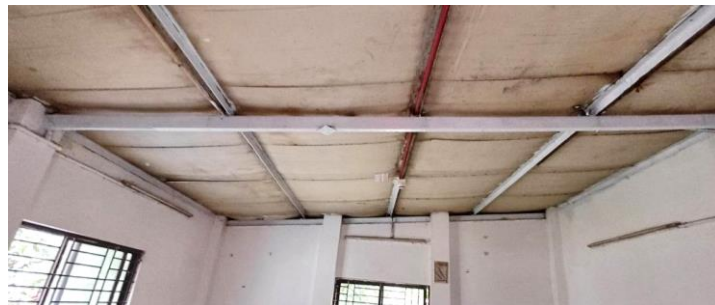
**Observation-12:** Lightweight steel roof shed [Shed 4, ETP small (Old)].

**Description:** Apparently inadequate members and connections were observed at the roof shed. The building engineer is required to check the member and connection adequacy check of the shed.

| Lightweight steel roof shed [Shed 4, ETP small (Old)]. | Building engineer is required to check the lateral stability of the shed and submit it to the RSC review. | within 6 weeks |
| | Carry out remedial work where required. | within 6 months |

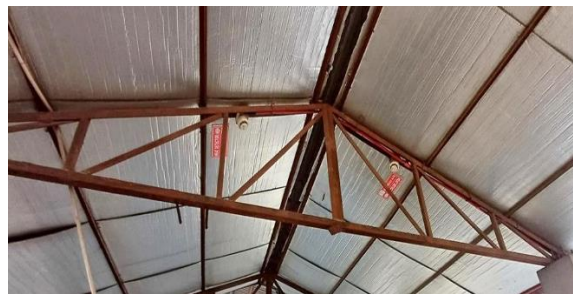
Shed 1

**Description:** Corrosion was observed on steel members of sheds 1 & 2. The building engineer is required to remove rust and apply anti-corrosive paint on steel members.

| Corrosion on steel member [Shed 1 & 2, ETP small (Old)]. | The building engineer is required to remove rust and apply anti-corrosive paint on steel members. | within 6 weeks |

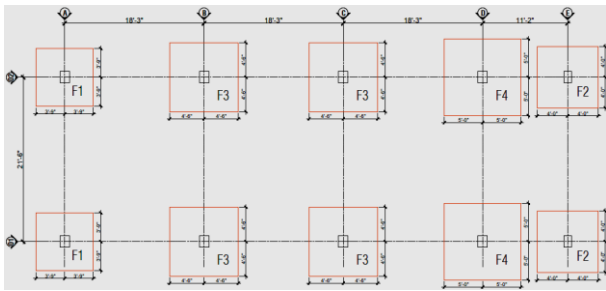
Footing Layout (Construction Drawing)

**Description:** During the inspection, mismatches (some snapshots were provided above) were found in all structural elements (foundation, column, beam, slab etc.) between construction drawing and as-built drawing. The building engineer is required to survey the whole structure & update the as-built drawing as per onsite condition.

| Inconsistency between construction drawing and as-built drawing (Substation & Generator Building). | The building engineer is required to survey the whole structure & update the as-built drawing as per onsite condition. | within 6 weeks |

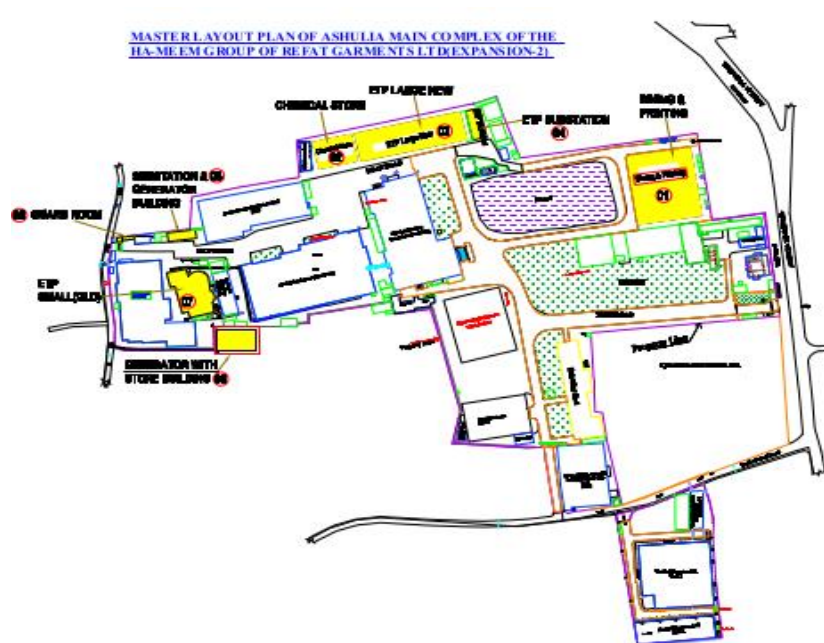
**Observation-16:** Building Permit from the local authority - not available (All Structures)

**Description:** During the inspection, a building permit from the local authority was not available for all the buildings. The factory authority is required to collect building permits from the local authority for the building.

| Building Permit from local authority not available (All Structures) | Factory authority is required to building permit from the local government authority for the building. | within 6 months |
