ARA / Apparel Export Ltd. (Extension)

2/c Darussalam Road, Mirpur, Dhaka
(23.783396, 90.352697)

25 February 2024

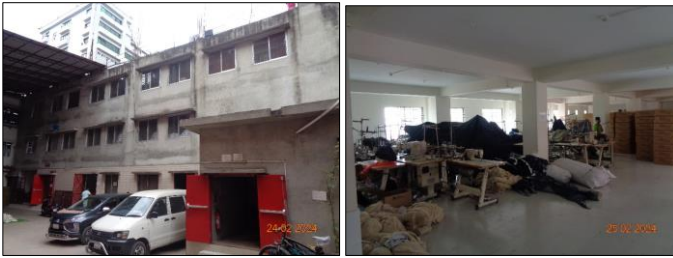
Three-storied building with underground water reservoir and fire pump room

As per the verbal confirmation, the construction of the building was constructed between August 2018 and May 2019. The columns are made of stone chips and beams are made of brick chips. During inspection, as-built drawing was not available for the structure as well as the foundation details are unknown. Also, design documents as well as material test reports were not available.

The Factory engineer is required to survey the whole structure and prepare accurate as built drawing. Also building engineer is required to perform Detail Engineering Assessment (DEA) for the structure based on in-situ material strength, floor live load and geotechnical investigation report and prepare DEA report based on the FEA model.

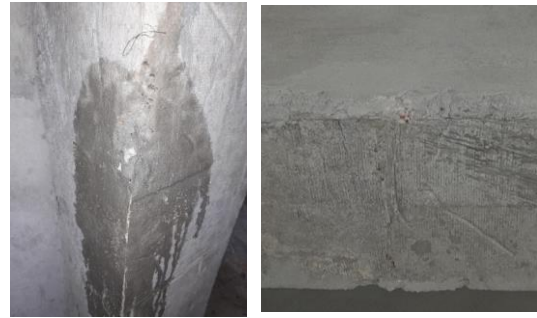
Stone chips aggregate- Column (Left)
Brick chips aggregate- Beam (Right)

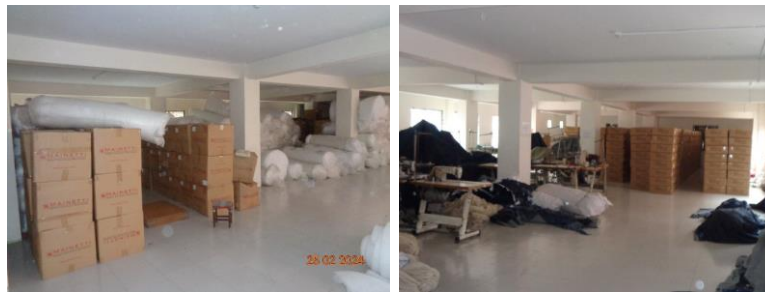
Storage found on the 2nd Floor and 1st floor

During the inspection, the load plan was not available for the building. The building is being used as storage on the 2nd floor and 1st floor. Also, the prayer room and dining hall are being used on the ground floor suspended slab over the underground water reservoir.

The building engineer is required to prepare the loading plan for the building based on the capacity of the structural members and design review. Also, post the load plan at the entry and storage area. The Factory engineer is required to ensure the implementation of the load management program.

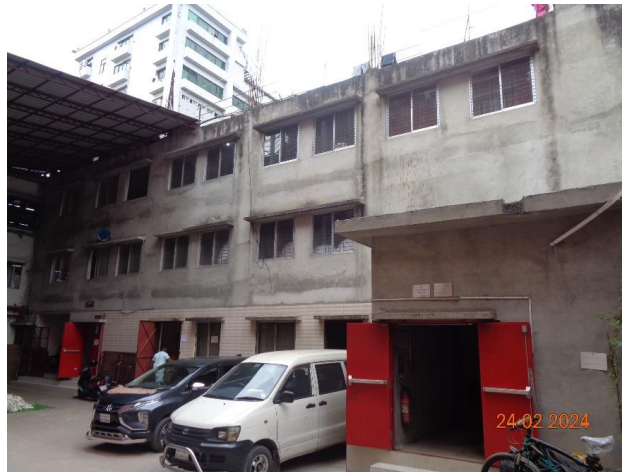
Observation-2: Permit drawing not available (Building-4)

Description: Factory building did not have a permit drawing from any authority. Factory is required to collect permission from the government's local authority.

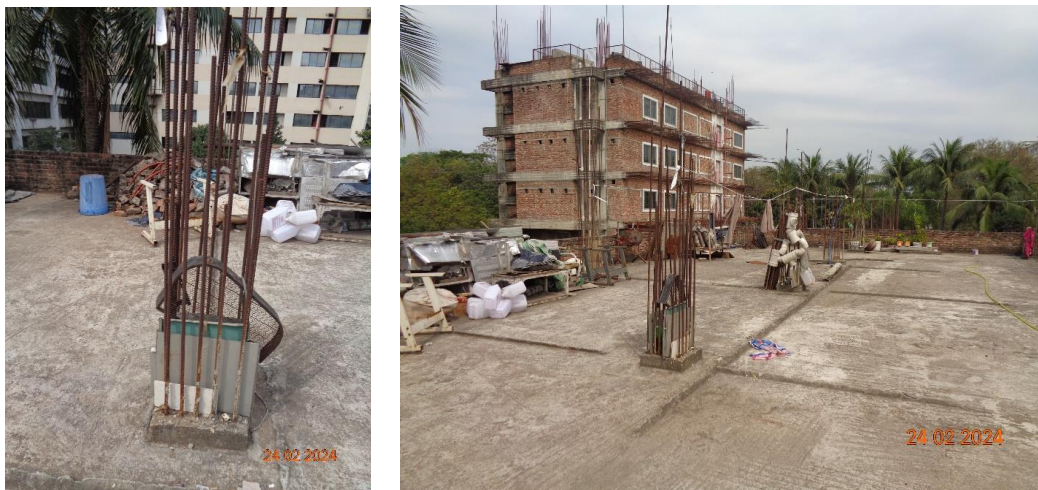
Observation-3: Exposed re-bar at the roof. (Building-4)

Description: Exposed reinforcement was found on roof top for columns. The factory engineer is required to provide anti-corrosive coating in re-bar to prevent the corrosion in exposed rebar.

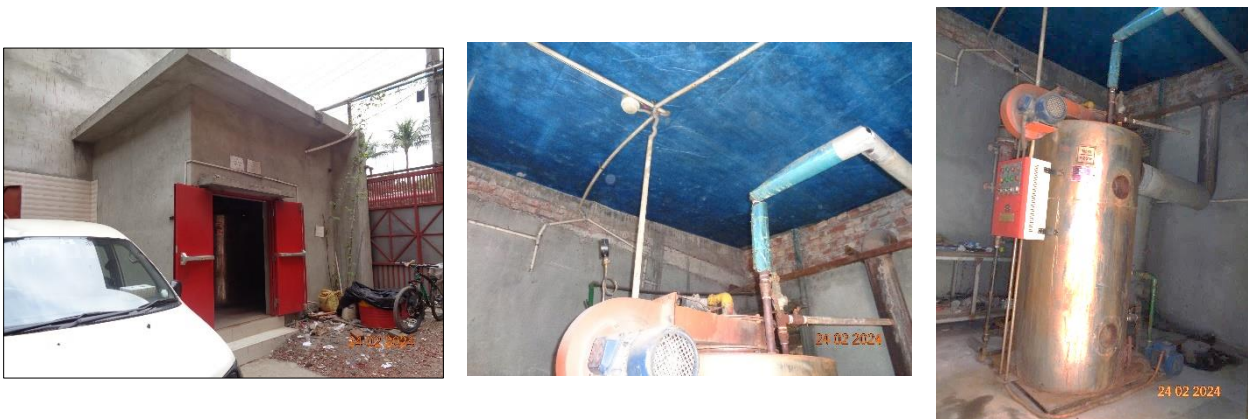
Observation-4: Lack of as-built drawing. (Boiler Room)

Description: No documents were available for the boiler room. Building engineer is required to survey the whole structure and prepare accurate as-built drawing for the boiler room.
