# Supreme Stitch Ltd. (Extension)

West Shaildube, Kashimpur, Gazipur-1700, Dhaka, Bangladesh.

22 February 2024

### Observation 1: Lack of lateral stability (Fabric Store Shed).

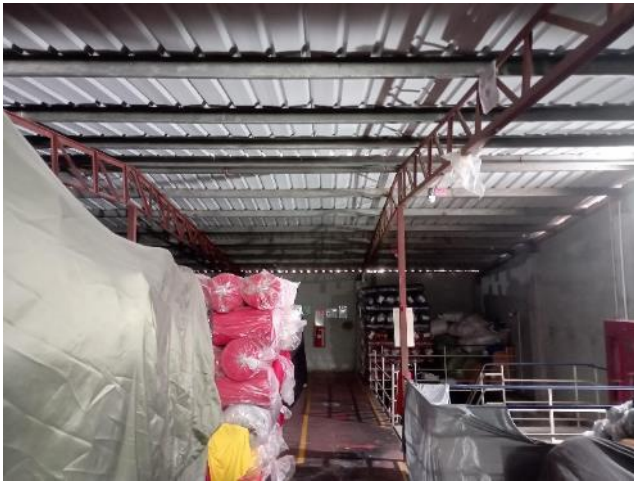
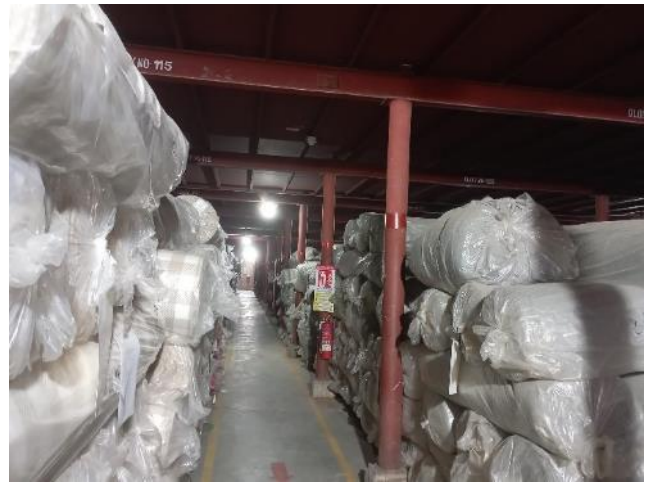
**Description:** No load transfer media (compression strut) and load resisting system (bracing) provided along east-west direction for shed. And all the connections of existing framing are hinged (free of rotation). The building engineer is required to check the connection and lateral stability of the structure and propose suitable remediation plan accordingly.

| Observation | Action Plan | Timeline |
|---|---|---|
| Lack of lateral stability (Fabric Store Shed). | The building engineer is required to check the connection and lateral stability of the structure and propose a suitable remediation plan accordingly. | within 6 weeks |

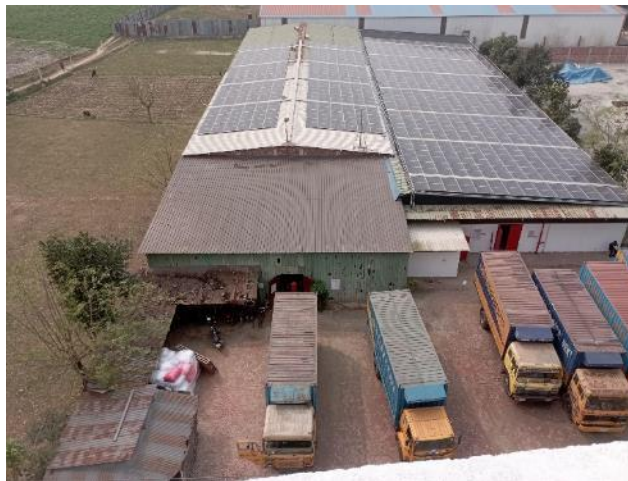
### Observation-2: Lack of geotechnical report (Fabric Store Shed)

**Description:** No geotechnical report was available for the structure. As per of Detail Engineering Assessment (DEA), the geotechnical engineer is required to conduct sub-soil investigation, prepare geotechnical investigation report, and check the capacity of foundations accordingly.

| Observation | Action Plan | Timeline |
|---|---|---|
| Lack of geotechnical report (Fabric Store Shed). | The geotechnical engineer is required to conduct sub-soil investigation and prepare a geotechnical investigation report. | within 6 weeks |

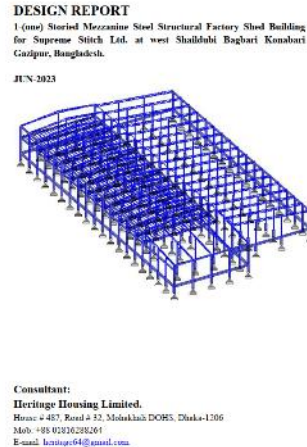
**Observation-3:** Lack of information in design report (Fabric Store Shed).

**Description:** Connection and member adequacy of steel members are not provided in design report. Also, the design report is prepared based on a software analysis, but the software analysis model was not available on site. As part of the DEA, the building engineer is required to prepare the design report as per 1.9.1 BNBC and submit it to RSC for further review.

| Observation | Action Plan | Timeline |
|---|---|---|
| Lack of information in design report (Fabric Store Shed). | As part of the DEA, the building engineer is required to prepare the design report as per 1.9.1 BNBC and submit it to RSC for further review. | within 6 weeks |
| Lack of information in design report (Fabric Store Shed). | Implement remediation work if required. | within 6 months |

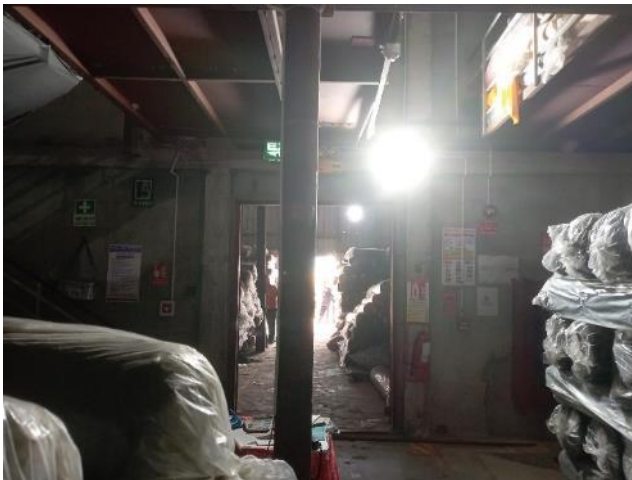
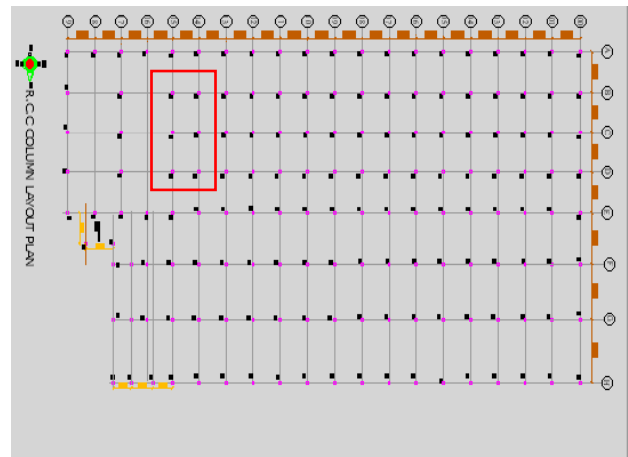
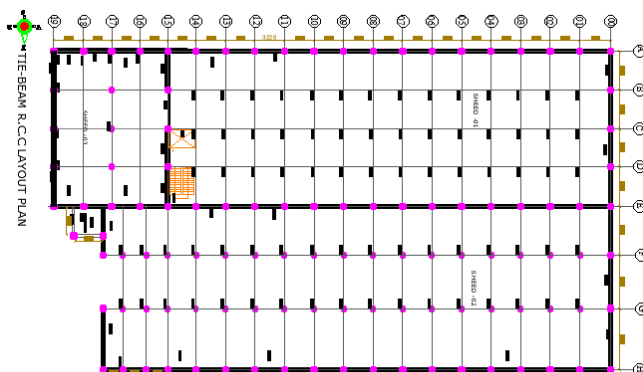
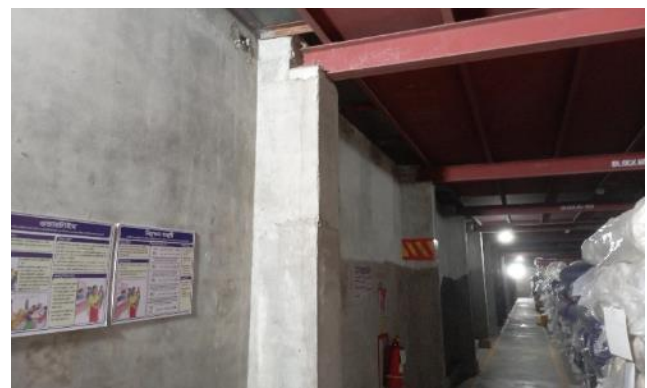
**Observation-4:** Discrepancy in as-built drawing (Fabric Store Shed).

**Description:** Marked columns are not found as per column layout. Also, tie beam is shown at south side but not found on site. The building engineer is required to update the as-built drawing.

| Observation | Action Plan | Timeline |
|---|---|---|
| Discrepancy in as-built drawing (Fabric Store Shed). | The building engineer is required to update the as-built drawing. | within 6 weeks |

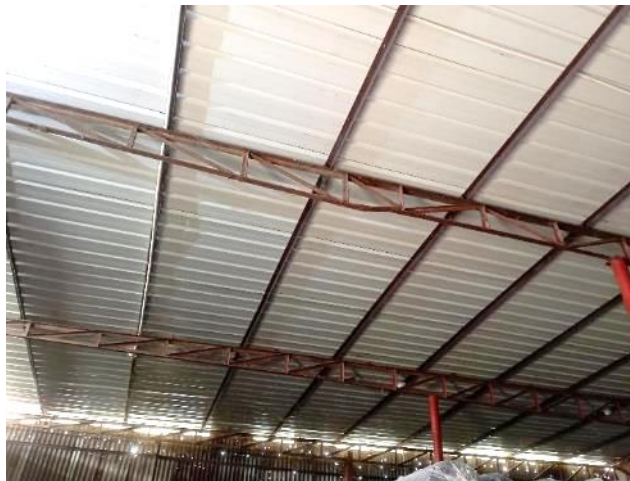
**Observation-5:** Corrosion on steel members (Fabric Store Shed).

**Description:** Corrosion was found at several locations. The building engineer is required to provide rust proof coating on steel members to protect from corrosion.

| Observation | Action Plan | Timeline |
|---|---|---|
| Corrosion on steel members (Fabric Store Shed). | The building engineer is required to provide rust proof coating on steel members to protect from corrosion. | within 6 weeks |
