# Talisman Ltd. (Extension)

Plot # 7-10, 13-16, DEPZ, Ganakbari, Ashulia, Savar, Dhaka-1349.

27 February 2024

## 1. Executive Summary

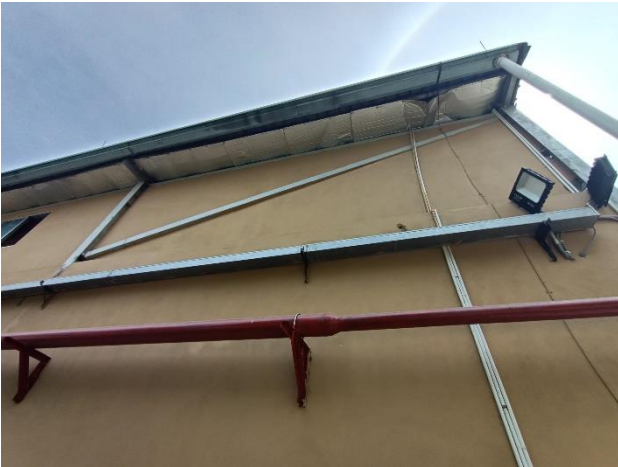
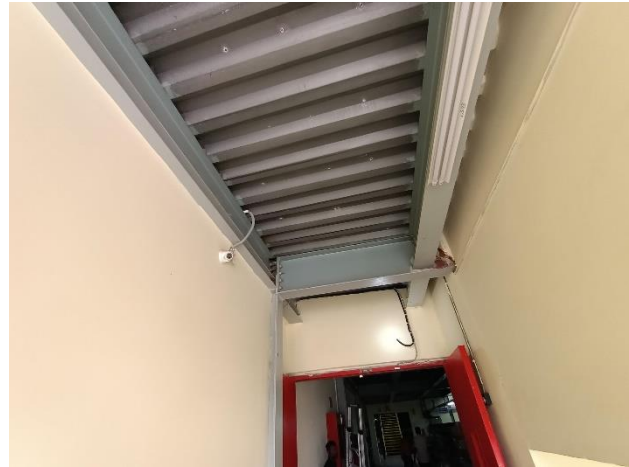
### Observation-1: Mismatch in as-built drawing. (Warehouse Building)

**Description:** Grid dimensions between 17 & 18 were found to be 6.5 m instead of 6 m. Also, a single vertical bracing was found onsite whereas drawings show cross bracing. Moreover, connection details were not found in the drawings.

Observation	Action Plan	Timeline
Mismatch in as-built drawing. (Warehouse Building)	The building engineer is required to update as-built drawing with necessary connection details.	within 6 weeks
Lateral stability needs to be checked for existing bracing system. (Warehouse Building)	Building engineer is required to check the lateral stability of the shed for existing condition.	within 6 weeks
Lateral stability needs to be checked for existing bracing system. (Warehouse Building)	Implement remediation work if required.	within 6 months
Quality of retrofitting work. (Warehouse Building)	Quality of retrofitting work needs to be checked and verified by building engineer.	within 6 weeks
Non-structural elements not anchored or braced. (Warehouse Building)	The factory is required to anchor/brace all non-structural elements adequately to resist earthquake forces.	within 6 weeks
Undocumented non-engineered adjacent structure. (Warehouse Building)	Building engineer is required to separate the structure from Warehouse Building and replace it with an engineered one.	within 6 months

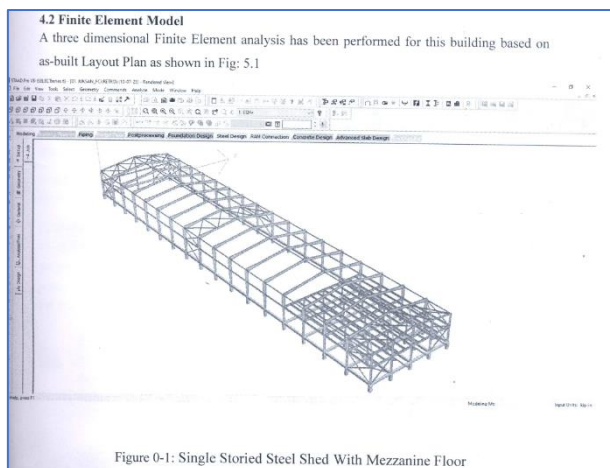
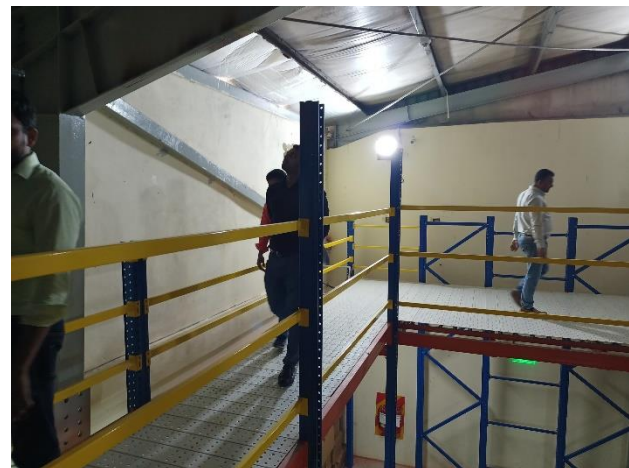
### Observation-2: Lateral stability needs to be checked for existing bracing system. (Warehouse Building)

**Description:** Concentric bracing frames were considered in the FEA model, but on-site eccentric bracings were found. Building engineer is required to check the lateral stability of the shed for existing condition.

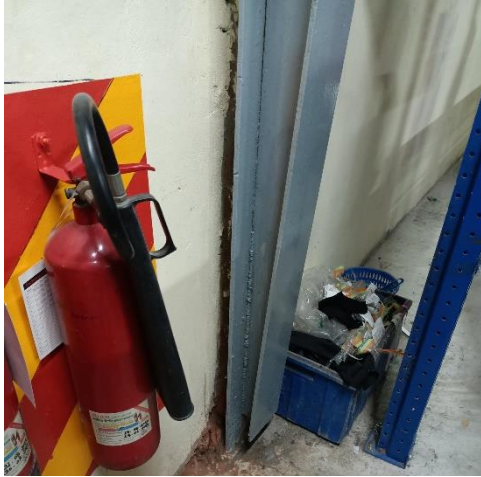
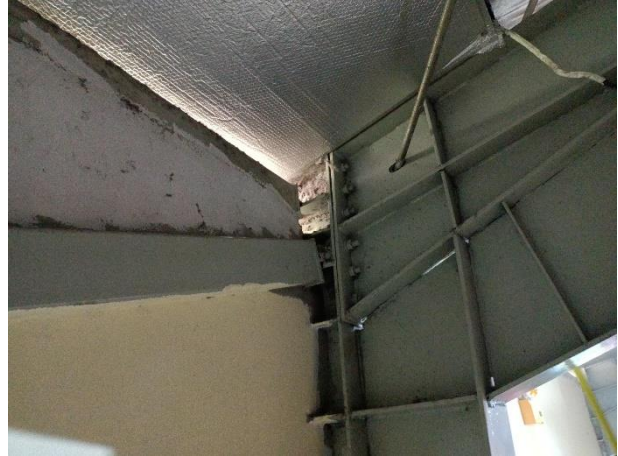
**Observation-3: Quality of Retrofitting work. (Warehouse Building)**

**Description:** Retrofitting works were carried out for steel columns and rafters. No documents or quality control certificates were found. During the inspection, some newly steel section were found poorly welded with existing section.

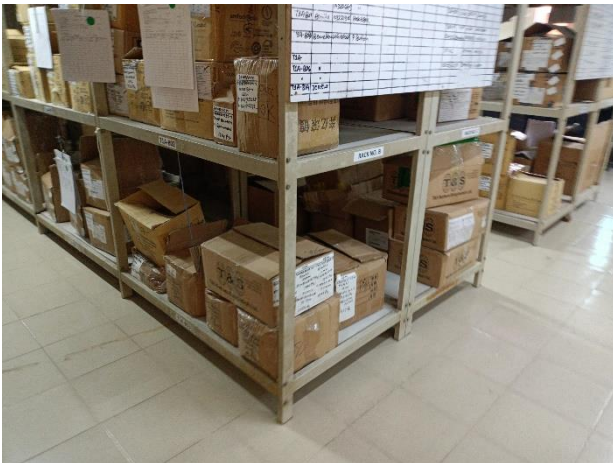
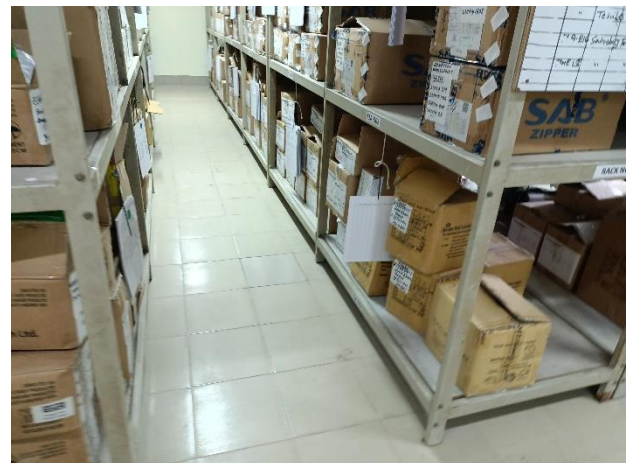
**Observation-4: Non-structural elements not anchored or braced. (Warehouse Building)**

**Description:** Some racks on floors are not anchored or braced to resist lateral (earthquake) forces. The factory is required to anchor/brace all non-structural elements adequately to resist earthquake forces.

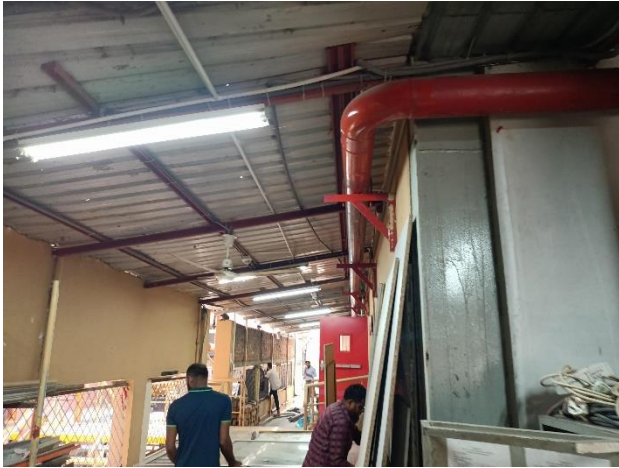
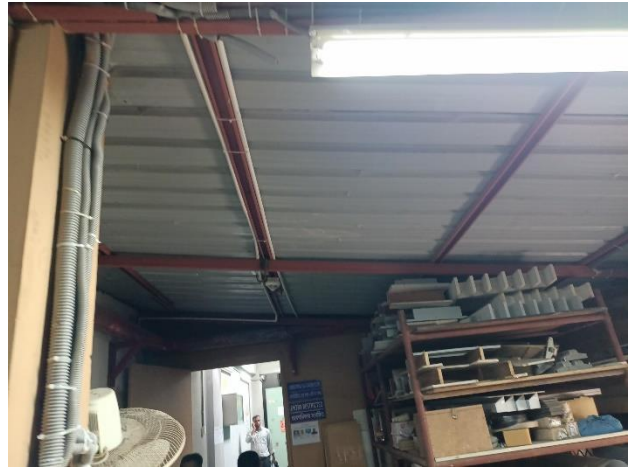
**Observation-5:** Undocumented non-engineered adjacent structure (Warehouse Building).

**Description:** Undocumented non-engineered lightweight steel structure was found adjacent to the Warehouse Building at South and East (partial). Building engineer is required to separate the structure from the Warehouse Building and replace it with an engineered one.

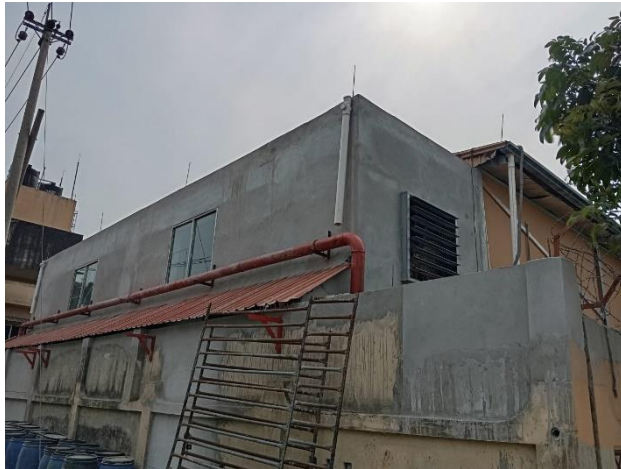
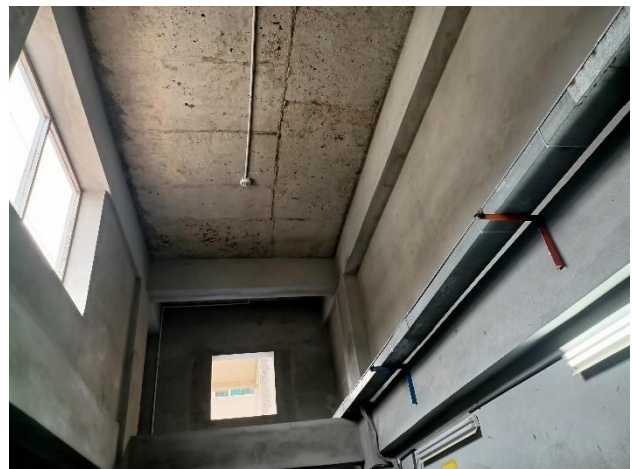
**Observation-6:** Absence of design documents. (Substation Building)

**Description:** As per BNBC, every building or structure designed shall have its design documents prepared following the provision of Section 1.9.1. The design document shall include a design report, and a set of structural drawings, which shall be prepared in compliance with section 1.9.1.1 and section 1.9.1.2 as per BNBC. At the time of inspection, a design report was not available which is required to be prepared in compliance with BNBC 2020.

Absence of design documents. (Substation Building)	Building engineer is required to prepare the design documents including a design report, and a set of structural drawings in compliance with section 1.9.1.1 and section 1.9.1.2, part-6 of BNBC and submit it to RSC for review.	within 6 weeks
Absence of design documents. (Substation Building)	Carry out remediation work if required.	within 6 months
Lack of as-built drawings. (Security Building)	The building engineer is required to survey the structure and prepare a full set of as-built drawings.	within 6 weeks

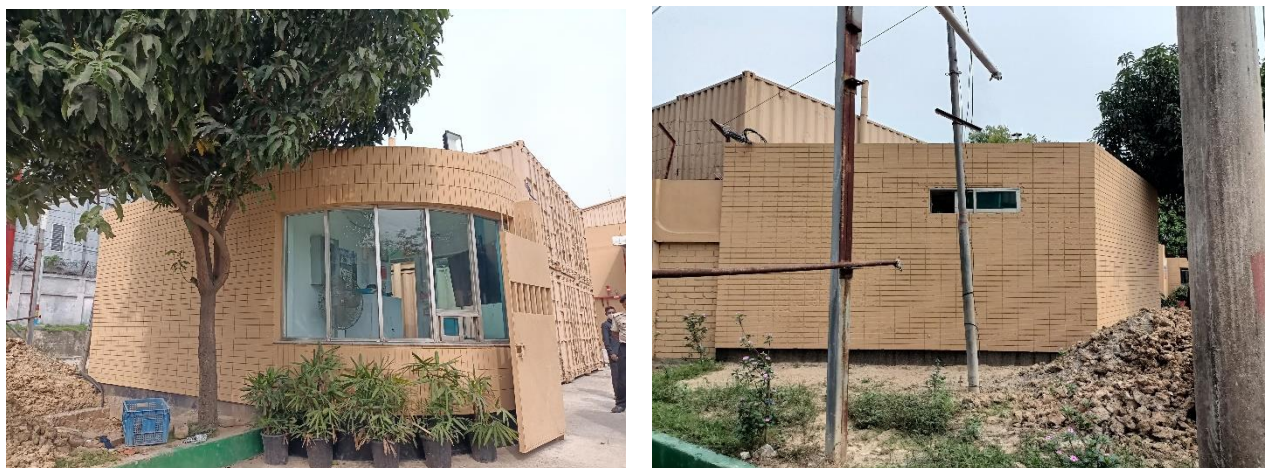
**Observation-7: Lack of as-built drawings. (Security Building)**

**Description:** Structural and architectural drawings were not found for the Security Building. The building engineer is required to survey the structure and prepare a full set of as-built drawings.
