# Fakir Fashion Ltd. (Extension - 3)

Dohargaon, Baliapara, Rupgonj.

5 February 2024

## 2. Observations

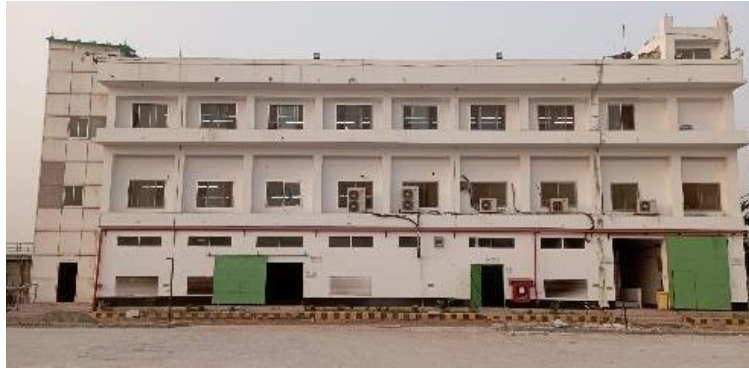
### Observation-1: Absence of design documents (Building-8 -New ETP).

**Description:** As per BNBC, every building or structure designed shall have its design documents prepared in accordance with the provision of Section 1.9.1. The design document shall include a design report, and a set of structural drawings, which shall be prepared in compliance with section 1.9.1.1 and section 1.9.1.2 as per BNBC. At the time of inspection, no architectural drawing or design reports were available which are required to be prepared in compliance with section 1.9.1.1 and section 1.9.1.2 (part 6, BNBC).

| Observation | Action Plan | Timeline |
|---|---|---|
| Absence of design documents (Building-8 -New ETP). | The building engineer is required to prepare a set of design report with a set of structural drawing in compliance with section 1.9.1.1 and section 1.9.1.2 (part 6, BNBC). | within 6 weeks |
| | Implement remediation work if required. | within 6 months |

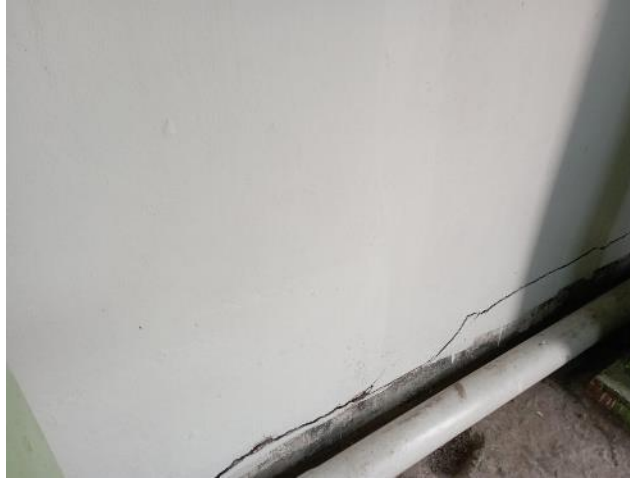
**Observation-3:** Crack on brick wall at ground floor (Building-8 -New ETP).

**Description:** Crack was found on brick wall at ground floor. The building engineer is required to investigate the reason of crack and repair as per investigation report.

| Observation | Action Plan | Timeline |
|---|---|---|
| Crack on brick wall at ground floor (Building-8 -New ETP). | The building engineer is required to investigate the reason of crack and repair as per investigation report. | within 6 weeks |

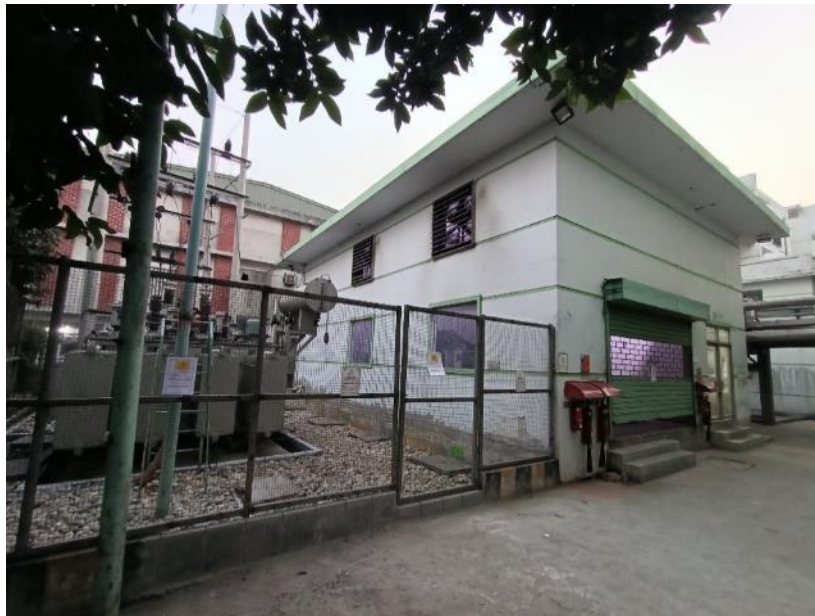
**Observation-4:** Incomplete as-built drawings (Building-10).

**Description:** Full set of as-built drawings were not available for the Transformer & Electric Substation building. Building engineer is required to survey the whole structure and prepare complete structural and architectural drawings for the building.

| Observation | Action Plan | Timeline |
|---|---|---|
| Incomplete as-built drawings (Building-10). | Building engineer is required to survey the whole structure and prepare complete structural and architectural drawings for the building. | within 6 weeks |

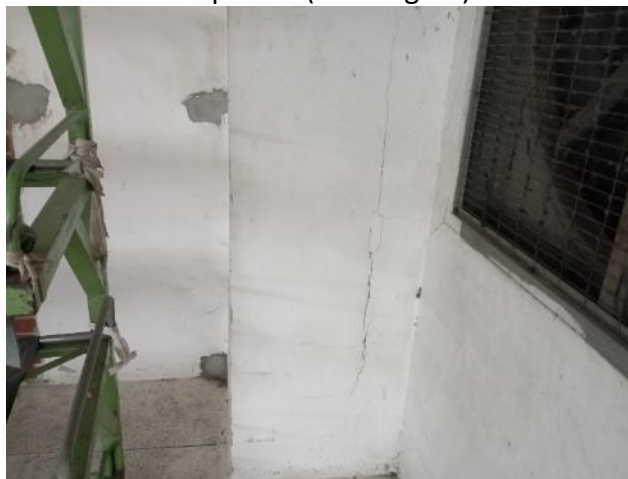
**Observation-06:** Crack on brick wall at top floor (Building-12).

**Description:** Crack was found on brick wall at top floor. The building engineer is required to investigate the cracked area and repair with a suitable method.

| Observation | Action Plan | Timeline |
|---|---|---|
| Crack on brick wall at top floor (Building-12). | The building engineer is required to investigate the cracked area and repair with a suitable method. | within 6 weeks |

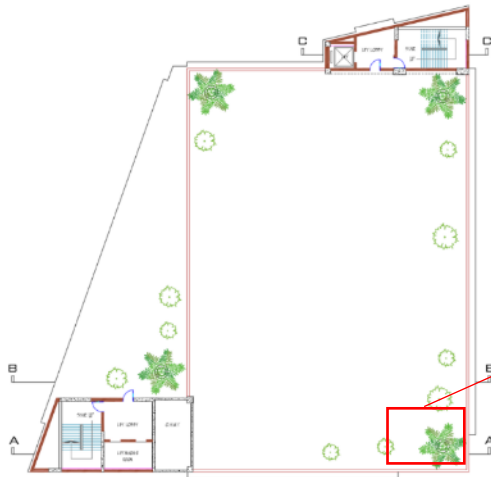
Roof floor plan

**Description:** During the inspection, a mismatch was found in the architectural floor layout.

- The marked staircase was not shown in architectural roof floor plan.
- The toilet location also doesn't match with the provided architectural floor plan.

The building engineer is required to survey the full structure and update the as-built drawing and design report accordingly.

| Observation | Action Plan | Timeline |
|---|---|---|
| Mismatch in as-built drawing. (Building 16) | The building engineer is required to survey the full structure and update the as-built drawing and design report accordingly. | within 6 weeks |

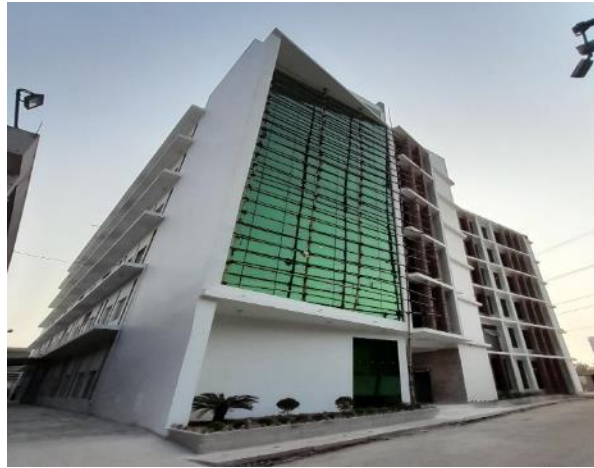
**Observation 08:** Absence of design report. (Building 16)

**Description:** As per BNBC, every building or structure designed shall have its design documents prepared in accordance with the provision of Section 1.9.1. During inspection, the design report was not available on site. Also, to confirm the design strength, the number of cylinders taken are not adequate as per the frequency test criteria of BNBC (Section 5.12).

The building engineer is required to prepare a set of design documents including as built drawings, live load plan at roof and a design report based on in-situ material strength and software-based analysis which shall be prepared in compliance with section 1.9.1, part-6 of BNBC.

| Observation | Action Plan | Timeline |
|---|---|---|
| Absence of design report. (Building 16) | The building engineer is required to prepare a set of design documents including as built drawings, live load plan at roof and a design report based on in-situ material strength and software-based analysis which shall be prepared in compliance with section 1.9.1, part-6 of BNBC. | within 6 weeks |

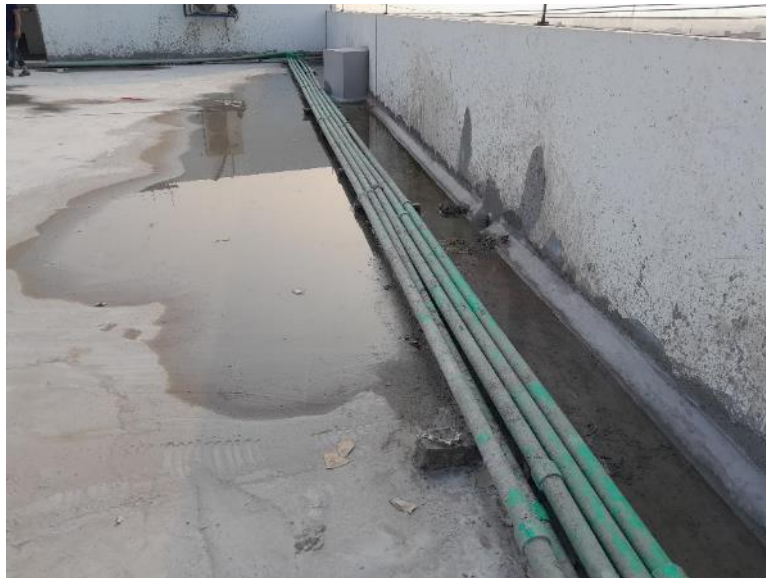
**Observation-09:** Water clogging and lack of drainage system on roof. (Building 16)

**Description:** During inspection, water ponding was observed on the roof. The building engineer is required to improve adequate slope for drainage purpose.

| Water clogging and lack of drainage system on roof. (Building 16) | The building engineer is required to improve adequate slope for drainage purpose. | within 6 months |

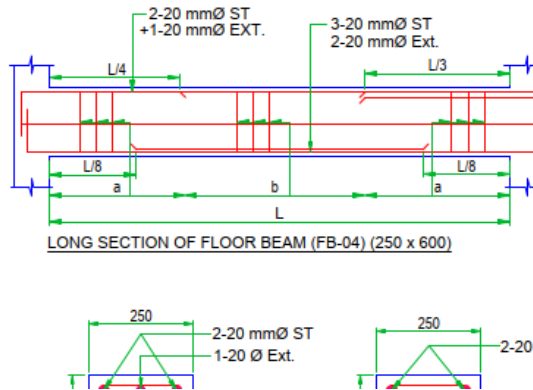
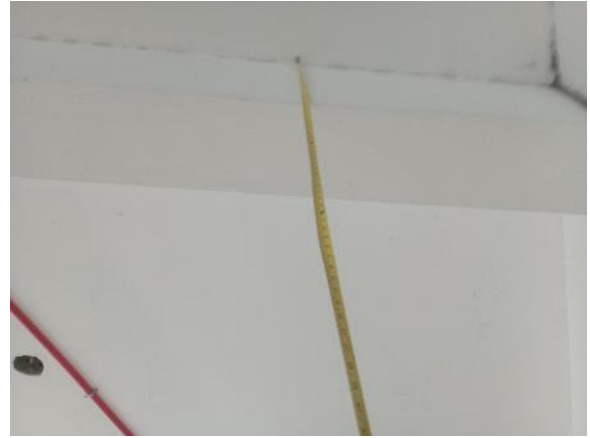
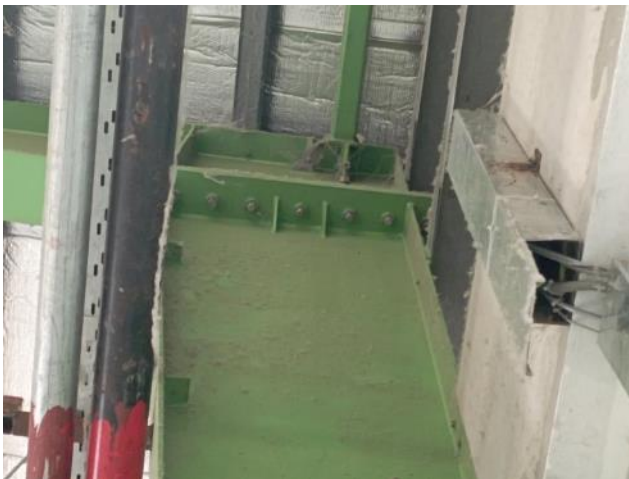
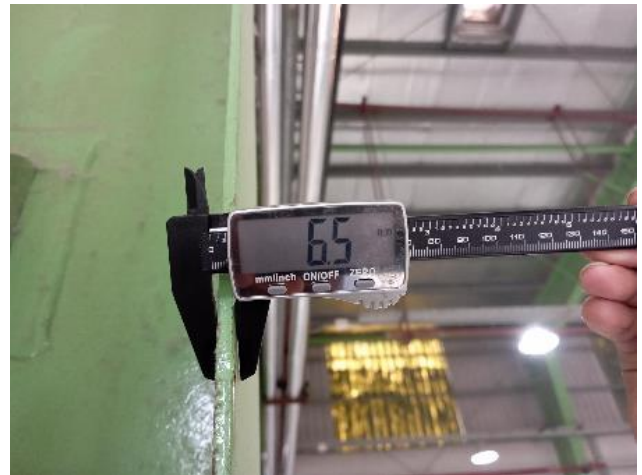
**Observation 12:** Lack of information and discrepancy in as-built drawing (Shed-13).

**Description:** thickness of column at gable side (east) was measured as 6mm instead of 8mm. No connection details were available. Also, Depth of beam was measured 500 mm instead of 600 mm (shown in drawing). The building engineer is required to update the as-built drawing.

| Lack of information and discrepancy in as-built drawing (Shed-13). | The building engineer is required to update the as-built drawing. | within 6 weeks |

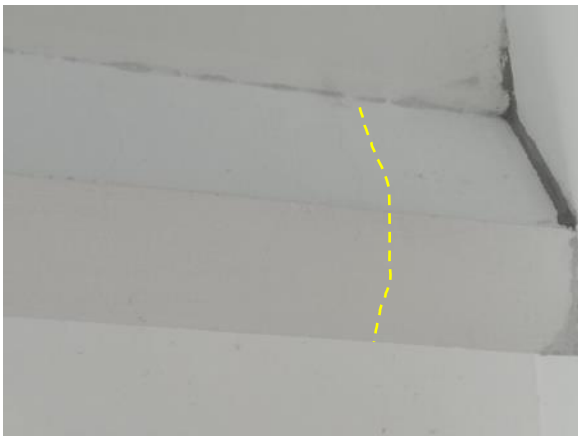
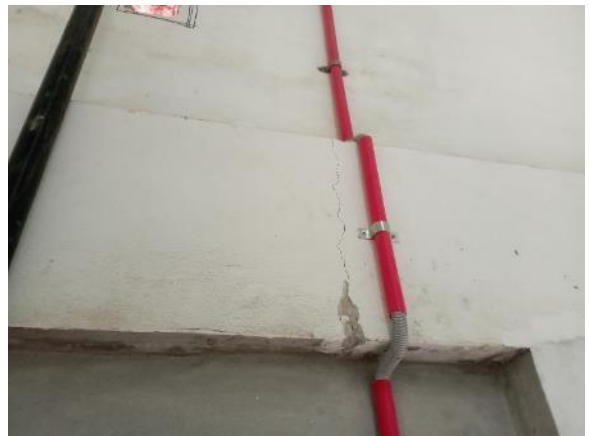
**Observation-13:** Hairline cracks on floor beams (Shed-13)

**Description:** Hairline crack was observed on floor and tie beams at several locations. The building engineer is required to investigate the reason of crack and repair as per investigation report.

| Hairline cracks on floor beams (Shed-13) | The building engineer is required to investigate the reason of crack and repair as per investigation report. | within 6 weeks |

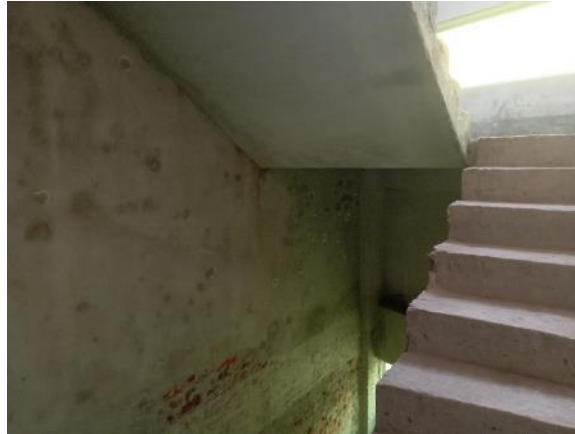
**Observation-14:** Falling hazard at staircase (Shed-13)

**Description:** Railing was not observed at staircase area. The building engineer is required to provide edge protection to avoid falling hazard.

| Falling hazard at staircase (Shed-13) | The building engineer is required to provide edge protection to avoid falling hazard. | within 6 weeks |

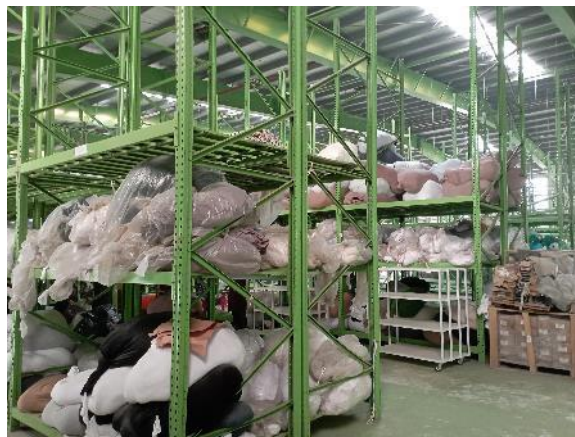
**Observation-15:** Storage rack found not anchored/braced (Shed-13)

**Description:** Storage rack was found not anchored/braced. The building engineer is required to anchor/brace all nonstructural elements within the factory.

| Storage rack found not anchored/braced (Shed-13) | The building engineer is required to anchor/brace all nonstructural elements within the factory. | within 6 months |

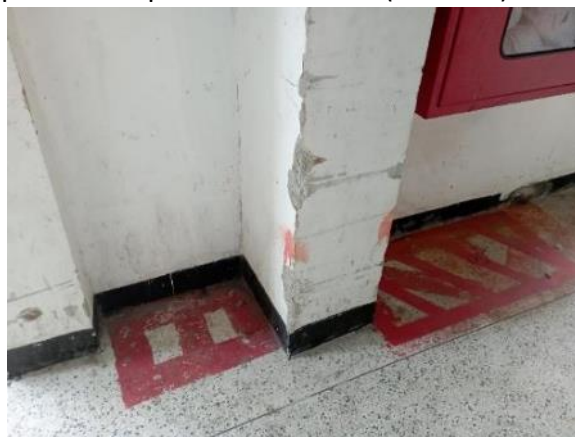
**Observation-16:** Trolley impact on RC pedestal columns (Shed-13)

**Description:** Trolley impact was observed on RC pedestal columns. The building engineer is required to repair the damaged plaster and provide guard to prevent trolley impact on RC pedestal columns.

| Trolley impact on RC pedestal columns (Shed-13) | The building engineer is required to repair the damaged plaster and provide column guard to prevent trolley impact on RC pedestal columns. | within 6 weeks |

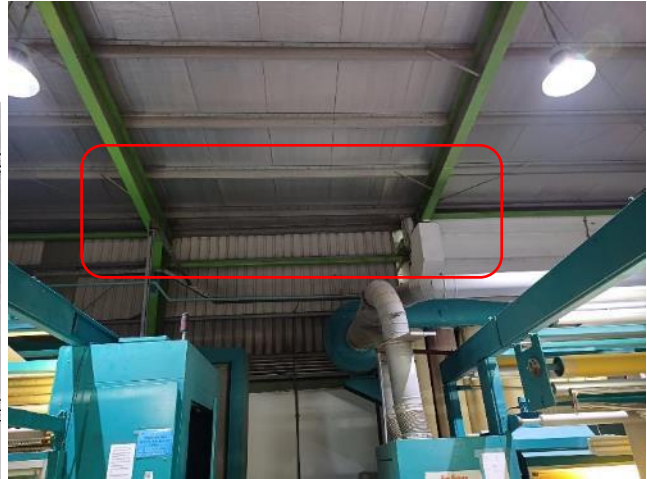
**Observation-17:** Inconsistencies in as-built drawings (Shed-16).

**Description:** Number of rebar in RC column doesn't match with as-built condition. Also, strut member was found offset. Moreover, all sectional and corbel details were not found in as-built drawings. Building engineer is required to survey the whole structure and prepare accurate as-built drawings.

| Inconsistencies in as-built drawings (Shed-16). | Building engineer is required to survey the whole structure and prepare accurate as-built drawings. | within 6 weeks |

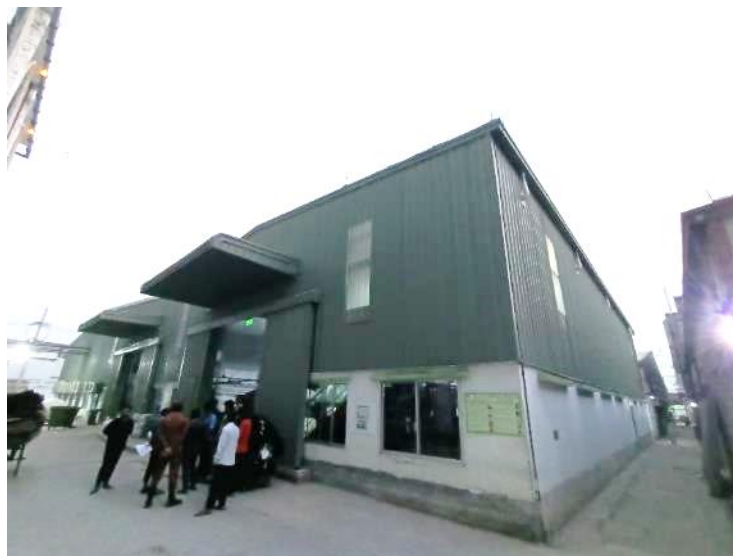
**Observation-18:** Absence of design documents. (Shed 16)

**Description:** As per BNBC, every building or structure designed shall have its design documents prepared in accordance with the provision of Section 1.9.1. During inspection, the design report was not available on site. Also, to confirm the design strength, the number of cylinders taken are not adequate as per the frequency test criteria of BNBC (Section 5.12).

The building engineer is required to prepare a set of design documents including as built drawings, live load plan at roof and a design report based on in-situ material strength and software-based analysis which shall be prepared in compliance with section 1.9.1, part-6 of BNBC.

| Absence of design documents. (Shed 16) | The building engineer is required to prepare a set of design documents including as built drawings, live load plan at roof and a design report based on in-situ material strength and software-based analysis which shall be prepared in compliance with section 1.9.1, part-6 of BNBC. | within 6 weeks |

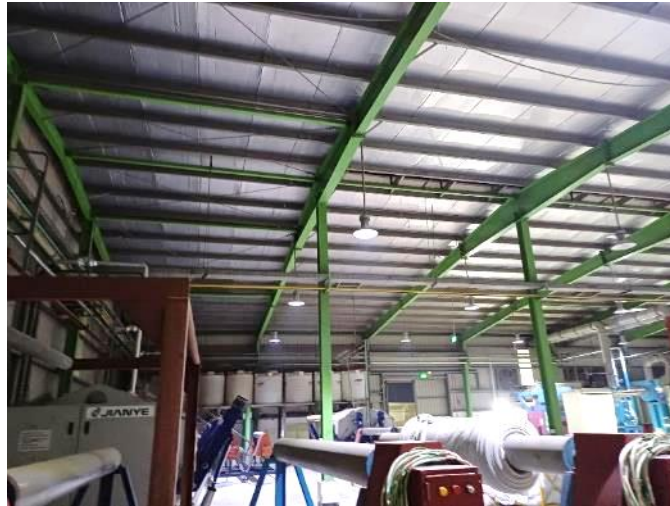
**Observation-19:** Loose cable bracings (Shed-16).

**Description:** Loose cable bracing was observed in several locations. Building engineer is required check all the cable bracing and tighten them accordingly.

| Loose cable bracings (Shed-16). | Building engineer is required check all the cable bracing and tighten them accordingly. | within 6 months |

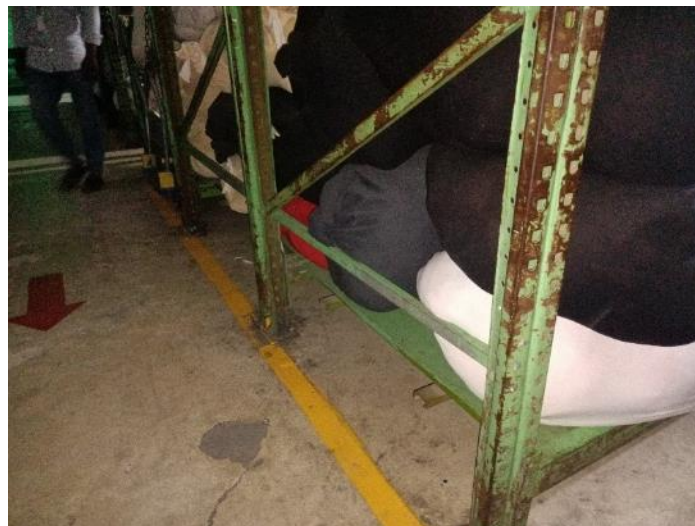
**Observation-20:** Storage rack found not anchored/braced (Shed-16)

**Description:** Storage rack was found not anchored/braced. The building engineer is required to anchor/brace all nonstructural elements within the factory.

| Storage rack found not anchored/braced (Shed-16) | The building engineer is required to anchor/brace all nonstructural elements within the factory. | within 6 months |

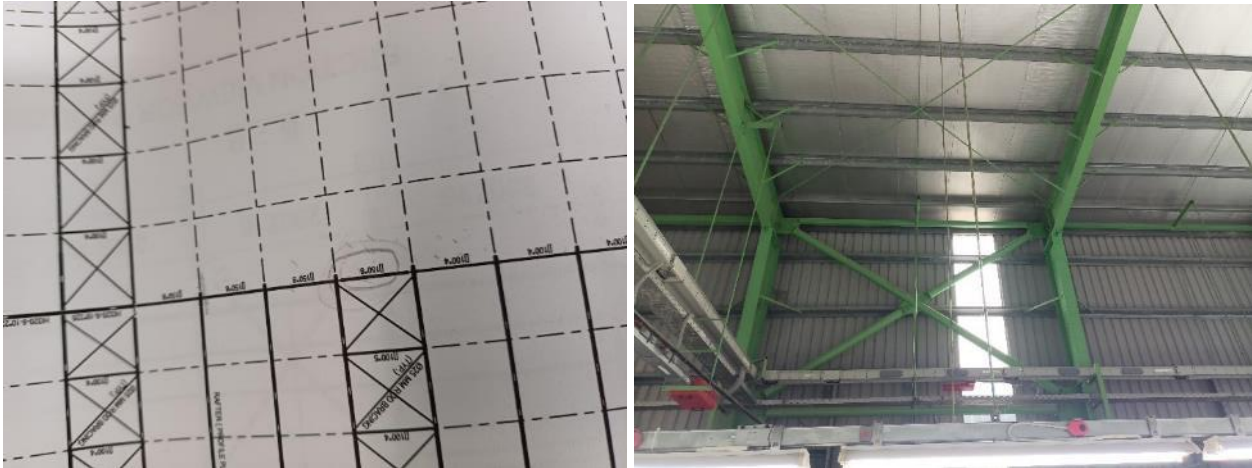
**Observation-21:** Mismatches in as-built drawings (Shed-19).

**Description:** Size of compression strut in between grid 9 & 10 doesn't match with as-built condition (100 mm was found instead of 150 mm). Moreover, all sectional details were not found in the provided as-built drawings. Building engineer is required to survey the full structure and prepare accurate as-built drawings.

| Mismatches in as-built drawings (Shed-19) | Building engineer is required to survey the full structure and prepare accurate as-built drawings. | within 6 weeks |

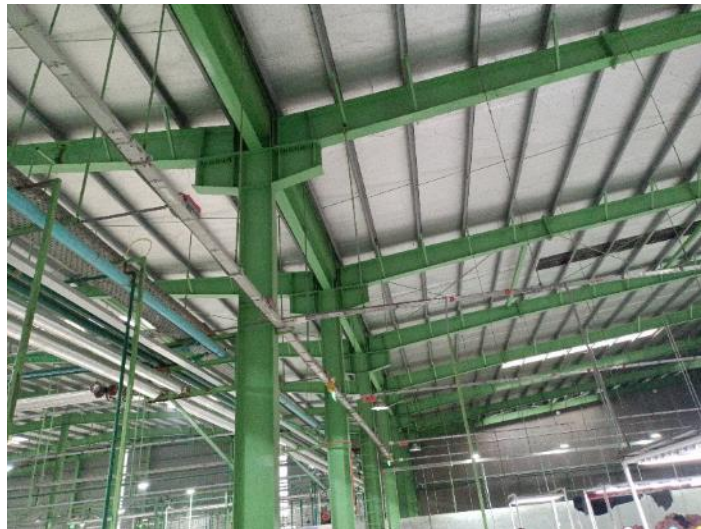
**Observation-22:** Design report required to be reviewed by RSC for lateral loading. (Shed 19)

**Description:** A set of design reports was available for the Shed. The design report needs to be reviewed against lateral loading by RSC. Submit the design documents to the RSC for review.

| Design report required to be reviewed by RSC for lateral loading. (Shed 19) | The design report needs to be reviewed against lateral loading by the RSC. Submit the design documents to the RSC for review. | within 6 weeks |

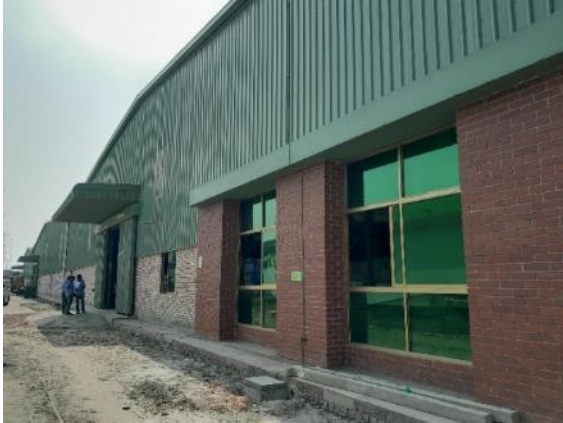
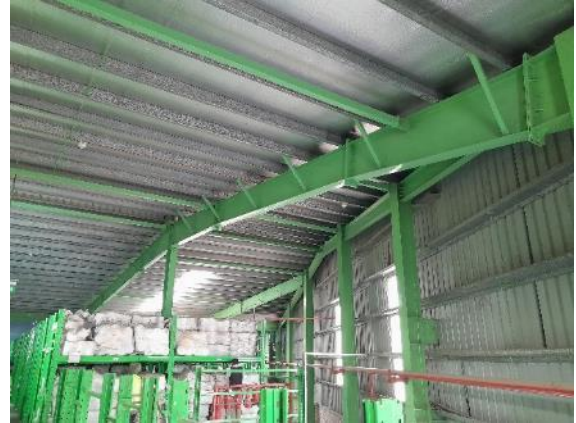
**Observation 23:** Inconsistencies in design report. (Shed 20)

**Description:** A Design Report was provided for Shed-20 where steel connection adequacy and foundation adequacy checks were not incorporated. The building engineer is required to revise the design report with all kinds of necessary calculations & consideration and submit it to RSC for review.

| Inconsistencies in design report. (Shed 20) | The building engineer is required to revise the design report with all kinds of necessary calculations & consideration and submit it to RSC for review. | within 6 weeks |

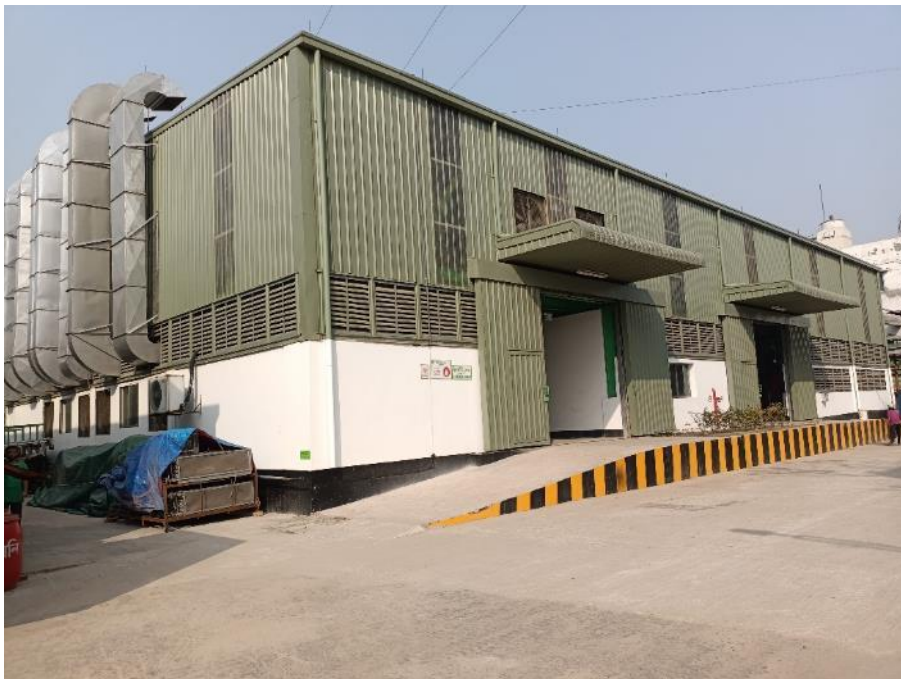
**Observation-24:** Design report required to be reviewed against lateral loading by RSC (Shed 21).

**Description:** A set of design reports was available for the Shed. The design report needs to be reviewed against lateral loading by RSC. Submit the design documents to the RSC for review.

| Design report required to be reviewed against lateral loading by RSC (Shed 21). | The design report needs to be reviewed against lateral loading by the RSC. Submit the design documents to the RSC for review. | within 6 weeks |
