# Metro Knitting & Dyeing Mills Ltd (Factory-02) (Extension 2)

Charabag, Ashulia, Savar  
(23.885180N, 90.310123E)  
29 February 2024

## 1. Building Information

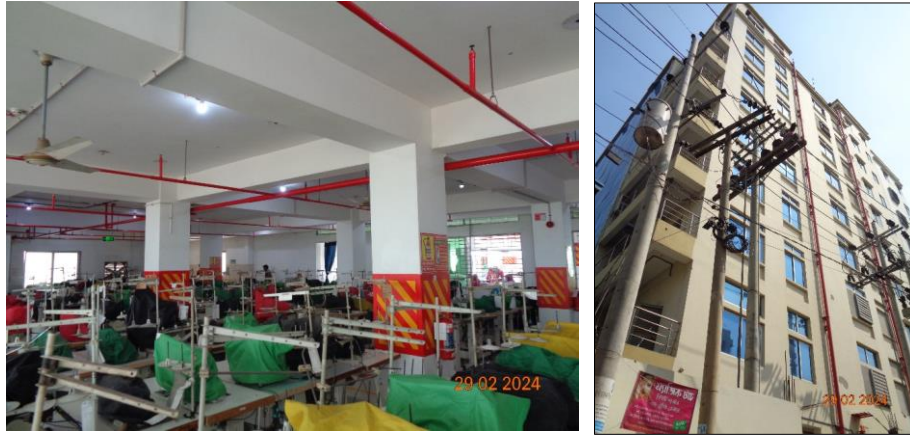
**Observation-1:** Lack of Design documents. Building-5 (Extension Building).

During the inspection, as-built architectural and structural drawings, load plans, geotechnical investigation report, and material test reports were available for the structure. However, a full set of design documents was unavailable per BNBC.

**Description:** As per BNBC, every building or structure designed shall have its design documents prepared following the provision of Section 1.9.1. The design document shall include a design report, and a set of structural drawings, which shall be prepared in compliance with section 1.9.1.1 and section 1.9.1.2 as per BNBC.

The factory engineer is required to prepare the full design documents based on in-situ material strength and load plan including a design report based on the FEA model in compliance with section 1.9.1 (part 6, BNBC).

| Serial No | Observation | Action Plan | Timeline |
|---|---|---|---|
| 1 | Lack of as Design documents. Building-5 (Extension Building) | Building engineer to Survey the whole structure and prepare accurate as-built drawings including the detailed foundation information. | within 6 weeks |
| 2 | Lack of as Design documents. Building-5 (Extension Building) | Building engineer to prepare the design document including a design report, and a set of structural drawings in compliance with section 1.9.1.1 and section 1.9.1.2 as per BNBC. | within 6 weeks |
| 3 | Lack of as Design documents. Building-5 (Extension Building) | Produce and actively manage a loading plan for all floor plates considering floor and column capacity. | within 6 weeks |

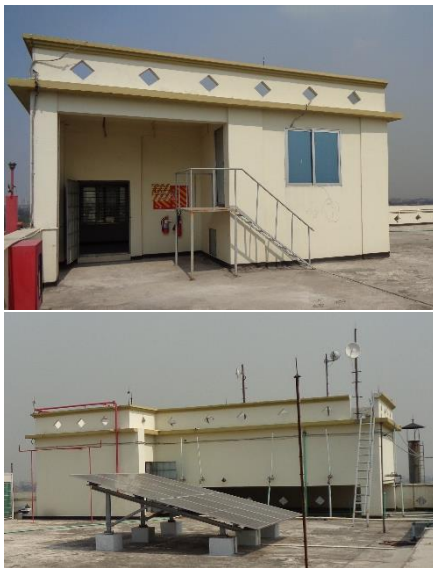
Staircase and OHWT

The structural details of the Overhead Water Tank and stair top details are not provided in the structural drawing. Also, a mismatch was found in the as-built drawing. In the floor layout plan, the toilet has been shown but at site condition, the toilet has not been constructed.

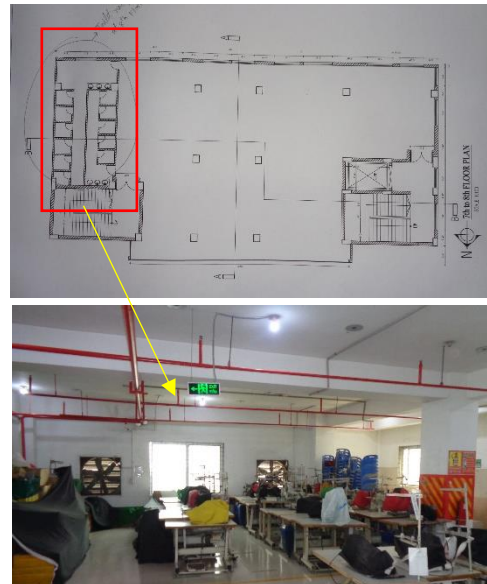
The toilet is not constructed as per the drawing.

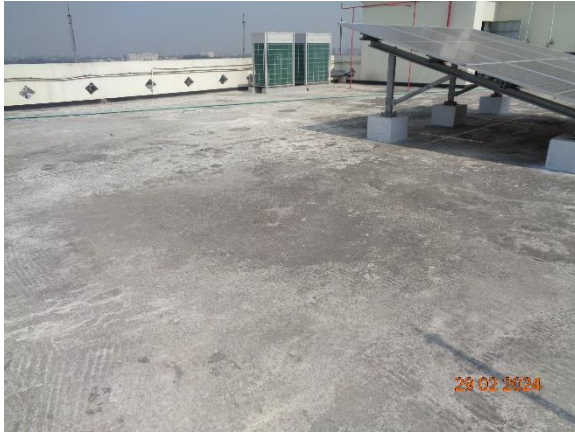
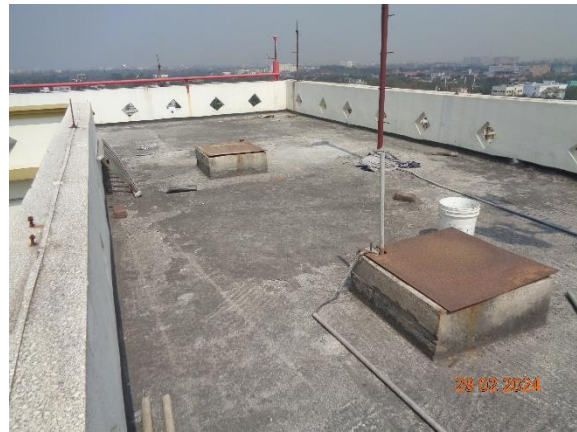
**Observation-2:** Signage of water ponding on the roof. Building-5 (Extension Building)

**Description:** Signage of water ponding on roof slab due to poor drainage system. The factory is required to improve the drainage system with a proper slope to prevent the water ponding on the roof slab.

| Serial No | Observation | Action Plan | Timeline |
|---|---|---|---|
| 6 | Signage of water ponding on the roof. Building-5 (Extension Building) | The factory engineer to develop a proper drainage system with an adequate slope to resist water ponding on the roof. | within 6 weeks |

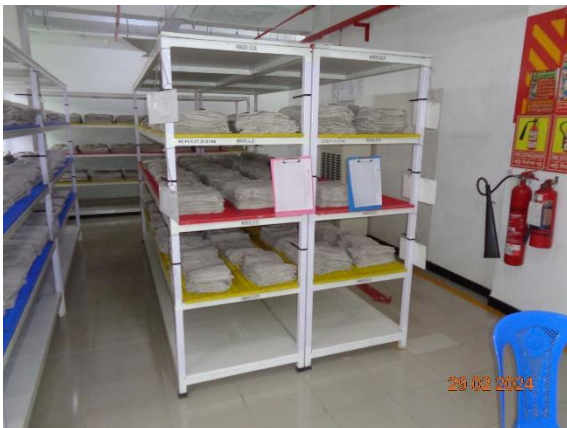
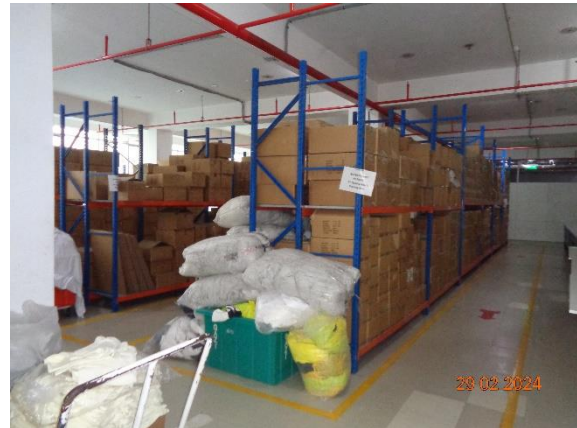
**Observation-3:** Non-structural elements not anchored or braced. Building-5 (Extension Building)

**Description:** Some racks on different floors are not adequately anchored or braced to resist lateral (earthquake) forces. Adequately anchor and brace all non-structural elements (all buildings) to resist earthquake forces to comply with the BNBC.

| Serial No | Observation | Action Plan | Timeline |
|---|---|---|---|
| 7 | Non-structural elements are not anchored or braced. Building-5 (Extension Building) | Adequately anchor and brace all non-structural elements to resist earthquake forces to comply with the BNBC. | within 6 weeks |

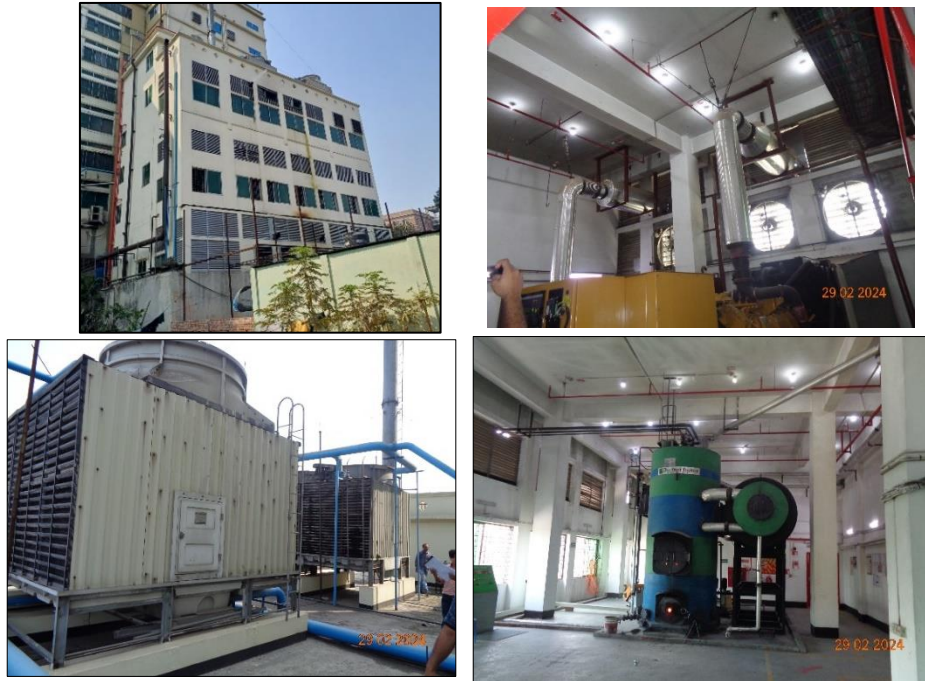
**Observation-4:** Lack of Design documents. (Utility Building)

**Description:** During inspection, as-built architectural and structural drawings, and load plan were available for the structure. In the load plan, the weight of the machines is not mentioned. Also, inadequate cylinder test report for the structure. The building engineer is required to update the load plan and verify the in-situ material strength.

The column having size 300X500 mm on the ground floor seems to be slender as the ratio the of least dimension of the column to the clear height of the column is 18. Slenderness is to be checked for the column.

As per BNBC, every building or structure designed shall have its design documents prepared following the provision of Section 1.9.1. The design document shall include a design report, and a set of structural drawings, which shall be prepared in compliance with section 1.9.1.1 and section 1.9.1.2 as per BNBC.

The factory engineer is required to prepare the full design documents based on in-situ material strength and load plan including a design report based on the FEA model in compliance with section 1.9.1 (part 6, BNBC).

| Serial No | Observation | Action Plan | Timeline |
|---|---|---|---|
| 8 | Lack of Design documents. (Utility Building) | Building engineer to prepare the design document including a design report, and a set of structural drawings in compliance with section 1.9.1.1 and section 1.9.1.2 as per BNBC. | within 6 weeks |
| 9 | Lack of Design documents. (Utility Building) | Verify in-situ concrete stresses by 100mm dia. cores from a minimum of 4 columns and beam & slab. | within 6 weeks |
| 10 | Lack of Design documents. (Utility Building) | Produce and actively manage a loading plan for all floor plates considering floor and column capacity. | within 6 weeks |

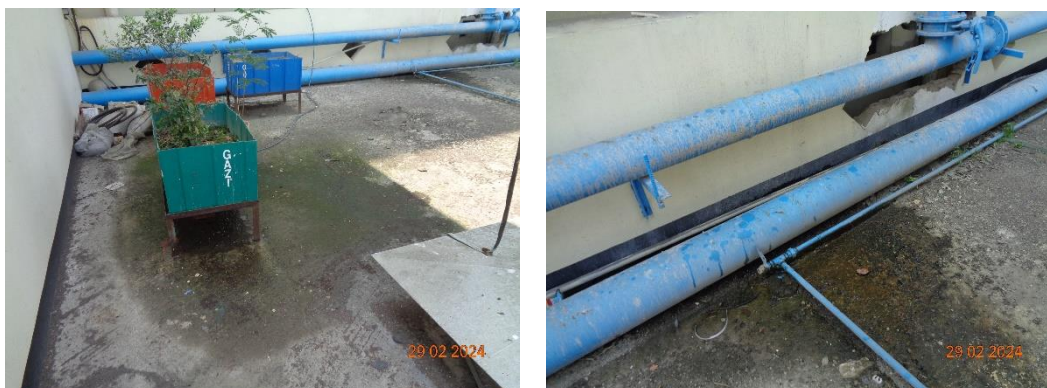
**Observation-5:** Signage of moisture on the roof. (Utility Building)

**Description:** Signage of moisture on the roof slab due to pipe leakage and poor drainage system. The factory is required to improve the drainage system with a proper slope to prevent the water ponding on the roof slab.

| Serial No | Observation | Action Plan | Timeline |
|---|---|---|---|
| 13 | Signage of moisture on the roof. (Utility Building) | The factory engineer to repair the leakage of the pipe and develop a proper drainage system with adequate slope to resist water ponding on the roof. | within 6 weeks |
