# BKC Sweater Limited (Extension)

Plot no. 212-214, Degerchala main road, Degerchala, National University, Gazipur.

27 February 2024

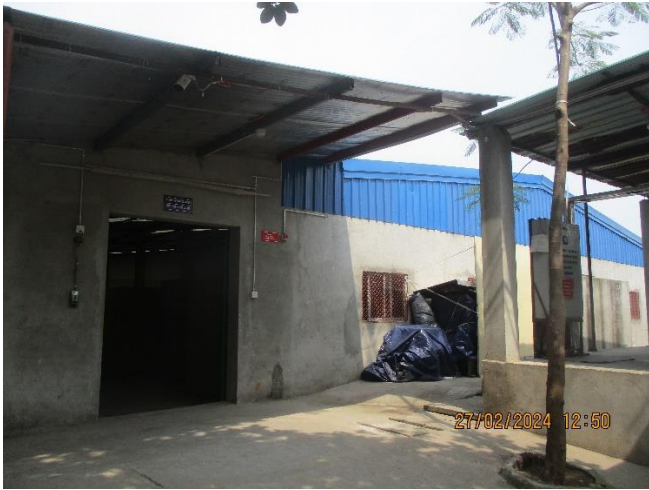
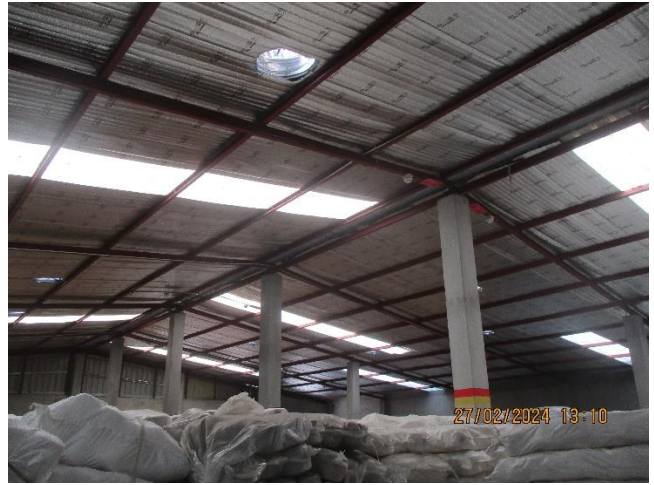
### Observation-1: Lack of design documents. (Extension Production Shed)

**Description:** As per BNBC, every building or structure designed shall have its design documents prepared in accordance with the provision of Section 1.9.1. The design document shall include a design report, and a set of structural drawings, which shall be prepared in compliance with section 1.9.1.1 and section 1.9.1.2 as per BNBC.

At the time of inspection, design documents (including complete as-built drawings, design report and material test reports) were not available which are required to be prepared in compliance with section 1.9.1 (part-6, BNBC).

| Observation | Action Plan | Timeline |
|---|---|---|
| Lack of design documents.<br>(Extension Production Shed) | The building engineer is required to prepare design documents (including as-built drawings, design report and material test reports) in compliance with section 1.9.1 (part-6, BNBC). | within 6 weeks |
| | Carry out the suggested remedial works. | within 6 months |

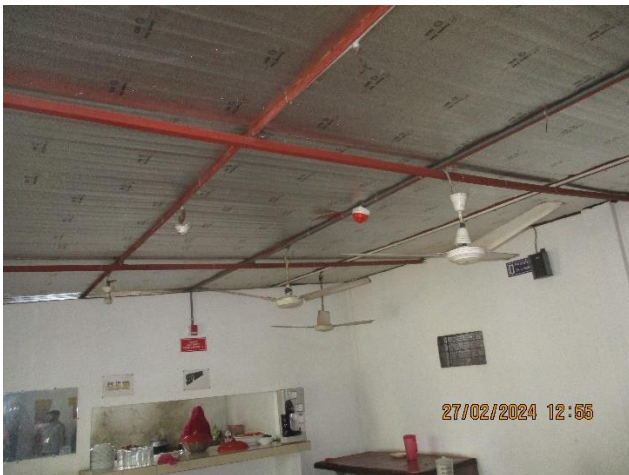
Staff Dining Shed

### Observation-2: Apparently non-engineered connection/Shed. (Staff Dining Shed, Compressor Room)

**Description:** During inspection, as-built drawing was not found on site. Steel rafter (box section) rested on the brick wall. The building engineer is required to check the connection adequacy of the lightweight roof against the uplift pressure of the wind. Also, building engineer is required to survey the structure and prepare accurate as-built drawings.

| Observation | Action Plan | Timeline |
|---|---|---|
| Apparently non-engineered connection/Shed. (Staff Dining Shed, Compressor Room) | Building engineer is required to survey the structure and prepare accurate as-built drawings. | within 6 weeks |
| | Building engineer is required to check the connection of the steel roof for the uplift pressure of wind. | within 6 weeks |
| | Complete implementation of remedial works if required. | within 6 months |

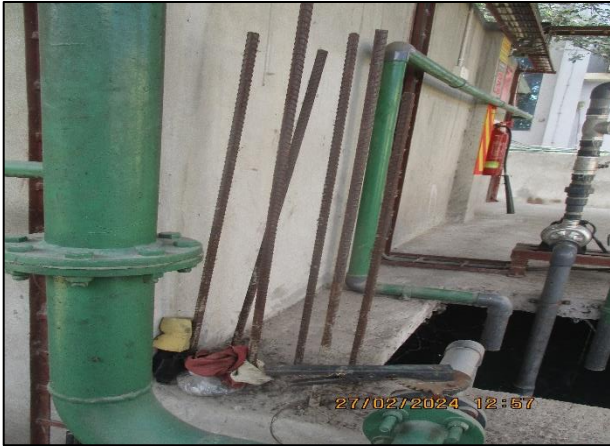
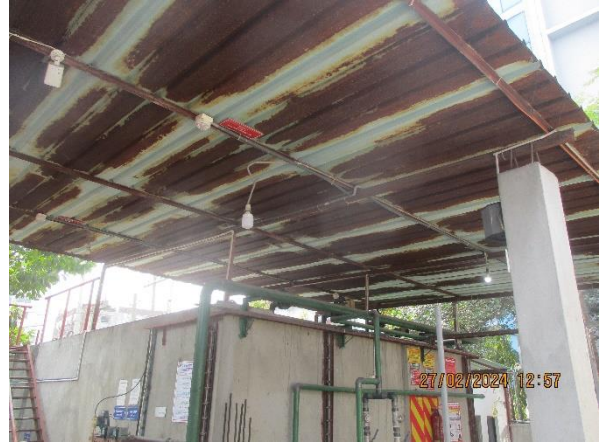
**Observation-3:** Corroded re-bar and tin shed. (ETP)

**Description:** Corroded re-bar and tin shed was observed at ETP. The building engineer is required to identify all corroded members, remove the corrosion, and apply suitable anti-corrosive coating to the affected steel members.

| Observation | Action Plan | Timeline |
|---|---|---|
| Corroded re-bar and tin shed. (ETP) | Building Engineer is required to identify all corroded member, remove the corrosion, and apply suitable anti-corrosive coating to the affected steel members. | within 6 weeks |
