# Colour & Co. Ltd.

Tepirbari, Sreepur, Gazipur

3 March 2024

## 2. Observations

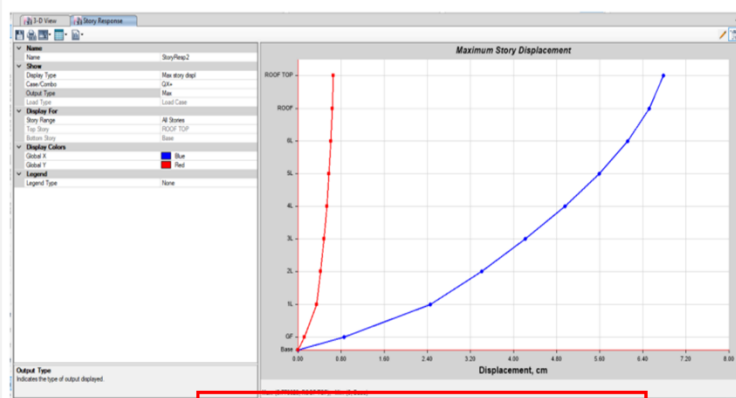
The value of deflection at top level has been found 97.56mm ( $L/400$ ) for wind at short direction. So sway of the structure is within the acceptable limit.

Mismatch in load case in lateral sway check

In the design report, lateral sway is checked for earthquake load cases although the deflection limit is provided for wind load case. The building engineer is required to check the lateral sway for wind load also. As per design report, maximum required reinforcement of 600X600 column is 4.63% at ground floor, however, maximum provided reinforcement of any 600X600 column is 2.11%. The grade and floor beams have been designed as sway special although value of R has been considered for Intermediate Moment Resisting Frame.

The building engineer is required to revise the Detailed Engineering Assessment (DEA) report and submit it to the RSC for further review.

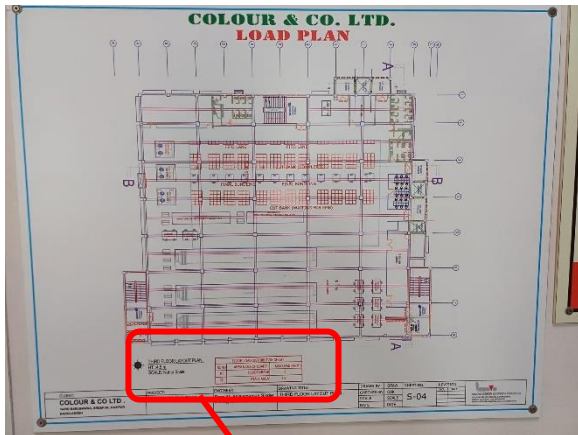
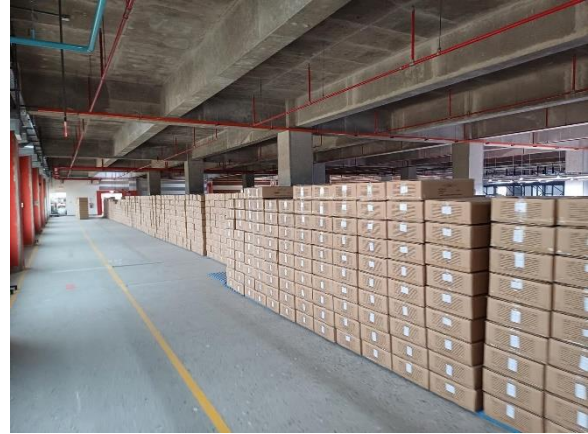
storage areas in 3<sup>rd</sup> floor

**Description:** As per BNBC, 6 kPa is required to consider floor loading for the light storage facilities. During the inspection, the load plan was found posted considering 3 kPa at the storage area. Height marking was not provided.

The Building Engineer is required to update the storage live load limit as per BNBC requirements and revise the structural analysis & DEA report accordingly. Post the updated load plan and provide storage height markings.

| Serial | Observation | Action Plan | Timeline |
|---|---|---|---|
| 5 | Storage live load limit does not comply with BNBC requirements. (Building-1) | The Building Engineer is required to update the storage live load limit as per BNBC requirements. | within 6 weeks |

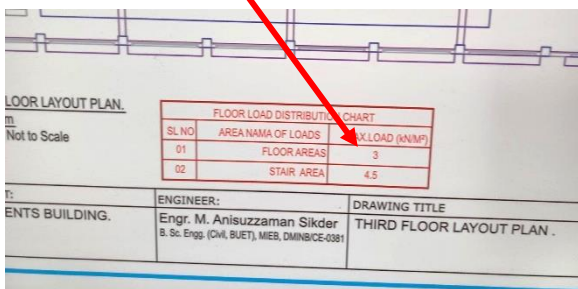
load plan of 3<sup>rd</sup> floor

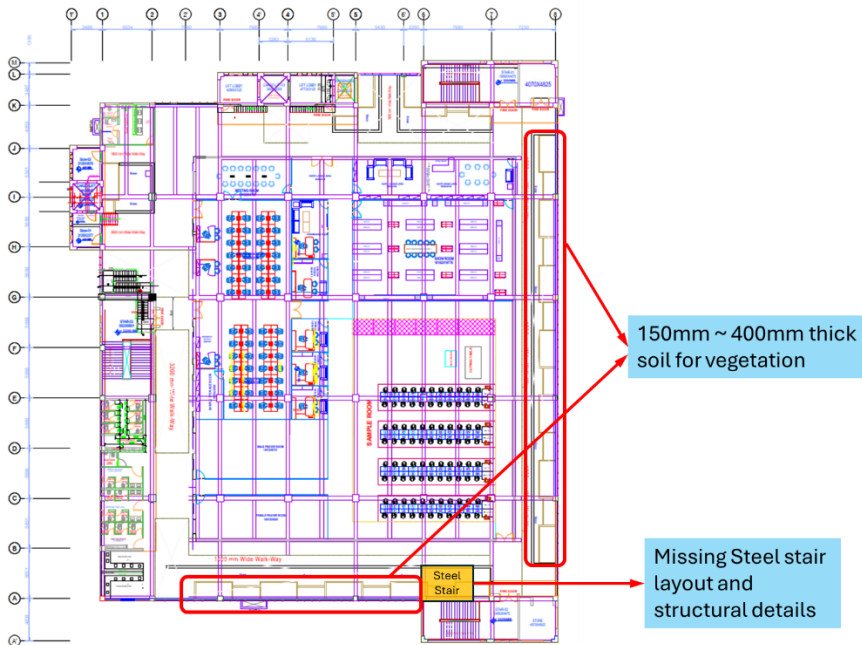
#### Missing details of steel stairs and soil thickness at the roof

- Mismatch was found in the marked column sizes (C1, C2 and C3 column sizes were found 900X900 at 1<sup>st</sup> floor, C7 and C8 column sizes were found 700X700 at 1<sup>st</sup> floor).
- Layout and structural details of steel stairs at the roof were found missing.
- There is Gardening on the roof. However, in architectural drawings, there is no mention of soil thickness.

The building engineer is required to survey the full structure and update the as-built drawings and DEA report accordingly.

| Serial | Observation | Action Plan | Timeline |
|---|---|---|---|
| 6 | Mismatch in the as-built drawing. (Building 1) | The building engineer is required to survey the full structure and update the as-built drawings and DEA report accordingly. | within 6 weeks |

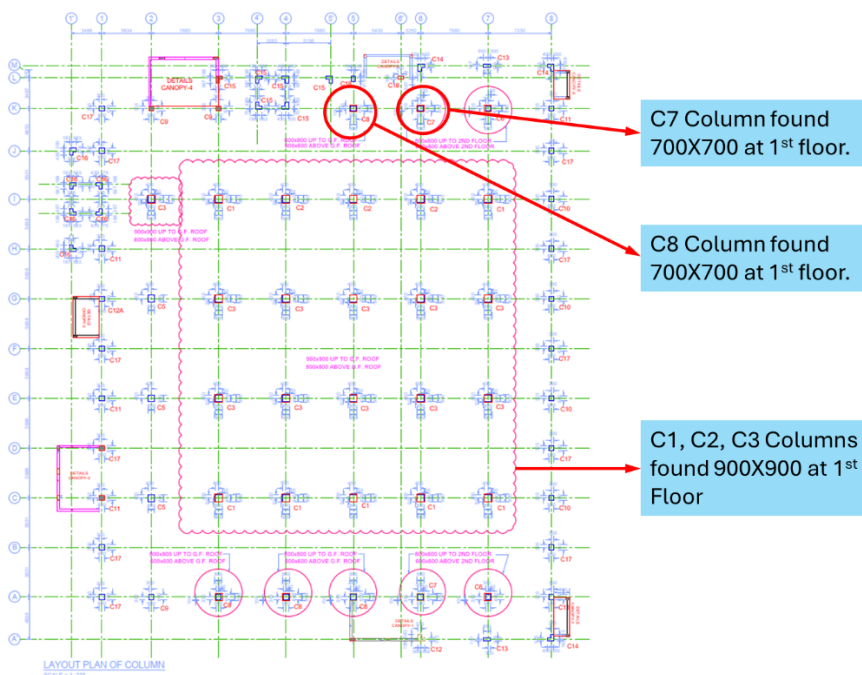
C7, C8 Column at 1<sup>st</sup> floor.

C1, C2, C3 Column at 1<sup>st</sup> floor.

#### Mismatch in column size

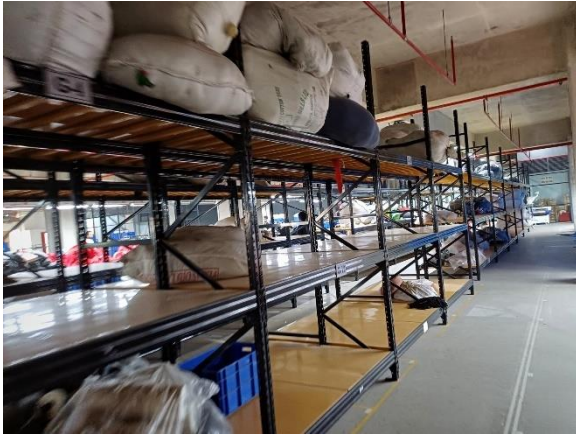
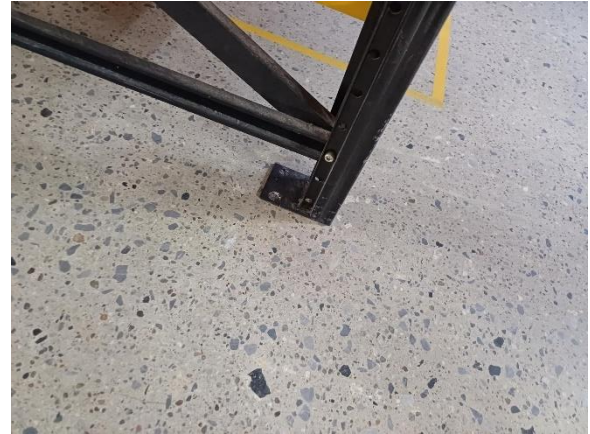
**Description:** During inspection, storage racks were found not anchored. The building engineer is required to anchor/ laterally brace all non-structural elements including storage racks to resist earthquake forces.

| Serial | Observation | Action Plan | Timeline |
|---|---|---|---|
| 7 | Lack of anchorage of storage rack. (Building-1) | The building engineer is required to anchor/ laterally brace all non-structural elements including storage racks to resist earthquake forces. | within 6 months |

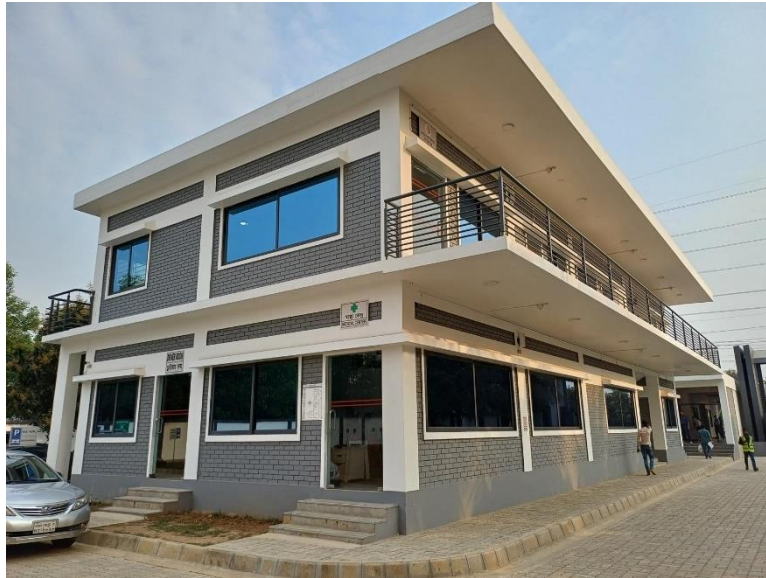
**Description:** As per BNBC, every building or structure designed shall have its design documents prepared following the provision of Section 1.9.1. The design document shall include a design report, a set of as-built drawings and load plans which shall be prepared in compliance with section 1.9.1.1 and section 1.9.1.2, part-6 of BNBC.

| Serial | Observation | Action Plan | Timeline |
|---|---|---|---|
| 9 | Lack of design report (Building-2) | The building engineer is required to prepare design documents in compliance with section 1.9.1.1 and section 1.9.1.2, part-6 of BNBC. | within 6 weeks |

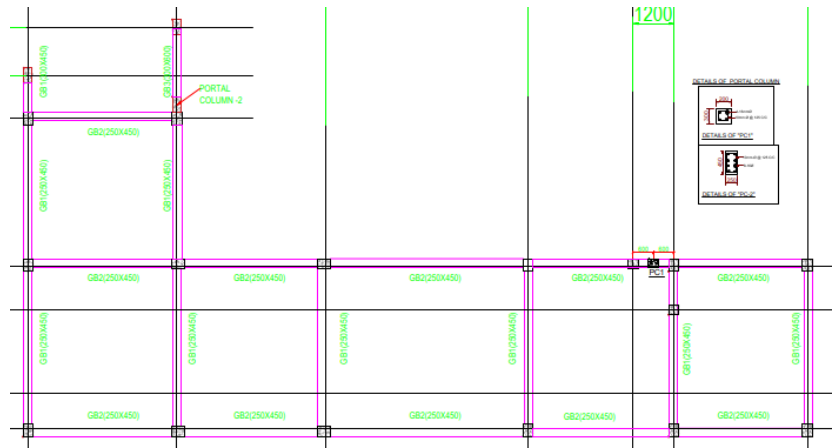
Missing schedule of C3 Column

Grade Beam size shown 250X450 in layout

- Mismatch was found in the marked grid distances.
- A shear wall was found supporting the landing of the stairs. In structural drawing, two columns are shown in place of the shear wall.
- In grid 2-E', C3 column is shown. However, a 250X250 RC column was found in place of the C3 column. Another 250X250 RC column was found supporting the landing of the stairs in place of the brick pier shown in the drawing. Details of C3 column are missing in the column schedule.
- Mismatches were found between the grade beam and floor beam layouts and sections.

The building engineer is required to survey the whole structure and update the as-built drawings as per site conditions.

| Serial | Observation | Action Plan | Timeline |
|---|---|---|---|
| 11 | Mismatch in as-built drawings (Building-2) | The building engineer is required to survey the whole structure and update the as-built drawings as per site conditions. | within 6 weeks |

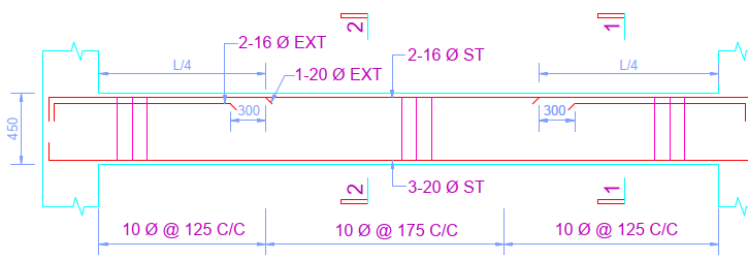
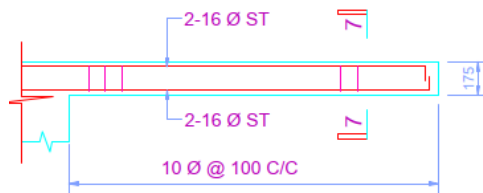
Mismatch in grade beam and floor beam sizes between beam layout and section

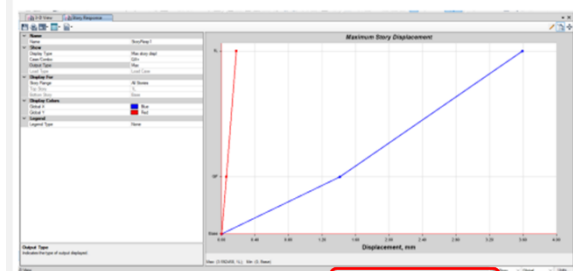
Mismatch in the load case in the lateral sway check

The value of deflection at top level has been found  $8.625\text{mm}$  ( $L/400$ ) for wind at short direction. So sway of the structure is within the acceptable limit.

In the design report, lateral sway is checked for earthquake load cases although the deflection limit is provided for wind load cases. The building engineer is required to check the lateral sway for wind load also. Floor beam sizes were found 250X450 on-site. As per the design report, the value of R has been considered for the Intermediate Moment Resisting Frame (IMRF). However, the spacing of transverse reinforcement of the beams doesn't comply with the requirement of IMRF.

The building engineer is required to revise the Engineering Assessment (EA) report and submit it to the RSC for review.

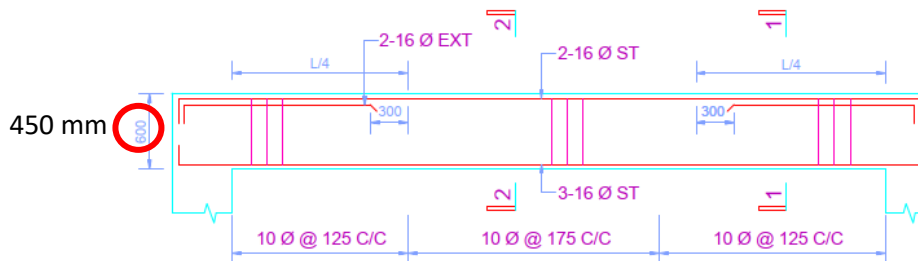
**LONG SECTION OF FB1 (250X450)**

Floor Beam Section

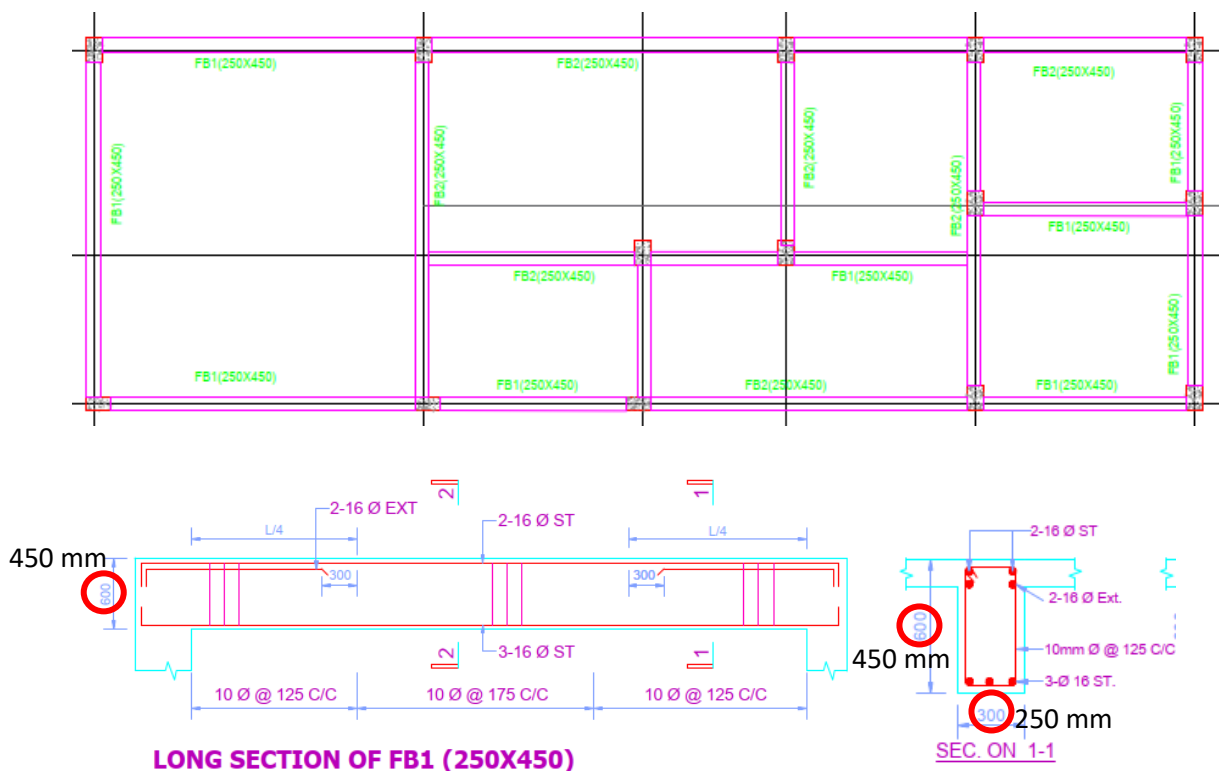
#### Mismatch in grade beam and floor beam sizes between beam layout and beam section

**Description:** During the inspection, mismatches were found in the as-built drawings of the floor beam and grade beam. The floor beam size was found 250X450 on-site whereas the section of floor beams in the as-built drawing shows 300X600. The building engineer is required to survey the full structure and update the as-built drawings and EA report accordingly.

| 16 | Mismatch in as-built drawings (Building-3) | The building engineer is required to survey the full structure and update the as-built drawings and EA report accordingly. | within 6 weeks |

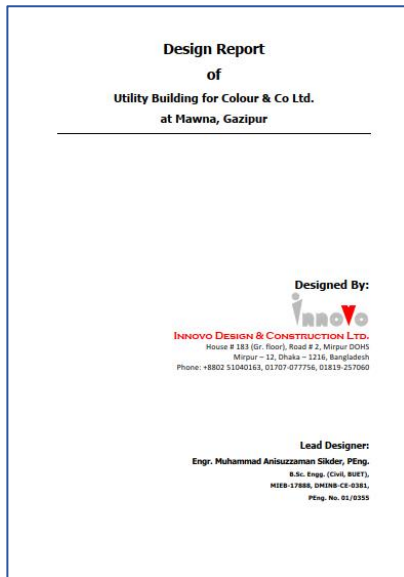
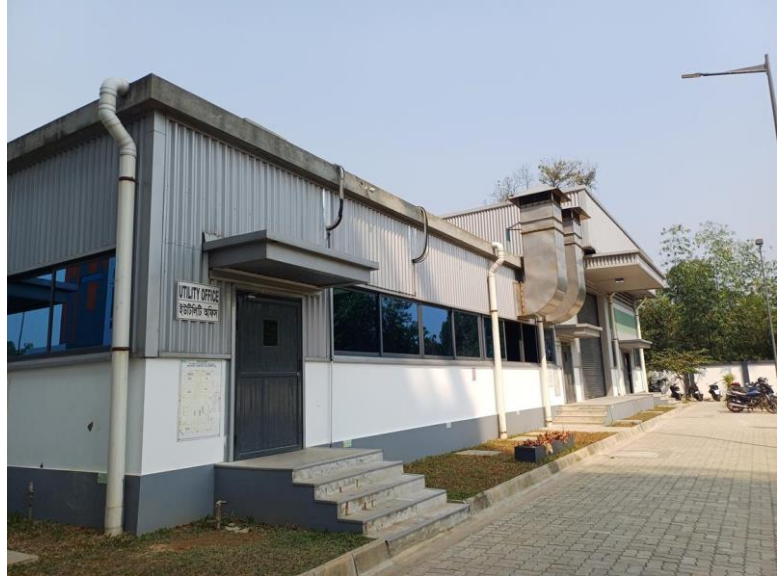
**Description:** During the inspection, a structural design report and as-built drawings were available on site which need to be reviewed by RSC in depth for lateral forces. Serviceability checks have not been provided in the design report and connection adequacy checks are also missing. The building engineer is required to revise the Engineering Assessment (EA) report, submit it to the RSC for review and implement remedial works if required.

| 17 | Design documents need to be reviewed for lateral forces. (Shed-1) | The building engineer is required to revise the Engineering Assessment (EA) report and submit it to the RSC for review. | within 6 weeks |
| 18 | Design documents need to be reviewed for lateral forces. (Shed-1) | Carry out remedial work if required. | within 6 months |

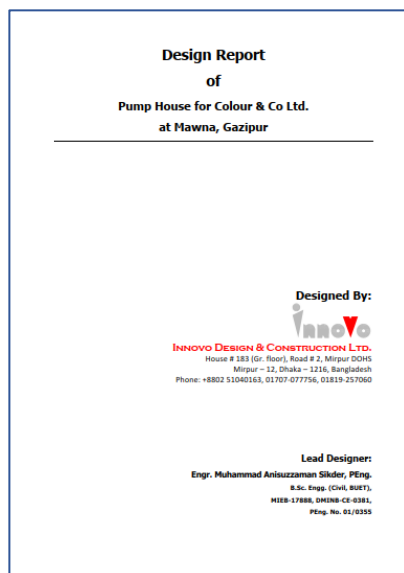
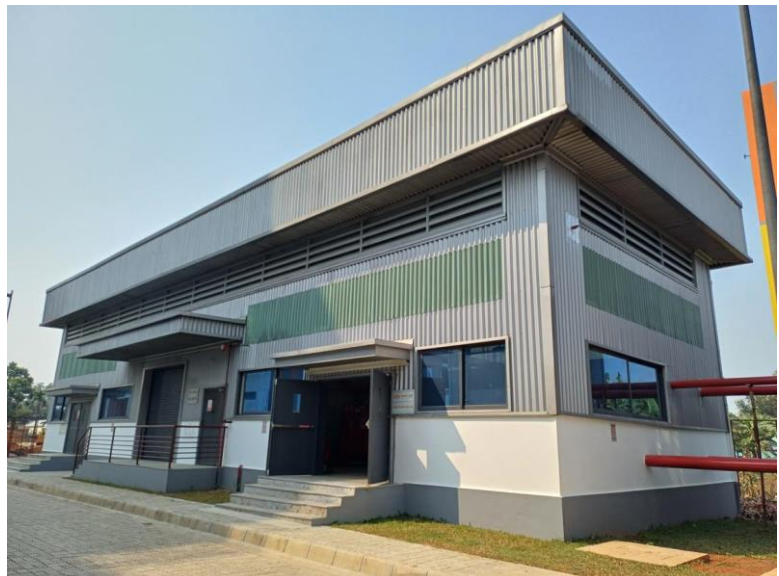
**Description:** During the inspection, a structural design report and as-built drawings were available on site which need to be reviewed by RSC in depth for lateral forces. Serviceability checks have not been provided in the design report and connection adequacy checks are also missing. The building engineer is required to revise the Engineering Assessment (EA) report, submit it to the RSC for review and implement remedial works if required.

| 20 | Design documents need to be reviewed for lateral forces. (Shed-2) | Carry out remedial work if required. | within 6 months |
