# Styllent Knit Limited

5 March 2024

## 1. Building Information

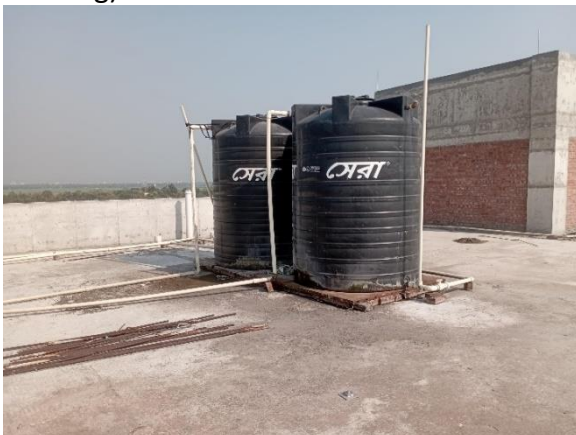
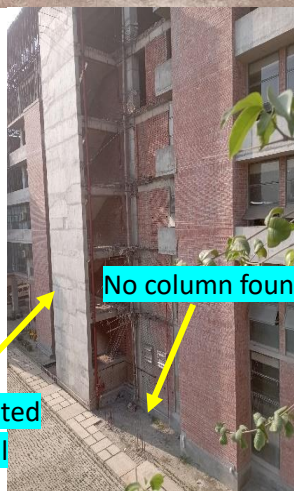
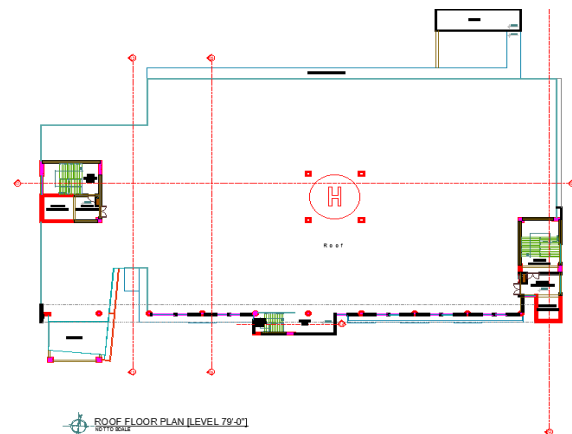
**Observation 2:** Discrepancy and missing information in as-built drawing. (Main Production Building).

**Description:** Two undocumented plastic water tanks (5000-liter capacity each) were found on the roof slab. Also, steel column is shown at marked location, but no such column was found. The building engineer is required to update the as-built drawing and consider it in the design check.

| Observation | Action Plan | Timeline |
|---|---|---|
| Discrepancy and missing information in as-built drawing<br>(Main Production Building) | The building engineer is required to prepare as-built drawings reflecting the on-site condition. | within 6 weeks |

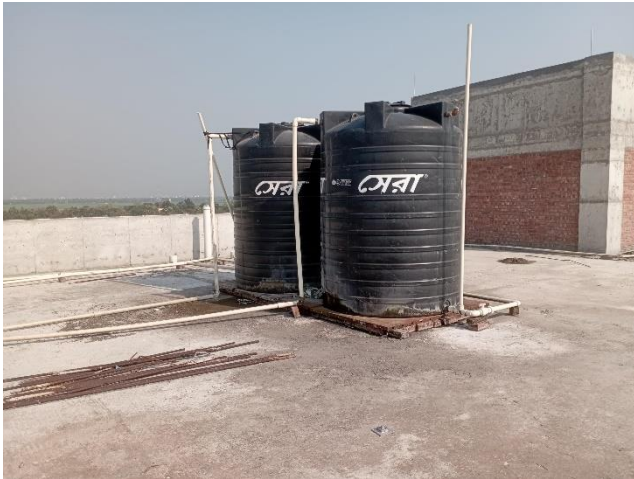
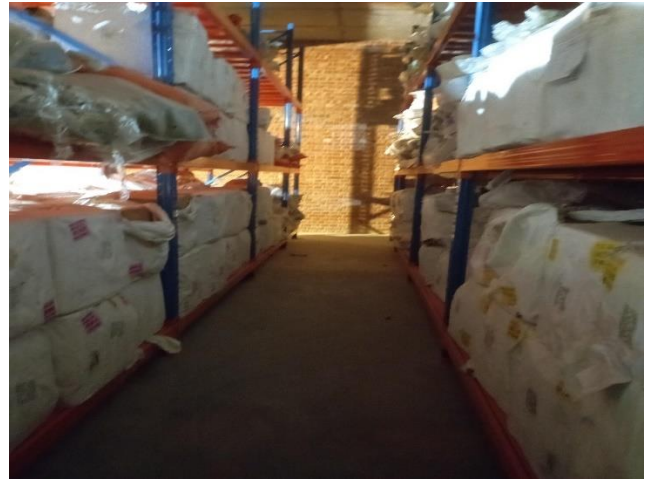
**Observation-3:** Nonstructural elements found not anchored/braced (Main Production Building).

**Description:** Nonstructural elements found not anchored/braced. The building engineer is required to anchor/brace all nonstructural elements within the factory.

| Observation | Action Plan | Timeline |
|---|---|---|
| Nonstructural elements found not anchored/braced<br>(Main Production Building) | The building engineer is required to anchor/brace all nonstructural elements within the factory. | within 6 months |

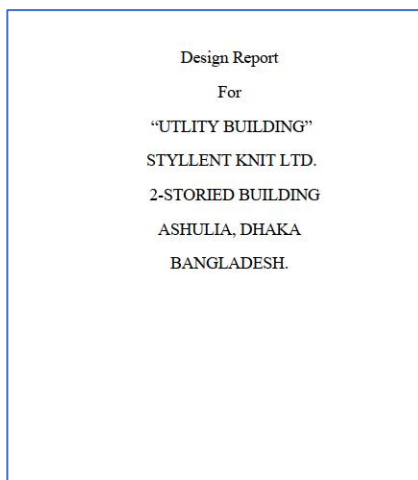
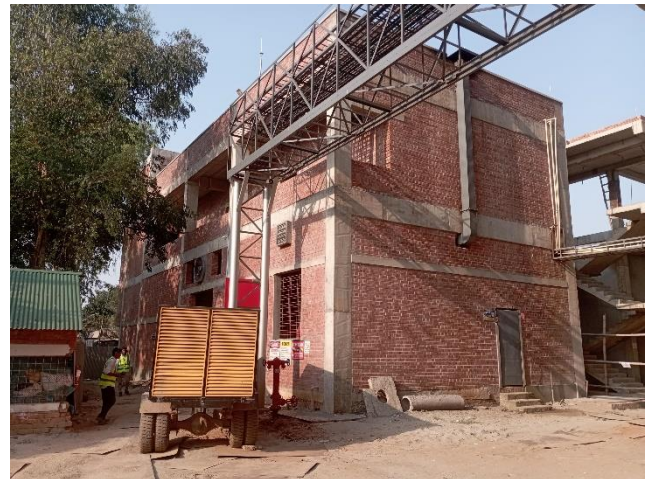
**Observation-4:** Building to be checked against lateral loading (Utility Building)

**Description:** A design report was available on site at the time of inspection. The building engineer is required to check the structure against lateral loading and submit the design report to RSC for review.

| Observation | Action Plan | Timeline |
|---|---|---|
| Building to be checked against lateral loading (Utility Building) | The building engineer is required to check the structure against lateral loading and submit the design report to RSC for review. | within 6 weeks |
| | Implement remediation work from design review. | within 6 months |

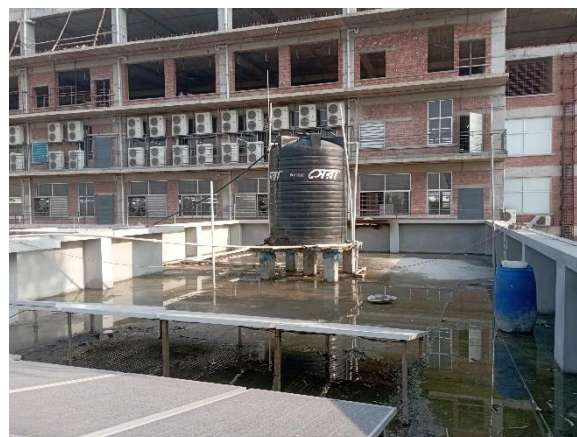
**Observation-5:** Stagnant water on the roof slab. (Utility Building).

**Description:** Stagnant water on the roof slab. The building engineer is required to improve the drainage system on the roof slab.

| Observation | Action Plan | Timeline |
|---|---|---|
| Stagnant water on the roof slab. (Utility Building) | The building engineer is required to improve the drainage system on the roof slab. | within 6 weeks |

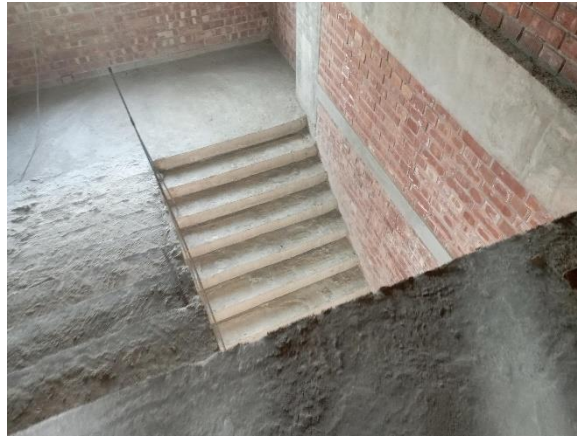
**Observation-6:** Falling hazard at roof level (Utility Building).

**Description:** Railing was not found on the staircase. The building engineer is required to provide edge protection to avoid falling hazards.

| Observation | Action Plan | Timeline |
|---|---|---|
| Falling hazard at roof level<br>(Utility Building) | The building engineer is required to provide edge protection to avoid falling hazard. | within 6 weeks |

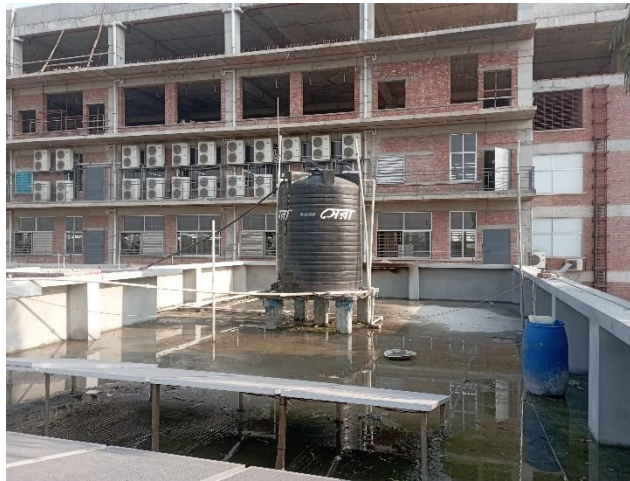
**Observation-7:** Nonstructural elements found not anchored/braced (Utility Building).

**Description:** Nonstructural elements were found not anchored/braced. The building engineer is required to anchor/brace all nonstructural elements within the factory.

| Observation | Action Plan | Timeline |
|---|---|---|
| Nonstructural elements found not anchored/braced<br>(Utility Building) | The building engineer is required to anchor/brace all nonstructural elements within the factory. | within 6 months |

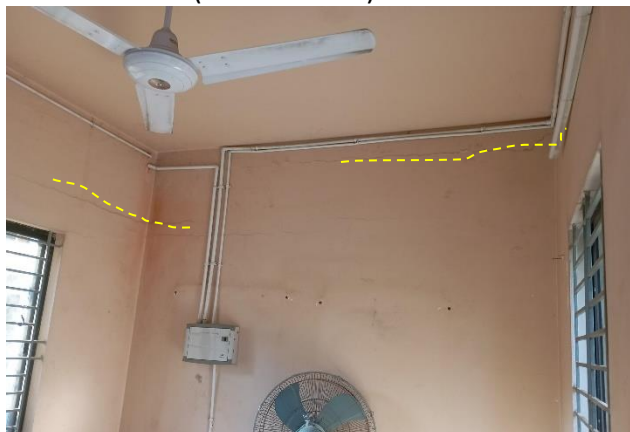
**Observation-8:** Crack on the brick wall (Guard Room).

**Description:** Crack was found on brick wall surface. The building engineer is required to investigate the cracked area and repair it with a suitable method.

| Observation | Action Plan | Timeline |
|---|---|---|
| Repair crack on wall<br>(Guard Room) | The building engineer is required to investigate the cracked area and repair with a suitable method. | within 6 months |

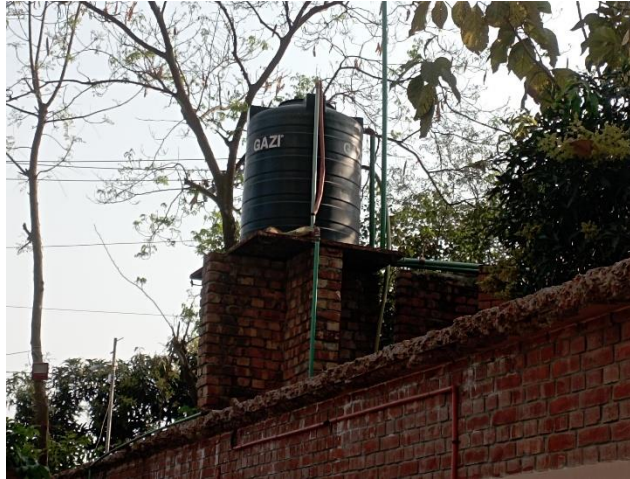
**Observation-9:** Nonstructural elements found not anchored/braced (Guard Room).

**Description:** Nonstructural elements were found not anchored/braced. The building engineer is required to anchor/brace all nonstructural elements within the factory.

| Observation | Action Plan | Timeline |
|---|---|---|
| Nonstructural elements found not anchored/braced<br>(Guard Room) | The building engineer is required to anchor/brace all nonstructural elements within the factory. | within 6 months |

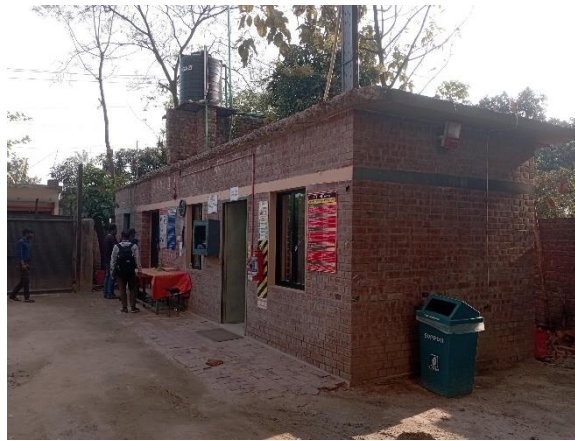
**Observation-10:** Lack of as-built drawing (Guard Room).

**Description:** As-built drawings for these structures were not found on site. The building engineer is required to produce as-built drawing for these structures.

| Observation | Action Plan | Timeline |
|---|---|---|
| Lack of as-built drawing<br>(Guard Room) | The building engineer is required to prepare as-built drawings reflecting the on-site condition. | within 6 weeks |

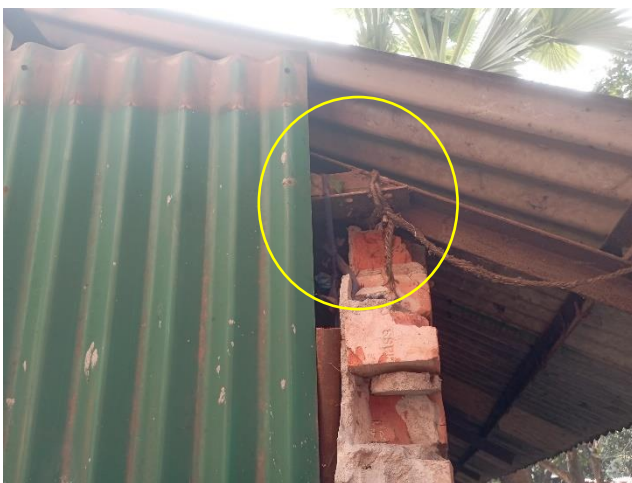
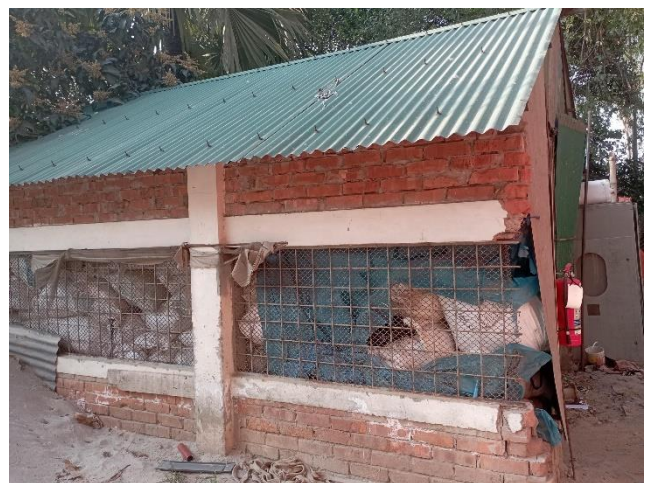
**Observation-11:** Poor connection (Wastage Shed)

**Description:** Poor connection was found for the structure. The building engineer is required to provide proper anchorage to resist the uplift forces. Otherwise replace the structure with a well-designed structure.

| Observation | Action Plan | Timeline |
|---|---|---|
| Poor connection<br>(Wastage Shed) | The building engineer is required to provide proper anchorage to resist the uplift forces. Otherwise replace the structure with a well-designed structure. | within 6 months |
