# Newtex Knit Fashion Ltd. (Extension)

Gorai, Mirzapur, Tangail, Bangladesh.

11 January 2024

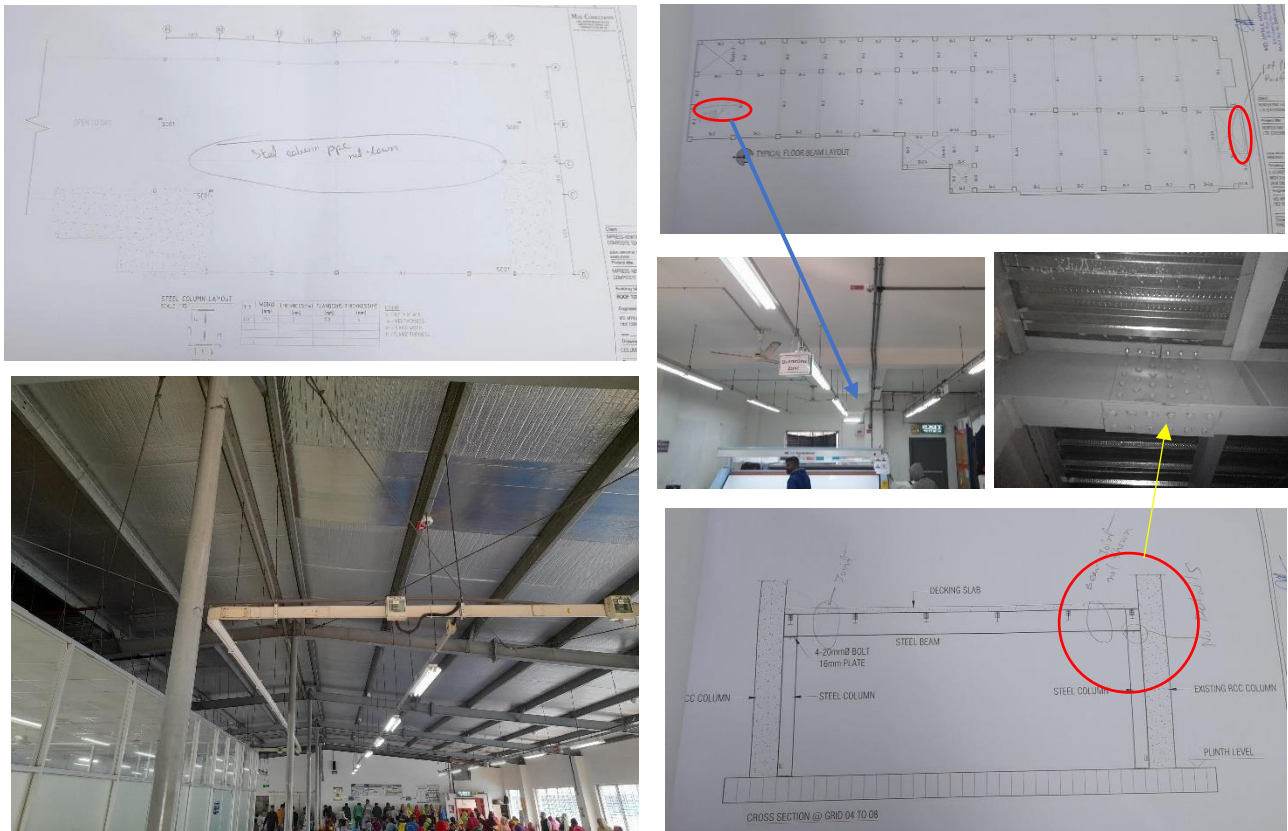
### Observation-01: Inconsistencies in as built drawings. (Building-2).

**Description:** Steel pipe columns at middle were not shown in the drawings for roof shed. Also, sectional details were not found. On the other hand, the beam layout of the 1<sup>st</sup> floor did not fully match. Moreover, connection details of steel beam of 1<sup>st</sup> floor not found in the drawings.

| Observation | Action Plan | Timeline |
|---|---|---|
| Inconsistencies in as built drawings. (Building-2). | The building engineer is required to survey the structure and prepare full set of as-built drawings. | within 6 weeks |

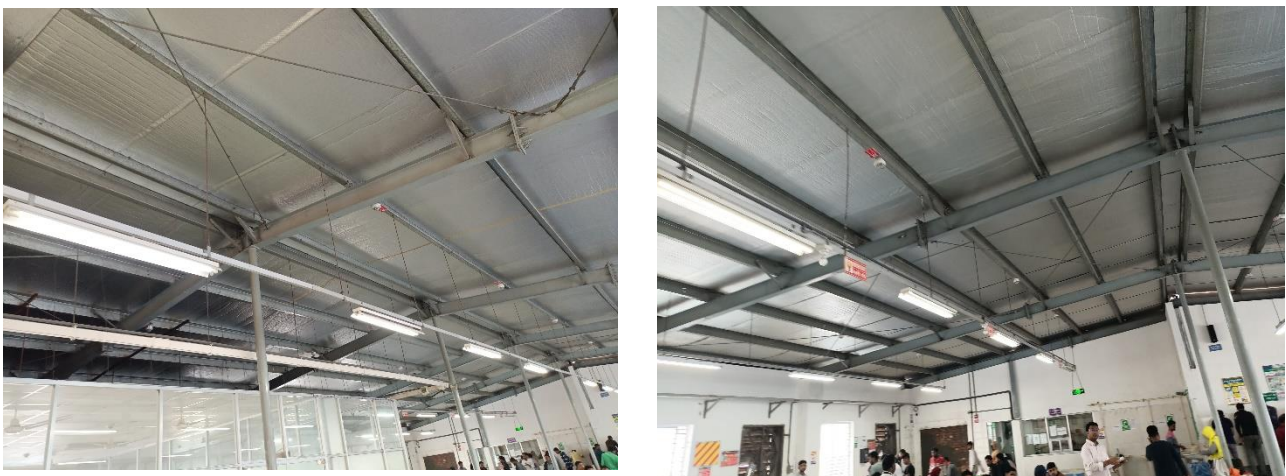
### Observation-02: Lack of lateral stability. (Building-2-roof shed).

**Description:** Only roof bracings are provided but Load transfer media is not provided along long direction for the roof shed. Therefore, the lateral stability system of the shed is apparently incomplete. Building engineer is required to check the lateral stability of the structure and submit the engineering assessment for whole structure for lateral loading to RSC for review.

| Observation | Action Plan | Timeline |
|---|---|---|
| Lack of lateral stability. (Building-2-roof shed). | Building engineer is required to check the lateral stability of the structure and submit the engineering assessment for whole structure for lateral loading to RSC for review. | within 6 weeks |
| | Implement remediation work if required. | within 6 months |

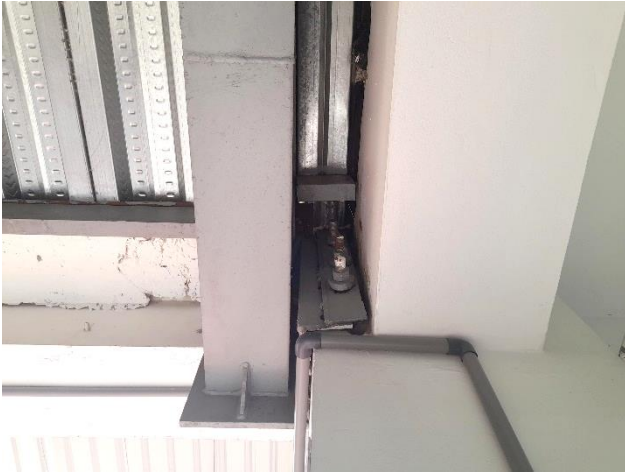
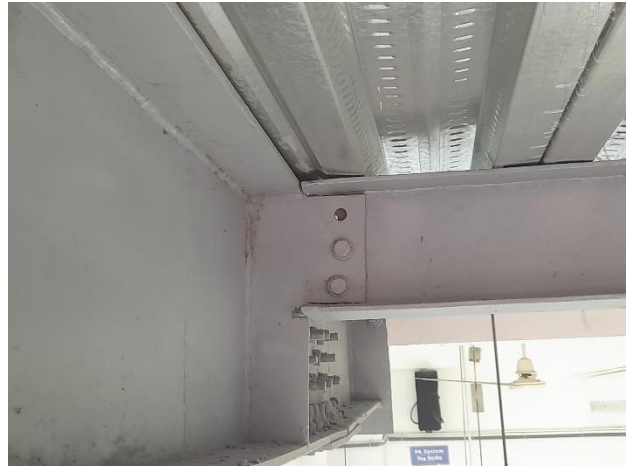
**Observation-03** Improper connection and bolt missing. (Building-2).

**Description:** Improper connection between steel beam and RC column was found in some locations. Also, bolt missing was found. The building engineer is required to check the connection and suggest proper remedial measures accordingly. Also install the missing bolts.

| Observation | Action Plan | Timeline |
|---|---|---|
| Improper connection and bolt missing. (Building-2). | The building engineer is required to check the connection and suggest proper remedial measures accordingly. Also install the missing bolts. | within 6 weeks |
| | Carry out suggested remedial works if required. | within 6 months |

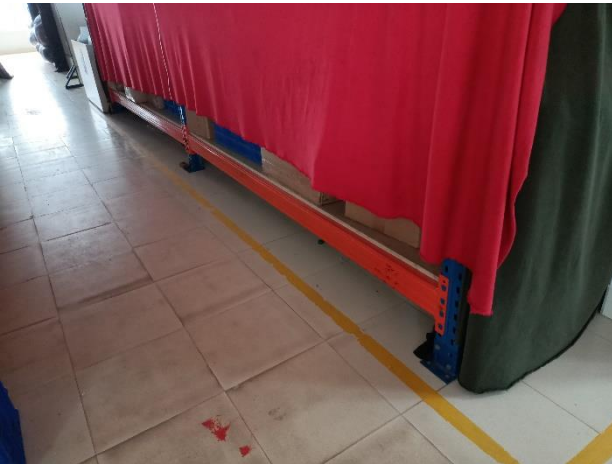
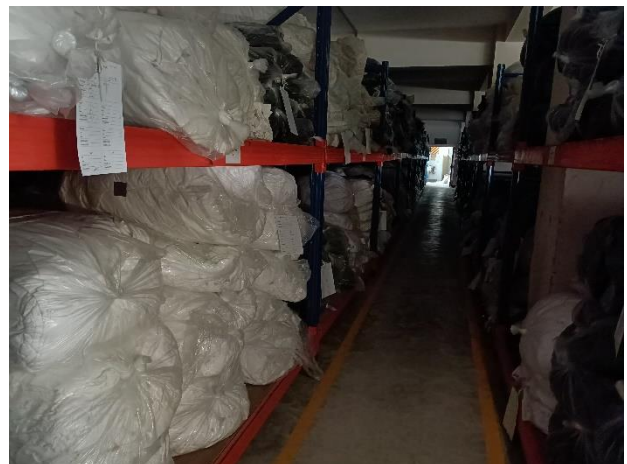
**Observation-04:** Non-structural elements not anchored or braced. (Building-2)

**Description:** Some racks on floors are not anchored or braced to resist lateral (earthquake) forces. The factory is required to anchor/brace all non-structural elements adequately to resist earthquake forces.

| Observation | Action Plan | Timeline |
|---|---|---|
| Non-structural elements not anchored or braced. (Building-2) | The factory is required to anchor/brace all non-structural elements adequately to resist earthquake forces. | within 6 weeks |

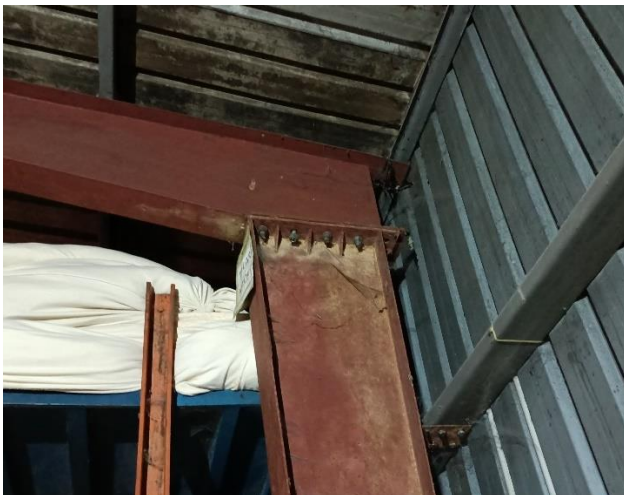
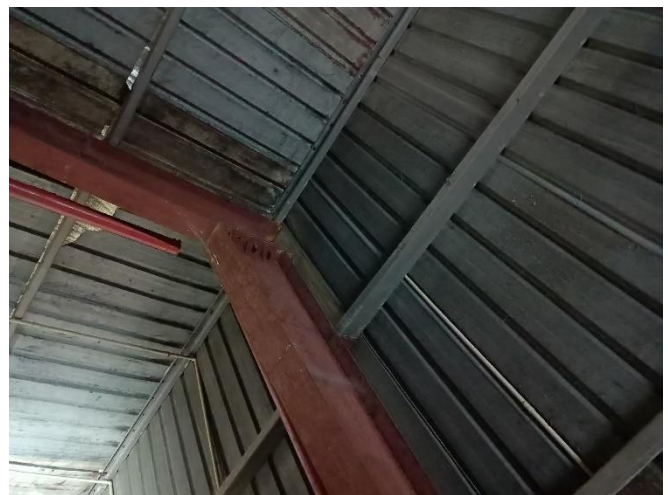
**Observation-06:** Prepare engineering assessment (EA) required to be revised and submitted to RSC for review. (Building-3).

| Observation | Action Plan | Timeline |
|---|---|---|
| Prepare engineering assessment required to be revised and submitted to RSC for review. (Building-3). | Revised EA report needs to be reviewed against lateral loading by RSC. | within 6 weeks |
| | Implement remediation work if required. | within 6 months |

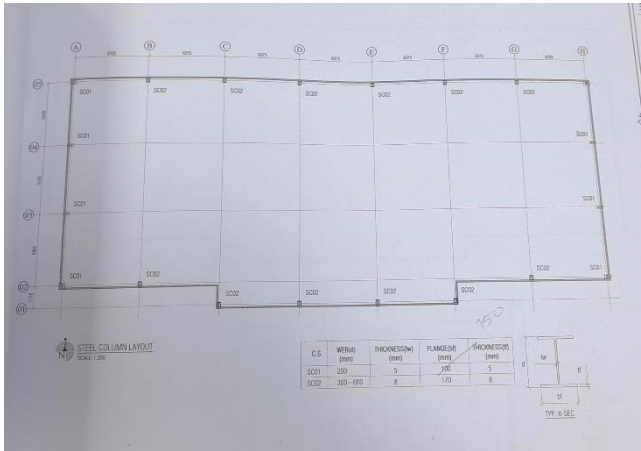
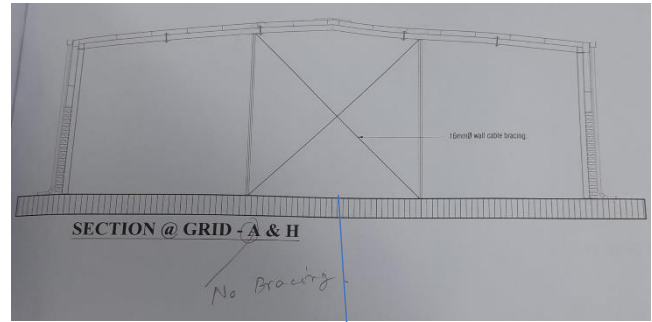
**Observation-07: Mismatches in as-built drawings. (Building 04).**

**Description:** Flange width of SC1 column was measured 150 mm instead of 100 mm. Also, cable bracing was found in grid-A as per drawings.

| Observation | Action Plan | Timeline |
|---|---|---|
| Mismatches in as-built drawings. (Building 04). | The building engineer is required to survey the full structure and produce accurate as-built drawings. | within 6 weeks |

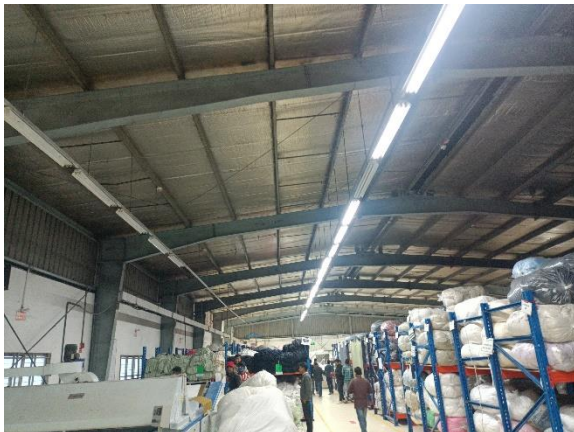
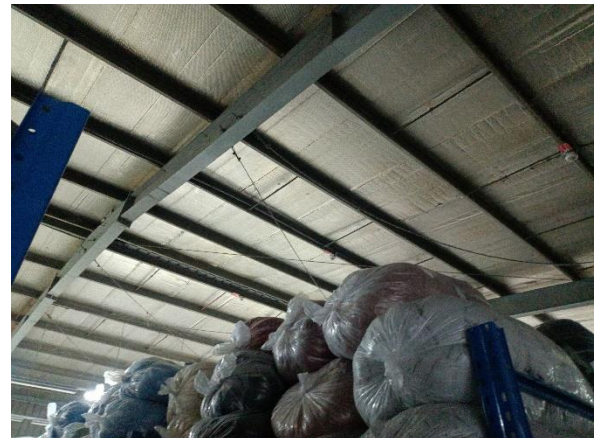
**Observation-08: Incomplete lateral stability system. (Building-04).**

**Description:** No compression strut was found along the long direction. Only cable bracings were found onsite. So lateral stability in the long direction is incomplete. The building engineer is required to check the stability system of the existing structure.

| Observation | Action Plan | Timeline |
|---|---|---|
| Incomplete lateral stability system. (Building-04). | The building engineer is required to check the stability system of the existing structure. | within 6 weeks |

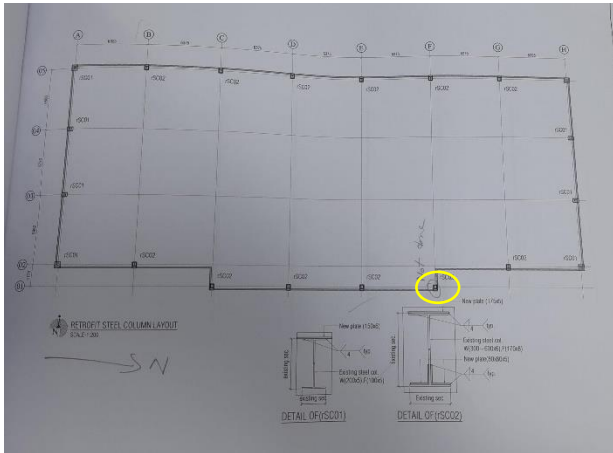
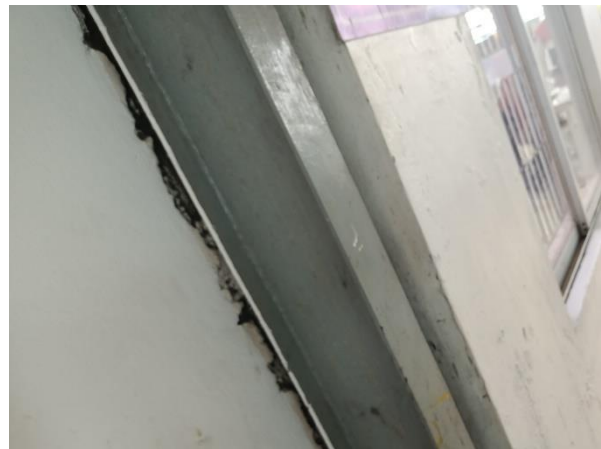
**Observation-09:** Incomplete retrofitting work. (Building-04).

**Description:** Retrofitting work for rSC2 column has not been done. All required retrofitting work need to be carried out as per EA report after reviewed by RSC.

| Observation | Action Plan | Timeline |
|---|---|---|
| Incomplete retrofitting work. (Building-04). | All required retrofitting work need to be carried out as per EA report after reviewed by RSC. | within 6 months |

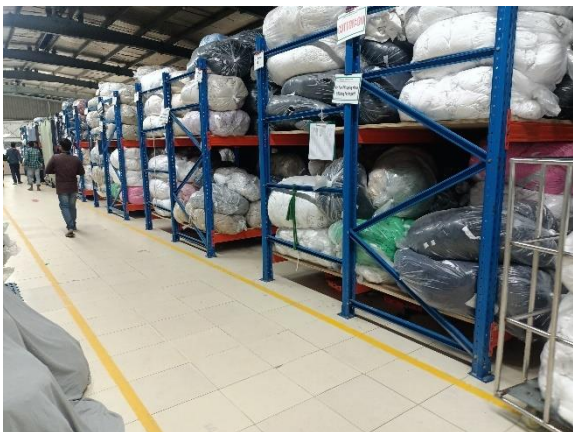
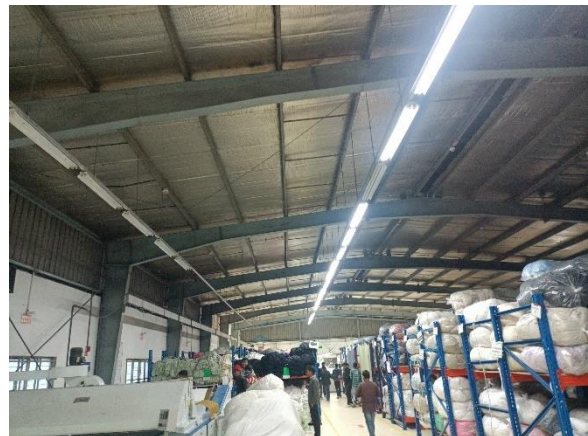
**Observation-10:** Non-structural elements not anchored or braced. (Building 04).

**Description:** Some racks on floors are not anchored or braced to resist lateral (earthquake) forces. The factory is required to anchor/brace all non-structural elements adequately to resist earthquake forces.

| Observation | Action Plan | Timeline |
|---|---|---|
| Non-structural elements not anchored or braced. (Building 04). | The factory is required to anchor/brace all non-structural elements adequately to resist earthquake forces. | within 6 weeks |

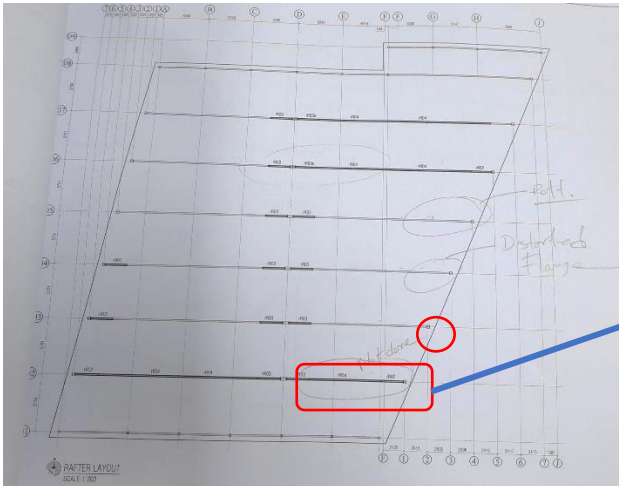
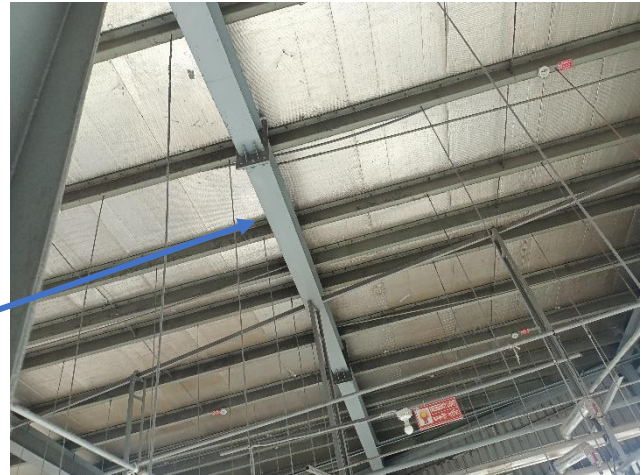
**Observation-11: Incomplete retrofitting work. (Building-05).**

**Description:** Retrofitting work for rSC3a column and rafter (marked in red) have not been done. All required retrofitting work need to be carried out as per EA report after reviewed by RSC.

| Observation | Action Plan | Timeline |
|---|---|---|
| Incomplete retrofitting work. (Building-05). | EA report needs to be reviewed against lateral loading by RSC. | within 6 weeks |
| | All required retrofitting work need to be carried out as per EA report after reviewed by RSC. | within 6 months |

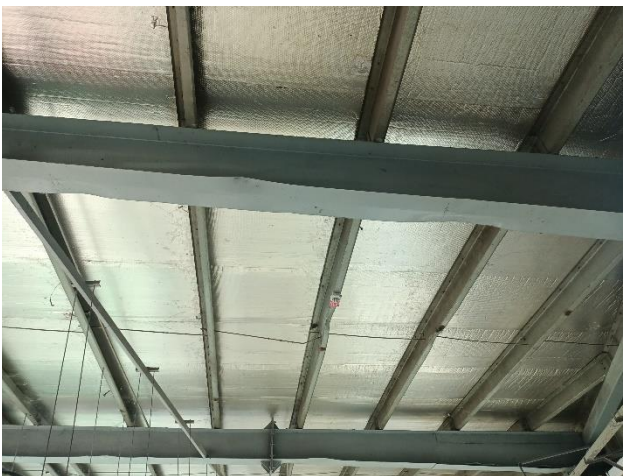
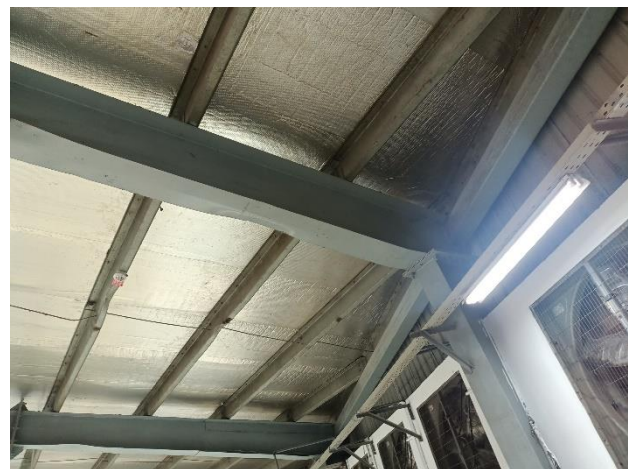
**Observation-12: Distorted flange of rafter. (Building 05).**

**Description:** A distorted steel flange was found in the rafter. Building engineer is required to check stability and serviceability of the distorted flange and suggest suitable remedial method.

| Distorted flange of rafter. (Building 05). | Building engineer is required to check stability and serviceability of the distorted flange and suggest suitable remedial method. | within 6 weeks |
| | Implement remediation work. | within 6 months |

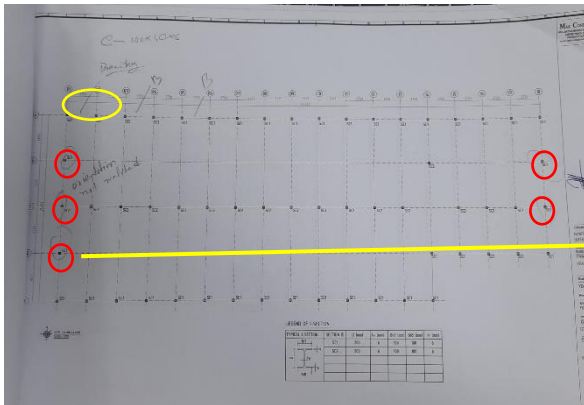
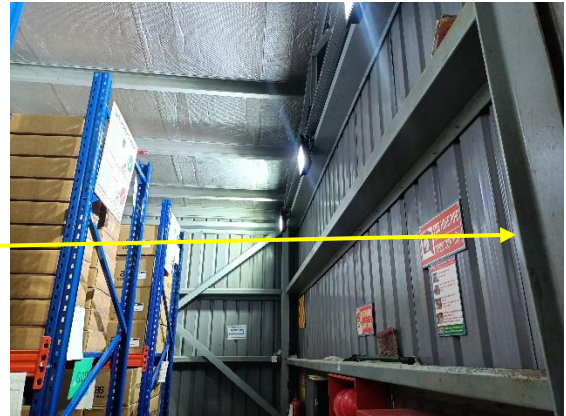
**Observation-13:** Mismatches in as-built drawings. (Building 06).

**Description:** Orientation of some steel column (marked at red in layout) didn't match with as-built condition. Also, box bracing in between grid 1 & 2 was found missing as per drawing.

| Mismatches in as-built drawings. (Building 06). | The building engineer is required to survey the full structure and produce accurate as-built drawings. | within 6 weeks |

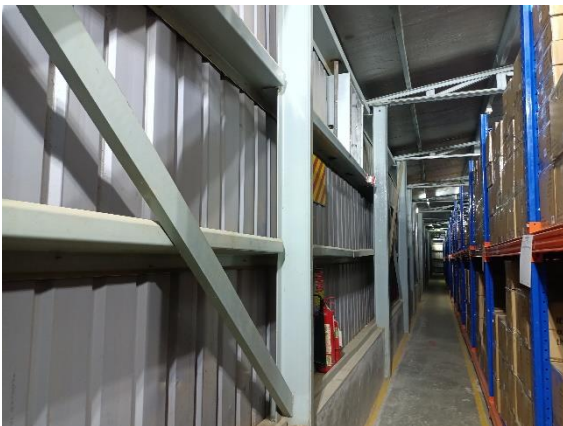
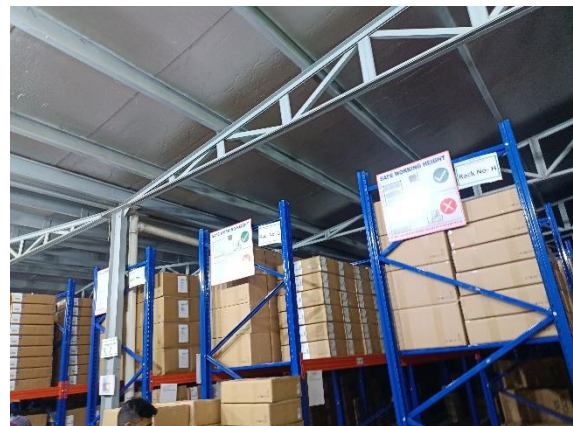
**Observation-14:** Incomplete lateral stability system. (Building 06)

**Description:** No compression strut was found along the long direction. Only cable bracings were found onsite. So lateral stability in the long direction is incomplete. The building engineer is required to check the stability system of the existing structure.

| Incomplete lateral stability system. (Building 06) | The building engineer is required to check the stability system of the existing structure. | within 6 weeks |
| | Implement remediation work if required. | within 6 months |

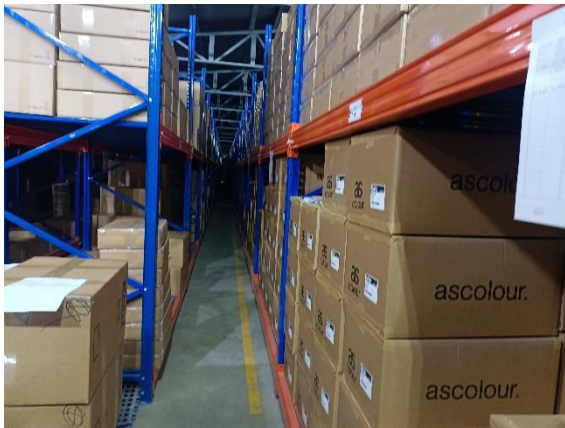
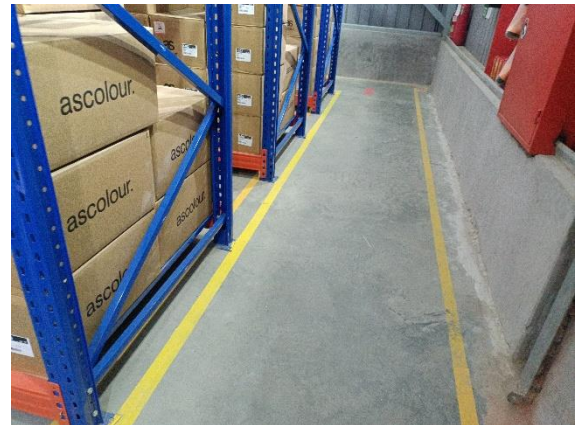
**Observation-15:** Non-structural elements not anchored or braced. (Building 06)

**Description:** Some racks on floors are not anchored or braced to resist lateral (earthquake) forces. The factory is required to anchor/brace all non-structural elements adequately to resist earthquake forces.

| Non-structural elements not anchored or braced. (Building 06) | The factory is required to anchor/brace all non-structural elements adequately to resist earthquake forces. | within 6 weeks |
