# SHINE EMBROIDERY LTD

198 Gajirchat, Modhapara, Ashuliya, Savar, Dhaka  
(23.935846, 90.281109)

5 March 2024

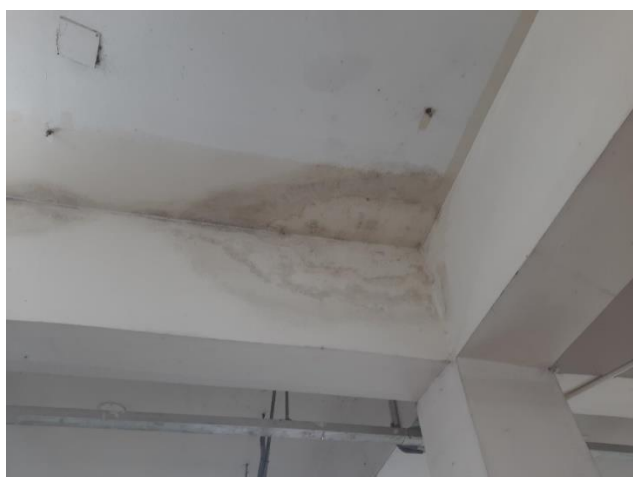
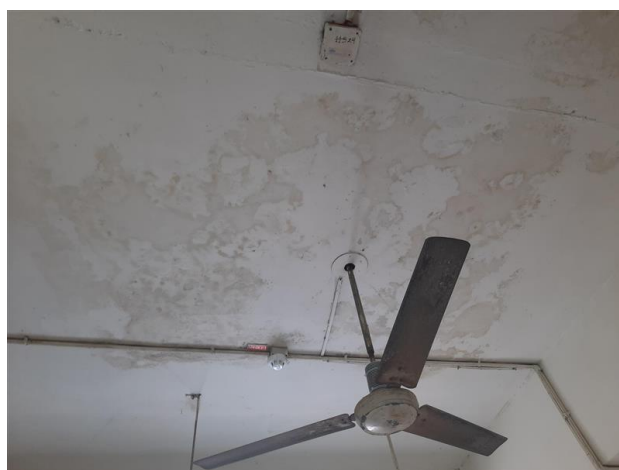
### Observation-2: Dampness at ceiling of roof floor. (Main Production Building)

**Description:** Dampness on ceiling of roof floor was observed. Building engineer is required to seal the source of water and repair the damp areas with suitable methods.

| Observation | Action Plan | Timeline |
|---|---|---|
| Dampness at ceiling of roof floor. (Main Production Building) | Building engineer is required to seal the source of water and repair the damp areas with suitable method. | within 6 weeks |

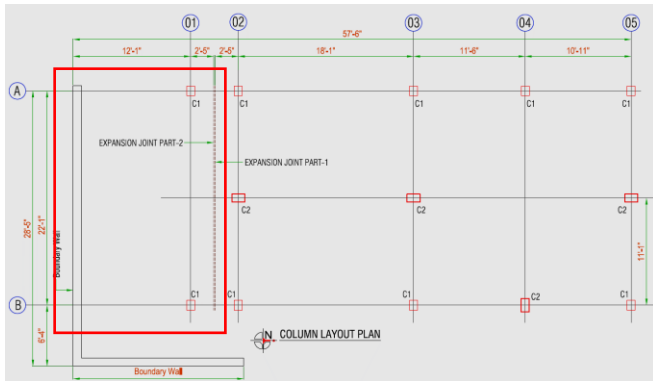
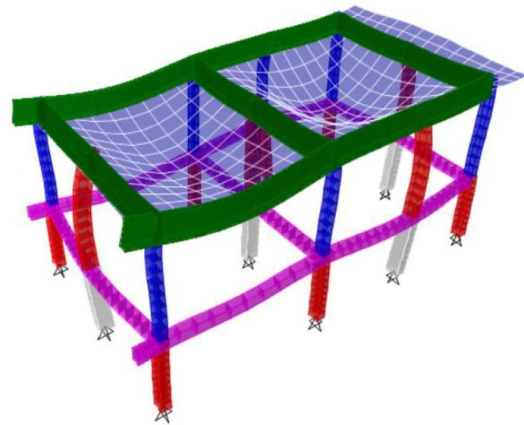
**Observation-3:** Inconsistencies in design report. (Security Building)

**Description:** In security building there are two parts, separated by an expansion joint. But in the design report only one part was considered, red marked part was not considered.

The building engineer is required to revise the design documents considering the inconsistencies and submit the documents to RSC for review.

| Observation | Action Plan | Timeline |
|---|---|---|
| Inconsistencies in design report. (Security Building) | Building engineer is required to address the inconsistencies in the EA report. | within 6 weeks |

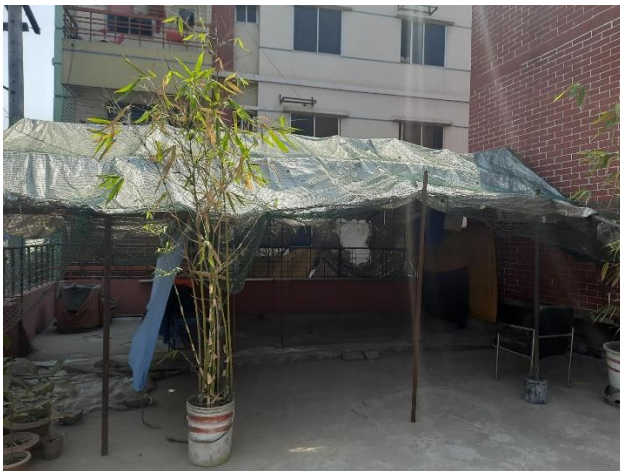
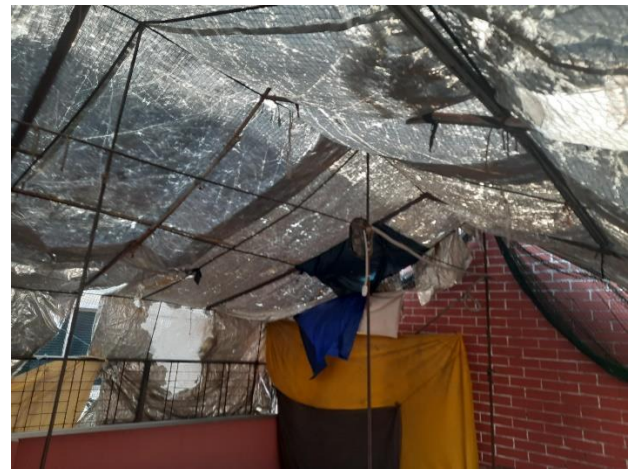
**Observation-4:** Non-engineered structure on the roof of security building. (Security Building)

**Description:** The structure is made of mild steel and the connection seems to be non-engineered. Building engineer is required to replace the structure with an engineering one.

| Observation | Action Plan | Timeline |
|---|---|---|
| Non-engineered structure on the roof of security building. (Security Building) | Building engineer is required to replace the shed with an engineering one. | within 6 months |

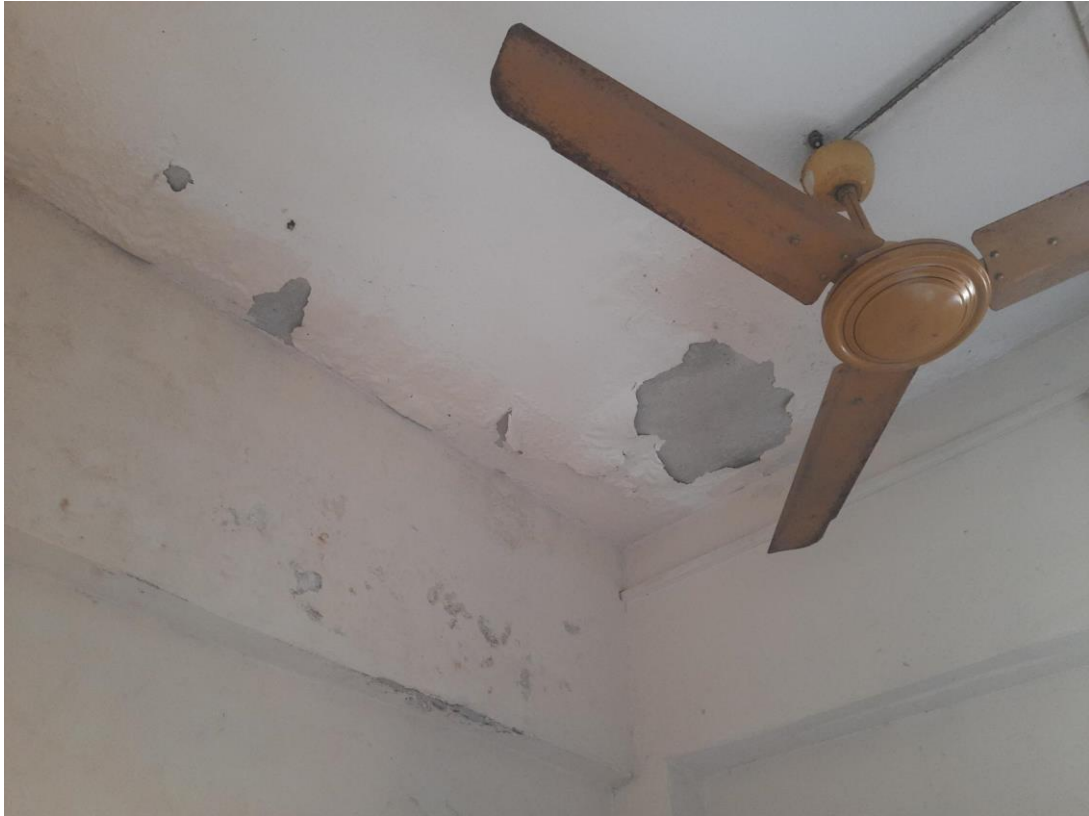
**Observation-5:** Dampness at ceiling of roof floor. (Security Building)

**Description:** Dampness on ceiling of roof floor was observed. Building engineer is required to seal the source of water and repair the damp areas with suitable methods.

| Observation | Action Plan | Timeline |
|---|---|---|
| Dampness at ceiling of roof floor. (Security Building) | Building engineer is required to seal the source of water and repair the damp areas with suitable method. | within 6 weeks |

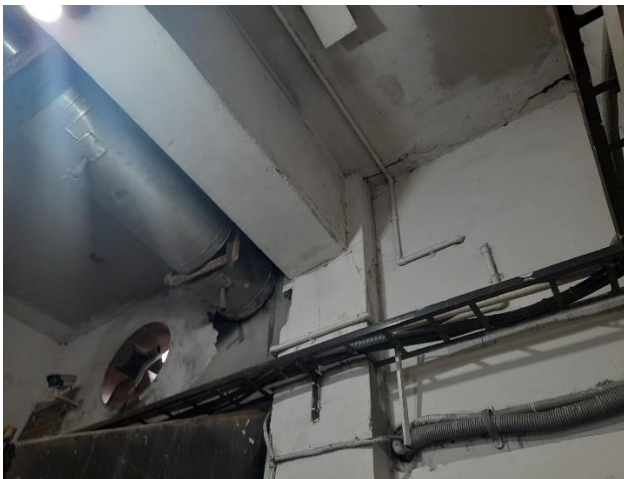
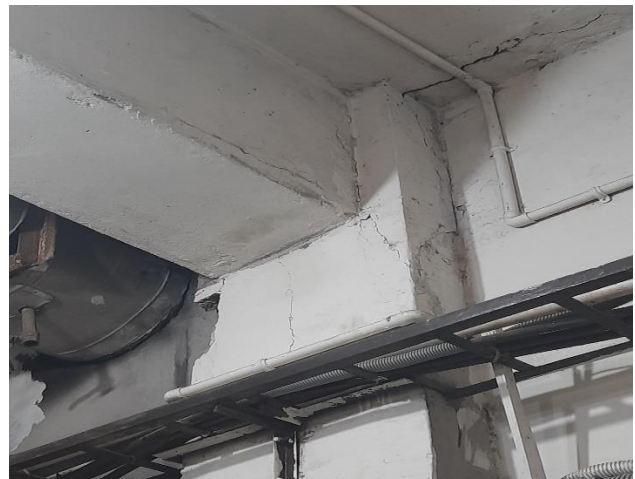
**Observation-6:** Cracks on beam-column joint and slab soffit. (Security Building)

**Description:** During the inspection, cracks were found on the beam-column joint and slab soffit at expansion joint. Building engineer is required to investigate and repair the crack with a suitable method.

| Observation | Action Plan | Timeline |
|---|---|---|
| Cracks on beam-column joint and slab soffit. (Security Building) | Building engineer is required to investigate and repair the crack with a suitable method. | within 6 weeks |
