# YP Ashulia Ltd.

Jamgora Bottola (Moyna Market), Gorat Bagbari Road, Gazirchat Aliya Madrasha,  
Ashulia, Dhaka-1349  
(23.943494, 90.297852)  
7 March 2024

## 2. Observations

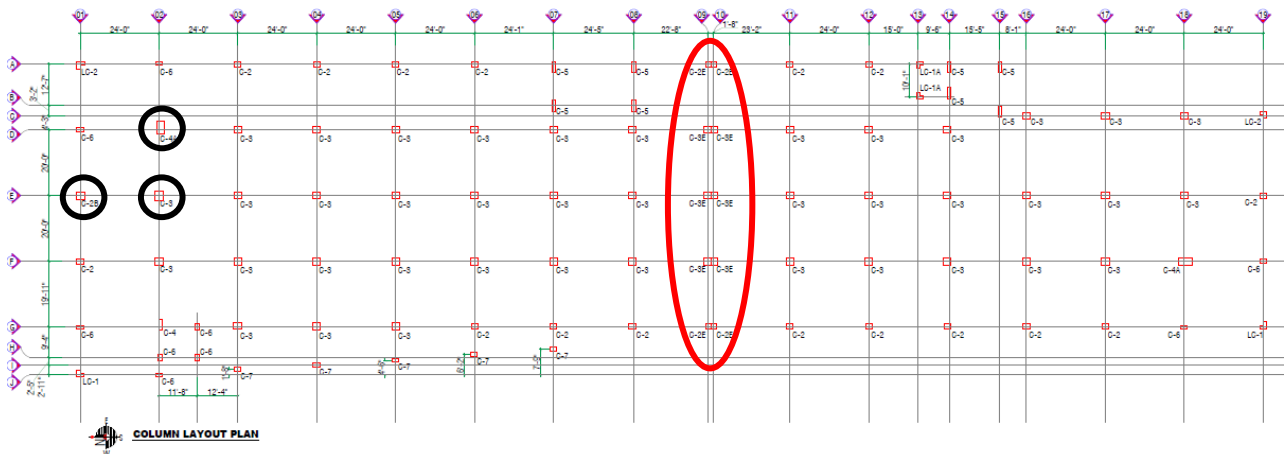
### Observation-1: Inconsistencies in the design report and floor load plan. (Building-1)

- All foundation found adequate in size for bearing capacity.
- All foundation is found inadequate in thickness for punching shear capacity.
- 1 RCC column is found inadequate.
- 1 grade beam is found inadequate in reinforcement requirement.
- All of the floor beam are found adequate in reinforcement requirement.
- Soft Story exists in Ground Floor and 1<sup>st</sup> Floor in both directions.
- Torsional Irregularity exists in upto 3<sup>rd</sup> floor, only in Y-direction.
- The separation gap between slabs is not adequate.

| Observation | Action Plan | Timeline |
|---|---|---|
| Inconsistencies in the design report and floor load plan. (Building-1) | Update the floor loading plan as per BNBC requirements for all floor plates within the factory, considering floor, column, and foundation capacity. | within 6 weeks |
| | Revise the structural analysis, design report, and retrofitting scheme of the structure. | within 6 weeks |
| | Carry out the suggested remedial works if required. | within 6 months |

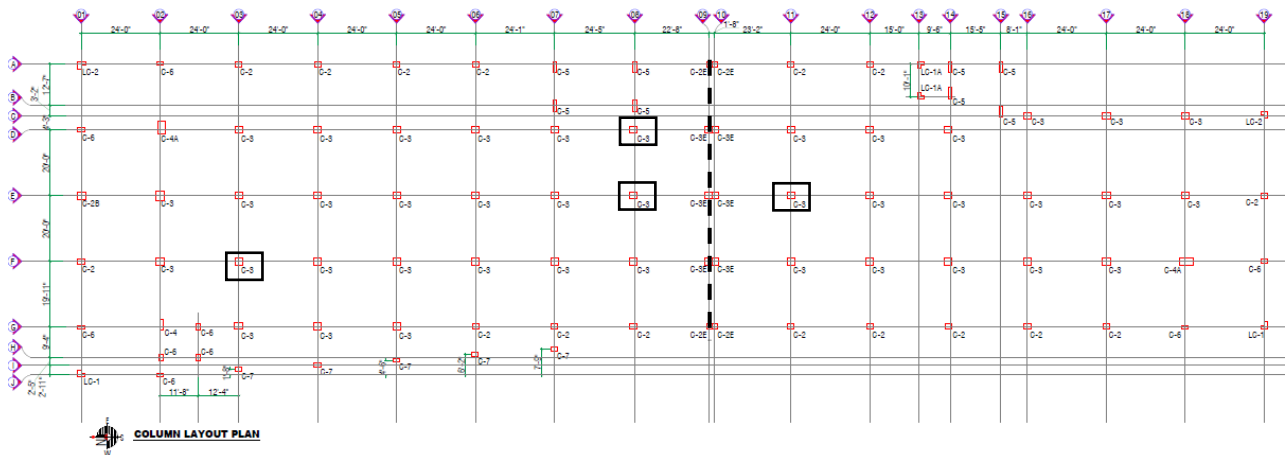
**Observation-2: Lack of material test report. (Building-1)**

**Description:** There is an expansion joint in the middle of the building. Three concrete cores from columns are taken from one part and only one number from the other. The building engineer is required to take a minimum of four concrete cores from each part of the building and confirm the material design strength.

| Observation | Action Plan | Timeline |
|---|---|---|
| Lack of material test report. (Building-1) | Verify in-situ material strength by taking a minimum 4-100mm dia. concrete core from each part of the building. | within 6 weeks |

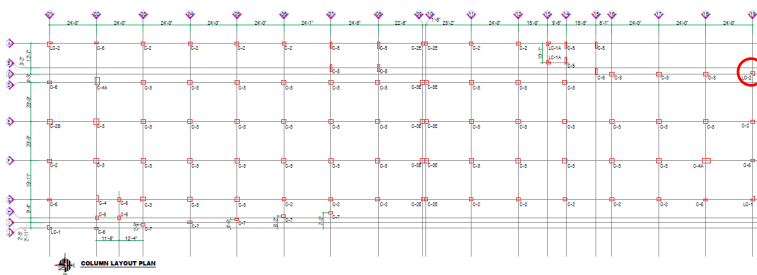
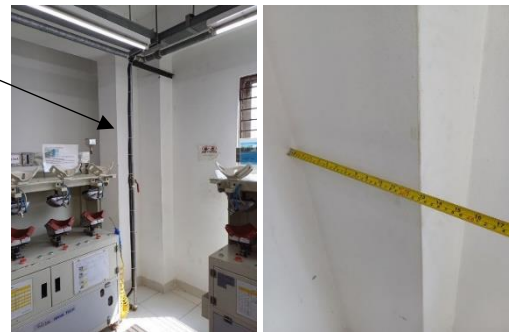
**Observation-3: Mismatch in as-built drawings. (Building-1).**

**Description:** During the inspection, an L-24x12 column was found in the marked location where the drawing showed an L-30x12 column. The ground-level retrofitted columns were not shown in the provided as-built column schedule. Also, the details of the steel canopy was missing in the drawing.

The building engineer is required to survey the structure and prepare accurate as-built drawings accordingly.

| Observation | Action Plan | Timeline |
|---|---|---|
| Mismatch in as-built drawings. (Building-1). | The building engineer is required to survey the structure and prepare accurate as-built drawings accordingly. | within 6 weeks |

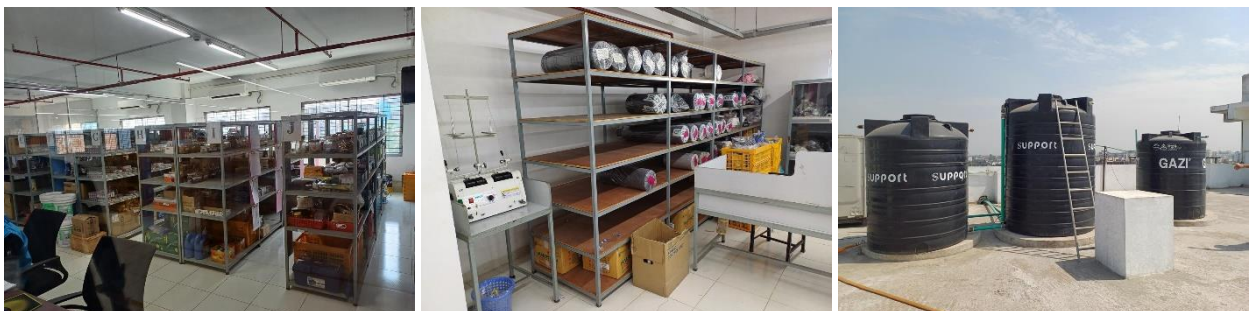
**Observation-4: Lack of anchorage on storage racks and water tank (Building-1).**

**Description:** Storage racks and rooftop water tanks at several locations were found unbraced. The building engineer is required to brace/anchor all the non-structural elements, including the water tank & storage rack.

| Observation | Action Plan | Timeline |
|---|---|---|
| Lack of anchorage on storage racks and water tank (Building-1). | The building engineer is required to brace/anchor all the non-structural elements, including the water tank & storage rack. | within 6 months |

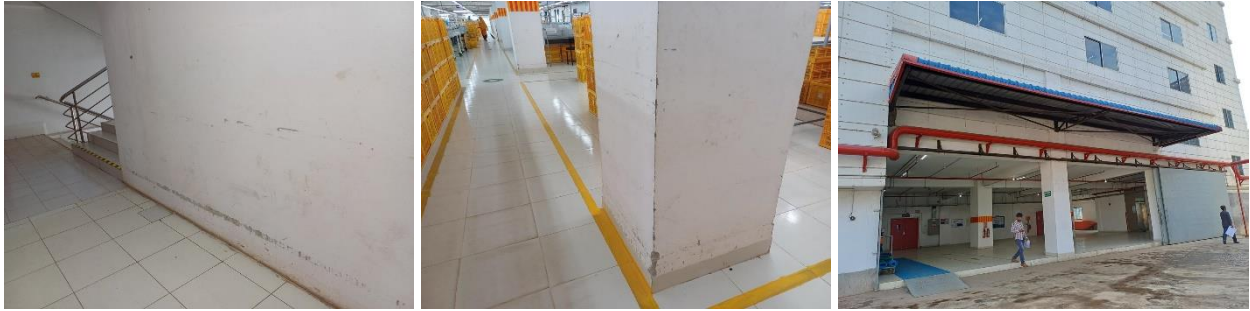
**Observation-5: Trolley and vehicle impact (Building-1)**

**Description:** Signs of trolley impact on columns and walls were found on several floors of the building. Also, the ground floor column at the loading-unloading zone is susceptible to vehicle impact. The factory is required to provide the necessary column & wall guards to protect against possible trolley impact and provide separate barriers surrounding the columns to avoid vehicle impact on them.

| Observation | Action Plan | Timeline |
|---|---|---|
| Trolley and vehicle impact (Building-1) | The factory is required to provide the necessary column & wall guards to protect against possible trolley impact and provide separate barriers surrounding the columns to avoid vehicle impact on them. | within 6 weeks |

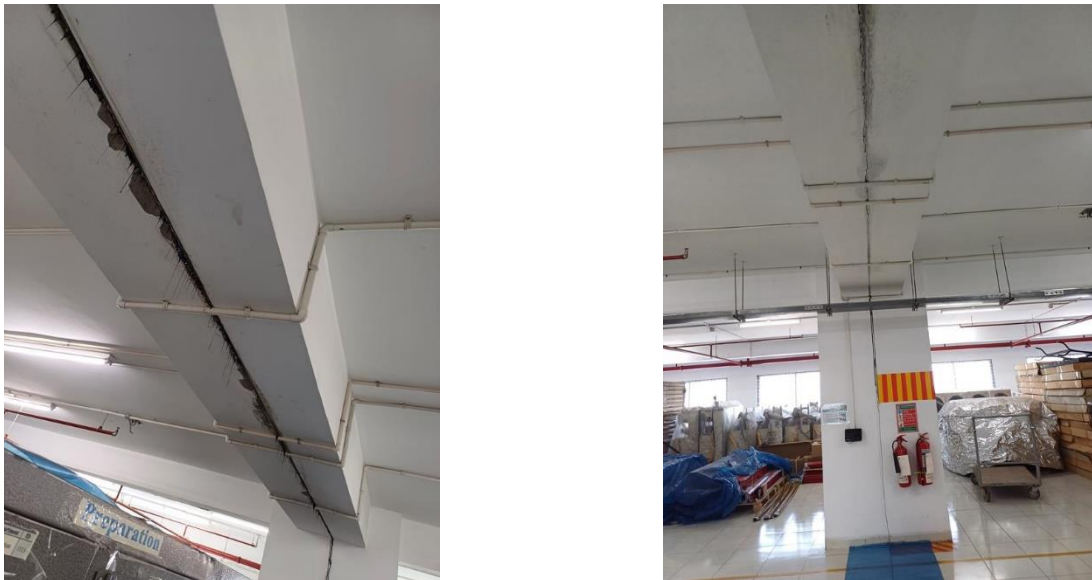
**Observation-6: Loose materials in construction joint (Building-1).**

**Description:** Construction joint was filled with loose materials. Building engineer is required to fill the joint with fireproof compressible materials as per engineers' suggestion.

| Observation | Action Plan | Timeline |
|---|---|---|
| Loose materials in construction joint (Building-1). | Building engineer is required to fill the joint with fireproof compressible materials as per engineers' suggestion. | within 6 weeks |

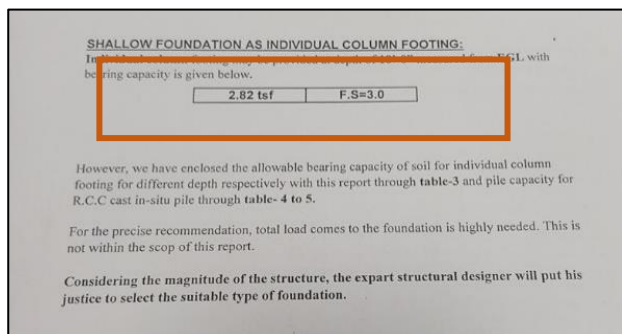
## Observation-7: Inconsistencies in the design report and soil test report. (Building-2)

Recommended footing capacity is 2.82 tsf (5.64ksf) at 3.05 m depth from EGL.

No design check for structural wall and overturning effect was found in design report.

**Description:** Foundation check of Building-2 was performed considering 7.56ksf instead of 5.64 ksf. Also, no design check was given for the shear wall in the design report. Building engineer is required to revise the design report with an overturning effect check as per Sec. 2.5.7.8 BNBC-2020 in addition to the above-mentioned issues and submit the revised design documents to the RSC for review.

Bearing capacity checked was performed considering 7.56ksf where footing depth is 2.1m from EGL.

| Observation | Action Plan | Timeline |
|---|---|---|
| Inconsistencies in the design report and soil test report (Building-2) | The building engineer is required to revise the design report and submit the revised design documents to the RSC for review. | within 6 weeks |
| | Carry out the suggested remedial works if required. | within 6 months |

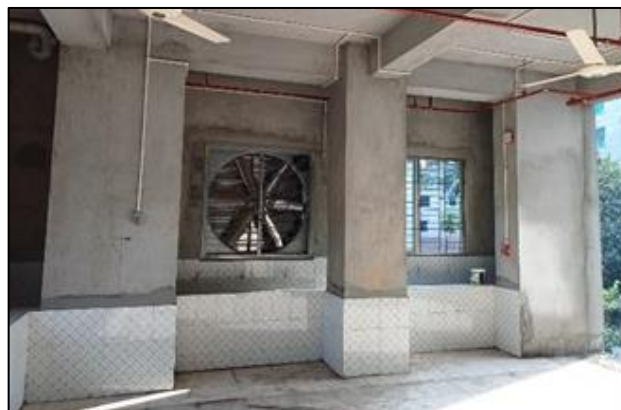
Shear wall frame.

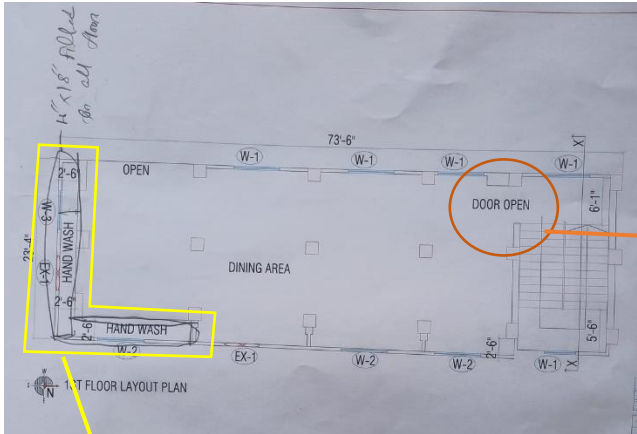
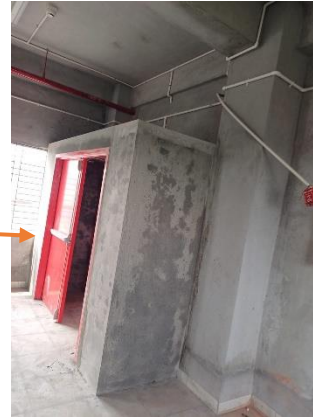
**Observation 8: Mismatch in as-built drawings. (Building – 2).**

Additional 250mm wall for fire door.

**Description:** During the inspection, a mismatch was found in the as-built drawing and as-built condition. Undocumented wall and built up was observed on the 1<sup>st</sup> to 6<sup>th</sup> floors which have been marked above. The building engineer is required to survey the structures and update the as-built drawings.

| Observation | Action Plan | Timeline |
|---|---|---|
| Mismatch in as-built drawings (Building – 2). | The building engineer is required to survey the structure and prepare accurate as-built drawings accordingly. | within 6 weeks |

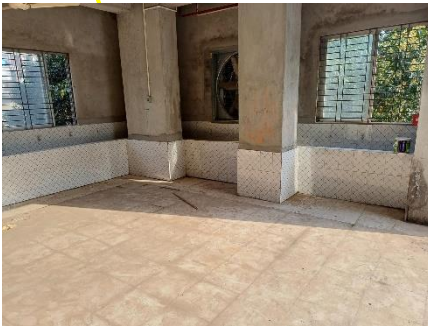
30" height 125mm wall and 18" height built-up along washing area.

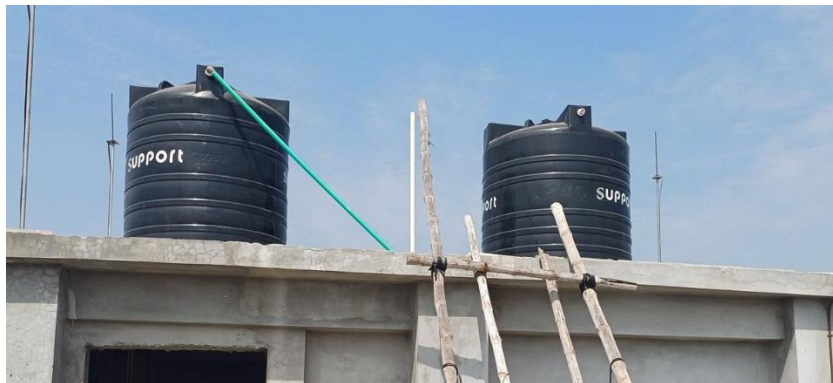
**Observation 9: Lack of anchorage on roof water tank (Building –2).**

**Description:** Roof water tanks were found unbraced. The building engineer is required to brace/anchor all the non-structural elements, including the water tank.

| Observation | Action Plan | Timeline |
|---|---|---|
| Lack of anchorage on roof water tank (Building –2). | The building engineer is required to brace/anchor all the non-structural elements including the water tank | within 6 months |

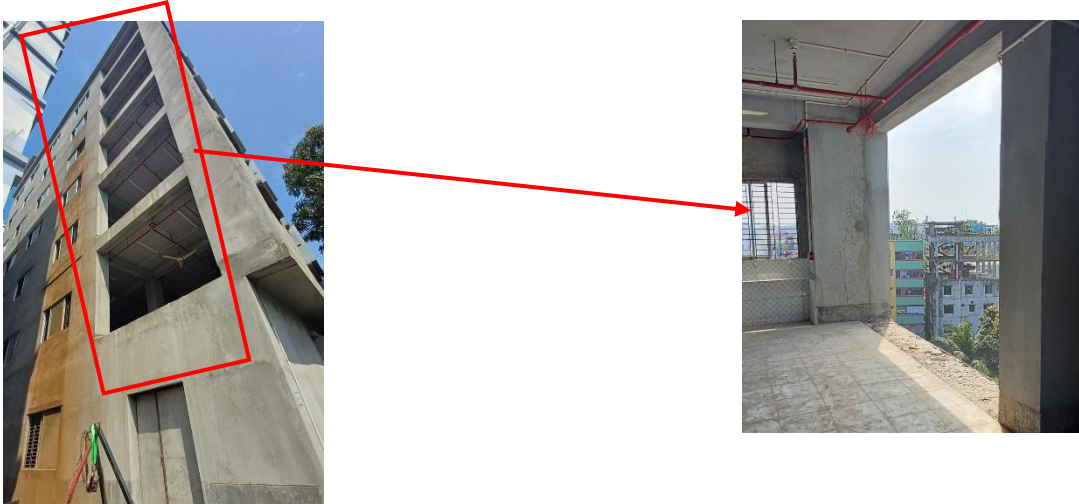
**Observation-10: Falling Hazard (Building-02).**

**Description:** A falling hazard was observed on the 1<sup>st</sup> floor to the 6<sup>th</sup> floor, at the South-East corner of the building. The building engineer is required to protect against falling hazards appropriately.

| Observation | Action Plan | Timeline |
|---|---|---|
| Falling Hazard (Building-02). | The building engineer is required to protect against falling hazards appropriately. | within 6 weeks |

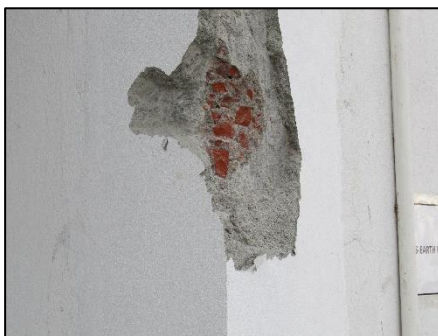
**Observation-11: Inconsistencies in the design report and concrete materials observed. (Building-3)**

In ground floor column, brick aggregates was observed.

**Description:** Material properties mentioned in the design report and test report does not match with on-site observation. Brick aggregate was found instead of stone aggregate in the ground floor column. Also, no test report was found for the ground floor column. Building engineer is required to verify the in-situ concrete strength and incorporate it in the design report.

In material test report from water reservoir and floor slab, stone chips is mentioned. However, no test report was found from ground floor column.

| Observation | Action Plan | Timeline |
|---|---|---|
| Inconsistencies in the design report and concrete materials observed (Building-3). | Verify in-situ material strength by taking a minimum 4-100mm dia. core from the lower tier of the building. | within 6 weeks |
| | The building engineer is required to review the design, loads, and column stresses based on in-situ material strength. | within 6 weeks |
| | Carry out suggested remedial works if required. | within 6 months |

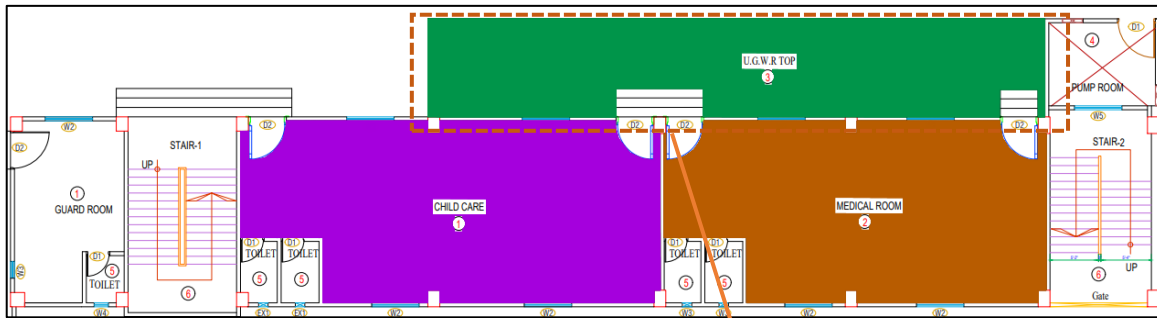
**Observation-12: Lack of load Management. (Building-3)**

Produced load plan considered 60 psf (3kPa) live load for marked area which is exposed to large vehicle movement.

**Description:** The top slab of the underground water reservoir was found exposed to large vehicle movement where a 3kPa load was considered in the load plan. Also, the load plan was not found posted on any floors. The building engineer is required to post the load plan on each floor and provide necessary barriers in the exposed area to prevent large vehicle movement.

| Observation | Action Plan | Timeline |
|---|---|---|
| Lack of load Management (Building-3). | Building engineer is required to post the load plan on each floor and provide necessary barriers in the exposed area to prevent large vehicle movement. | within 6 weeks |

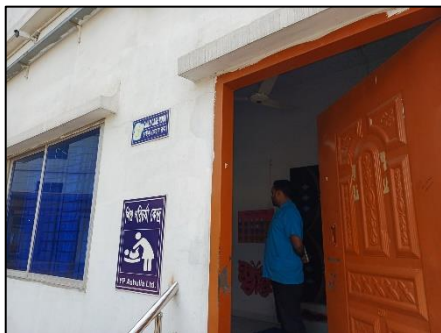
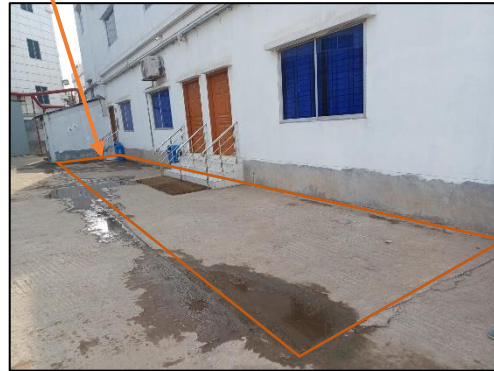
No live load plan was found posted on each floor of Building-3.

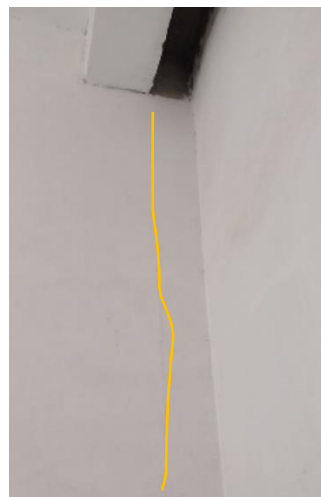
**Observation-13: Crack in the Brick wall (Building-3).**

**Description:** During the inspection, cracks were observed in the brick wall along the column-to-wall joint in stair. The building engineer is required to repair the wall crack with a suitable method.

| Observation | Action Plan | Timeline |
|---|---|---|
| Crack in the Brick wall (Building-3). | The building engineer is required to repair the wall crack with a suitable method. | within 6 weeks |

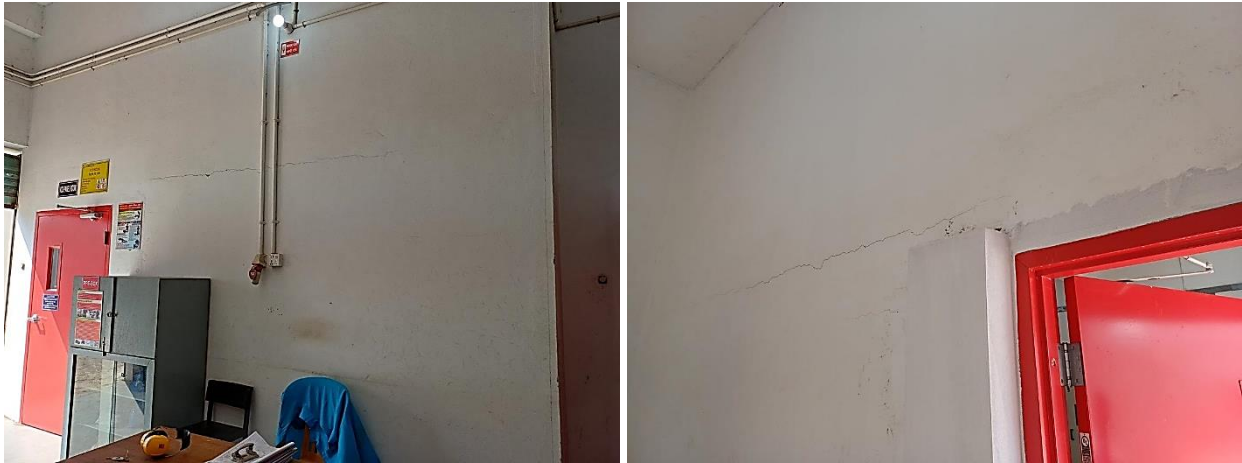
**Observation-14: Crack in the Brick wall (Building-4).**

**Description:** During the inspection, cracks were observed in the brick wall along the lintel level. The building engineer is required to investigate the presence of a lintel in the wall and repair the crack with suitable methods.

| Crack in the Brick wall (Building-4). | The building engineer is required to investigate the presence of a lintel in the wall and repair the crack with suitable methods. | within 6 weeks |

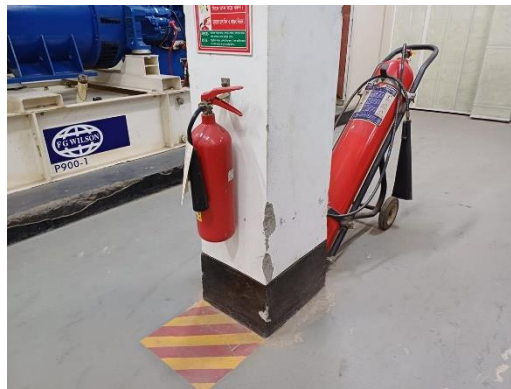
**Observation-15: Trolley impact on column (Building-4)**

**Description:** A sign of trolley impact on the column was found. The factory is required to provide the necessary column guard to protect against possible trolley impact.

| Trolley impact on column (Building-4). | The factory is required to provide the necessary column guard to protect against possible trolley impact. | within 6 weeks |

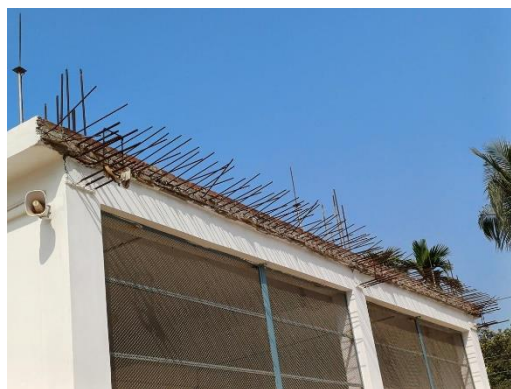
**Observation-16: Exposed rebar. (Building-4).**

**Description:** During the inspection, exposed rebar was found at the roof level of the building. The factory is required to provide an anti-corrosive coating to the exposed rebar to protect it from corrosion.

| Exposed rebar (Building 4). | The factory is required to provide an anti-corrosive coating to the exposed rebar to protect it from corrosion. | within 6 months |

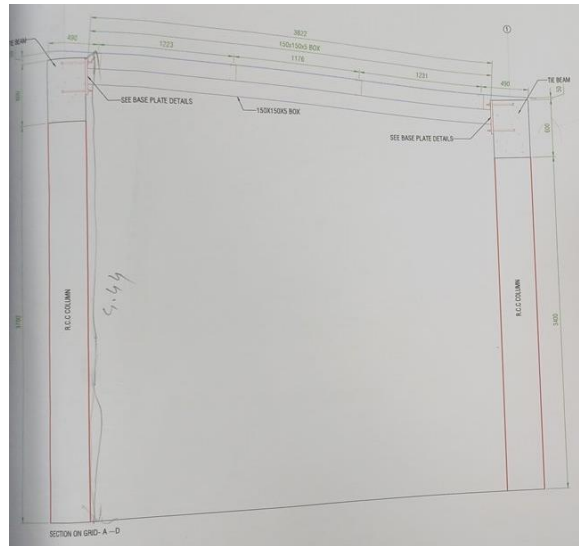
**Observation-17: Mismatch in as built drawings (Building-5).**

**Description:** During the inspection, the top height was observed at 4.44m instead of 4.8m. The building engineer is required to survey the structures and update the as-built drawings.

| Mismatch in as-built drawings (Building-5). | The building engineer is required to survey the structures and update the as-built drawings. | within 6 weeks |

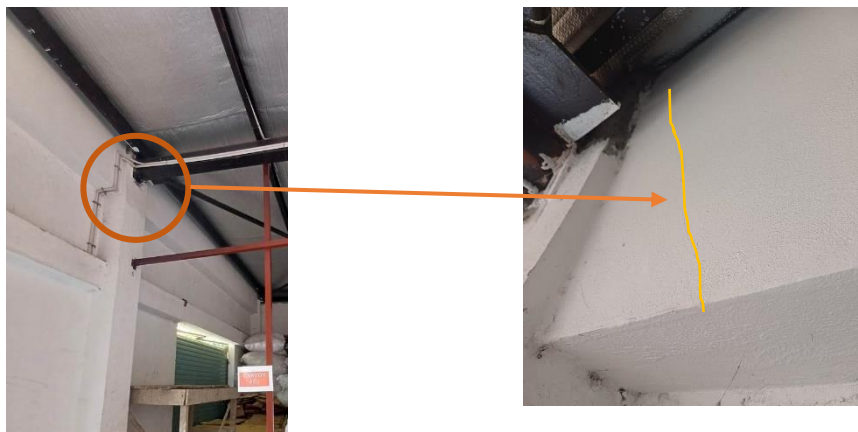
**Observation-18: Hairline Crack in the Beam (Building-5).**

**Description:** During the inspection, hairline cracks were observed in the RC beam at both sides of multiple column-beam joints. The building engineer is required to investigate the extent of the crack and repair the crack as per the investigation report.

| Hairline Crack in the Beam (Building-5). | The building engineer is required to investigate the extent of the crack and repair the crack as per the investigation report. | within 6 weeks |
