# Chancellor Garments Ltd. (relocated)

295/JA/4/A, Rayer bazar, Dhaka-1209, Bangladesh.

7 March 2024

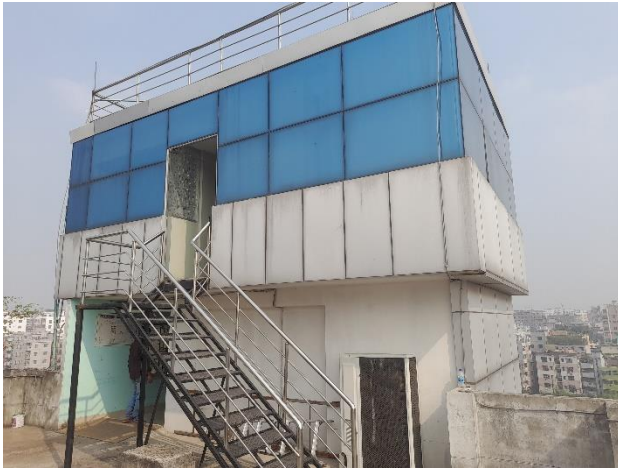
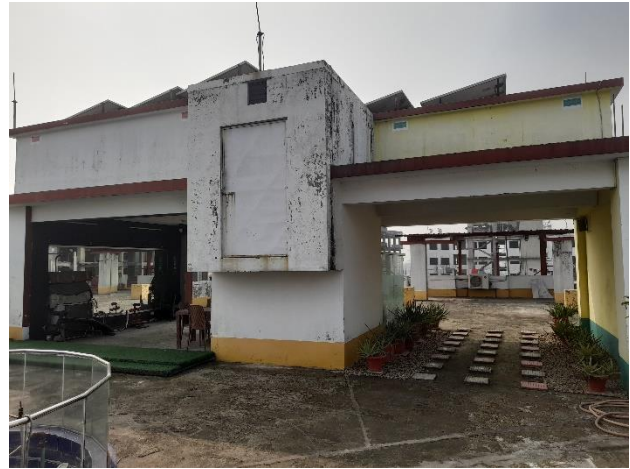
### Observation-1: Lack of information in as-built drawing. (Building-1)

Rooftop RC structure

Rooftop RC O.W.R

**Description:** During the inspection, no structural information regarding Rooftop RC O.W.R and the common room was available in the as-built architectural and structural drawing. The building engineer is required to update as-built drawings incorporating all details of this Building.

| Observation | Action Plan | Timeline |
|---|---|---|
| Lack of information in as-built drawing. (Building-1) | The building engineer is required to update the as-built drawing incorporating all architectural details of this building. | within 6 weeks |

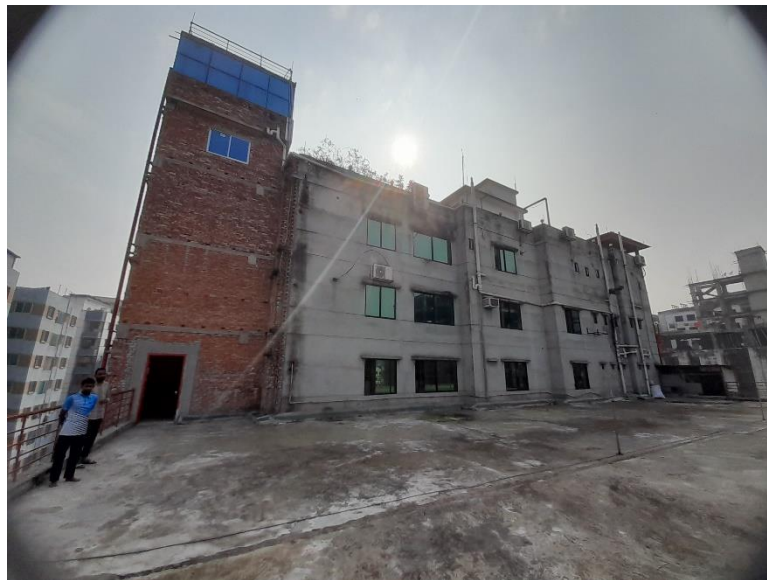
Building-1

### Observation 2: Absence of design documents. (Building-1)

**Description:** As per BNBC, every building or structure designed shall have its design documents prepared in accordance with the provision of Section 1.9.1. The design document shall include a design report, and a set of structural drawings, which shall be prepared in compliance with section 1.9.1.1 and section 1.9.1.2 as per BNBC. At the time of inspection, design report was not available which is required to be prepared in compliance with BNBC.

| Observation | Action Plan | Timeline |
|---|---|---|
| Absence of design documents. (Building-1) | Building is required to prepare a set of design reports in compliance with BNBC. | within 6 weeks |
| | Implement remediation work if required. | within 6 months |

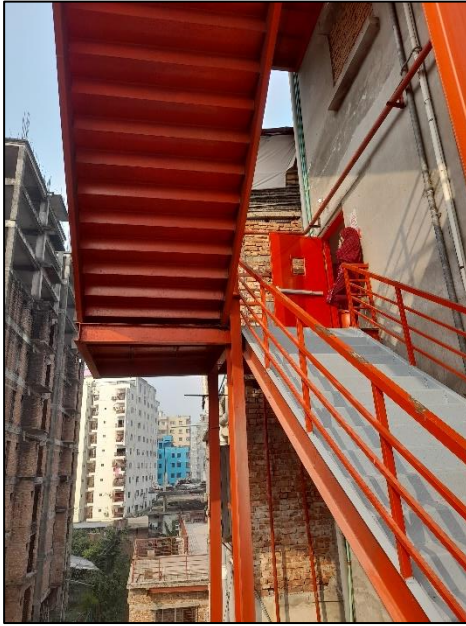
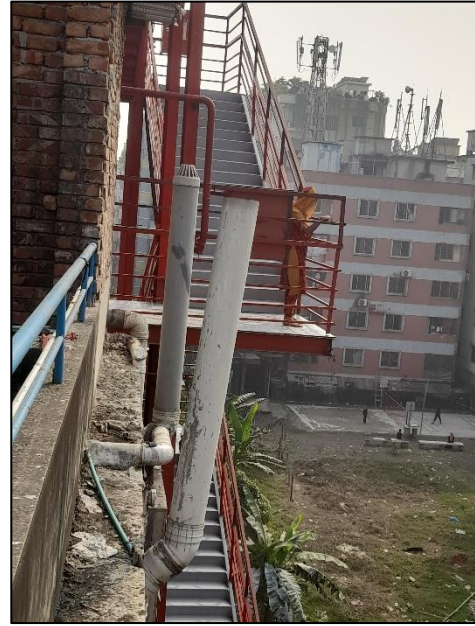
**Observation-3:** Lack of Lateral Stability in external steel stair. (Building-1)

External steel stair without any vertical and horizontal bracing

**Description:** There is an external steel stair adjacent to Building-1 from ground to 7<sup>th</sup> floor without any vertical and horizontal bracing along long direction. Therefore, lateral stability of this stair is along long direction is questionable. The building engineer is required to check the lateral stability of the structure.

| Observation | Action Plan | Timeline |
|---|---|---|
| Lack of Lateral Stability of steel stair. (Building-1) | A building engineer is required to check the lateral stability of the steel stair. | within 6 weeks |
| | Implement remediation work if required. | within 6 months |

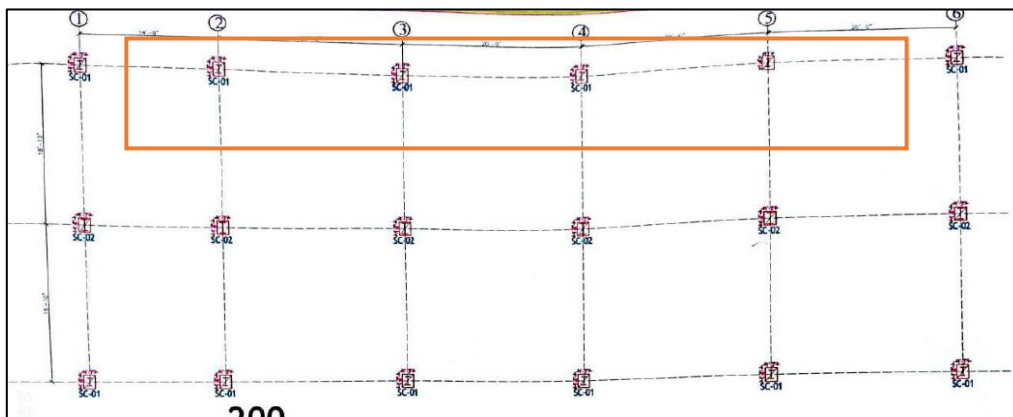
**Observation-4:** High-stress level in ground floor column. (Building-2)

Highly stressed columns in the layout

**Description:** Cursory calculation indicates the high-stress level in ground floor columns (marked area) considering the live load 3 kPa for the typical floor, 1.5 kPa for the roof, and minimum steel strength 250 MPa. Factory engineer is required to review the design, loads and column stresses for the marked columns and carry out a Detail Engineering Assessment (DEA). Maintain the floor live load of 2 kPa on each floor.

| Observation | Action Plan | Timeline |
|---|---|---|
| High Stress level in ground floor column. (Building-2) | Maintain the floor live load 2 kPa at each floor. | Immediate |
| | Factory engineers are required to review the design, loads and column stresses for the marked columns and carry out a Detail Engineering Assessment (DEA). | Immediate |
| | The Grade of steel of structural members are required to be confirmed by material test. | Immediate |
| | Produce and actively manage the loading plan according to the floor capacity. | within 6 weeks |
| | Implement remediation work if required. | within 6 months |

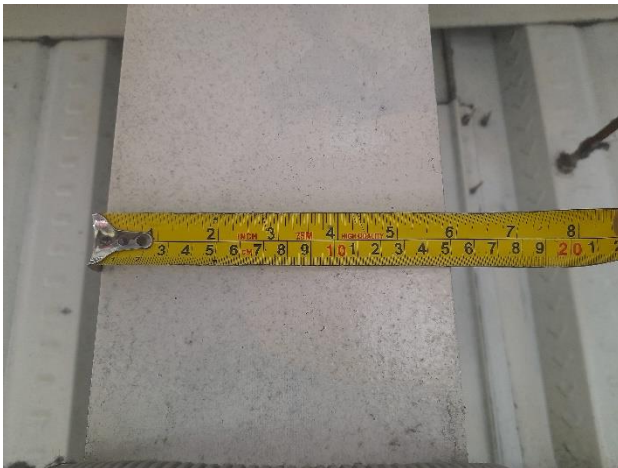
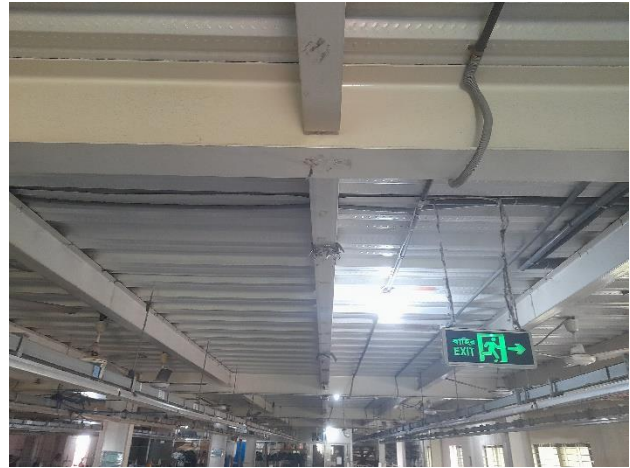
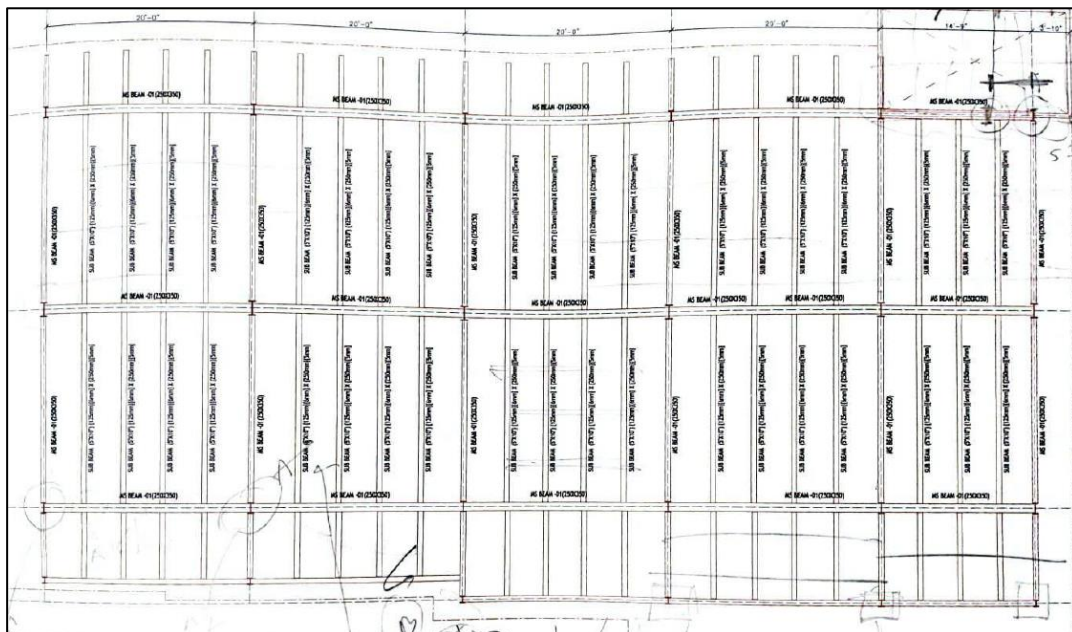
#### Observation-5: Discrepancies in as-built drawing. (Building-2)

Main beam flange size measured 150 mm

Typical framing system

Typical main beam and sub-beam layout plan

**Description:** During the inspection, the main beam flange size was measured at 150 mm. However, in the as-built drawing, it was shown 200 mm. In addition, the sub-beam orientation doesn't match with the existing condition. Building engineer is required to update the as-built drawing incorporating all structural details of this Building.

| Observation | Action Plan | Timeline |
|---|---|---|
| Discrepancies in as-built drawing. (Building-2) | Building engineer is required to update as-built drawing incorporating all architectural details of this building. | within 6 weeks |

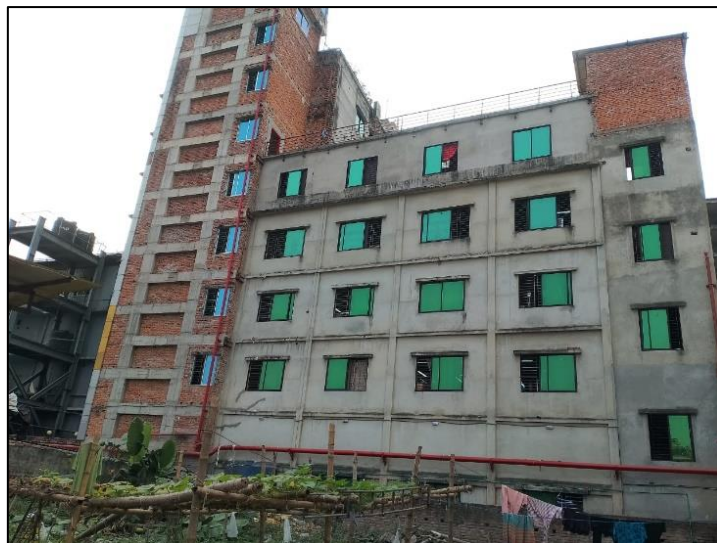
Building-2

**Observation 6: Absence of design documents. (Building-2)**

**Description:** As per BNBC, every building or structure designed shall have its design documents prepared following the provision of Section 1.9.1. The design document shall include a design report, and a set of structural drawings, which shall be prepared in compliance with section 1.9.1.1 and section 1.9.1.2 as per BNBC. At the time of inspection, a design report was not available which is required to be prepared in compliance with BNBC.

| Observation | Action Plan | Timeline |
|---|---|---|
| Absence of design documents. (Building-2) | Building is required to prepare a set of design report in compliance with BNBC. | within 6 weeks |
| | Implement remediation work if required. | within 6 months |

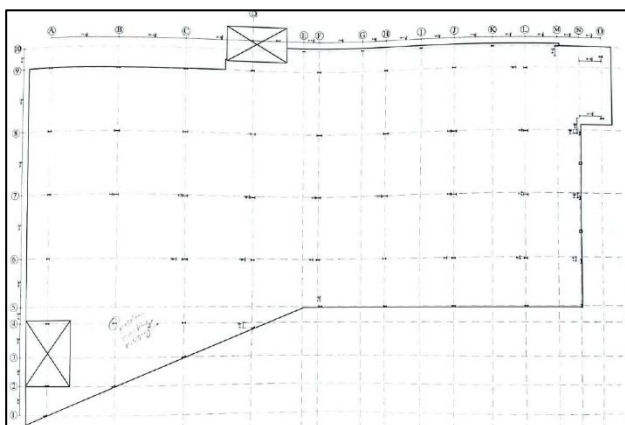
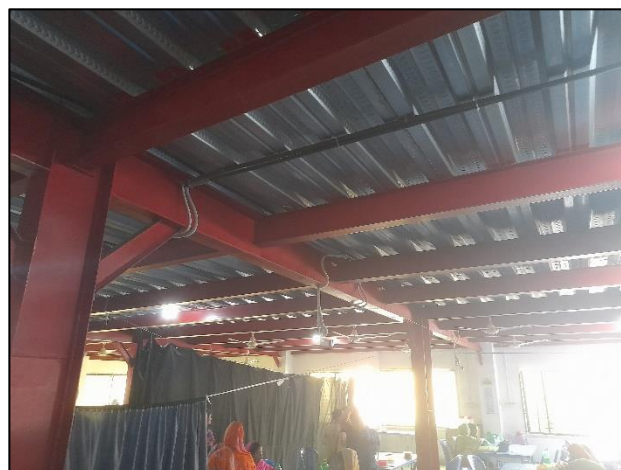
**Observation-7: Lack of information in as-built drawing. (Building-3)**

Column Layout plan

Typical framing of the structure

**Description:** During the inspection, only the sub-structure drawing for Building 3 was available. The building engineer is required to prepare a full set of as-built drawings incorporating both substructure and superstructure and all details of this Building.

| Lack of information in as-built drawing. (Building-3) | Building engineer is required to update as-built drawing incorporating all architectural details of this building. | within 6 weeks |

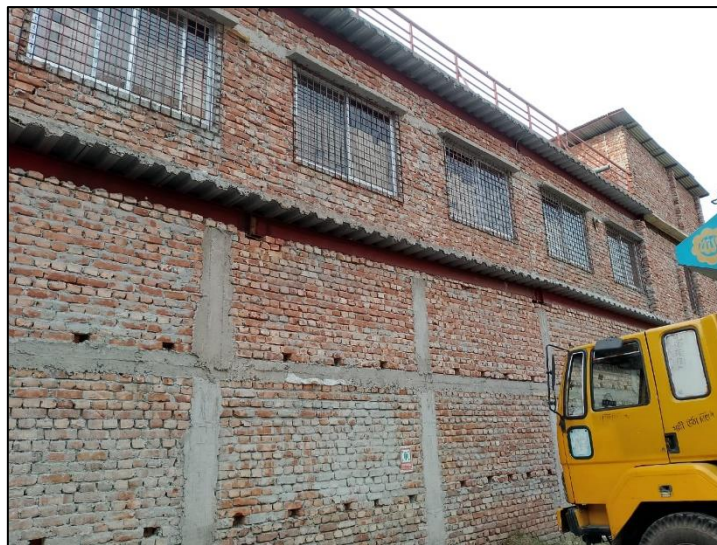
Building-3

**Observation-8: Absence of design documents. (Building-3)**

**Description:** As per BNBC, every building or structure designed shall have its design documents prepared following the provision of Section 1.9.1. The design document shall include a design report, and a set of structural drawings, which shall be prepared in compliance with section 1.9.1.1 and section 1.9.1.2 as per BNBC. At the time of inspection, a design report was not available which is required to be prepared in compliance with BNBC.

| Absence of design documents. (Building-3) | Building is required to prepare a set of design report in compliance with BNBC. | within 6 weeks |
| | Implement remediation work if required. | within 6 months |

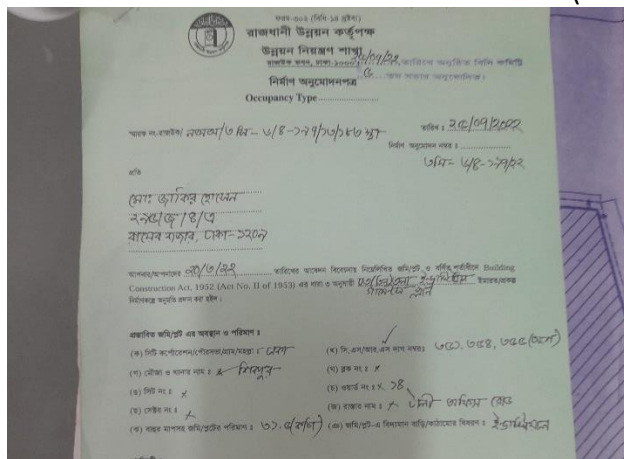
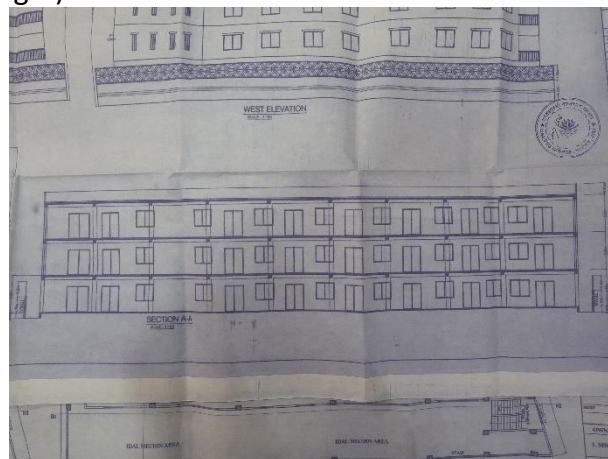
**Observation-9: Possible vertical extension. (Building-3)**

Permit drawing- 3 storey

**Description:** The building has a permit drawing for 3 storied and the factory is intended to conduct vertical extension in future. However, the building currently existed as two storied. The building engineer is required to prepare a Detail Engineering Assessment (DEA) report before the start of vertical extension.

| Possible vertical extension. (Building-3) | Factory engineer is required to prepare a Detail Engineering Assessment (DEA) report prior conducting any vertical extension. | within 6 weeks |
| | Implement remediation work if required. | within 6 months |

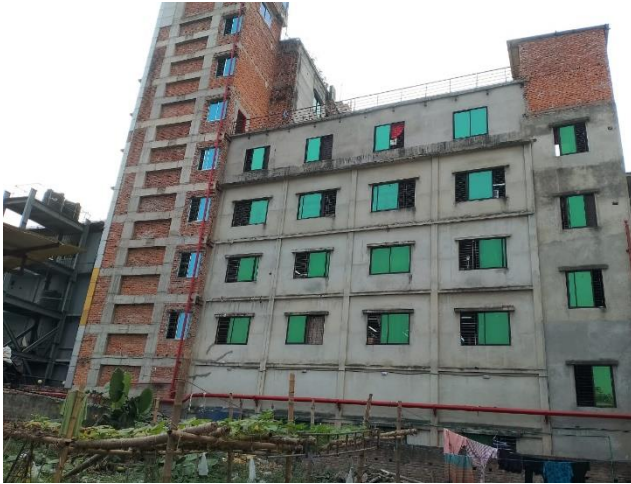
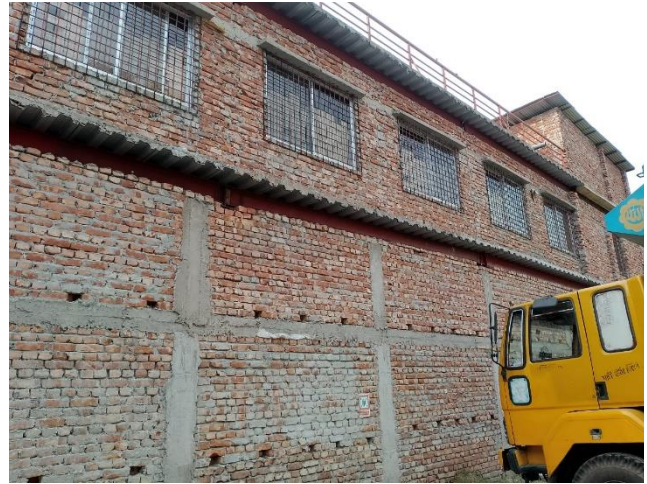
**Observation-10: Lack of geotechnical investigation report. (Building-2 & 3)**

Building-2

Building-3

**Description:** During inspection, no geotechnical investigation report was available for buildings 2 and 3. The building engineer is required to prepare a geotechnical investigation report to identify the bearing capacity of soil for a foundation adequacy check.

| Observation | Action Plan | Timeline |
|---|---|---|
| Lack of geotechnical investigation report. (Building-2) | Factory is required to prepare geotechnical investigation report to identify the bearing capacity of soil for foundation adequacy check. | within 6 weeks |

| Lack of geotechnical investigation report. (Building-3) | Factory is required to prepare geotechnical investigation report to identify the bearing capacity of soil for foundation adequacy check. | within 6 weeks |

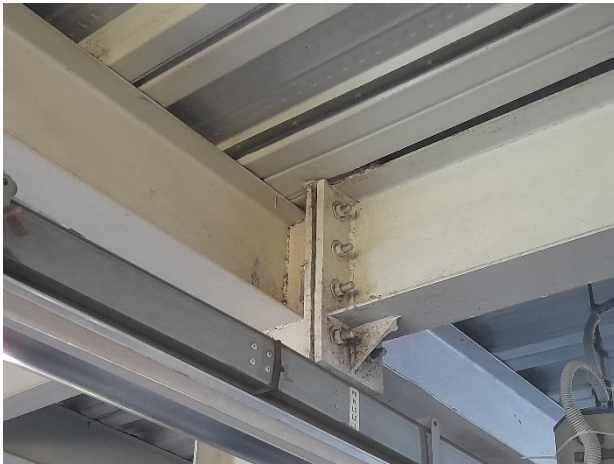
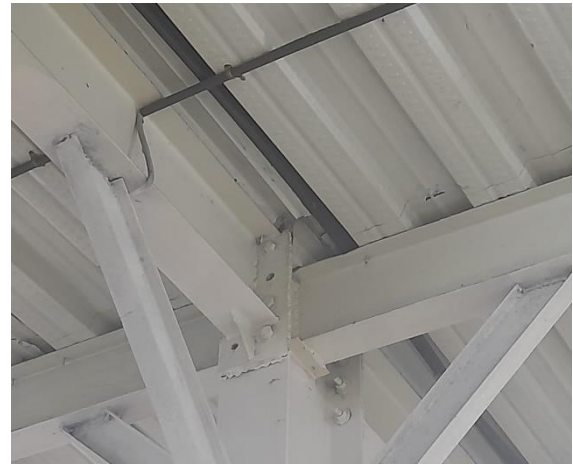
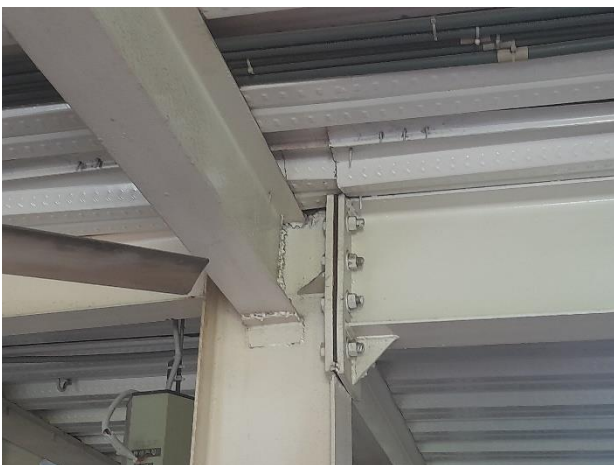
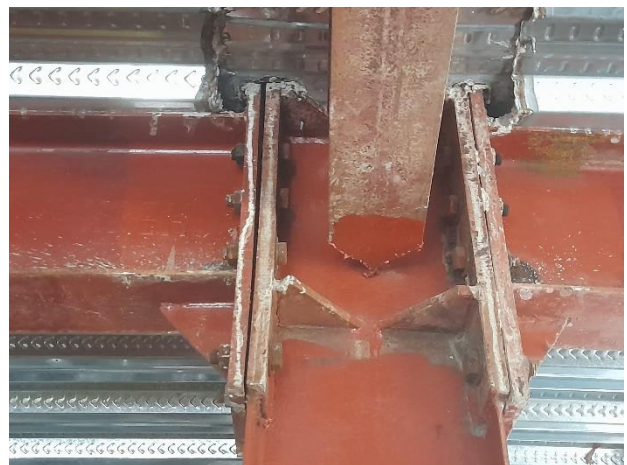
**Observation-11: Bolt missing and connection gap. (Building-2 & 3)**

**Description:** During the inspection, missing bolts and significant gaps were observed in the beam-column joint at several locations. The building engineer is required to install the missing bolts and fill the connection gaps with seam plates.

| Bolt missing and connection gap (Building-2) | Building engineer is required to repair the gap in connections with a suitable method and install the missing bolt where necessary. | within 6 weeks |
| Bolt missing and connection gap (Building-3) | Building engineer is required to repair the gap in connections with a suitable method and install the missing bolt where necessary. | within 6 weeks |
