# ACS Textiles (Bangladesh) Ltd. (Extension)

Tetlabo, Barpa, Rupgonj, Narayangonj.

10 March 2024

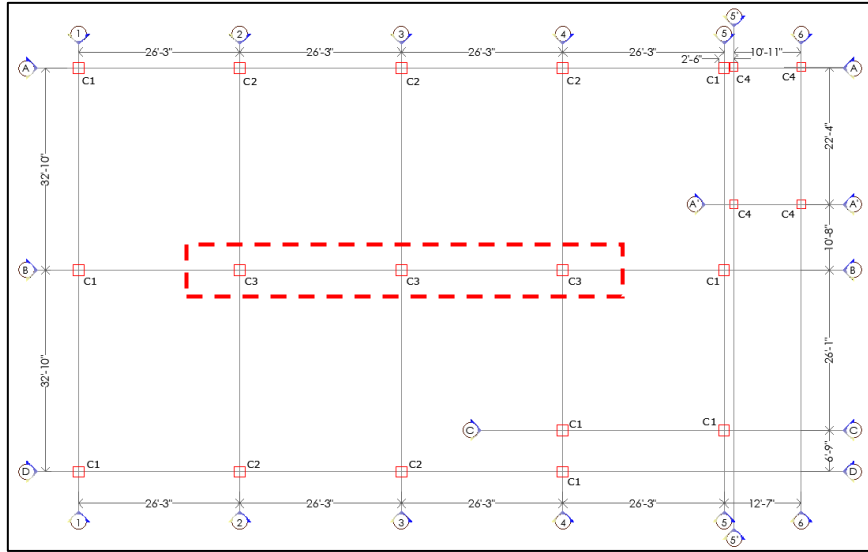
**Observation-1:** Marginal stress in column exceeds normal design limit (Digital Printing building).

**Description:** The cursory calculation indicates that stress in the marked column exceeds the normal design limit considering the floor live load of 3 kPa for the typical floor & 6 kPa for the storage area and concrete strength of 17.4 MPa. The building engineer is required to review the design, loads, and column stresses for the marked columns based on in-situ material strength. The building engineer is also required to Produce and actively manage a loading plan for all floor plates within the factory considering floor capacity and column capacity.

| Observation | Action Plan | Timeline |
|---|---|---|
| Marginal stress in the column exceeds the normal design limit (Digital Printing building). | The building engineer is required to review the design, loads, and column stresses for the marked columns based on in-situ material strength. | within 6 weeks |
| | The building engineer is required to Produce and actively manage a loading plan for all floor plates within the factory considering floor capacity and column capacity. | within 6 weeks |
| | Implement remediation work if required. | within 6 months |

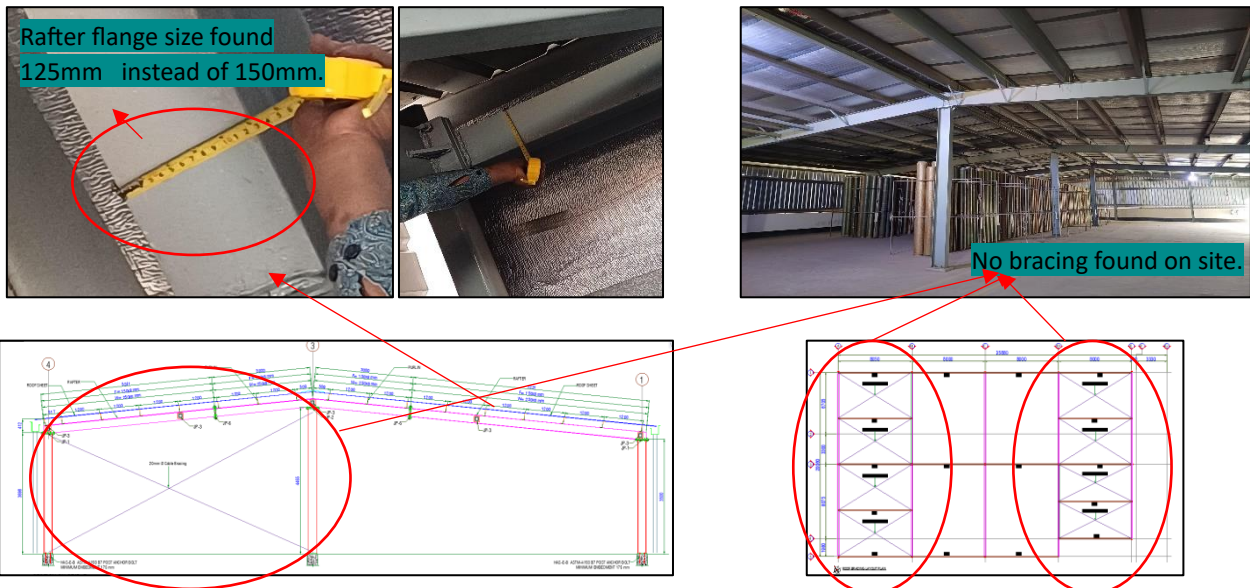
**Observation-2:** Mismatch in as-built drawings (Digital Printing building).

**Description:** During the inspection, some mismatch was found in the as-built drawings of the roof shed of the Digital Printing Building. The flange size of the rafter was found 125mm instead of 150mm along grid E. Furthermore, No bracing was found on-site at the roof and wall but as-built drawings are showing cable bracing at the roof and wall. The building engineer is required to survey the whole structure, update the as-built drawings, and perform an Engineering Assessment (EA).

| Observation | Action Plan | Timeline |
|---|---|---|
| Mismatch in as-built drawings (Digital Printing building). | The building engineer is required to survey the whole structure, update the as-built drawings, and perform an Engineering Assessment (EA). | within 6 weeks |

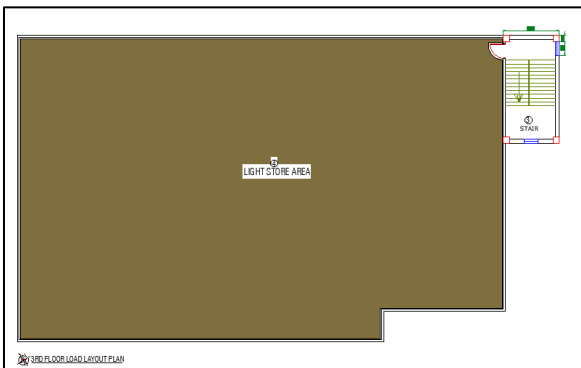
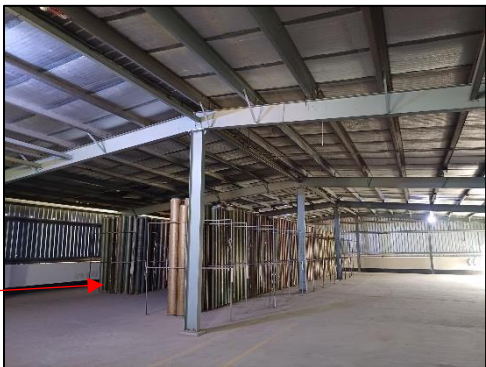
**Observation-3:** Storage live load limit does not comply with BNBC requirement (Digital Printing building).

**Description:** As per BNBC, 6 kPa is required to be considered as floor loading for the light storage facilities. During the inspection, the load plan was found considering (63 psf) 3kPa at the 3<sup>rd</sup> floor (roof shed) storage area. However, the building engineer is required to update the storage live load limit as per BNBC requirements and revise the structural analysis & design accordingly.

| Observation | Action Plan | Timeline |
|---|---|---|
| Storage live load limit does not comply with BNBC requirement (Digital Printing building). | The building engineer is required to update the storage live load limit as per BNBC requirements, revise the structural analysis & design accordingly. | within 6 weeks |
| | Implement remediation work if required. | within 6 months |

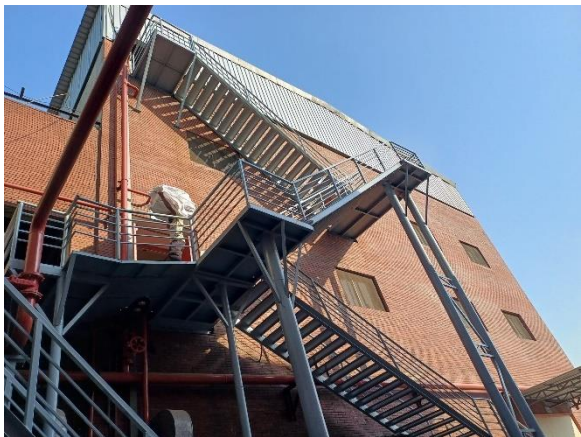
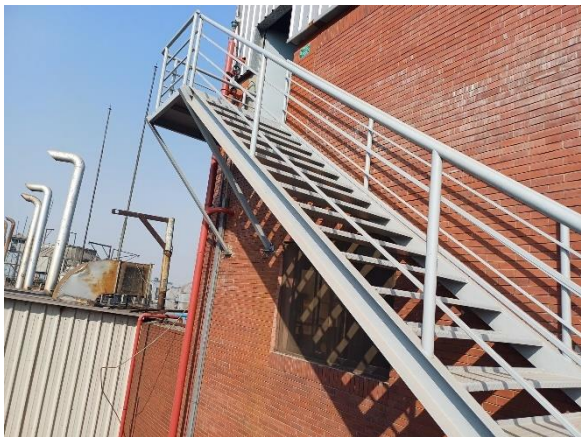
**Observation-4:** Lack of lateral stability of adjacent steel stairs (Digital Printing building).

**Description:** The steel stair appeared to be unstable due to a lack of lateral load transfer media. The building engineer is required to check the lateral stability of the steel stair, perform an Engineering assessment (EA) and suggest remediation if required.

| Observation | Action Plan | Timeline |
|---|---|---|
| Lack of lateral stability of adjacent steel stairs (Digital Printing building). | The building engineer is required to check the lateral stability of the steel stairs and perform an Engineering assessment (EA). | within 6 weeks |
| | Implement remediation work if required. | within 6 months |

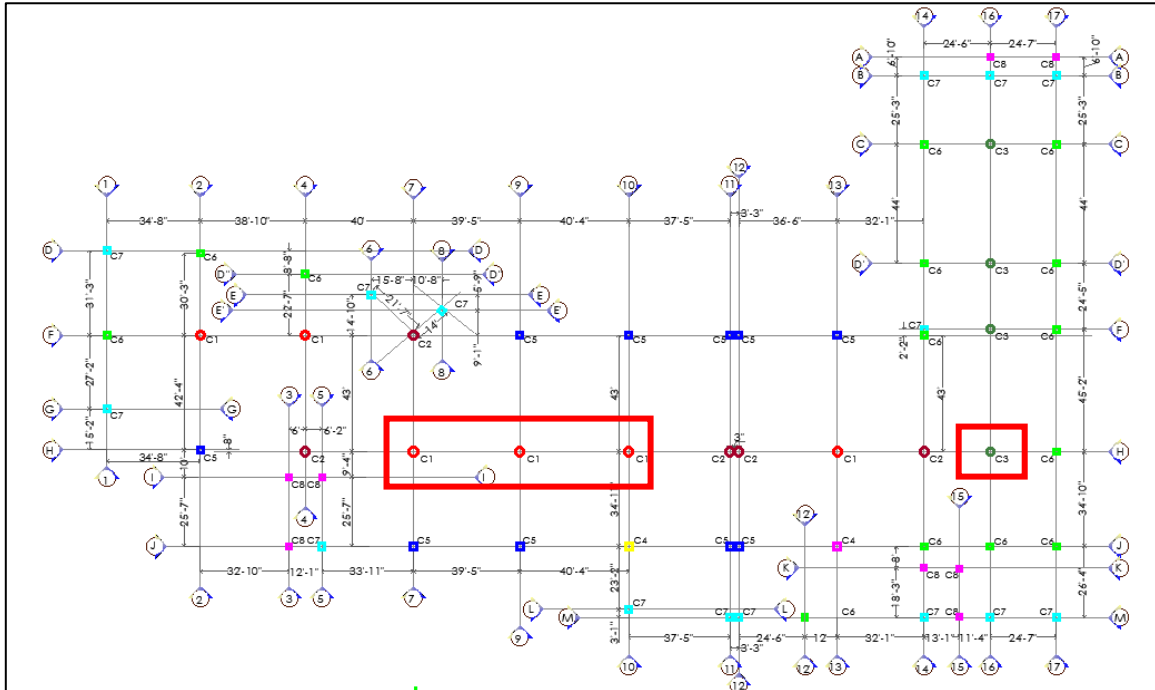
**Observation-5:** Marginal stress in column exceeds normal design limit (Weaving Building 4).

**Description:** The cursory calculation indicates that stress in the marked column exceeds the normal design limit considering the floor live load of 6 kPa for the storage area & typical floor and concrete strength of 18.4 MPa. The building engineer is required to review the design, loads, and column stresses for the marked columns based on in-situ material strength. The building engineer is also required to Produce and actively manage a loading plan for all floor plates within the factory considering floor capacity and column capacity.

| Observation | Action Plan | Timeline |
|---|---|---|
| Marginal stress in the column exceeds the normal design limit (Weaving Building 4). | The building engineer is required to review the design, loads, and column stresses for the marked columns based on in-situ material strength. | within 6 weeks |
| | The building engineer is also required to Produce and actively manage a loading plan for all floor plates within the factory considering floor capacity and column capacity. | within 6 weeks |
| | Implement remediation work if required. | within 6 months |

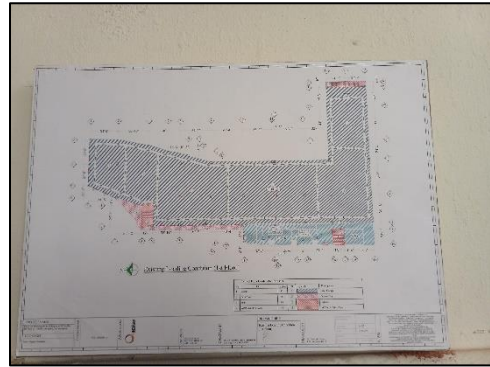
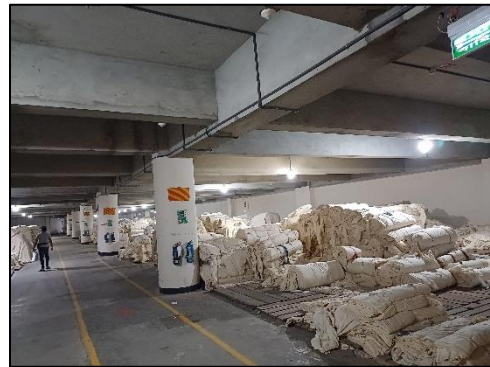
**Observation-6:** Storage live load limit does not comply with BNBC requirement (Weaving Building 4)

**Description:** As per BNBC, 6 kPa is required to be considered as floor loading for the light storage facilities. During the inspection, the load plan was found considering (63 psf) 3kPa at the 3<sup>rd</sup> floor (roof shed) storage area. However, the building engineer is required to update the storage live load limit as per BNBC requirements, and revise the structural analysis & design accordingly.

| Observation | Action Plan | Timeline |
|---|---|---|
| Storage live load limit does not comply with BNBC requirement (Weaving Building 4) | The building engineer is required to update the storage live load limit as per BNBC requirements, revise the structural analysis & design accordingly. | within 6 weeks |
| | Implement remediation work if required. | within 6 months |

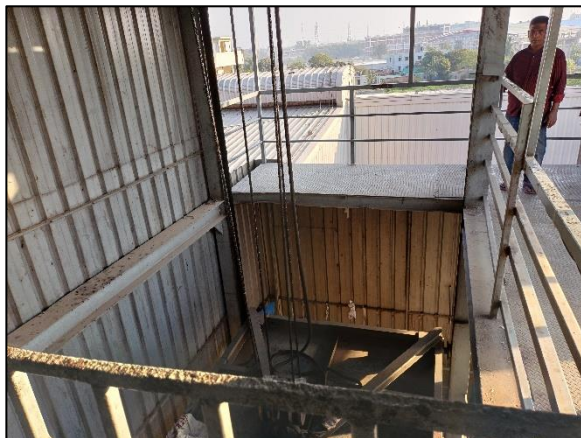
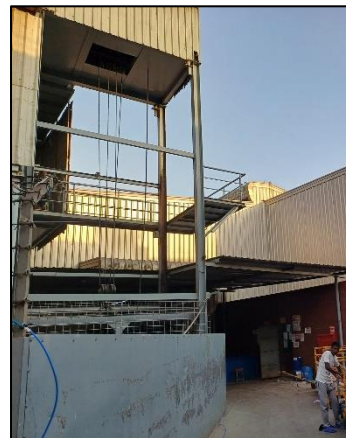
**Observation-7:** Lack of lateral stability of adjacent steel framing lift (Weaving Building 4).

**Description:** The steel framing lift appeared to be unstable due to a lack of lateral load transfer media. The building engineer is required to check the lateral stability of the steel lift, perform an Engineering assessment (EA) and suggest remediation if required.

| Observation | Action Plan | Timeline |
|---|---|---|
| Lack of lateral stability of adjacent steel framing lift (Weaving Building 4). | The building engineer is required to check the lateral stability of the steel lift and perform an Engineering assessment (EA). | within 6 weeks |
| | Implement remediation work if required. | within 6 months |

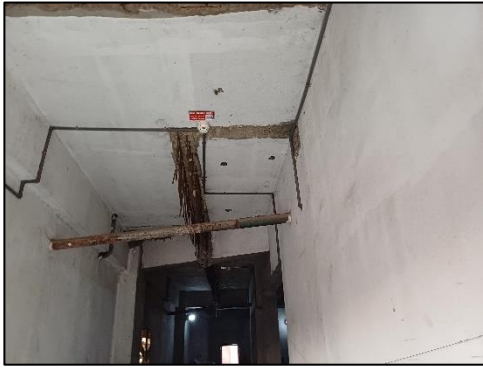
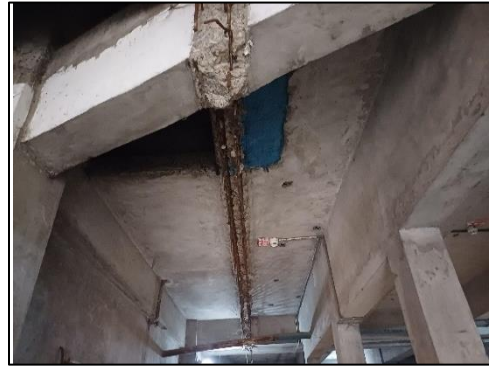
**Observation-8:** Exposed rebar at ground floor beam & slab (Weaving Building 4).

**Description:** Exposed reinforcement was found at the ground floor roof slab. The factory is required to take necessary measures to prevent corrosion in the exposed rebar.

| Exposed rebar at ground floor beam & slab (Weaving Building 4). | The factory is required to take necessary measures to prevent corrosion in exposed rebar. | within 6 weeks |

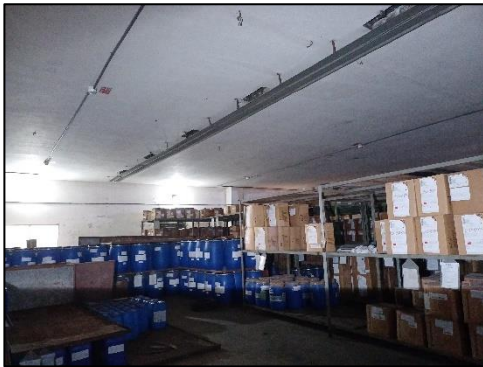
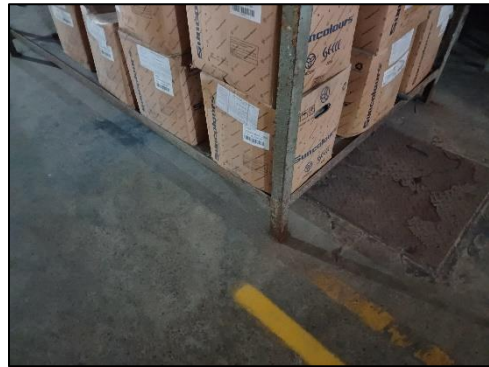
**Observation-9:** Storage rack without anchorage (Weaving Building 4).

**Description:** Racks on ground floors are not adequately anchored or braced to resist lateral (earthquake) forces. The factory is required to adequately anchor and brace all non-structural elements to resist earthquake forces to comply with the BNBC.

| Storage rack without anchorage (Weaving Building 4). | The factory is required to adequately anchor and brace all non-structural elements to resist earthquake forces to comply with the BNBC. | within 6 months |

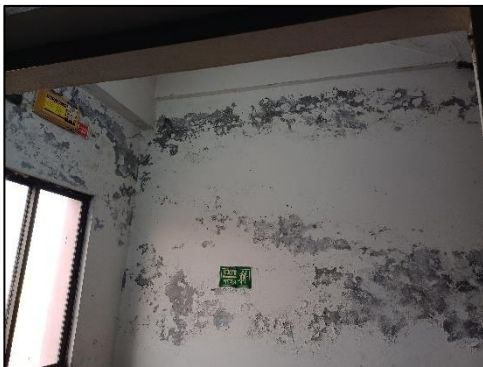
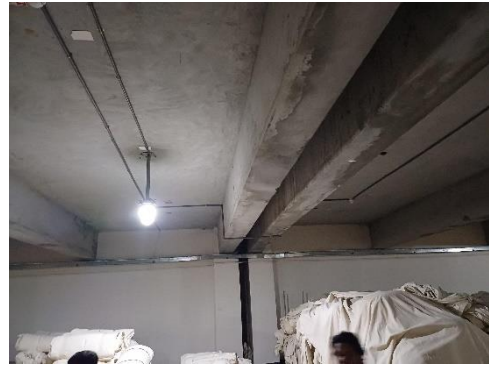
**Observation-10:** Dampness on Wall & slab (Weaving Building 4).

**Description:** Dampness was found on the wall and slab of Weaving Building 4. The building engineer is required to investigate the source of dampness and take necessary measures to prevent the dampness.

| Dampness on Wall & slab (Weaving Building 4). | The building engineer is required to investigate the source of dampness and take necessary measures to prevent the dampness. | within 6 months |

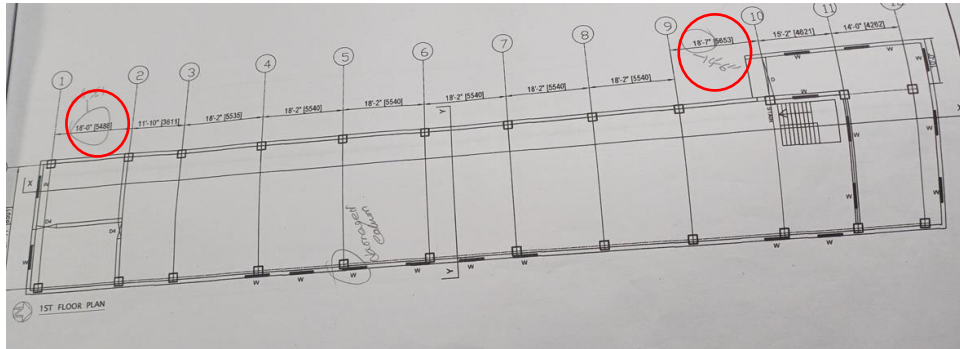
**Observation-11: Mismatch in as built drawings - Sizing-3 (Re-Coning building).**

**Description:** During inspection, a grid mismatch was found in the as-built drawings. The building engineer is required to survey the whole structure, update the as-built drawings, perform an Engineering Assessment (EA) and submit it to RSC for review.

| Mismatch in as-built drawings - Sizing-3 (Re-Coning building). | The building engineer is required to survey the whole structure, update the as-built drawings, perform an Engineering Assessment (EA) and submit it to RSC for review. | within 6 weeks |
| | Implement remediation work if required. | within 6 months |

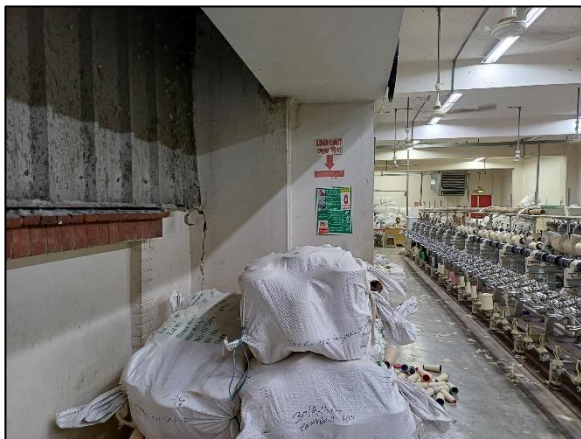
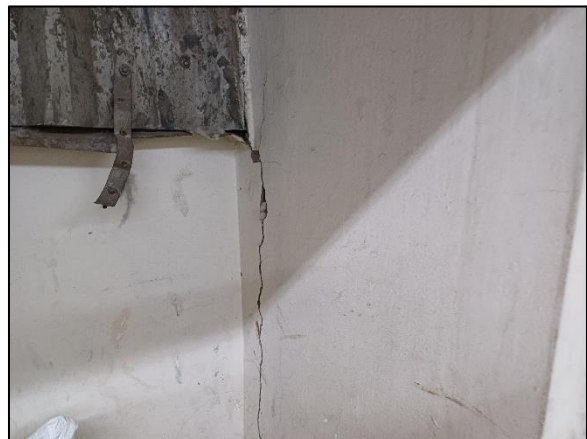
**Observation-12: Crack in brick wall - Sizing-3 (Re-Coning building).**

**Description:** During the inspection, a crack in the brick wall was observed on the first floor of Sizing-3 (Re-Coning building). The factory is required to repair the brick wall crack as per adequate technique.

| Crack n brick wall - Sizing-3 (Re-Coning building). | The factory is required to repair the brick wall crack as per adequate technique. | within 6 weeks |

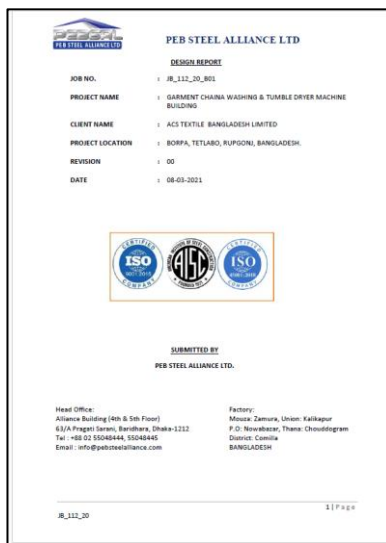
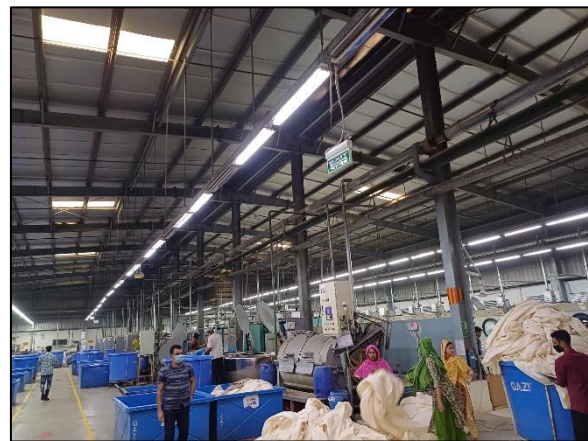
**Observation-13:** Design documents need to be reviewed by RSC for lateral forces - Dryer shed (washing units).

**Description:** During the inspection, a design report and as-built drawings were available on site which need to be reviewed by RSC in depth for lateral forces. The building engineer is required to submit the design documents to RSC for review and implement remedial works If required.

| Design documents need to be reviewed by RSC for lateral forces - Dryer shed (washing units). | The building engineer is required to submit the design documents to RSC for review. | within 6 weeks |
| | Implement remediation work if required. | within 6 months |

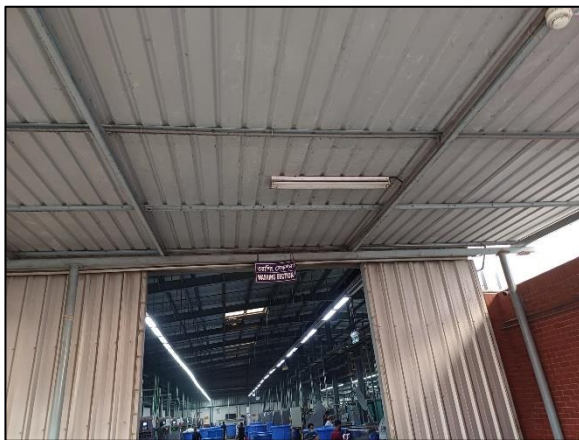
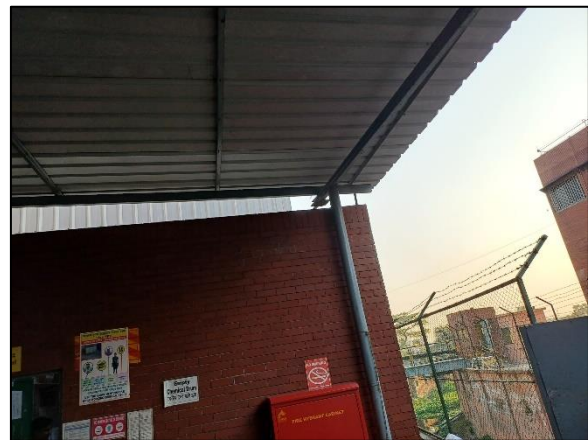
**Observation-14:** Non-engineered lightweight roof shed - Dryer shed (washing units).

**Description:** During the inspection, a non-engineered lightweight roof shed was observed in front of the Dryer shed (washing units). The building engineer is required to suggest necessary alternatives for the structure.

| Non-engineered lightweight roof shed - Dryer shed (washing units). | The building engineer is required to suggest necessary alternatives for the structure. | within 6 months |

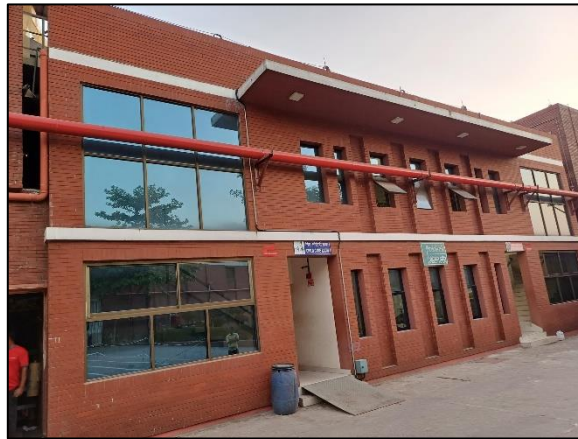
**Observation-15:** Lack of design documents (Medical center).

**Description:** As per BNBC, every building or structure designed shall have its design documents prepared following the provision of Section 1.9.1. The design document shall include a design report, load plan and a set of structural drawings, which shall be prepared in compliance with section 1.9.1.1 and section 1.9.1.2, part-6 of BNBC. At the time of inspection, a design report was not available which is required to be prepared in compliance with section 1.9.1.1 (part-6, BNBC) and submitted to RSC for detailed review.

| Lack of design documents (Medical center). | The building engineer is required to prepare a design report in compliance with section 1.9.1.1 (part-6, BNBC) and submit it to RSC for detailed review. | within 6 weeks |
| | Implement remediation work if required. | within 6 months |

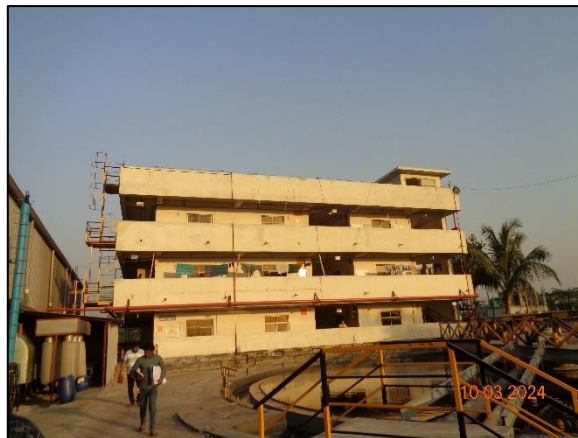
**Observation-16:** Design documents need to be reviewed by RSC for lateral forces (Security Quarter).

**Description:** During the inspection, a design report and as-built drawings were available on site which need to be reviewed by RSC in depth for lateral forces. The building engineer is required to submit the design documents to RSC for review and implement remedial works if required.

| Design documents need to be reviewed by RSC for lateral forces (Security Quarter) | The building engineer is required to submit the design documents to RSC for detailed review. | within 6 weeks |
| | Implement remediation work if required. | within 6 months |
