# Mac-Tex Industries Ltd.

11 March 2024

## 2. Observations

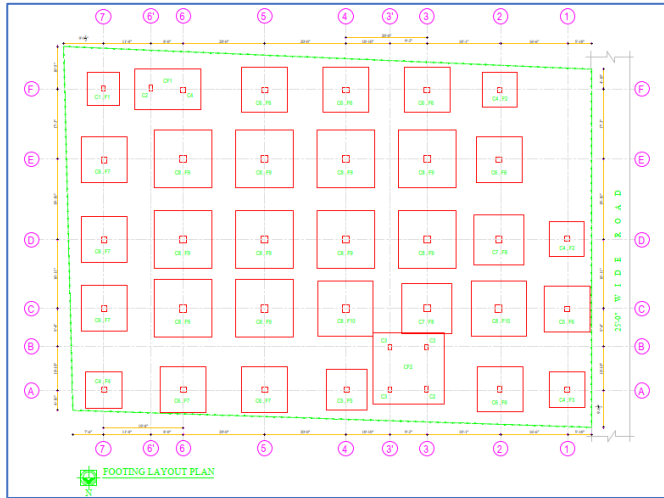
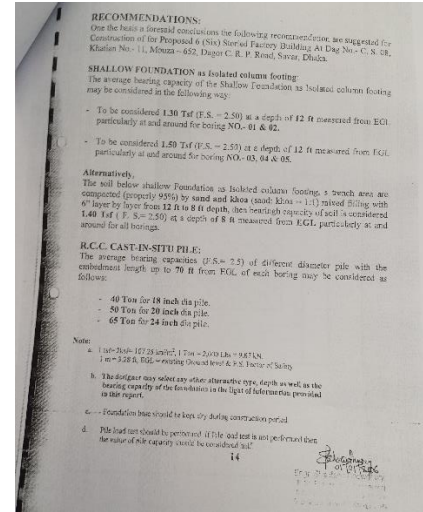
### Observation-01: Foundation found to be stressed. (Production Building)

**Description:** Cursory calculation indicates the footing is stressed for Punching. The loading is considered 3 kPa for a typical floor and minimum concrete strength (16.3 MPa) based on aggregate type. The building engineer is required to verify in-situ material strength and review the design load and foundation stresses.

| Observation | Action Plan | Timeline |
|---|---|---|
| Foundation found to be stressed.<br>(Production Building) | The building engineer is required to review the design load and foundation stresses. | within 6 weeks |
| | Verify in-situ material strength. | within 6 weeks |
| | Produce and actively manage a loading plan for all floor plates within the factory, considering floor, column, and foundation capacity. | within 6 weeks |
| | Carry out the suggested remedial works if required. | within 6 months |

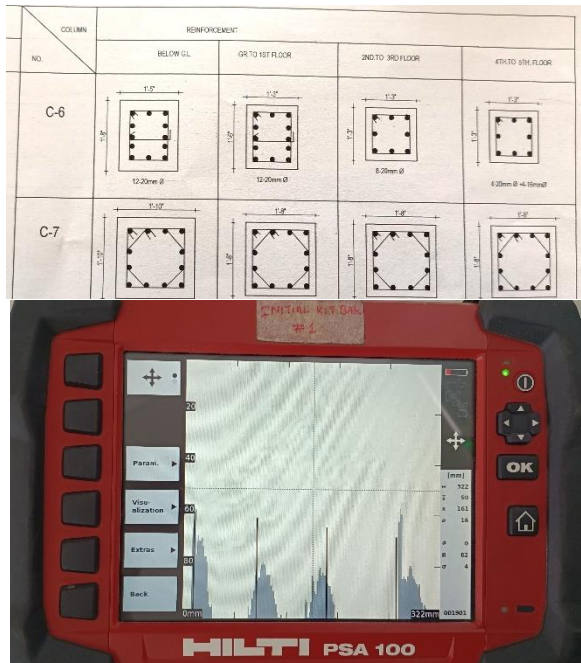
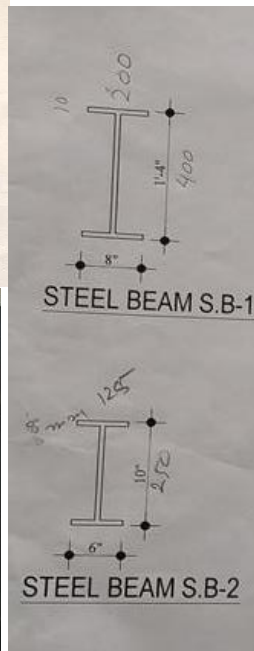
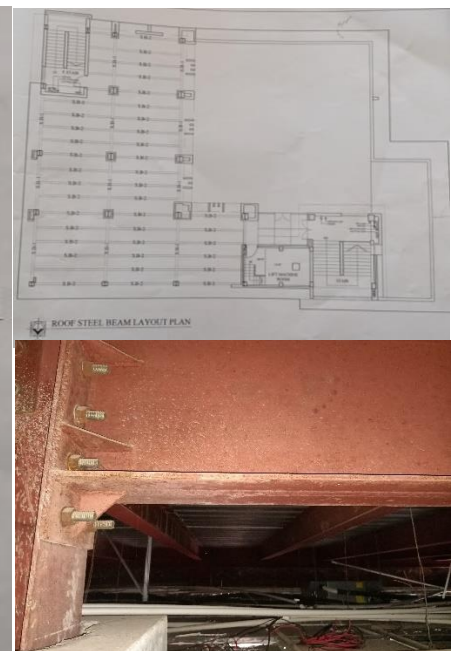
### Observation-02: Mismatches in as-built drawings. (Production Building)

**Description:** The number of rebars in the periphery column (C-6 type) was found to be 5 nos on the long face instead of 5 nos. On the other hand, steel member thickness and connection details were not found in the provided drawings for the roof shed. The building engineer is required to survey the whole structure and prepare full set of as-built drawing.

| Observation | Action Plan | Timeline |
|---|---|---|
| Mismatches in as-built drawings.<br>(Production Building) | The building engineer is required to survey the whole structure and prepare full set of as-built drawing. | within 6 weeks |

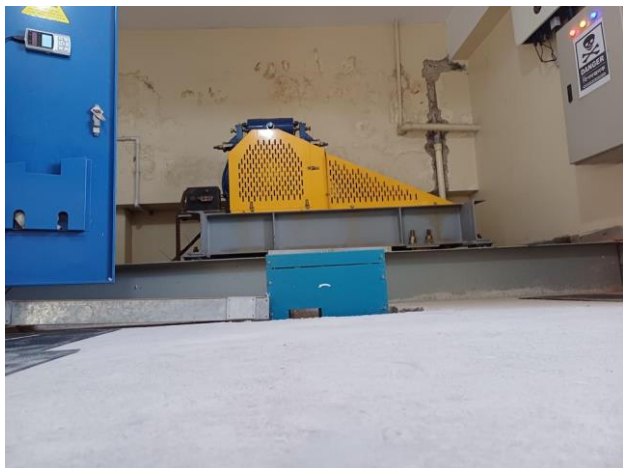
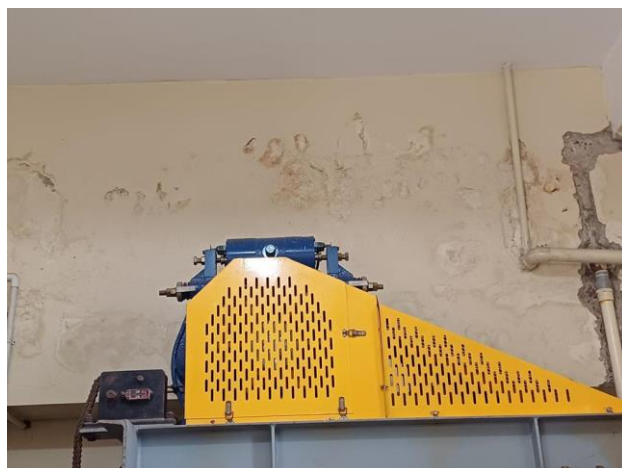
**Observation-03:** Dampness found on the walls. (Production Building)

**Description:** Dampness was found on the roof of the water tank's side walls. The building engineer is required to investigate the cause of the dampness and repair it using a suitable method.

| Observation | Action Plan | Timeline |
|---|---|---|
| Dampness found on the walls.<br>(Production Building) | The building engineer is required to investigate the cause of the dampness and repair it using a suitable method. | within 6 weeks |

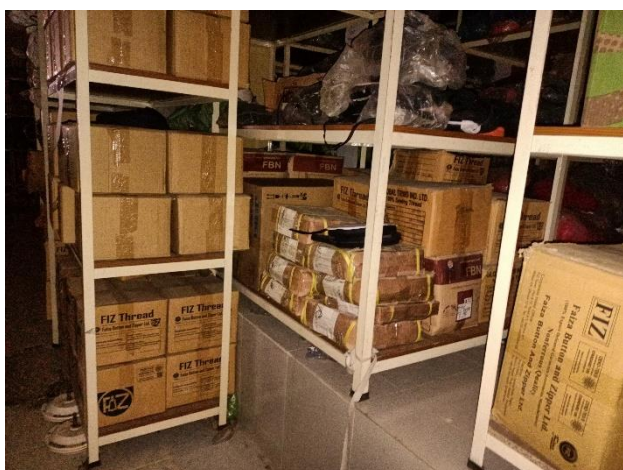
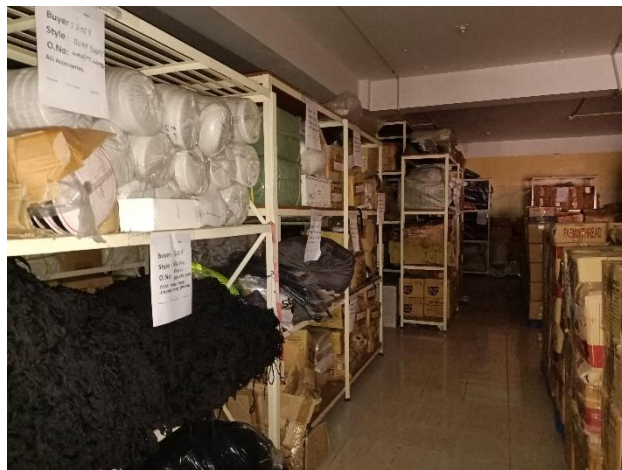
**Observation-04:** Non-structural elements not anchored or braced. (Production Building)

**Description:** Some racks on floors are not anchored or braced to resist lateral (earthquake) forces. The factory is required to anchor/brace all non-structural elements adequately to resist earthquake forces.

| Observation | Action Plan | Timeline |
|---|---|---|
| Non-structural elements are not anchored or braced. (Production Building) | The factory is required to anchor/brace all non-structural elements adequately to resist earthquake forces. | within 6 weeks |

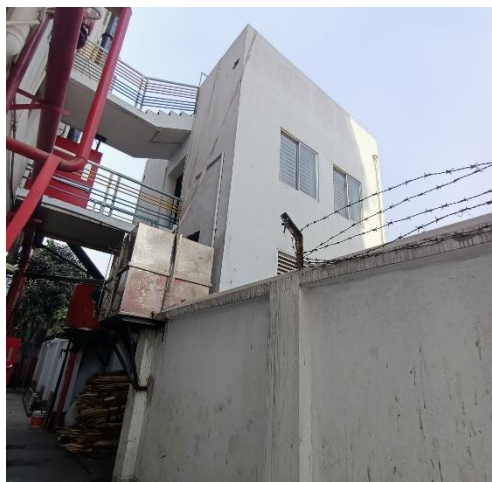
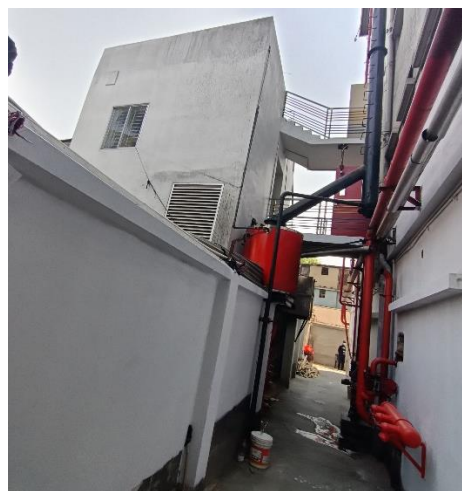
**Observation-05: Absence of design documents. (Boiler Building)**

**Description:** As per BNBC, every building or structure designed shall have its design documents prepared following the provision of Section 1.9.1. The design document shall include a design report, and a set of structural drawings, which shall be prepared in compliance with section 1.9.1.1 and section 1.9.1.2, part 6 of BNBC.

| Observation | Action Plan | Timeline |
|---|---|---|
| Absence of design documents.<br>(Boiler Building) | The building engineer is required to prepare the design documents, including a design report and a set of structural drawings in compliance with section 1.9.1.1 and section 1.9.1.2, part-6 of BNBC, and submit it to RSC for review. | within 6 weeks |
| | Implement remediation work if required. | within 6 months |

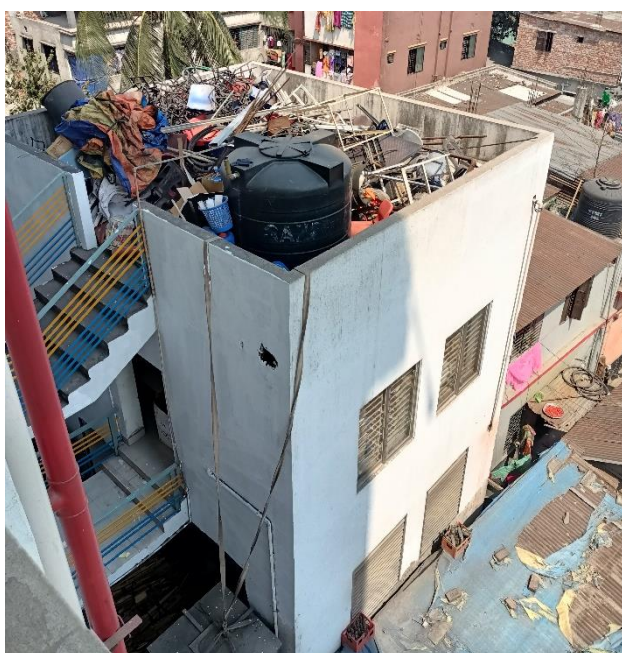
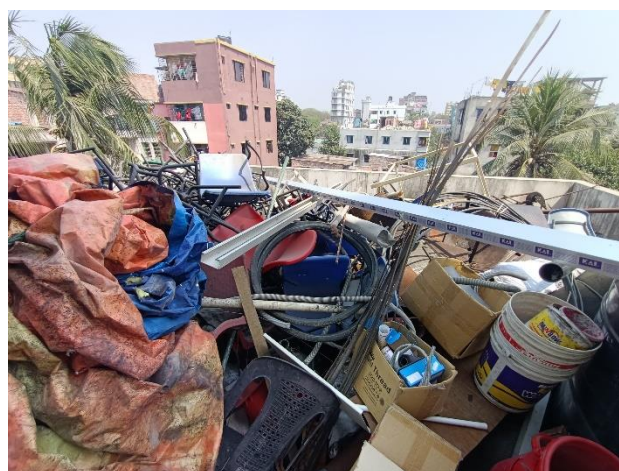
**Observation-06: Wastage material on the roof. (Boiler Building)**

**Description:** Wastage material was found almost everywhere on the roof. The factory is required to remove all kinds of waste/debris from the roof.

| Observation | Action Plan | Timeline |
|---|---|---|
| Wastage/Debris on the roof. (Boiler Building) | The factory is required to remove all kinds of waste/debris from the roof. | within 6 weeks |

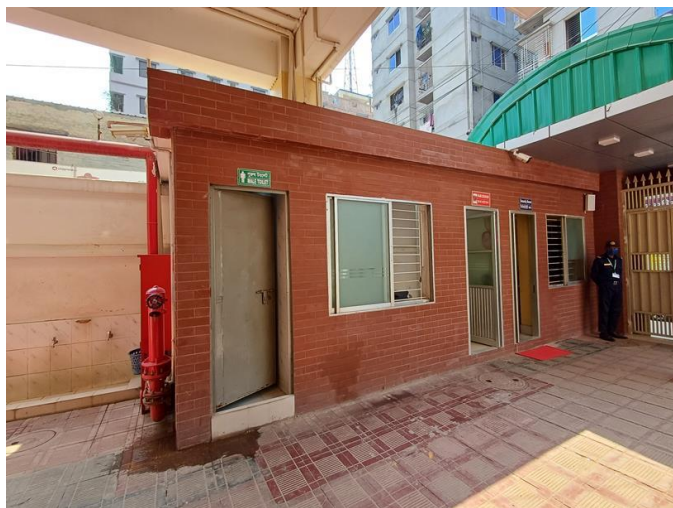
**Observation-07:** lack of as-built drawing. (Security Building)

**Description:** As-built drawings were unavailable for the security building at the inspection time. The building engineer is required to prepare complete as-built (structural & architectural) drawings.

| Observation | Action Plan | Timeline |
|---|---|---|
| Lack of as-built drawing. (Security Building) | The building engineer is required to prepare complete as-built (structural & architectural) drawings. | within 6 weeks |

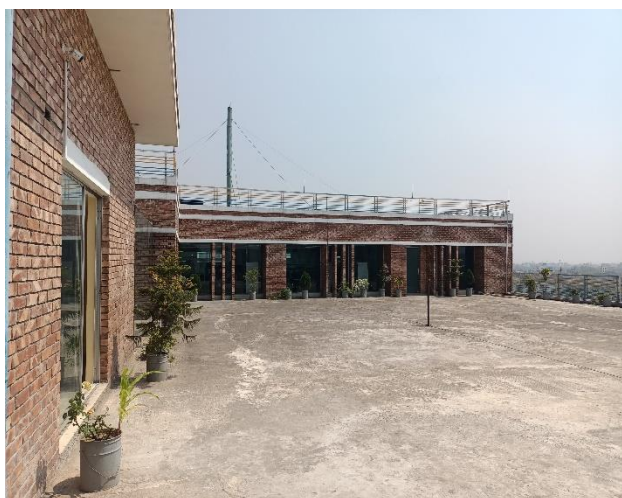
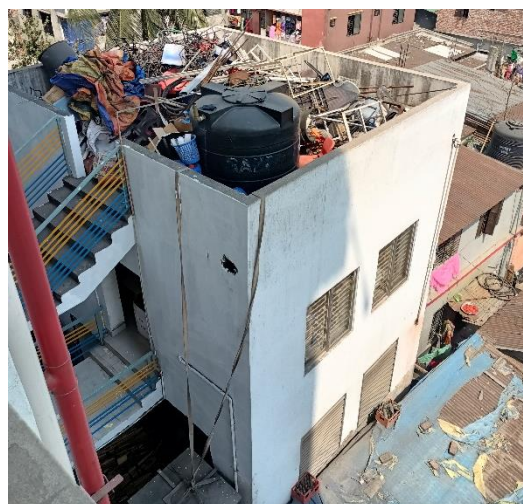
**Observation-08:** Absence of building permit. (Steel Roof-Production Building; and Boiler Building)

**Description:** The production building was permitted for 5 stories. During the inspection, a partial steel roof structure was found above 5 stories, used for office space. Also, no permit drawing was found for the boiler building.

The building engineer is required to collect a building permit from the local government authority.

| Observation | Action Plan | Timeline |
|---|---|---|
| Absence of building permit.<br>(Steel Roof-Production Building, and Boiler Building) | The building engineer is required to collect building permit from the local building authority. | within 6 months |
