# Vintage Denim Apparels Ltd. (New building)

Boherarchala, Sreepur, Gazipur-1740.

25 February 2024

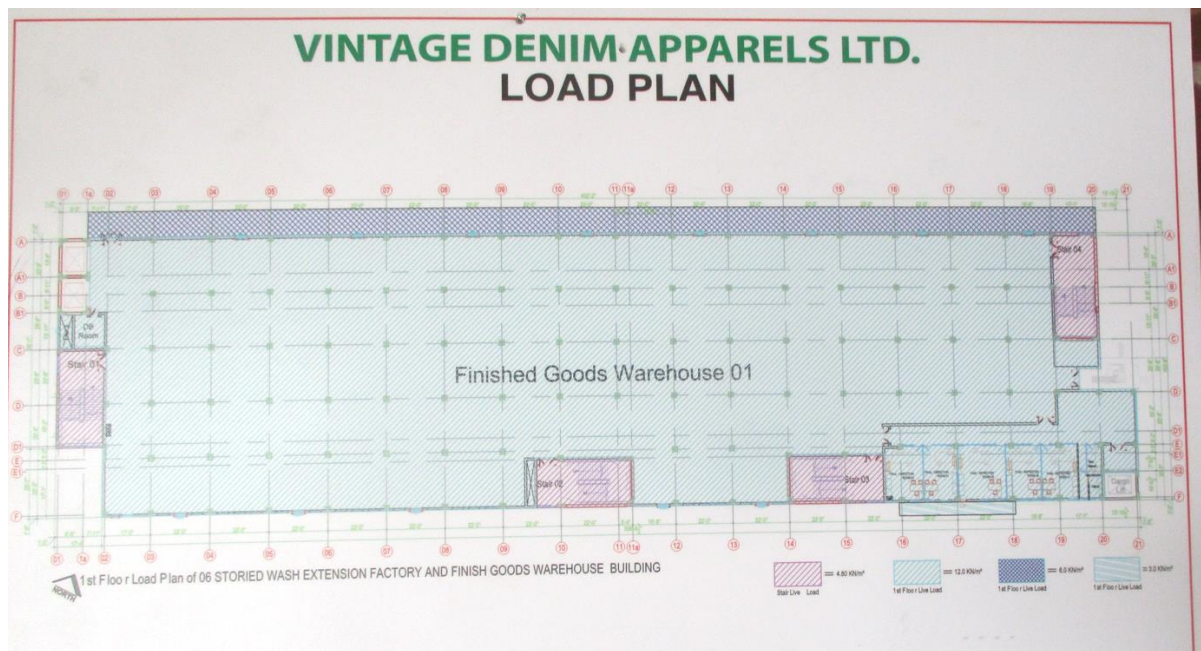
**Observation-1:** Inconsistency in the design documents. (Building 8 – Production Building)

**Description:** In the design report live load considered as 3, 5, 6 kPa for roof, production, and storage areas respectively. But in the posted load plan we found 3, 6, 12 kPa for roof, production, and storage areas.

**Description:** In the design report pile capacity considered 80 tons (FoS=2.0) based on soil test report and pile load test. But no pile load test report was found onsite. The building engineer is required to revise the design documents considering the inconsistencies and submit the documents to RSC for review.

| Observation | Action Plan | Timeline |
|---|---|---|
| Inconsistency in the design documents. (Building 8 – Production Building) | The building engineer is required to revise the design documents considering the inconsistencies and submit the documents to RSC for review. | within 6 weeks |

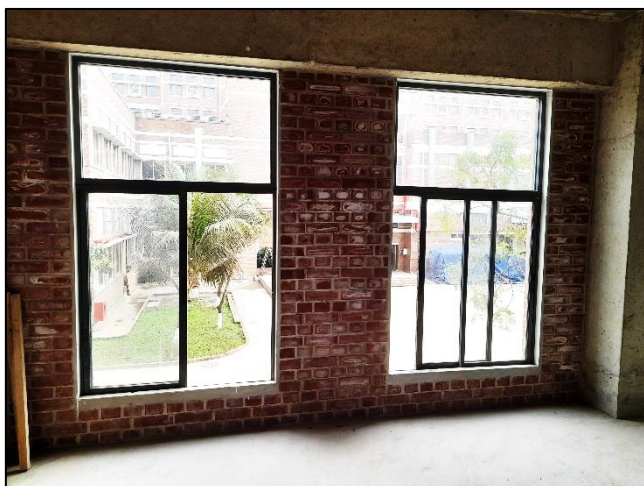
Falling Hazard on 1<sup>st</sup> floor

**Description:** During the inspection, no barrier was observed in the 1st floor window area. The factory is required to provide a protective barrier to avoid the possible falling hazard.

| Observation | Action Plan | Timeline |
|---|---|---|
| Possible falling hazard on the roof. (Building 9 – Utility Building) | The factory is required to provide protective barriers to avoid possible falling hazards. | within 6 weeks |

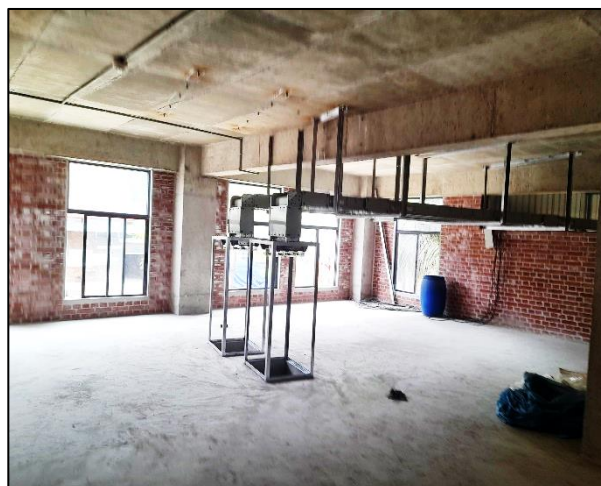
Falling Hazard on 1<sup>st</sup> floor
