# Anowara Knit Composite Ltd. (10925)

Mulayed, Maona, Sreepur, Gazipur

22.APRIL.2014

ACCORD  
on Fire and Building Safety in Bangladesh

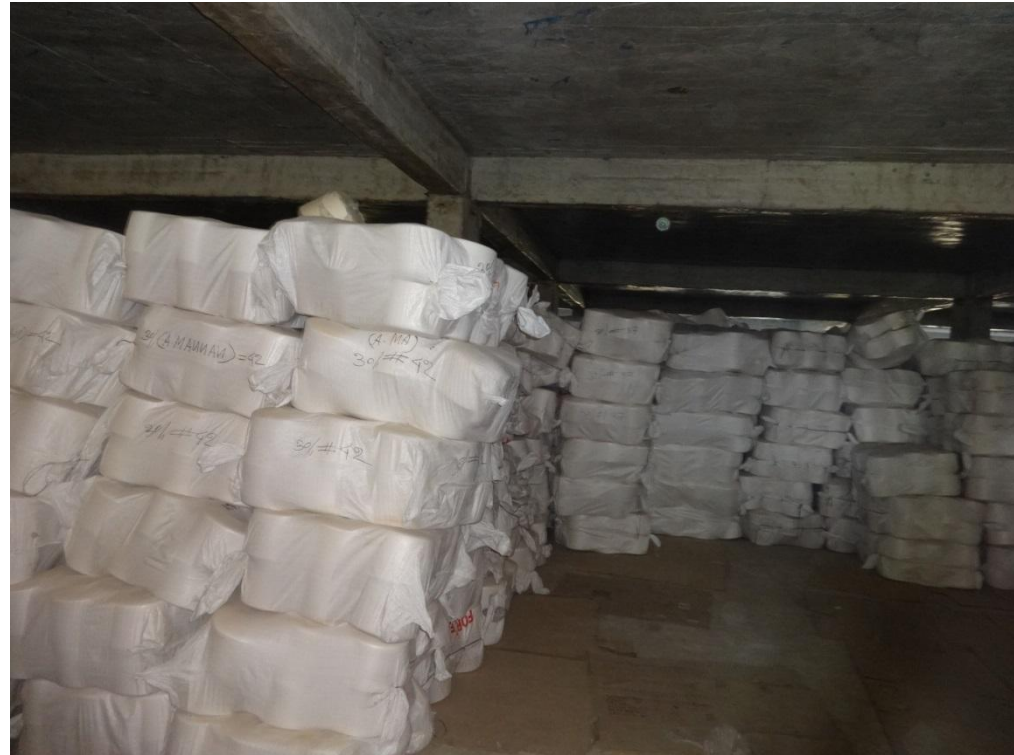
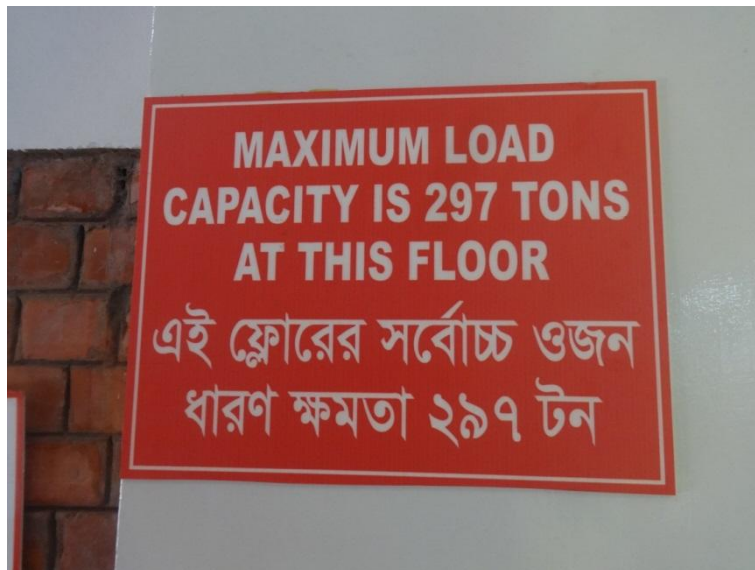
High storage loads were observed in buildings 6 & 7. In addition, no loading plans were made available for any of the buildings.

**ITEM 1: Storage of materials in buildings 6 & 7, and no loading plans produced for any buildings.**

Storage of materials in buildings 6 & 7, coupled with no loading plans.

- Remove all storage down to 3.0 kPa.

- Carry out an Engineering Assessment on the buildings to determine capacity of floors.
- Produce loading plans in pounds per square foot (psf) format for each building.
- Manage loading plans.

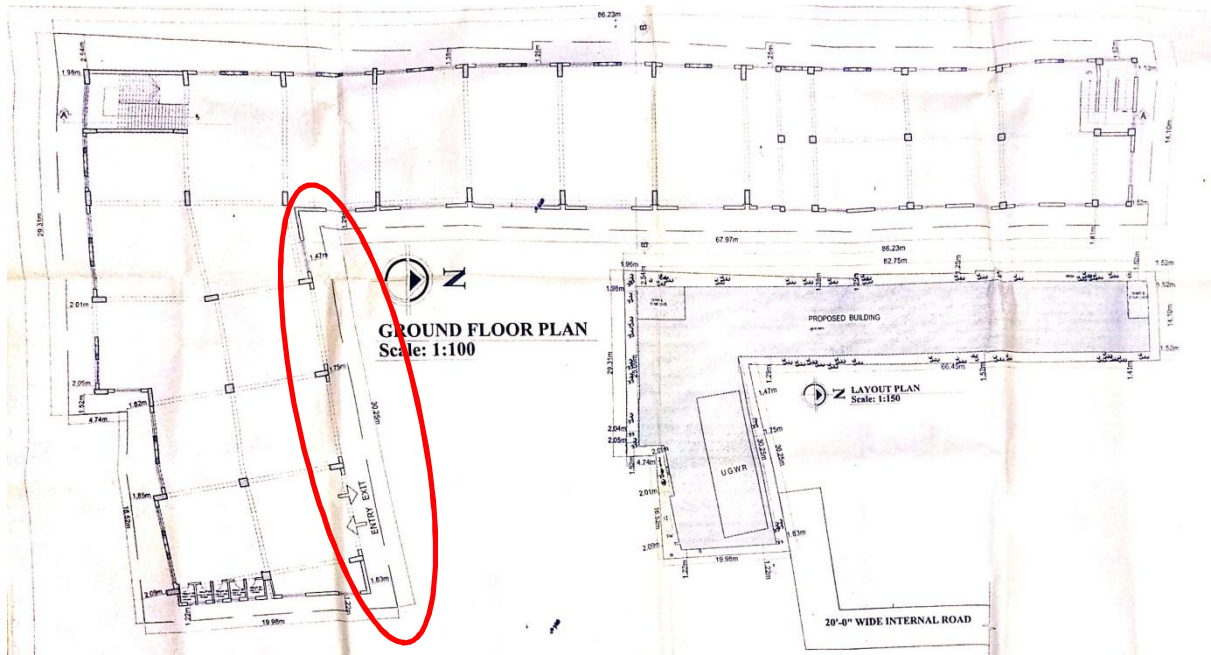
Maximum total floor loading was posted on a few levels, however the information displayed was not in a format that could be easily managed. In addition, this maximum loading was exceeded in building 6.

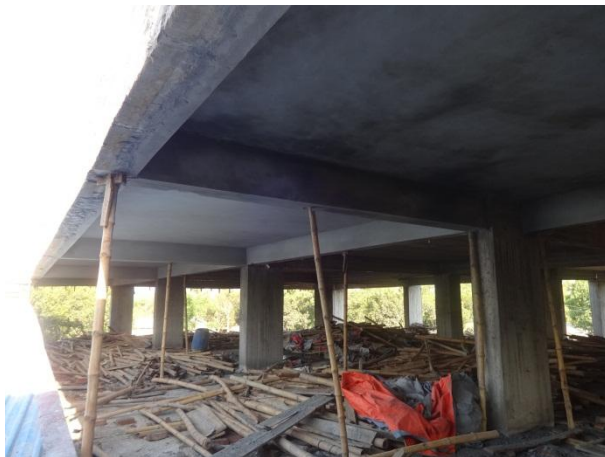
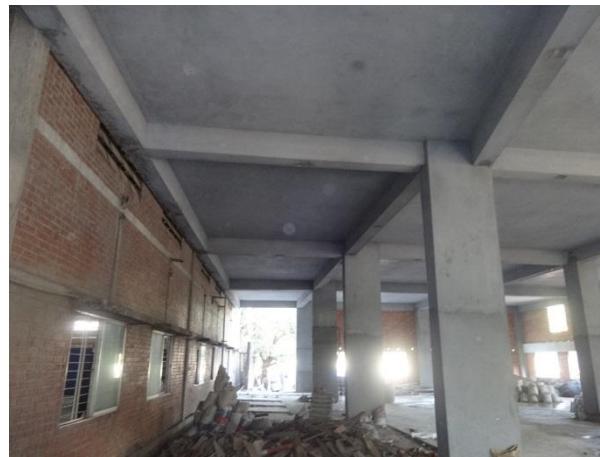
5.5m cantilevered slab not shown on the drawing.  
Backspan and beams do not appear adequate for the span.

**ITEM 2: 5.5 meter cantilevered slab at building 5 not shown on drawings.**

Large cantilevered slab in building 5 has not been built in accordance with the construction drawings.

- Remove all loading on the cantilever and close access under the cantilever.

- Carry out a Detailed Engineering Assessment of the cantilever to determine its structural capacity.

- Carry out any remedial works highlighted from engineering assessment.

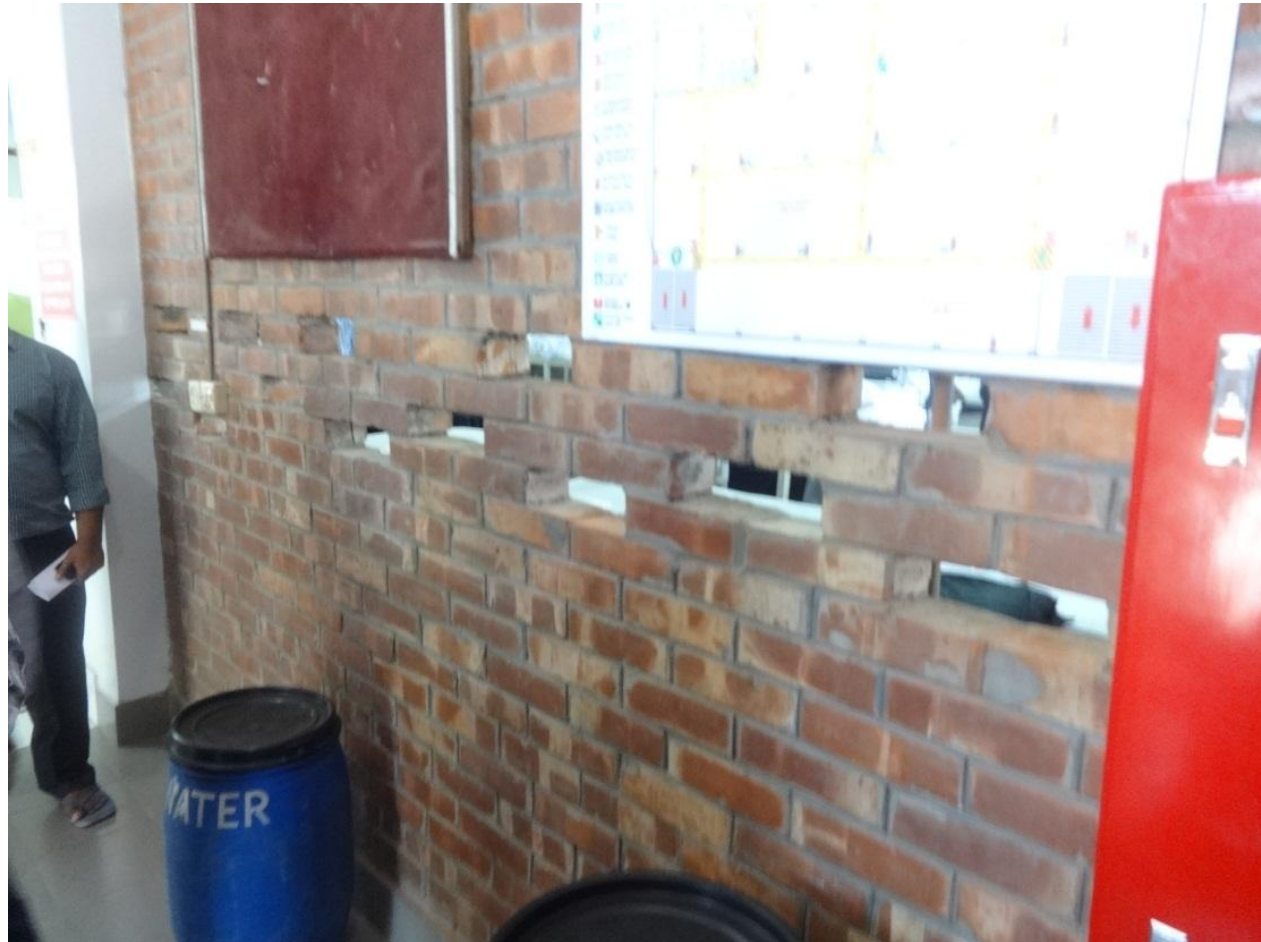
Openings to masonry partition wall in building 2 are not formed correctly.

**ITEM 4: Openings to masonry partition wall in building 2 are not formed correctly.**

- Infill existing openings.
- If new openings are to be formed lintels and piers should be provided.

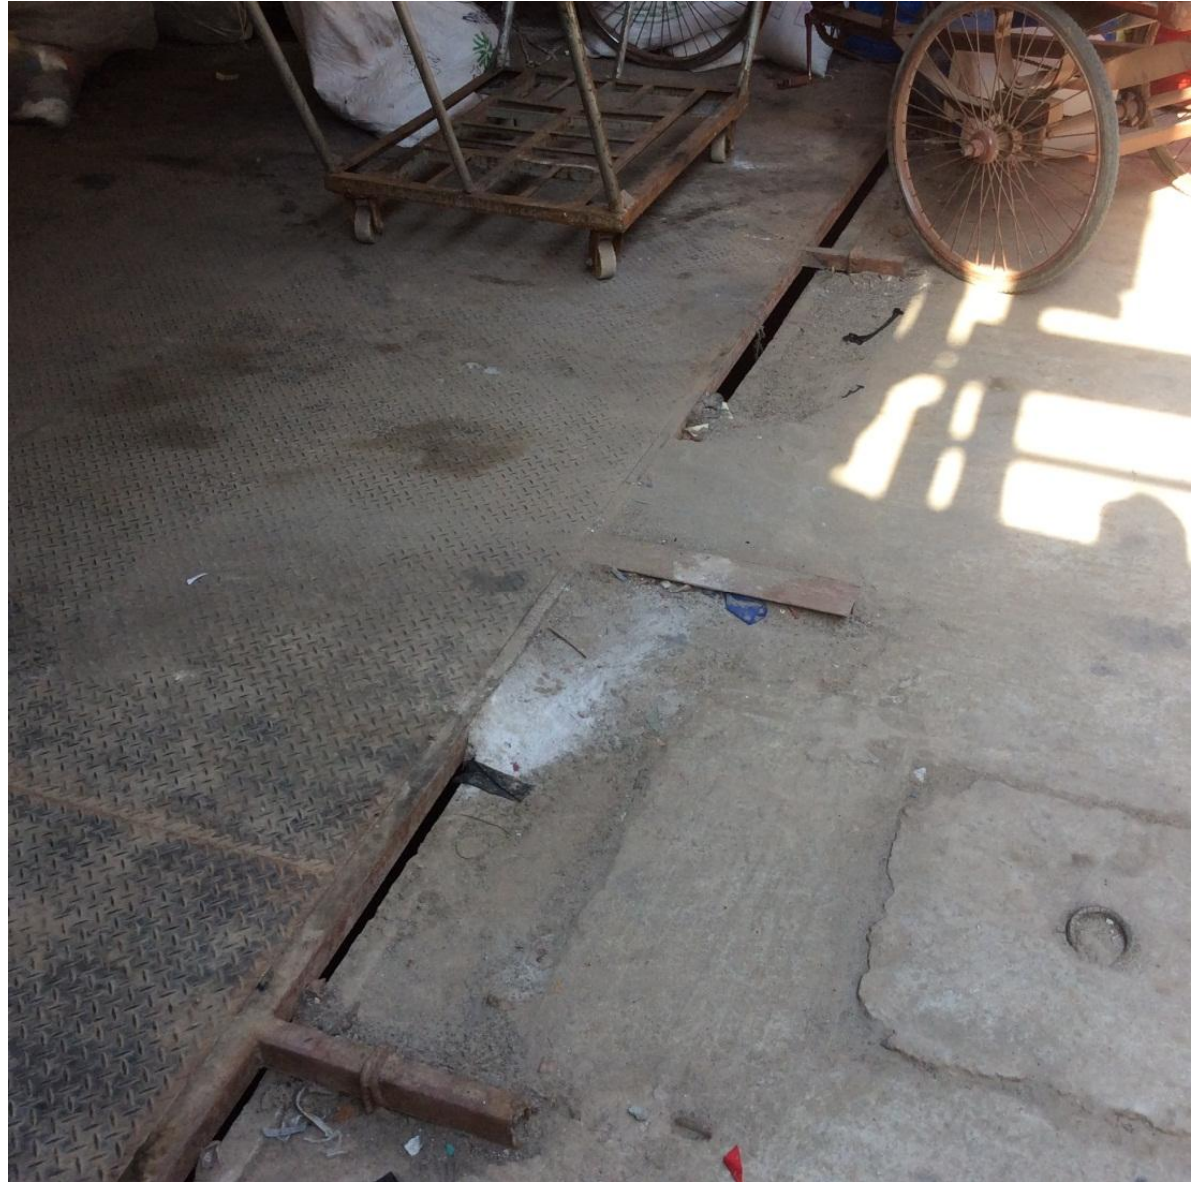
A steel plate covering old water storage tanks at building 6 appears inadequate. Large deflection was noted. In addition storage is loaded on the plate.

**ITEM 5: Steel plate over old water tanks in building 6.**

- Carry out Engineering Assessment on steel plate to determine load carrying capacity.

- Carry out any recommendations highlighted in Engineering Assessment.

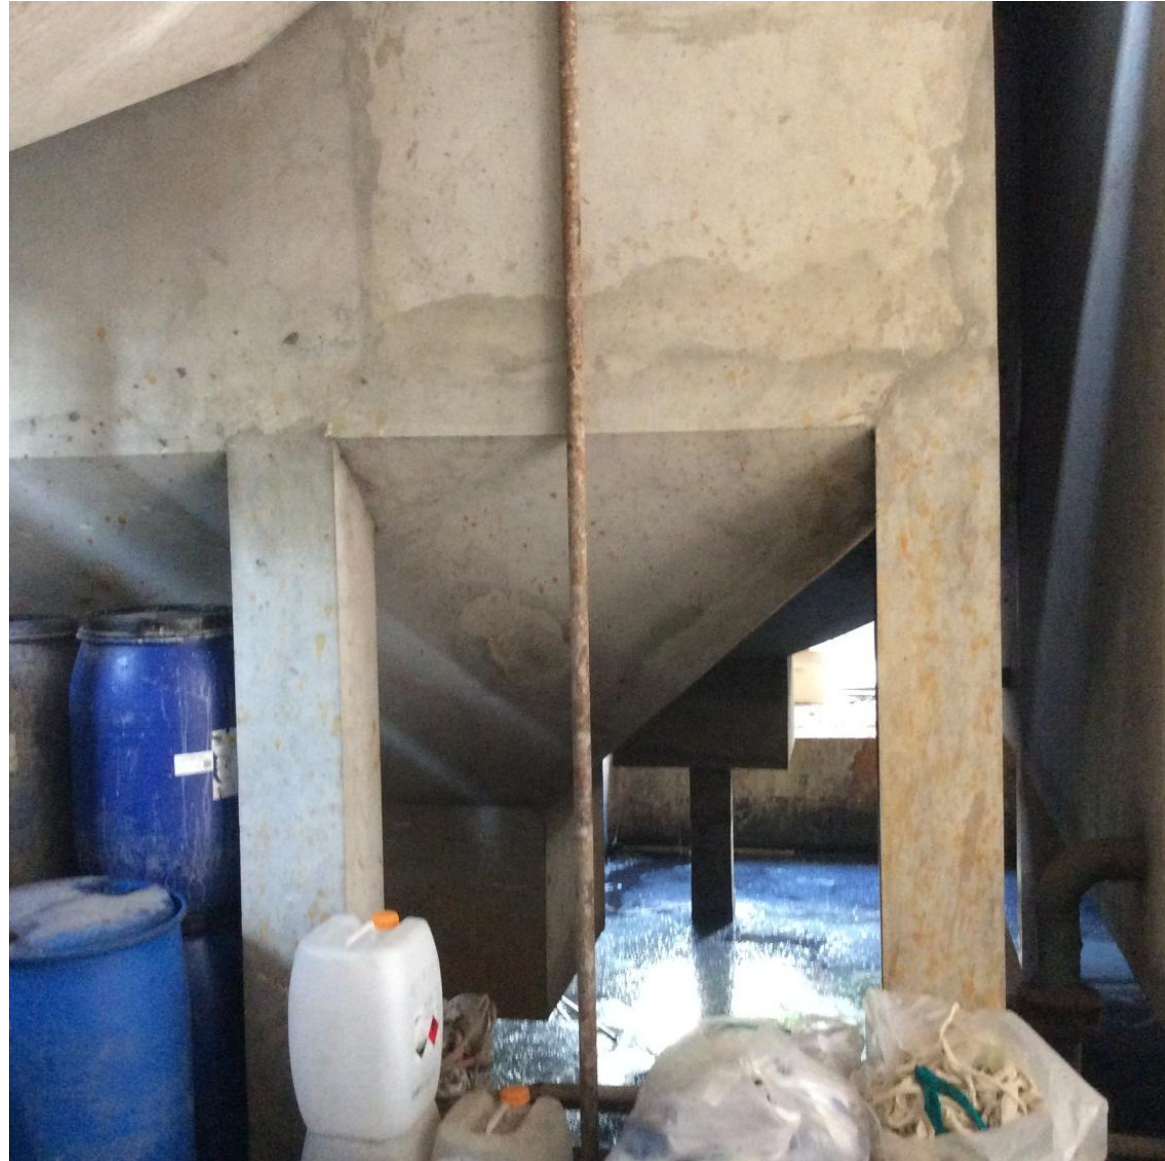
Hairline cracking to columns and walls was observed in old water reservoir at building 6.

**ITEM 6: Cracking to old water tank in building 6.**

- Ensure tank is kept empty.

- Repair or remove the tank.

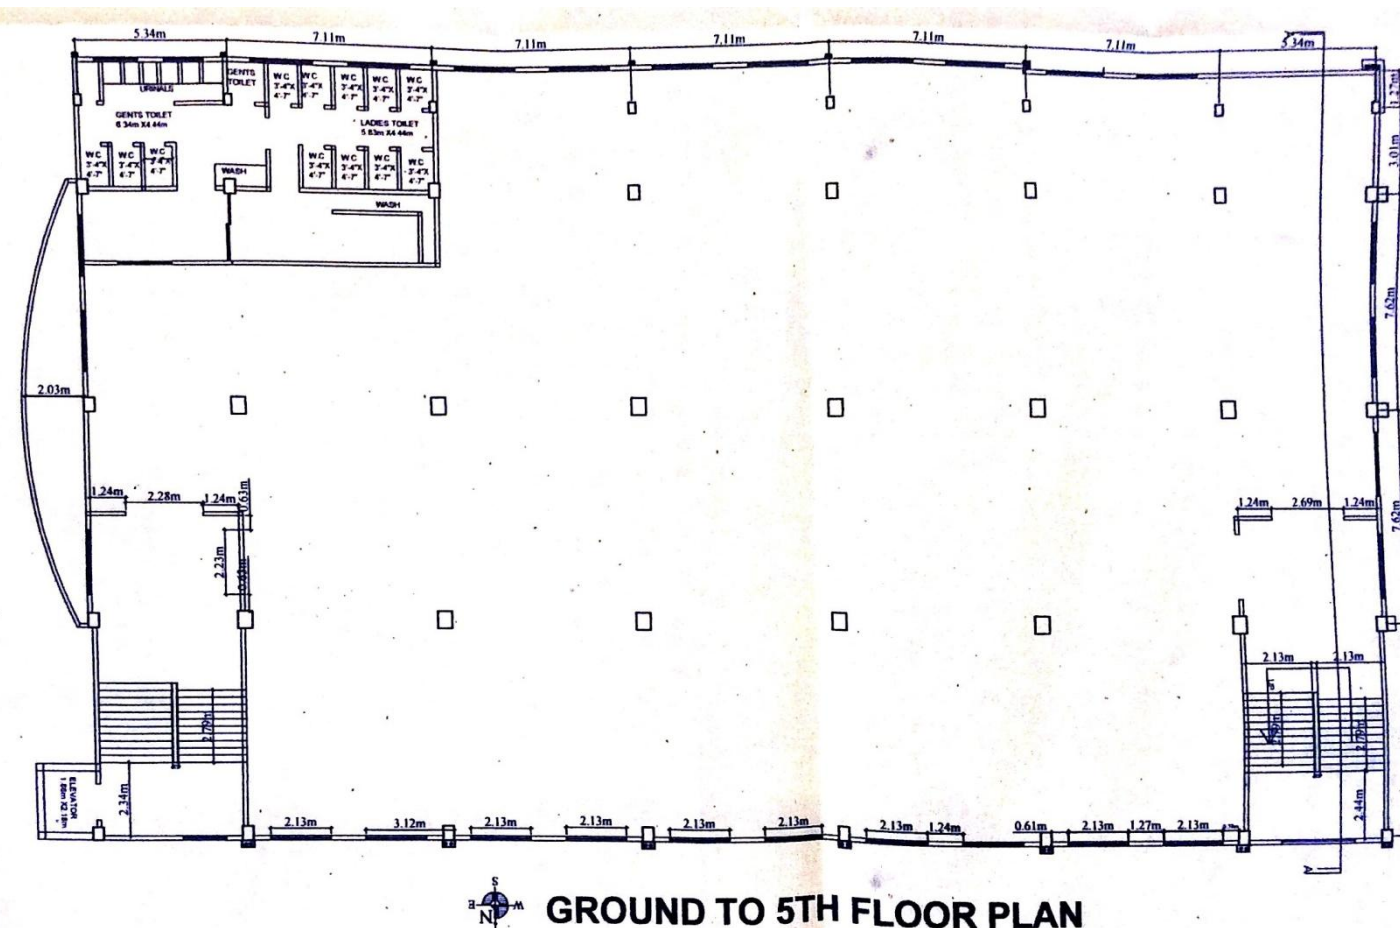
## Building 2: Main Factory

The building did not feature any core or shear walls. Stability was achieved through sway action between beams and columns and masonry infill walls.

We require that these items be investigated in a Detailed Engineering Assessment.

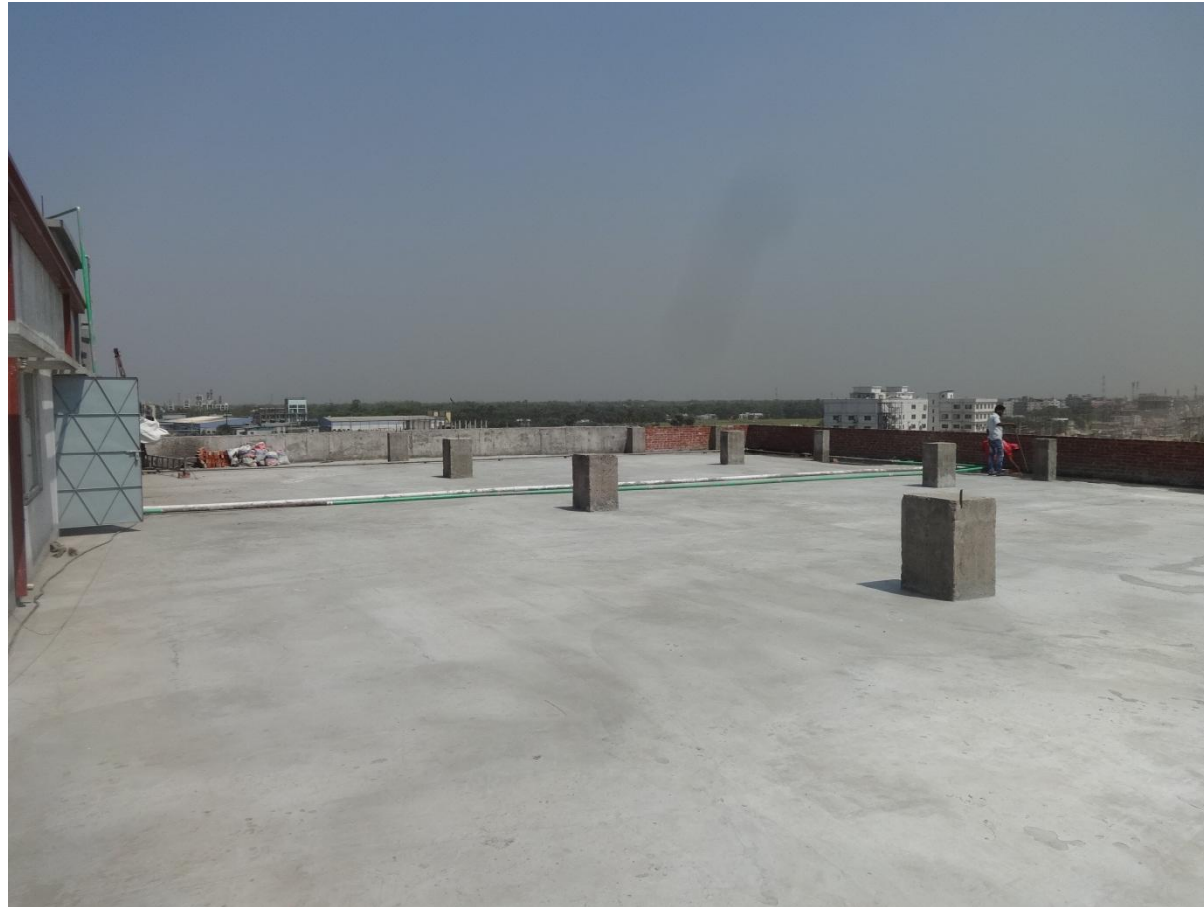
No waterproofing membrane was visible on the roof of the building. This means that any cracks in the surface finishes on the roof will allow water to seep into the concrete slab beneath the finishes, and cause long-term soaking of the slab.
