# Yester Accessories Co.(Bd) Ltd

Plot-111-114, Adamjee EPZ, Siddhirganj, Narayanganj.

12 March 2024

DEA

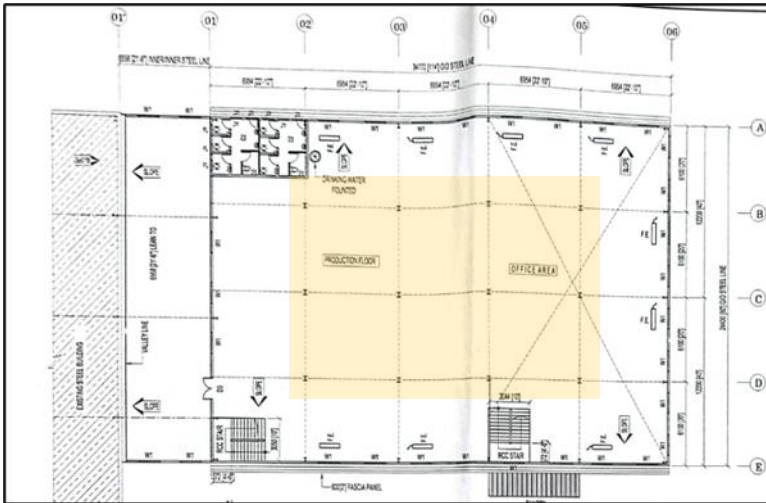
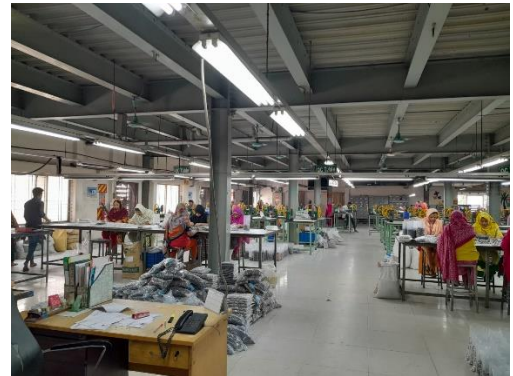
### Observation-1: High stress in columns. (Office Building)

**Description:** cursory calculation indicates that are stressed above the design limit that requires immediate design review.

The building engineer is required to carry out a Detail Engineering Assessment (DEA) to check the design, loads, and stresses in the floors, columns and foundations.

The floor load in marked areas of the floor must not exceed 1.0 kPa until the finalization of DEA. An interim floor live load plan must be prepared by your consultant and used by the factory with immediate effect.

| Observation | Action Plan | Timeline |
|---|---|---|
| High stress in columns. (Office Building) | The floor load in marked areas of the floor must not exceed 1.0 kPa. A live load plan must be prepared by a consultant and used by the factory with immediate effect. | Immediate |
| | Confirm the steel grade by testing the existing steel member. | Immediate |
| | The building engineer is required to A detailed engineering Assessment is required carry out by Building Engineer. | Immediate |
| | DEA to be completed. | within 6 weeks |
| | Carry out suggested remedial works if required. | within 6 months |
| | Implement the floor load plan. | within 6 months |

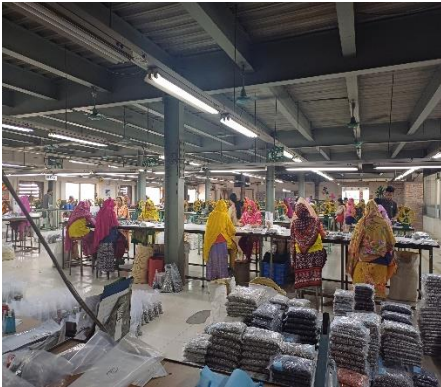
Office Building

**Observation 2: Lack of Lateral stability. (Button injection, Office Building, Electroplating Building, Store Building, and Wastage Shed).**

**Office Building:** Missing Vertical bracing in the staircase zone.

Load transfer media is not provided along the long direction of the structures. Therefore, the lateral stability system of these structures is incomplete.

The building engineer is required to check the stability system of the existing structures and suggest proper remedial action.

| Observation | Action Plan | Timeline |
|---|---|---|
| Lack of Lateral stability. (Office Building) | The building engineer is required to check the stability system of the existing structure as part of DEA and suggest proper remedial action. | within 6 weeks |
| | Carry out suggested remedial works if required. | within 6 months |

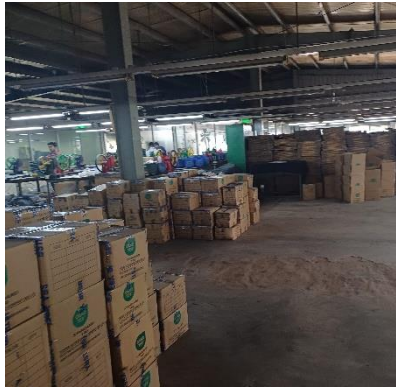
Button injection

**Button Injection:** Missing compression strut in the long direction.

| Observation | Action Plan | Timeline |
|---|---|---|
| Lack of Lateral stability. (Button injection) | The building engineer is required to check the stability system of the existing structure as part of DEA and suggest proper remedial action. | within 6 weeks |
| | Carry out suggested remedial works if required. | within 6 months |

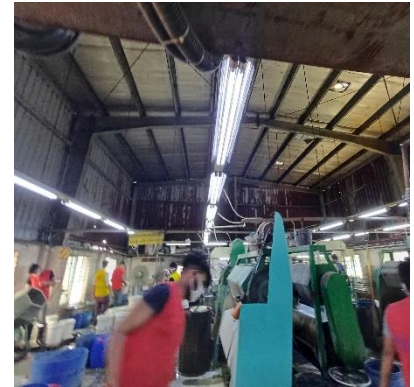
Electroplating Building

**Electroplating Building:** Missing compression strut in the long direction.

| Lack of Lateral stability.<br>(Electroplating Building) | The building engineer is required to check the stability system of the existing structure as part of DEA and suggest proper remedial action. | within 6 weeks |
| | Carry out suggested remedial works if required. | within 6 months |

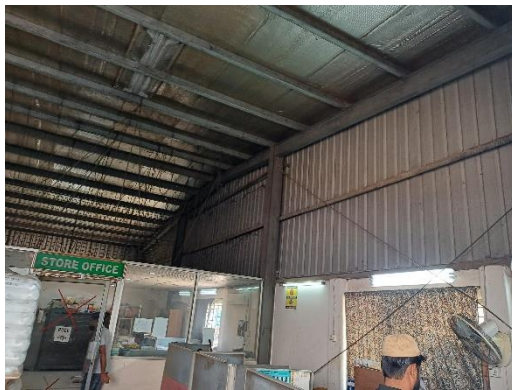
Store Building

**Store Building:** Missing compression strut in the long direction.

| Lack of Lateral stability. (Store Building). | The building engineer is required to check the stability system of the existing structure as part of DEA and suggest proper remedial action. | within 6 weeks |
| | Carry out suggested remedial works if required. | within 6 months |

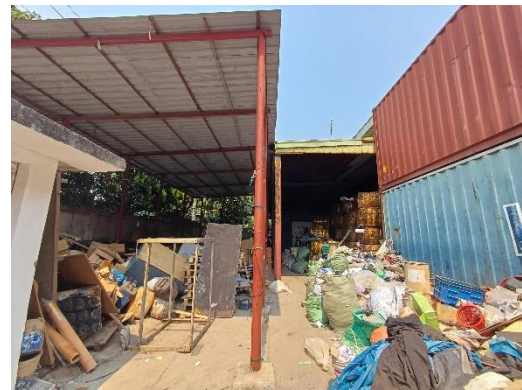
Wastage Shed

**Wastage Shed:** No bracing, Inadequate structural members.

| Lack of Lateral stability.<br>(Wastage Shed). | The building engineer is required to check the stability system of the existing structure as part of DEA and suggest proper remedial action. | within 6 weeks |
| | Carry out suggested remedial works if required. | within 6 months |

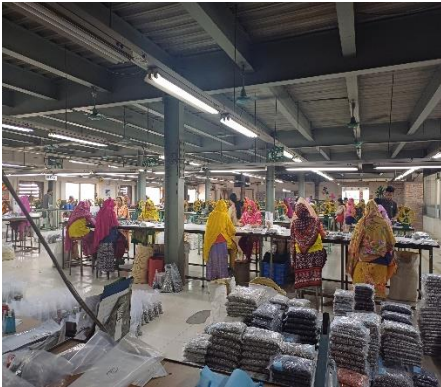
Office Building

**Observation-3:** Lack of as-built drawing. (Button injection, Office Building, Electroplating Building, Store Building, Security Guard & RMS room and Wastage Shed).

**Description:** The built drawing of Button injection, Office Building, Electroplating Building, Store Building, Security Guard & RMS room, and Wastage Shed were not available on site at the time of inspection. The building engineer is required to survey the whole structure and prepare accurate as-built drawings of all these structures.

| Lack of as-built drawing.<br>(Office Building). | The building engineer is required to survey the whole structure and prepare accurate as-built drawings of all these structures. | within 6 weeks |

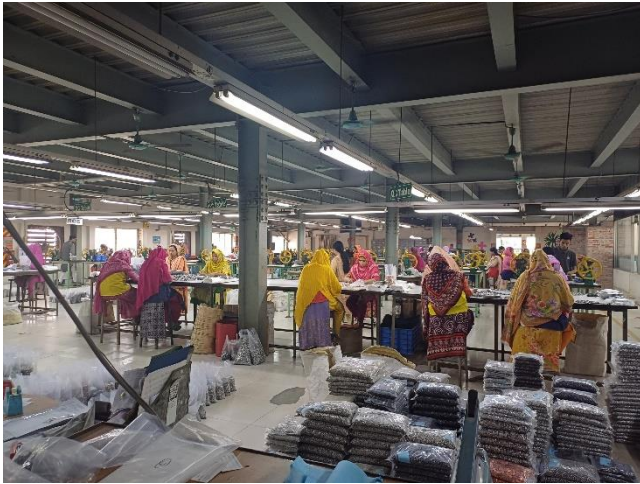
**Observation-4:** Severe vibration on the 1<sup>st</sup> floor of the Button injection building and Office Building due to machinery. (Button Injection Building & Office Building)

**Description:** Significant vibration was felt on the first floor due to the operation of heavy machinery. Building engineer is required to investigate the long-term effect of the vibration and suggest remediation.

| Observation | Action Plan | Timeline |
|---|---|---|
| Severe vibration on the 1 <sup>st</sup> floor of the Button injection building and Office Building due to machinery. (Office Building) | The building engineer is required to investigate the long-term effect of the vibration and suggest proper remediation. | within 6 weeks |

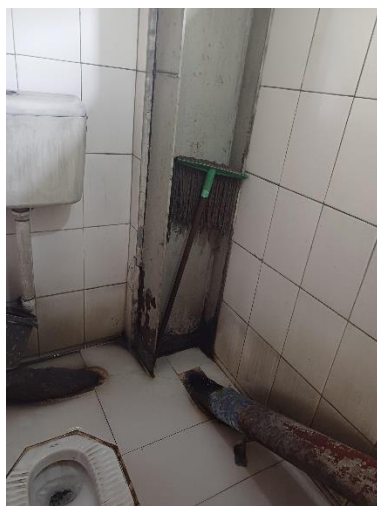
Office Building

**Observation-5:** Severe corrosion on columns (Button injection, Office Building).

**Description:** Severe corrosion was observed on steel columns at the steel toilet zone of the Button Injection Building and Office Building. The factory is required to identify the locations, remove corrosion, replace the damaged steel members where required, and provide rust-proof paint on all steel members to protect them from rusting.

| Observation | Action Plan | Timeline |
|---|---|---|
| Severe corrosion on columns (Button injection, Office Building). | The building engineer is required to replace the damaged steel members and provide rust-proof paint on all steel members to protect from corrosion. | within 6 weeks |

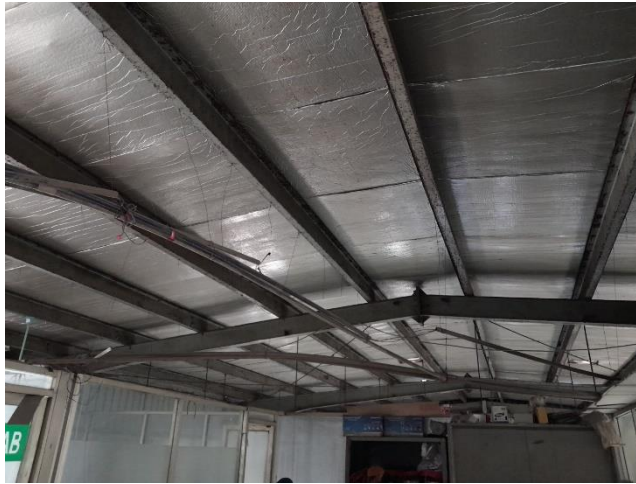
**Observation-6:** Loose cable bracing (Electroplating Building).

**Description:** Some of the roof cable bracings were found loose. The building engineer is required to tighten the bracings to transfer the lateral loads properly.

| Loose cable bracing<br>(Electroplating Building). | The building engineer is required to tighten the bracings to transfer the lateral loads properly. | within 6 weeks |

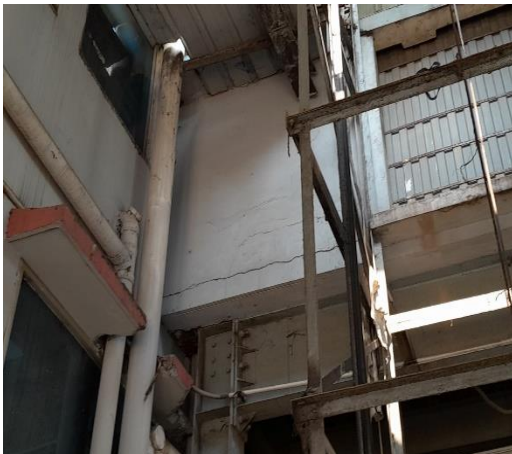
Office Building

**Observation-7:** Crack on Wall. (Button injection, Office Building)

**Description:** Crack was found on the façade wall of the Button injection and Office Building. The building engineer is required to investigate the cause of wall cracks and repair with a suitable method.

| Observation | Action Plan | Timeline |
|---|---|---|
| Crack on Wall. (Button injection, Office Building) | The building engineer is required to investigate the cause of wall cracks and repair with a suitable method. | within 6 weeks |
