INITIAL FIRE SAFETY INSPECTION REPORT

Talisman Ltd. (Extension)

RSC ID: 25503

Date: 28/02/2024

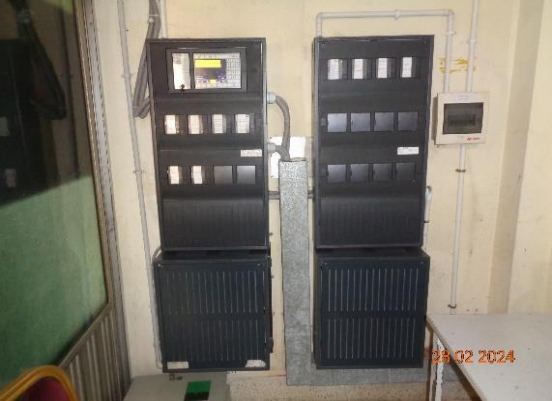
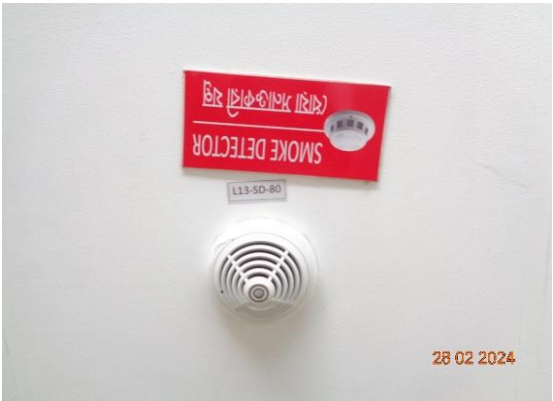
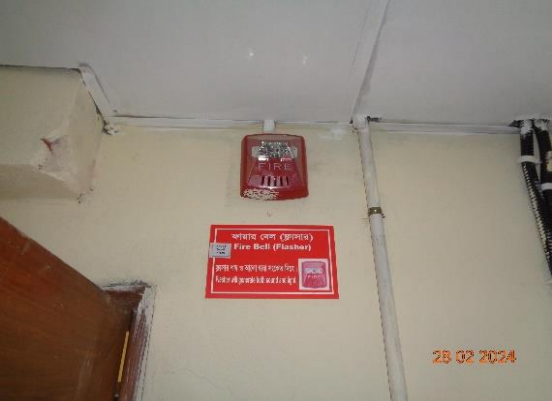
SI No.	Category	Findings	Required Action	Remediation Time Frame
1	Fire Alarm & Detection system	Fire alarm & detection system installation requires detailed review to confirm compliance with NFPA 72 and RSC Technical Guidelines (Standards).	Submit as-built drawings, testing records, equipment certification and other relevant documentation to the RSC for review. Modification (if required) shall have to done as per the reviewed design and NFPA-72 with a listed Addressable Fire Alarm System. Upon approval & modification (if required) the factory shall inform RSC to conduct final testing and commissioning verification of the system for final acceptance.	Design Review within 2 months and modification within 4 months (if required).

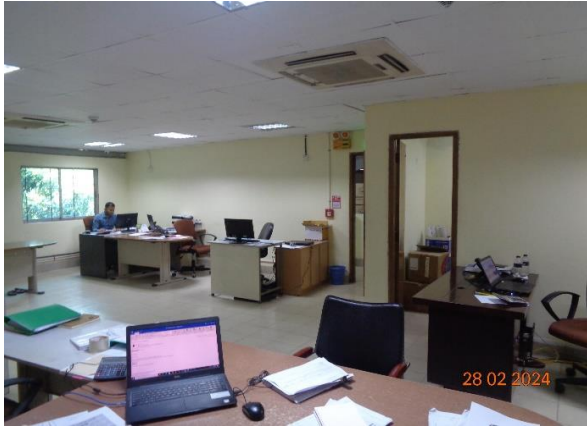
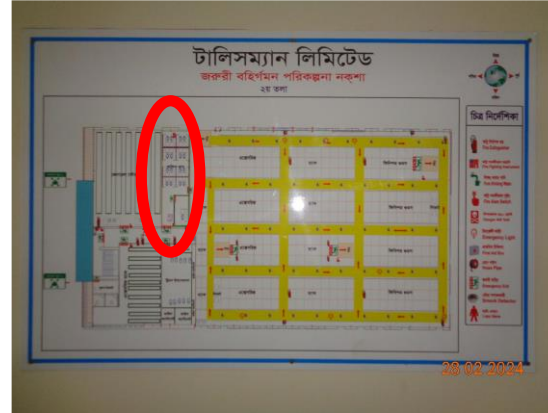
4	Fire Rated Construction	Office area is not separated from the store on the mezzanine floor.	Office area is required to be separated from the store with 2 hour fire rated separation.	Within 3 Months

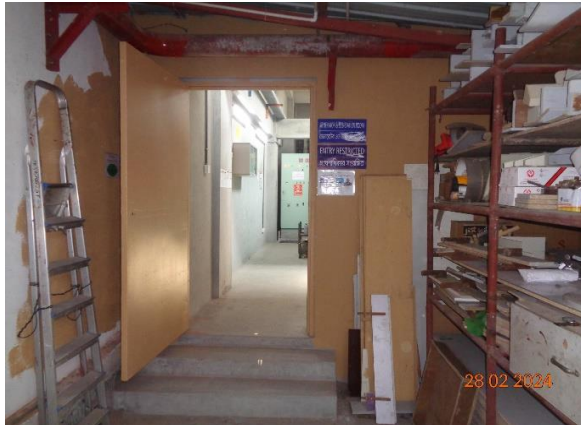
5	Fire Rated Construction	The generator, and substation rooms are not fire separated with fire rated construction barrier or assemblies.	Separate generator and substation room by a minimum 2-hr fire rated construction with 1.5-hr fire rated opening protective assemblies like fire rated door. Provide proper ventilation and consult a qualified engineer for overall solution. When located to the exterior of a building by at least 3m (10 ft.) distance from surroundings then fire rated construction barrier is not mandatory.	Within 3 months
---	-------------------------	--	--	-----------------

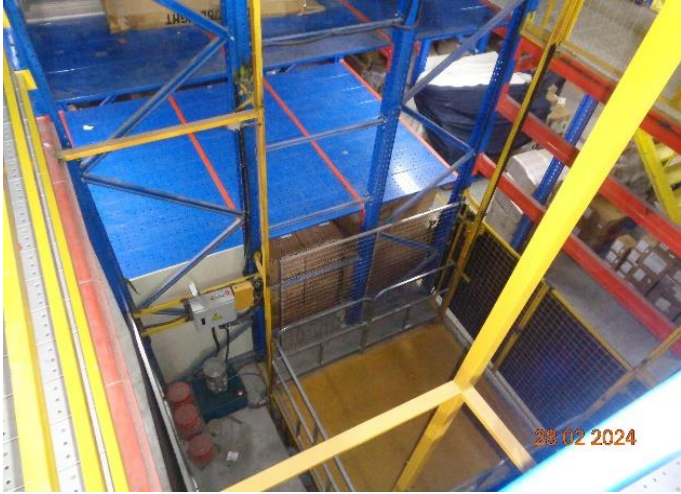
6	Fire Rated Construction	Elevator shafts are directly open inside the floor. Location: Warehouse shed.	Ensure minimum 1.5-hr fire rating for the doors of elevator shafts otherwise close the shafts area with 2-hr fire rated construction barrier and 1.5-hr fire rated doors.	Within 3 months

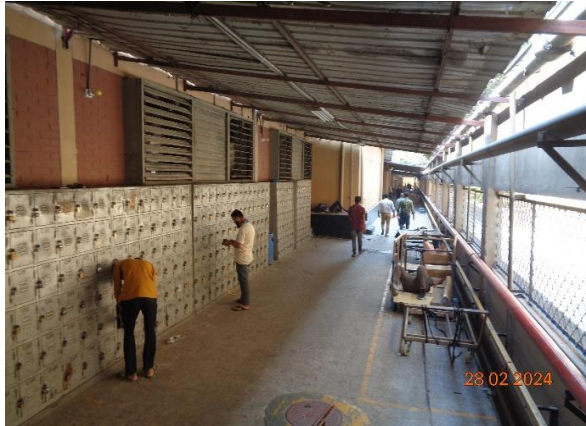
7	Mean of Egress	Walking surface were not found level from exit discharge of all stair and are not protected from slip or tripling hazard. (South side of the building)	Provide an level walking surface in exit discharge in accordance with 6.3.4 of RSC Technical Guidelines (Standard).	Within 3 Months
8	Means of egress	The south exit discharge path is not separated from the building interior of the production building.	Seal all penetrations and openings to the interior of the building along the discharge path to provide a minimum 1-hr fire separation. Alternatively, provide a second remote discharge path to the public way (only include this if feasible).	Within 3 months

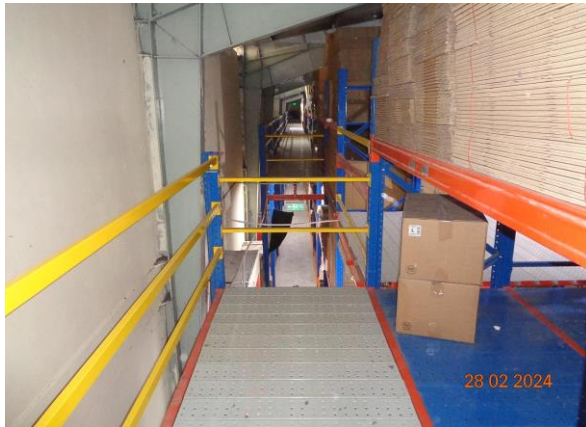
9	Means of egress	Building did not have stair designation signs and occupant load signs at required locations on all floor.	Provide stair designation signs and occupant load signs at required locations.	Within 1 month
10	Means of egress	Dead-end corridor/aisles exceed 15 m (50 ft) limit at jacquard section.	Reconfigure the egress arrangement to reduce the maximum dead-end distance to not more than 15 m (50 ft) in accordance with RSC Technical Guidelines standard 6.13.3.	Within 3 months
