# GLOBAL FIT (BANGLADESH) LIMITED

Plot # 868/1, Block - A, Jangalia Para, Vawal Mirjapur, Gazipur Sadar, Gazipur-1700  
(24.092802, 90.384984)

17 January 2024

## 2. Observations:

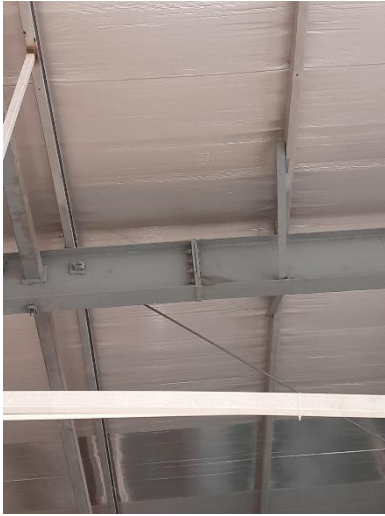
Connection between rafter to rafter

**Description:** The connection of the rafter is partially rigid. Full rigid connection was considered in the analysis. Building engineer is required to check the adequacy of the connection.

| Observation | Action Plan | Timeline |
|---|---|---|
| Connection adequacy of the shed.<br>(Production Shed) | Building engineer is required to check the connection adequacy of the shed and incorporate it in the design report. | within 6 weeks |
| | Carry out remedial work if required. | within 6 months |

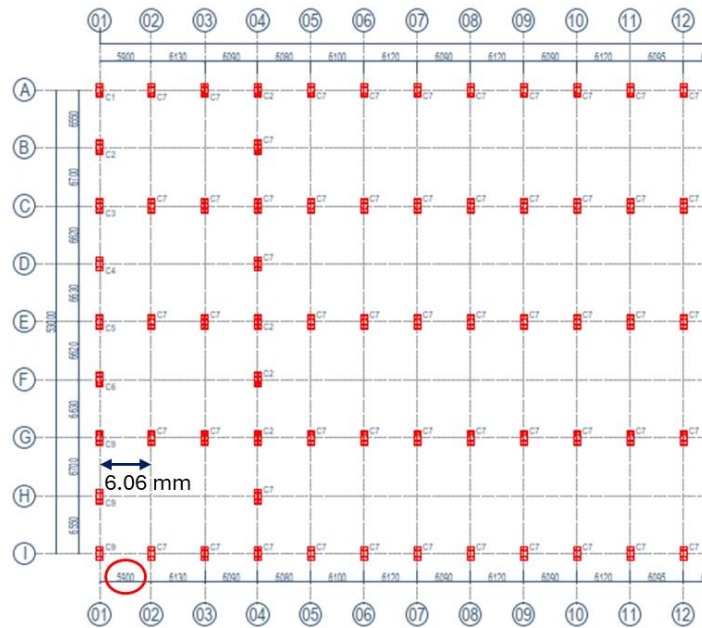
Mismatch in grid distance

**Description:** In the as-built drawing, the mismatch was found in the grid distance, rafter size, eave & ridge height. Grid distance between Grid 1 & 2 is found 6.06m, whereas the drawing shows 5.9m. All rafter sizes are shown W-440X6, F-140X8 but during inspection, rafter size was found W-420X6, F-135X8 on-site. Eave height is shown 4.91m in drawing but 5.0m was found on-site.

| Observation | Action Plan | Timeline |
|---|---|---|
| Mismatch in as-built drawings.<br>(Production Shed) | The building engineer is required to survey the structure, collect information, and prepare accurate as-built drawings. | within 6 weeks |

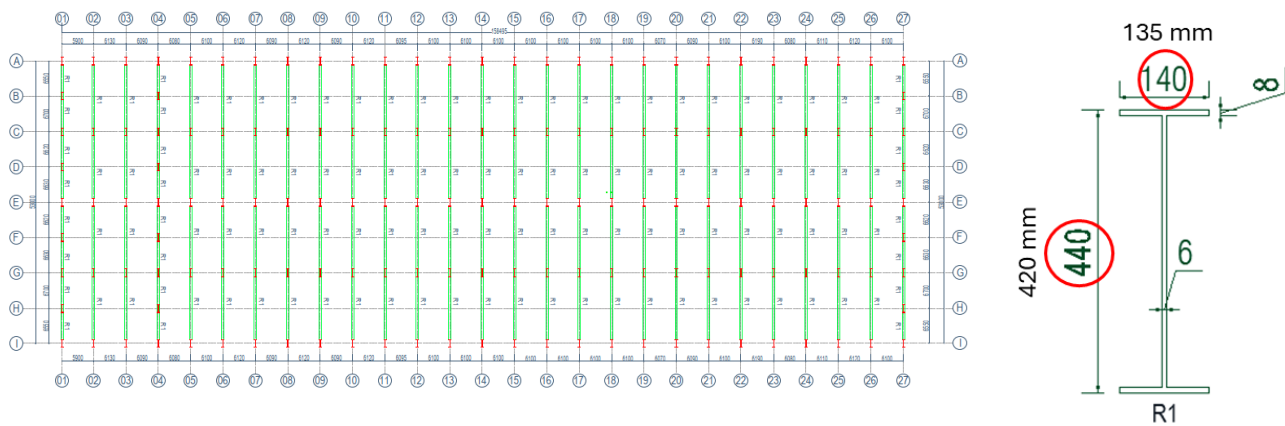
Mismatch in rafter size

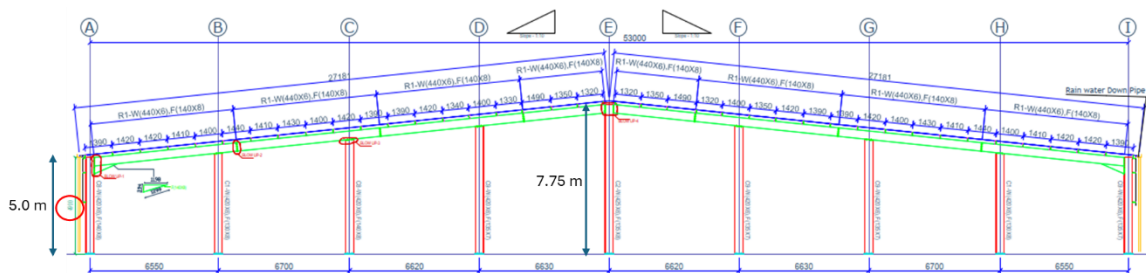
Mismatch in eave and ridge height

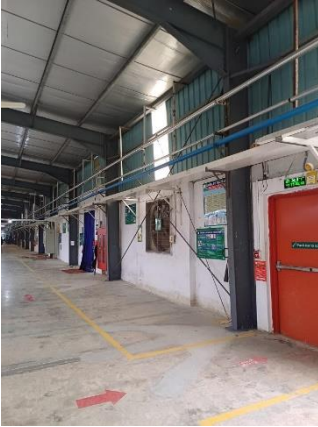
Wall bracing

**Description:** During the inspection, apparently non-engineered wall bracing was observed. 25 mm deformed bar was provided as wall bracing and lapping were provided at different locations of the rebars. The lapping length provided appears to be inadequate and the connections of the deformed bars are also poorly detailed.

| Observation | Action Plan | Timeline |
|---|---|---|
| Apparently non-engineered wall bracing.<br>(Production Shed) | The building engineer is required to justify the application of the wall bracings and check the detailing of the connections. | within 6 weeks |
| | Carry out remedial work if required. | within 6 months |

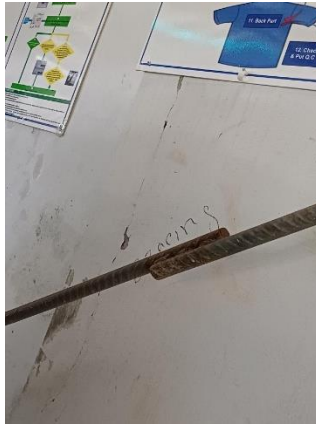
Lapping of deformed bar

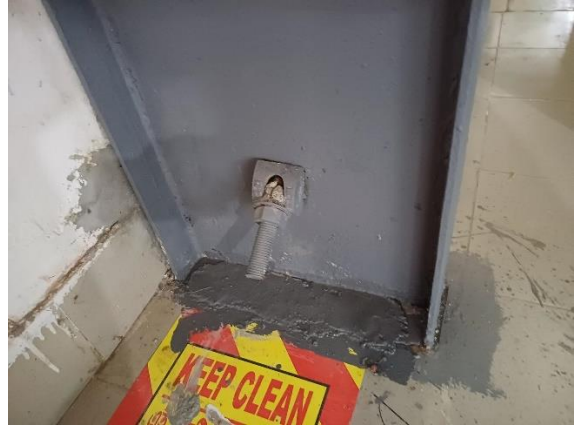
Connection of deformed bar

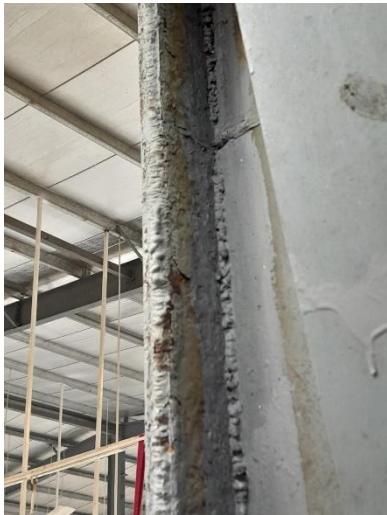
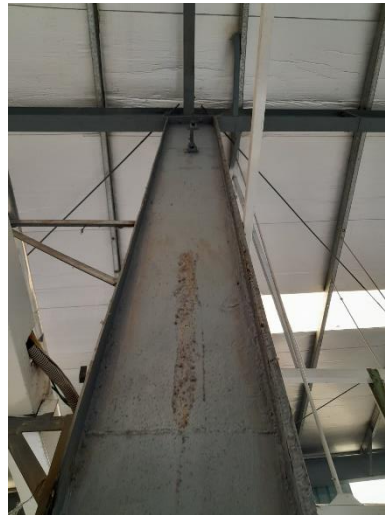
Wall bracing

**Description:** During the inspection, corrosion was observed in the steel member.

| Observation | Action Plan | Timeline |
|---|---|---|
| Corrosion in steel members.<br>(Production Shed) | Building engineer is required to remove the rust and apply anti-corrosive paint. | within 6 weeks |

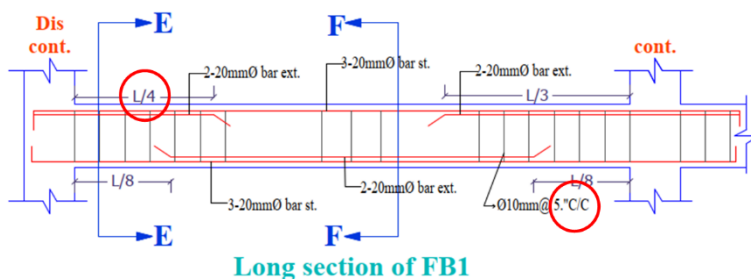
### Inconsistency in material strength consideration

**Description:** As per design report, existing concrete strength for both beam and column is taken 2993 psi. Despite having concrete cores from slab, concrete strength of slab is taken same as equivalent concrete strength of columns. Since, construction drawing was not found on-site, design strength of columns and slabs cannot be verified. The building engineer is required to revise the material strength considerations for beams and slabs and give necessary justifications for not taking strengths of concrete cores obtained from slabs.

The strength of retrofitted concrete is taken 3500 psi, but no test is carried out to verify the concrete strength. In design report, roof live load is taken 1 kPa (21 psf) but as per BNBC 2006, roof live load is 1.5 kPa (31.5 psf). In design report, Intermediate moment resisting frame is considered but stirrup spacing of grade and floor beams doesn't comply with IMRF consideration of BNBC 2006.

| Observation | Action Plan | Timeline |
|---|---|---|
| Inconsistency in design report.<br>(Office Building) | The building engineer is required to revise the design report and FEA model. | within 6 weeks |
| | Carry out remedial work if required. | within 6 months |

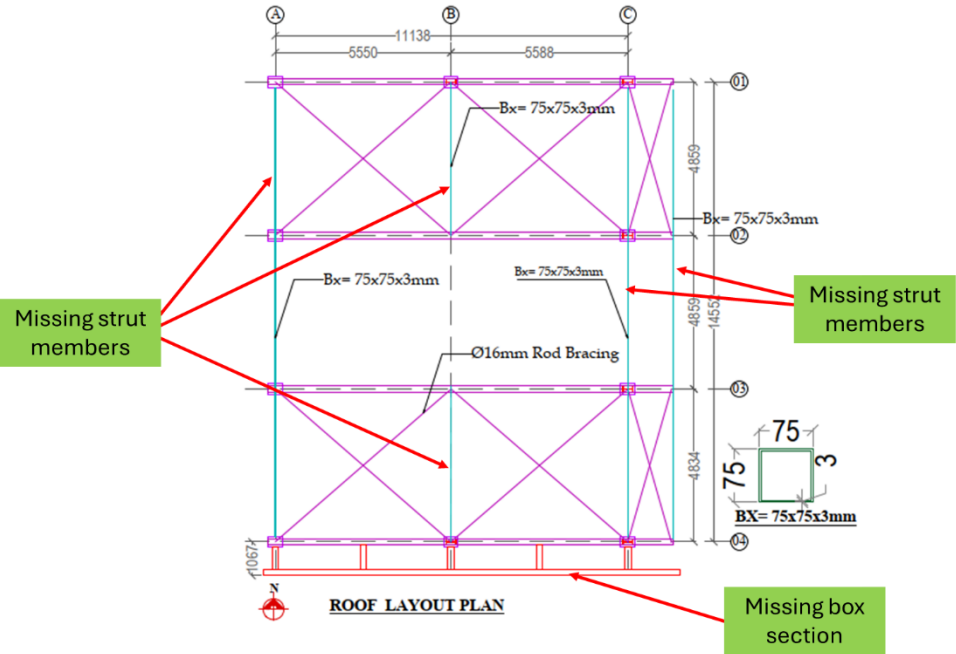
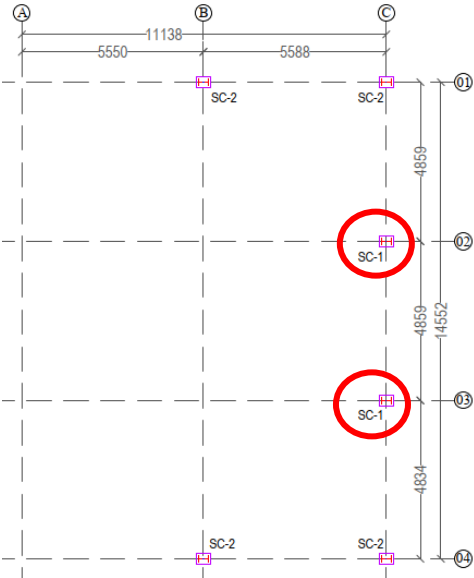
**Description:** During the inspection, the mismatch was found in the as-built drawing. Strut members are shown in the as-built drawing, but during the inspection, strut members were found missing on-site. A steel rafter supported by the cantilever rafters was found missing on-site. Sizes of steel column SC-1 is shown as W-316X5, and F-200X8 in the drawing, but column size was found W-316X5, and F-150X8 on-site.

| Observation | Action Plan | Timeline |
|---|---|---|
| Mismatch in as-built drawings.<br>(Toilet Block) | The building engineer is required to survey the structure, collect information, and prepare accurate as-built drawings. | within 6 weeks |

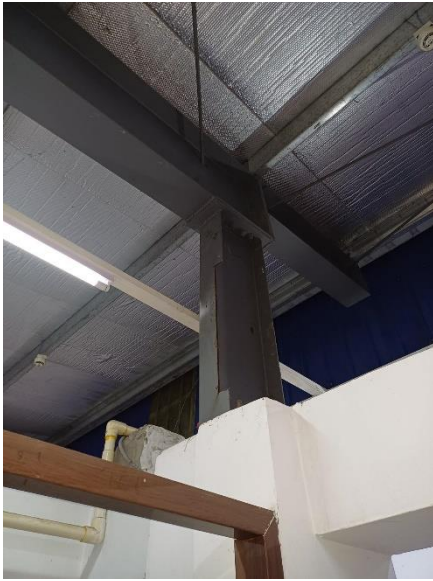
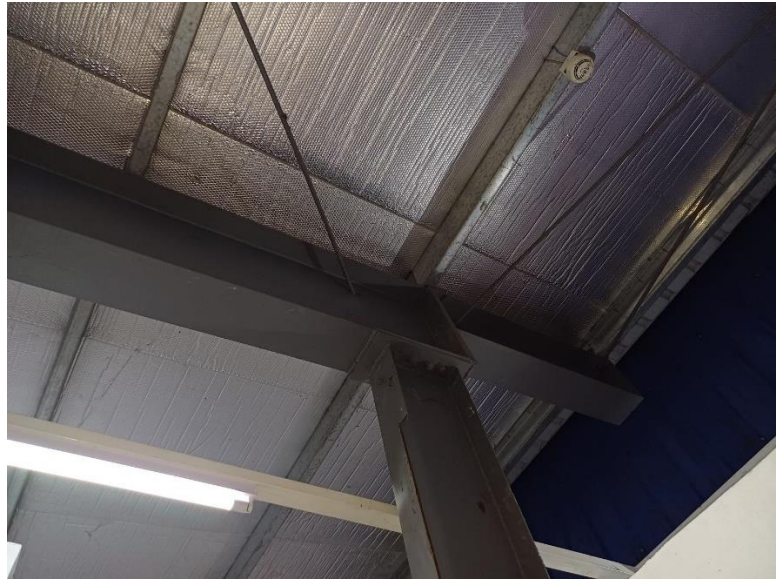
**Description:** During the inspection, cut off flange in a steel column was found at the Toilet Shed. The building engineer is required to investigate the cause of cutting off, prepare an investigation report, and repair the steel column accordingly.

| Observation | Action Plan | Timeline |
|---|---|---|
| Cut off flange found on steel column.<br>(Toilet Block) | The building engineer is required to investigate the cause of cutting off, prepare an investigation report, and repair the steel column accordingly. | within 6 weeks |
| | Carry out remedial work if required. | within 6 months |

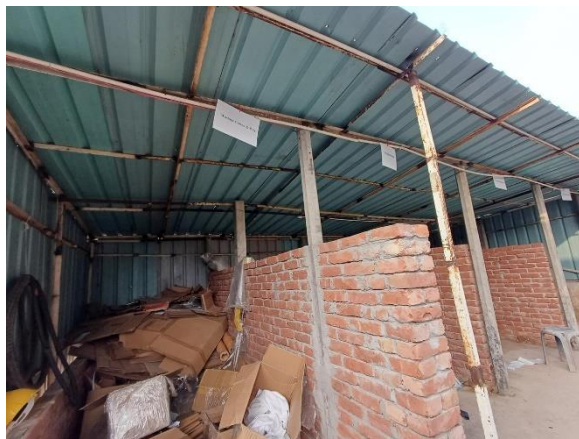
Inadequate steel members

**Description:** Apparently non-engineered lightweight steel shed. Lack of lateral stability, apparently inadequate steel members, and poorly detailed connections were found. During the inspection, corrosion was also found in the steel sections. The factory is required to replace the non-engineered shed with a properly engineered shed.

| Observation | Action Plan | Timeline |
|---|---|---|
| Apparently non-engineered steel shed.<br>(Wastage Shed) | The building engineer is required to replace the non-engineered shed with a properly engineered shed. | within 6 months |

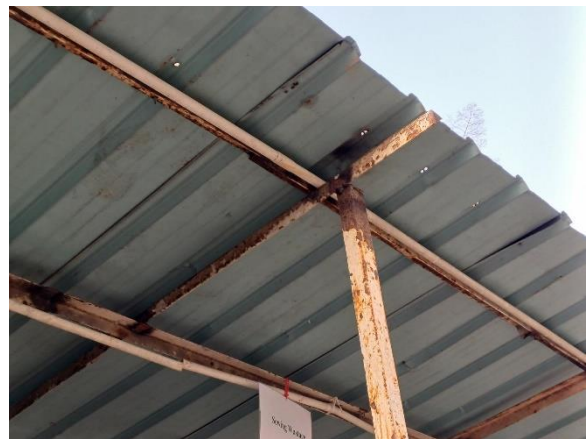
Poor steel rafter-column connection

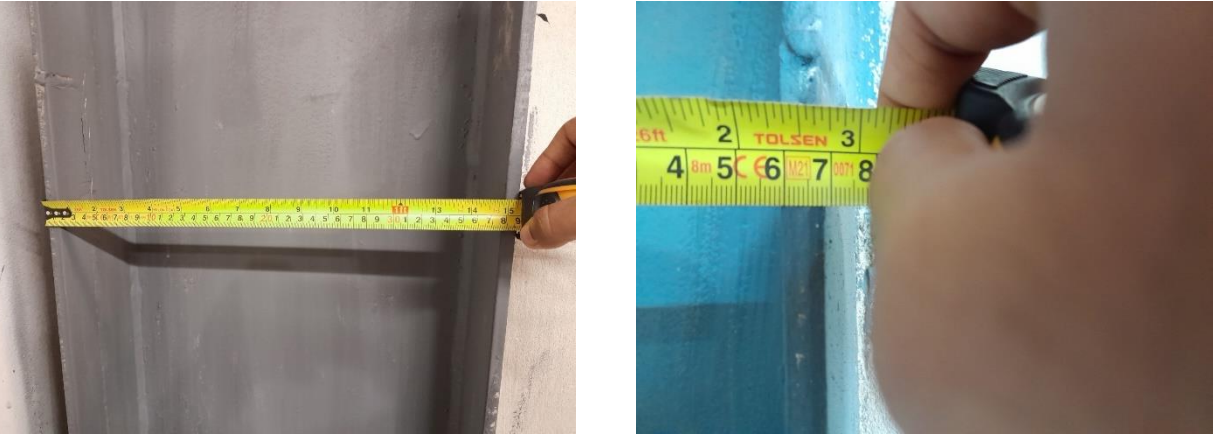
Mismatch in the as-built drawing

**Description:** Mismatch was found in the as-built drawing. The depth size of C1 was measured 390mm instead of 420mm and flange thickness was measured 6 mm instead of 8 mm.

| Observation | Action Plan | Timeline |
|---|---|---|
| Mismatch in the as-built drawing.<br>(Warehouse) | The building engineer is required to survey the structure, collect information, and prepare accurate as-built drawings. | within 6 weeks |

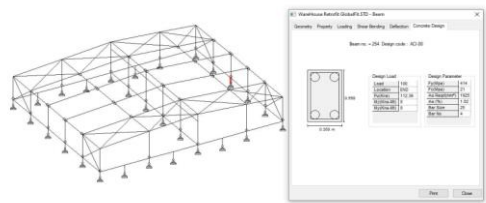
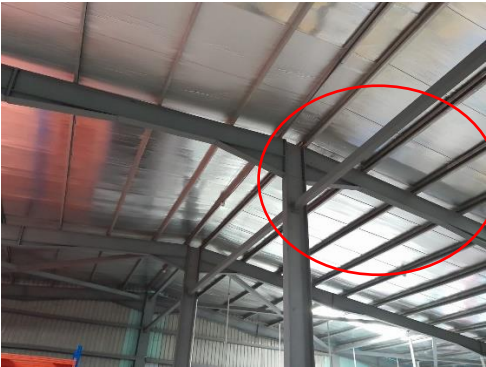
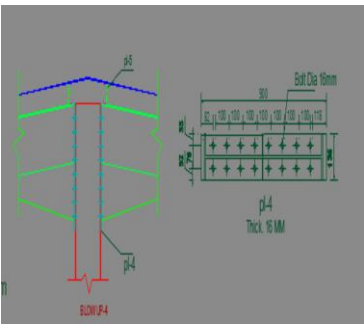
**Description:** The steel strength is considered as 415 MPa in design analysis but in the material strength chapter it was considered as 323 MPa. Also, no test report was provided for the 415 MPa rebar. Also in the connection adequacy chapter, the type of connection is shown as not matched with the site condition.

| Observation | Action Plan | Timeline |
|---|---|---|
| Inconsistencies in design report.<br>(Warehouse) | Building engineer is required to prepare the design report following the provision of BNBC 1.9. | within 6 weeks |
| | Carry out remedial work if required. | within 6 months |

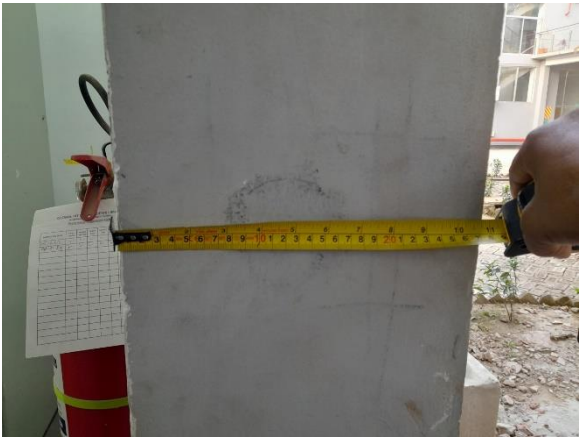
Mismatch in column dimension

**Description:** During the inspection it was observed that the C1 column width is 250 mm however in the drawing it shows 375mm.

| Observation | Action Plan | Timeline |
|---|---|---|
| Mismatch in the as-built drawing.<br>(Utility Building) | The building engineer is required to survey the structure, collect information, and prepare accurate as-built drawings. | within 6 weeks |
