# INITIAL FIRE SAFETY INSPECTION REPORT

## SHINE EMBROIDERY LTD

Date: 5 March, 2024

# Fire Safety Inspection Report

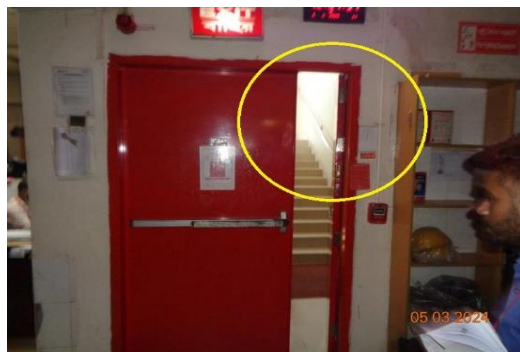
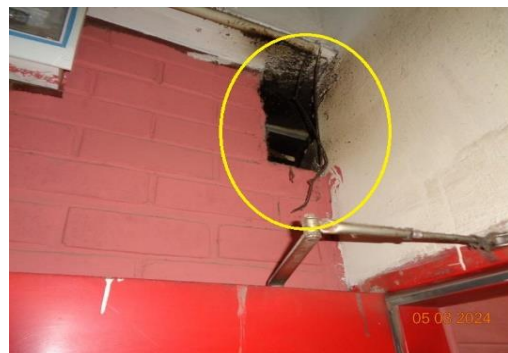
| F-2 | Fire Rated Construction | The exit stair enclosures are not separated from work areas and other spaces on each floor by fire-rated construction due to unprotected opening & Penetration, non-functional door accessories etc. | <p>The exit stair enclosure shall be provided with a minimum 1-hr fire resistance rating for buildings with 3 or fewer stories and a minimum of 2-hr. fire resistance rating for buildings 4 or more stories. Provide 0.75 hr. fire rated door and seal all penetrations and openings by 1 hr. fire rated fire rated barrier construction for building with 3 or fewer stories. Provide 1.5 hr. fire rated door and seal all penetrations and openings by 2 hr. fire rated fire rated barrier construction for building with 4 or more stories.</p> <p>Ensure that the fire doors are self-closing and positive latching and that they are provided with fire exit (panic) hardware where serving production floors. If fire doors are required to be held open for functional reasons, provide automatic closing devices tied to the fire alarm system.</p> | Within 3 Month |

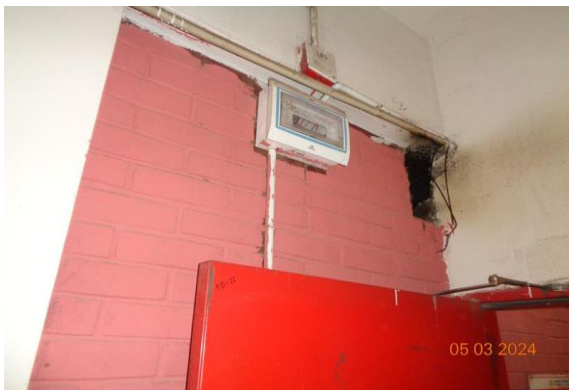
| F-3 | Fire Rated Construction | Electrical panels were located in the exit stair enclosure. | Remove all electrical panels & electrical cables from exit stair enclosures & relocate on a safe locations. | Within 3 Month |

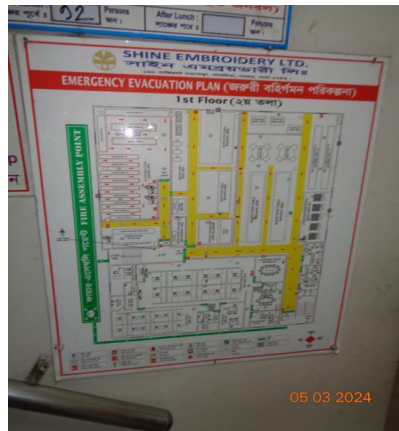
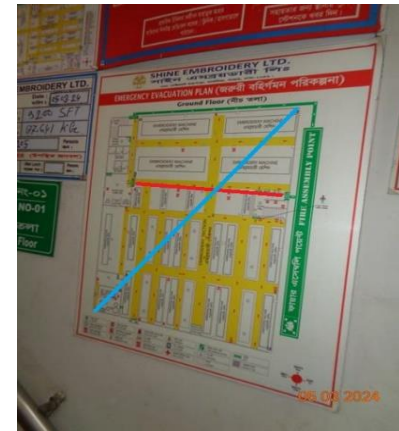
| F-4 | Mean of Egress | <p>The exits in the work area are not remotely located from each other (less than one-half maximum diagonal distance of pace) such that a single fire event could compromise both exits.</p> <p>Diagonal distance is 140 ft whereas distance between exits at Ground floor 52 ft, 1st floor: 67 ft and 2nd floor: 61 ft.</p> | <p>Modify exit arrangement to provide remote exits.</p> <p>Alternatively,</p> <p>provide sprinkler protection throughout the building in accordance with NFPA 13.</p> | Within 3 months |

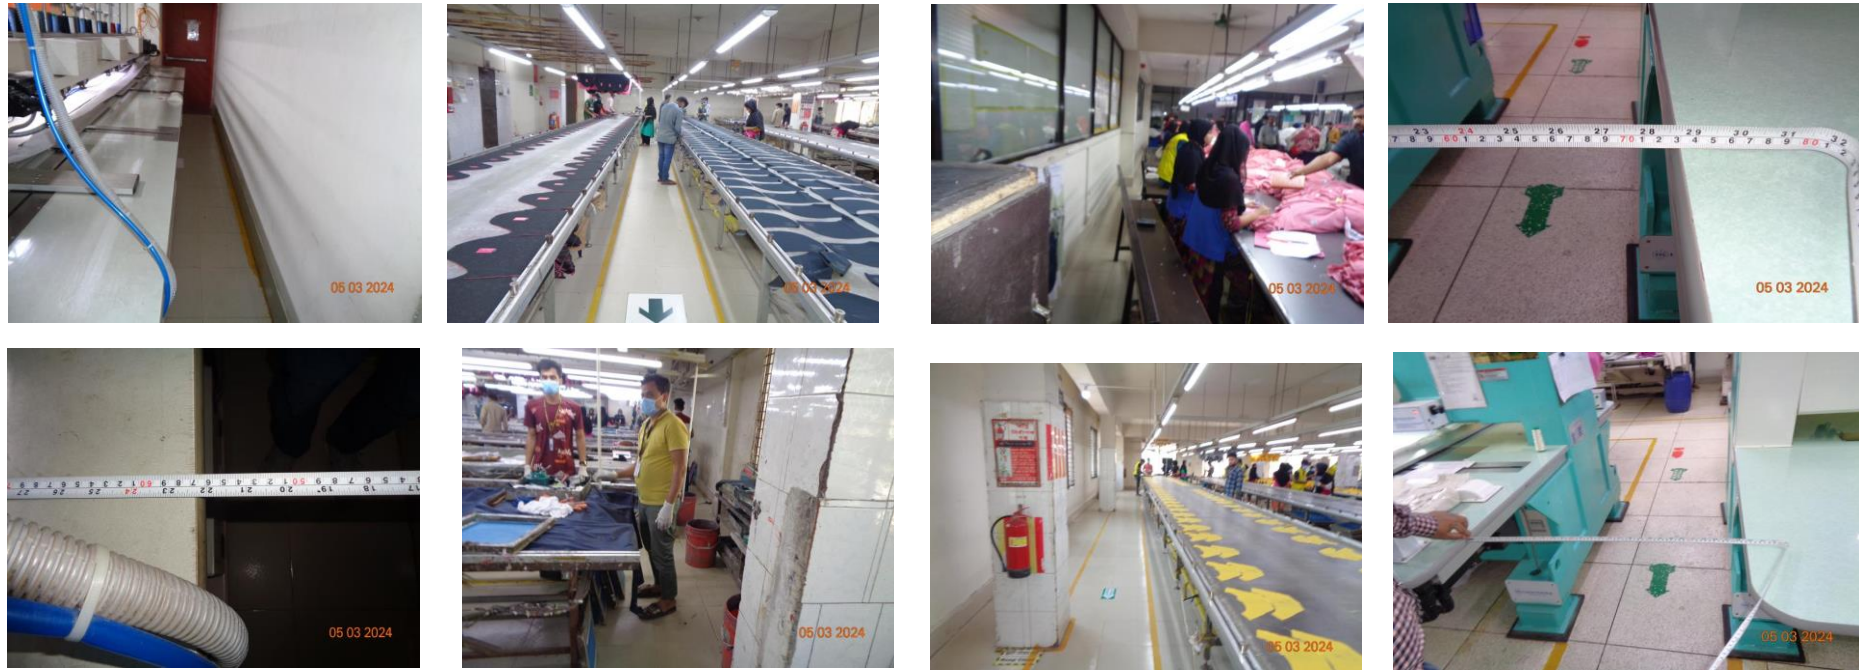
| F-5 | Mean of Egress | Aisles were found missing on several locations & aisles were found less than 36 inch throughout the building. | Provide minimum aisle widths of 36-in. Aisles mark shall be clearly visible. Aisles shall be free from all obstruction , storage & process work. | Within 3 months |

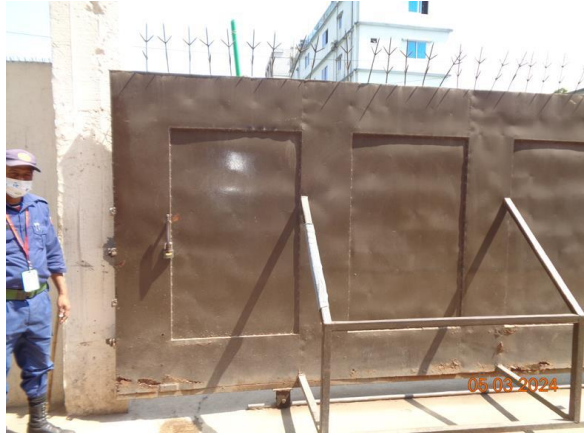
| F-6 | Mean of Egress | Non-compliant sliding gate has been provided at building exit. | Replace all gates and doors along the means of egress with side-hinged, swinging egress doors in accordance with RSC Technical Guidelines 6.8.1. | Within 1 month |

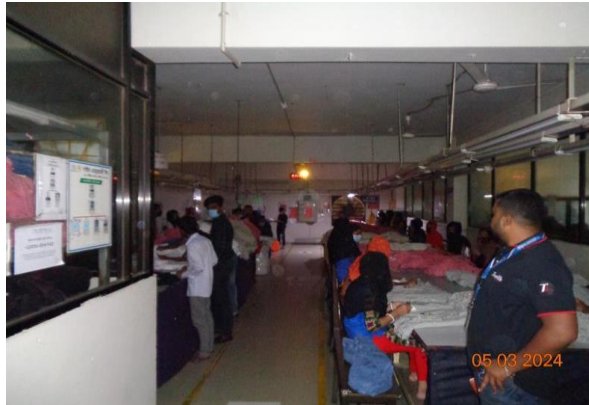
| F-7 | Emergency Lighting | Emergency light weren't provided and adequate illumination levels are not anticipated along egress routes and at exit stairs. | Test the emergency lighting system on each floor and provide additional emergency fixtures to supply adequate illumination along the means of egress. Provide a minimum illumination of 10 lux at the floor level within exit stairs and along exit discharge paths and a minimum 2.5 lux along exit access aisles. | Within 3 months |

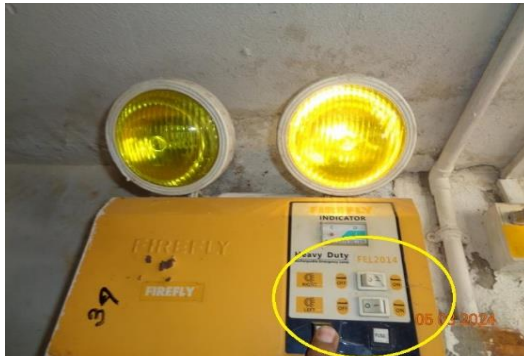
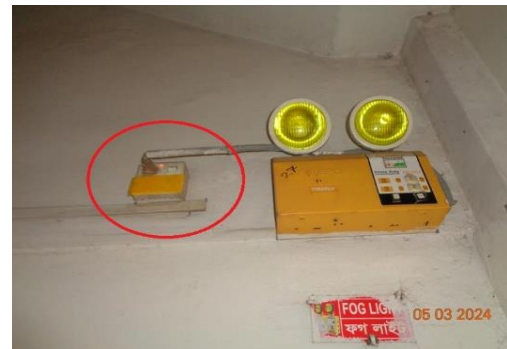
| F-8 | Emergency Lighting | Manual on-off switch is provided for exit signage at the door to the egress on all floors. | Remove manual on/off switches from exit signage units to prevent them from being switched off. | Within 1 month |
