# Scandex Textile Industries Ltd.

Uttar Gazaria, Kaliakoir, Gazipur

31 December 2023

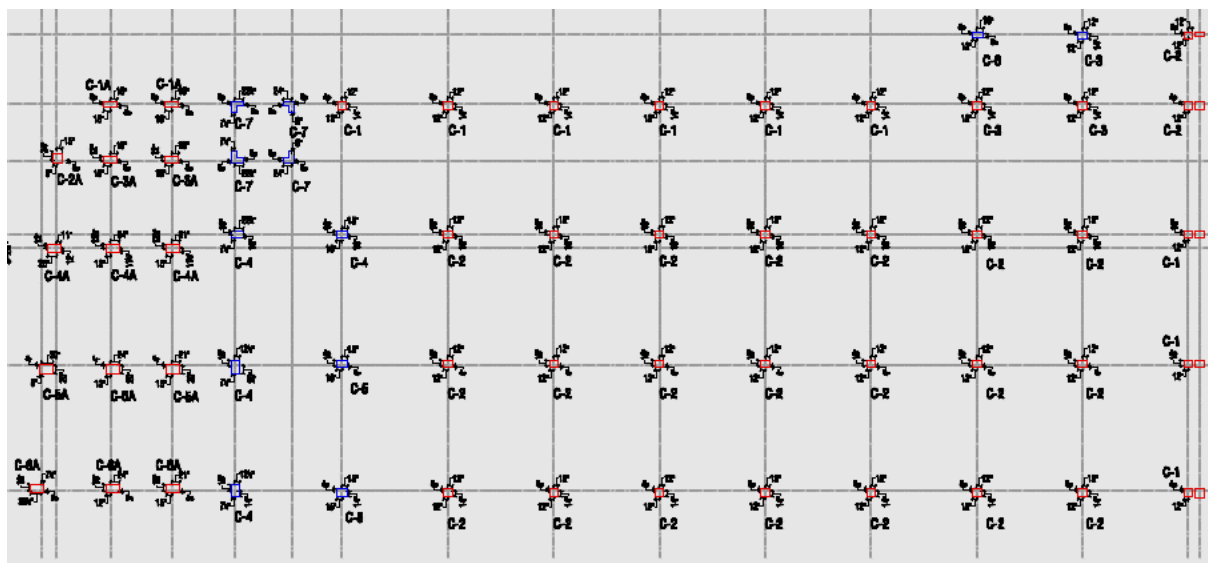
### Column Layout (Building 1 – West Part)

**Observation 1:** Column stressed above normal design limit. (Building 1)

**Description:** Cursory calculation indicates that interior columns are stressed above the normal design limit considering 3kPa live load and minimum concrete strength (2370 psi) based on aggregate type (available test reports are insufficient to meet the evaluation and acceptance criteria of BNBC). The building engineer is required to carry out Detail Engineering Assessment (DEA) to review the design, loads and column stress based on in-situ material strength and floor live loads.

| Observation | Action Plan | Timeline |
|---|---|---|
| Column stressed above normal design limit.<br>(Building 1) | As part of Detailed Engineering Assessment (DEA), the building engineer is required to review the design load, column stresses. | within 6 weeks |
| | Verify in situ concrete strength (100mm dia. cores from 4 columns) from the lower tier of the building. | within 6 weeks |
| | Produce and actively manage a loading plan for all floor plates within the factory considering column capacity. | within 6 weeks |
| | Carry out the suggested remedial works. | within 6 months |
| | Continue to implement final floor live load plan. | within 6 months |

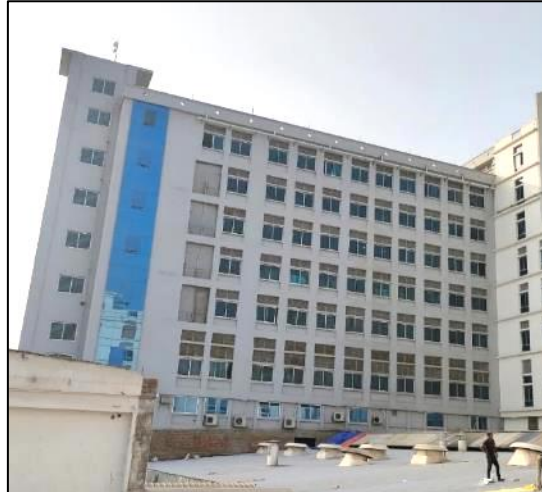
**Observation-2:** Lack of design documents. (Building 4)

**Description:** As per BNBC, every building or structure designed shall have its design documents prepared in accordance with the provision of Section 1.9.1. The design document shall include a design report, and a set of structural drawings, which shall be prepared in compliance with section 1.9.1.1 and section 1.9.1.2 as per BNBC.

At the time of inspection, the design report and sufficient concrete compressive strength test reports were not available. The building engineer is required to evaluate concrete strength as per BNBC, produce design report accordingly and submit to RSC for review.

| Observation | Action Plan | Timeline |
|---|---|---|
| Lack of design documents.<br>(Building 4) | The building engineer is required to prepare design documents (including as-built drawings, design report, load plan and material test reports) in compliance with section 1.9.1 (part-6, BNBC). | within 6 weeks |
| | Verify in situ concrete strength (100mm dia. cores from 4 columns) from the lower tier of the building. | within 6 weeks |
| | Carry out the suggested remedial works. | within 6 months |

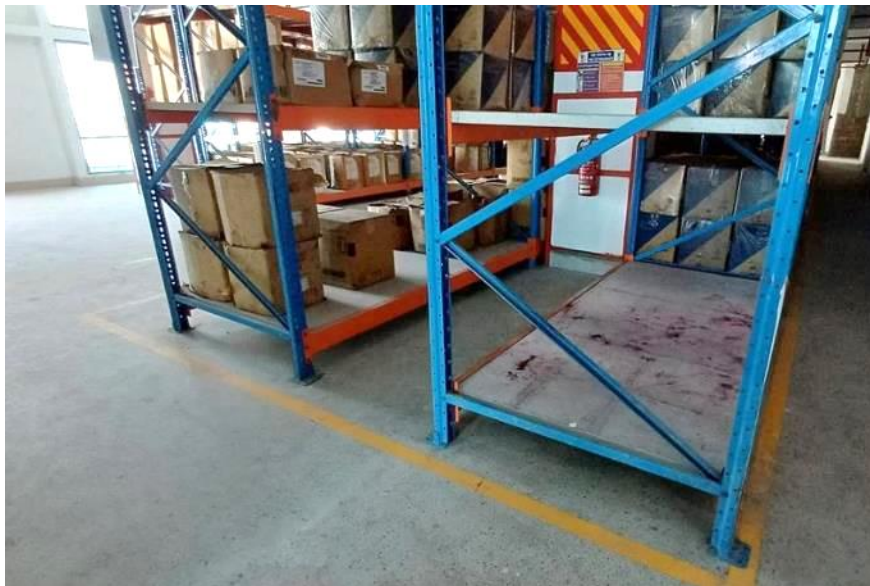
**Observation-3:** Non-structural elements found unbraced/not anchored. (Building 1 & 4)

**Description:** Non-structural elements suspended from, attached to, or resting top the structure shall be adequately anchored and braced to resist earthquake forces. Factory is required to brace/anchor all non-structural elements.

| Observation | Action Plan | Timeline |
|---|---|---|
| Non-structural elements found unbraced/not anchored.<br>(Building 1 & 4) | Factory is required to brace/anchor all non-structural elements. | within 6 weeks |

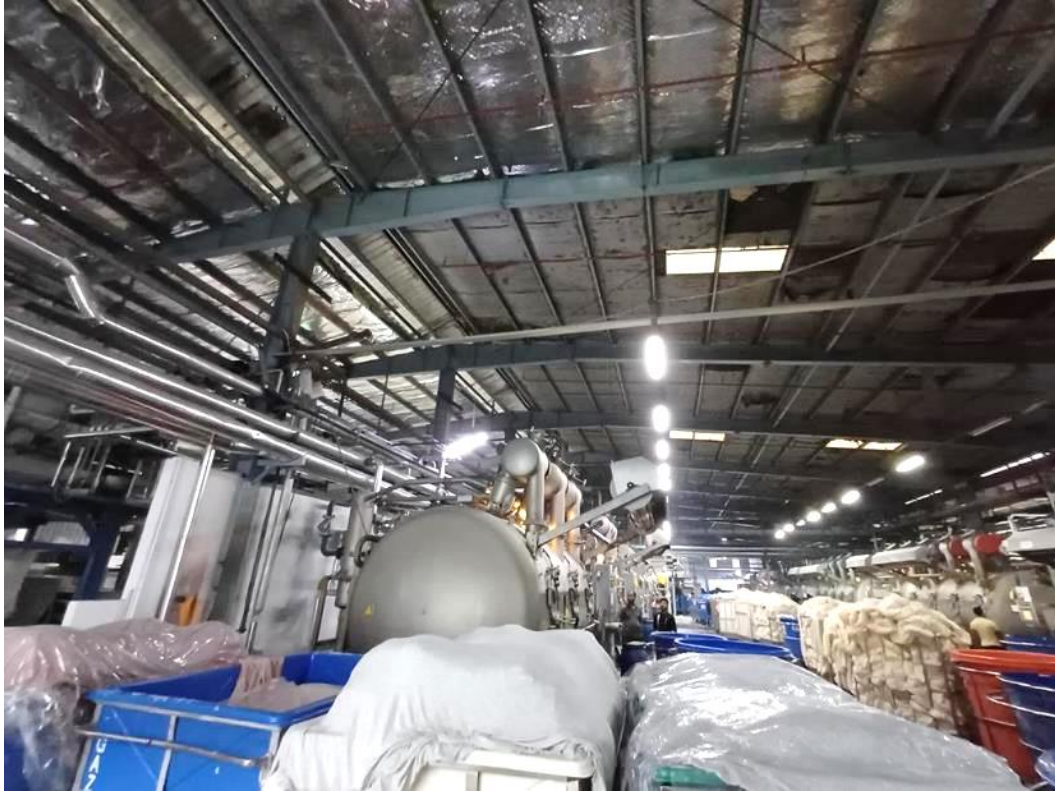
**Observation-4:** Lack of design documents (Building 2).

**Description:** As per BNBC, every building or structure designed shall have its design documents prepared in accordance with the provision of Section 1.9.1. During the inspection, the design report and soil test report was not available on site.

The building engineer is required to prepare a set of design documents including as built drawings and a design report based on in-situ material strength and software-based analysis which shall be prepared in compliance with section 1.9.1, part-6 of BNBC.

| Observation | Action Plan | Timeline |
|---|---|---|
| Lack of design documents<br>(Building 2). | The building engineer is required to carry out Engineering Assessment (EA) based on in-situ material strength and submit to RSC for review. | within 6 weeks |
| | Carry out suggested remedial works if required. | within 6 months |

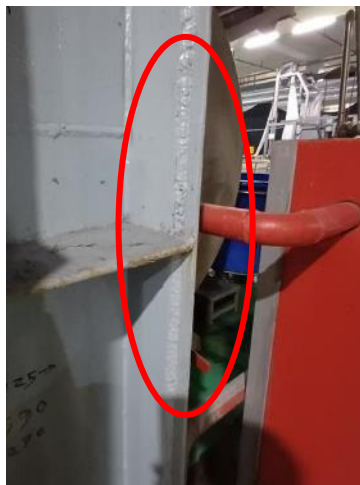
**Observation-5:** Faulty retrofitting works (Building 2).

**Description:** During inspection, additional plate was observed shorter than the existing column size. Building engineer is required to check the column stress for actual effective area.

| Observation | Action Plan | Timeline |
|---|---|---|
| Faulty retrofitting works (Building 2). | As per the suggestion if the building engineer carry out remedial works where required. | within 6 weeks |

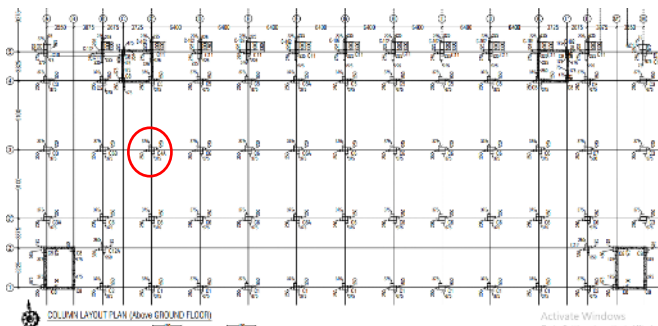
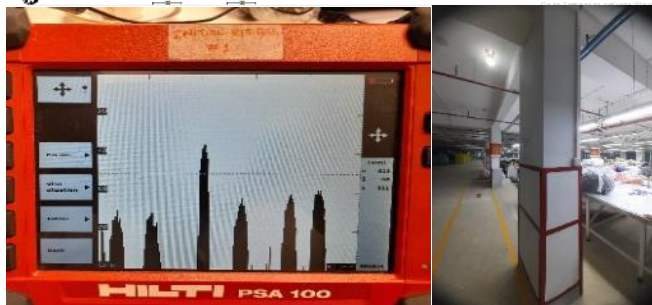
### Observation-6: Discrepancies in the provided drawing (Building-3).

RC Column C4A (750X500) re-bar profile found by scanning 6/5 (18 no's) instead of 9/5 (24 no's)

**Description:** During the inspection, discrepancies were observed between the provided drawing and on-site conditions. RC column re-bar profile mismatch and steel column web-flange size & thickness mismatches were observed. The building engineer is required to survey the whole structure and update the drawing reflecting on-site condition.

| Observation | Action Plan | Timeline |
|---|---|---|
| Discrepancies in the provided drawing<br>(Building-3) | The building engineer is required to survey the whole structure and update the drawing reflecting on-site condition. | within 6 weeks |

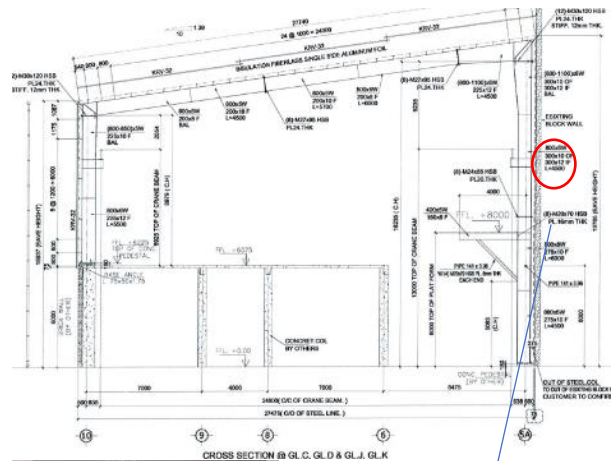
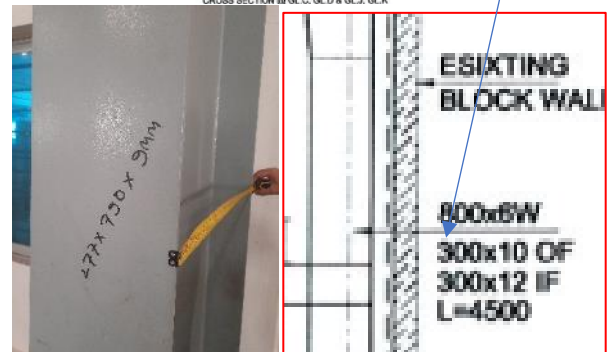
Steel Column size observed F-277X9 W-790 instead of F-300X(10/12) W-800

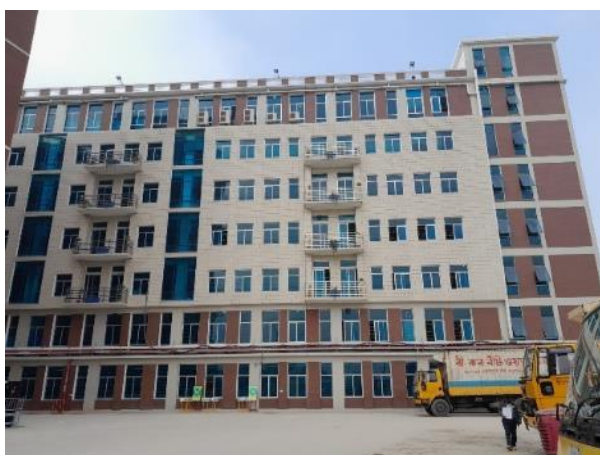
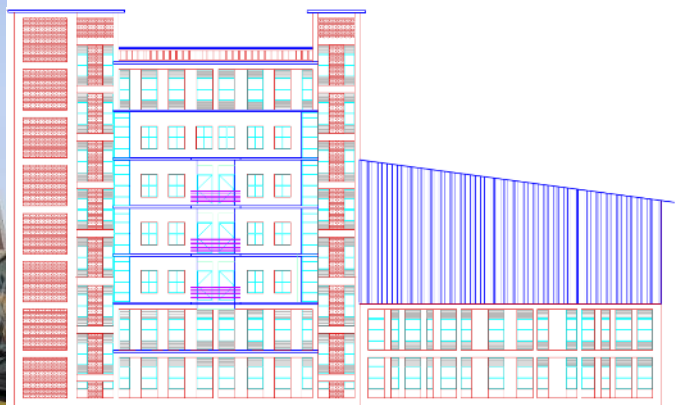
### Observation-7: Lack of Design Report (Building-3).

**Description:** The design report was not prepared for the mentioned structure. The building engineer is required to prepare a design report following BNBC (part-6, section 1.9.1)

| Observation | Action Plan | Timeline |
|---|---|---|
| Lack of Design Report<br>(Building-3) | The building engineer is required to prepare a design report considering BNBC (part-6, Section-1.9.1). | within 6 weeks |
| | Carry out suggested remedial works if required. | within 6 months |

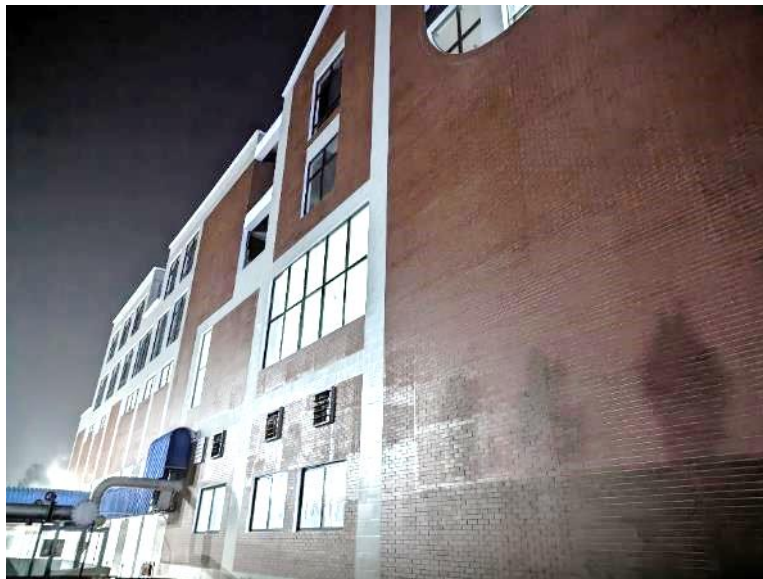
## Observation-9: Lack of design documents. (Building 5)

**Description:** As per BNBC, every building or structure designed shall have its design documents prepared in accordance with the provision of Section 1.9.1. The design document shall include a design report, and a set of structural drawings, which shall be prepared in compliance with section 1.9.1.1 and section 1.9.1.2 as per BNBC.

At the time of inspection, the design report and sufficient concrete compressive strength test reports were not available. The building engineer is required to evaluate concrete strength as per BNBC, produce design report accordingly and submit to RSC for review.

| Lack of design documents.<br>(Building-5) | The building engineer is required to prepare design documents (including as-built drawings, design report, load plan and material test reports) in compliance with section 1.9.1 (part-6, BNBC). | within 6 weeks |
| | Verify in situ concrete strength (100mm dia. cores from 4 columns) from the lower tier of the building. | within 6 weeks |
| | Carry out the suggested remedial works. | within 6 months |

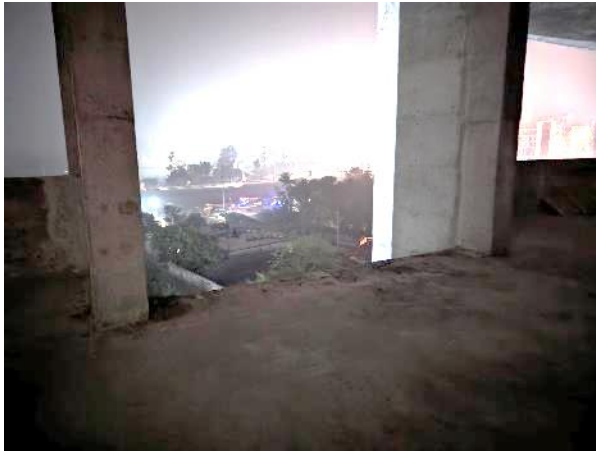
**Observation-10:** Possible falling hazard on roof. (Building-5)

Falling Hazard on 4<sup>th</sup> floor

**Description:** During inspection the barrier was observed in 4<sup>th</sup> floor and roof level. Factory is required to provide parapet/railing at all locations of roof and staircase to avoid possible falling hazard.

| Possible falling hazard on roof. (Building-5) | Factory is required to provide parapet/railing at all locations of roof and staircase to avoid possible falling hazard. | within 6 weeks |

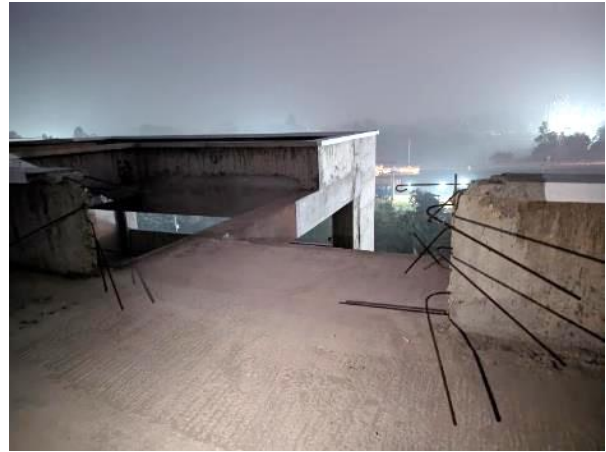
Falling Hazard on roof level

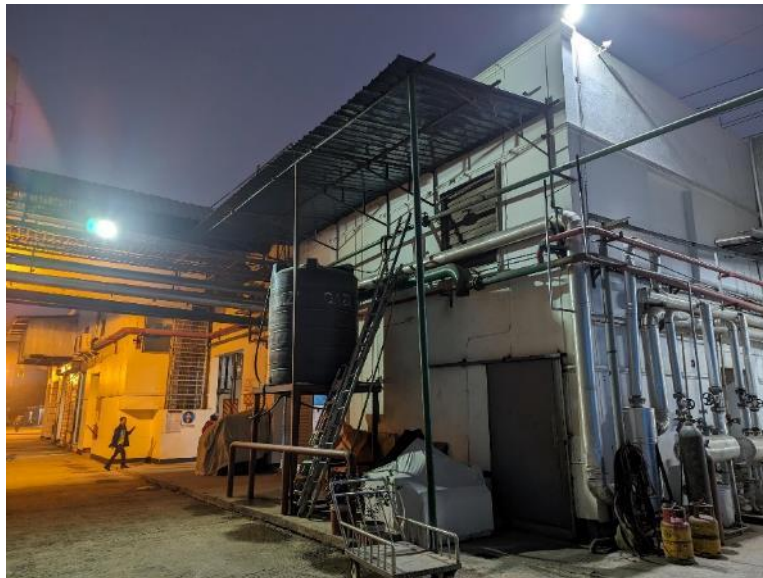
**Observation-11:** Lack of design documents. (Building 6)

**Description:** As per BNBC, every building or structure designed shall have its design documents prepared in accordance with the provision of Section 1.9.1. The design document shall include a design report, and a set of structural drawings, which shall be prepared in compliance with section 1.9.1.1 and section 1.9.1.2 as per BNBC.

At the time of inspection, the design report and sufficient concrete compressive strength test reports were not available. The building engineer is required to evaluate concrete strength as per BNBC, produce design report accordingly and submit to RSC for review.

| Lack of design documents<br>(Building-6) | The building engineer is required to prepare a design report considering BNBC (part-6, Section-1.9.1). | within 6 weeks |
| | Carry out suggested remedial works if required. | within 6 months |

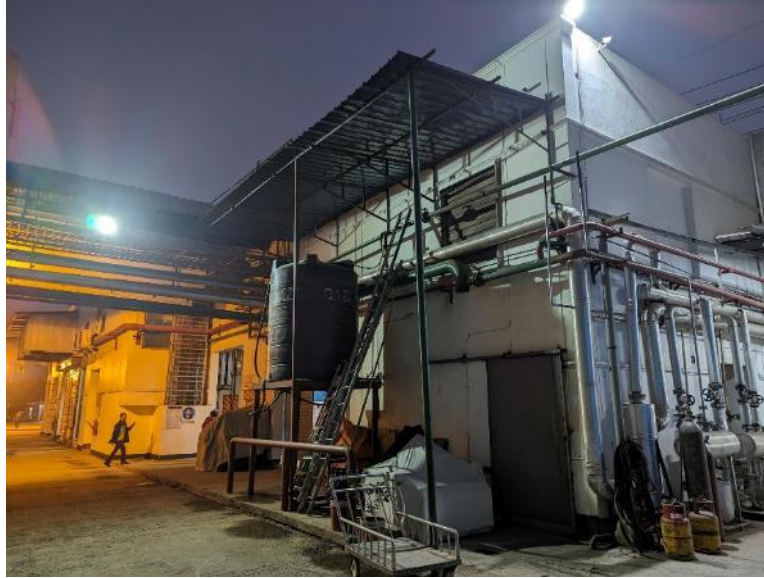
Building-6

**Observation-12:** Lack of as-built structural drawings (Building-6).

**Description:** During the inspection, no as-built drawings were available for Building-6. The building engineer is required to survey the full structure and produce accurate as-built drawings.

| Lack of as-built structural drawings<br>(Building-6). | The building engineer is required to survey the full structure and produce accurate as-built drawings. | within 6 weeks |

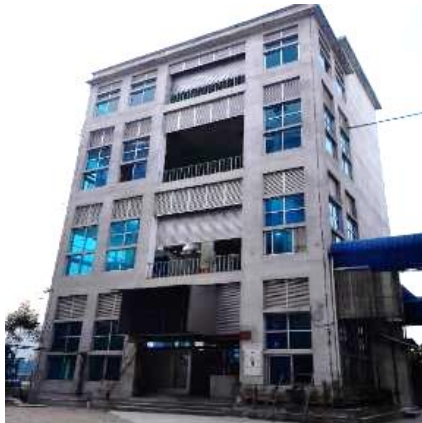
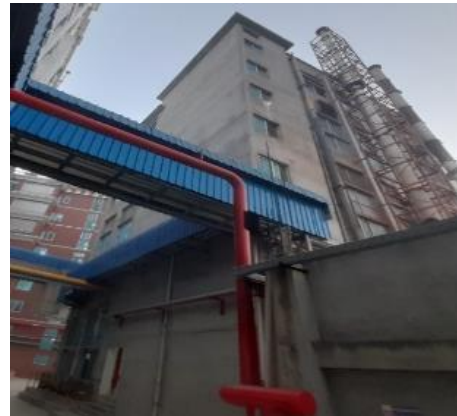
**Observation-13:** Lack of Design Report (Building-7).

**Description:** The design report was not prepared for the mentioned structure. The building engineer is required to review the design of the long columns. The building engineer is required to prepare a design report following BNBC (part-6, section 1.9.1)

| Lack of Design Report<br>(Building-7) | The building engineer is required to prepare a design report considering BNBC (part-6, Section-1.9.1). | within 6 weeks |
| | The building engineer is required to review the design of the long columns. | within 6 weeks |
| | Carry out suggested remedial works if required. | within 6 months |

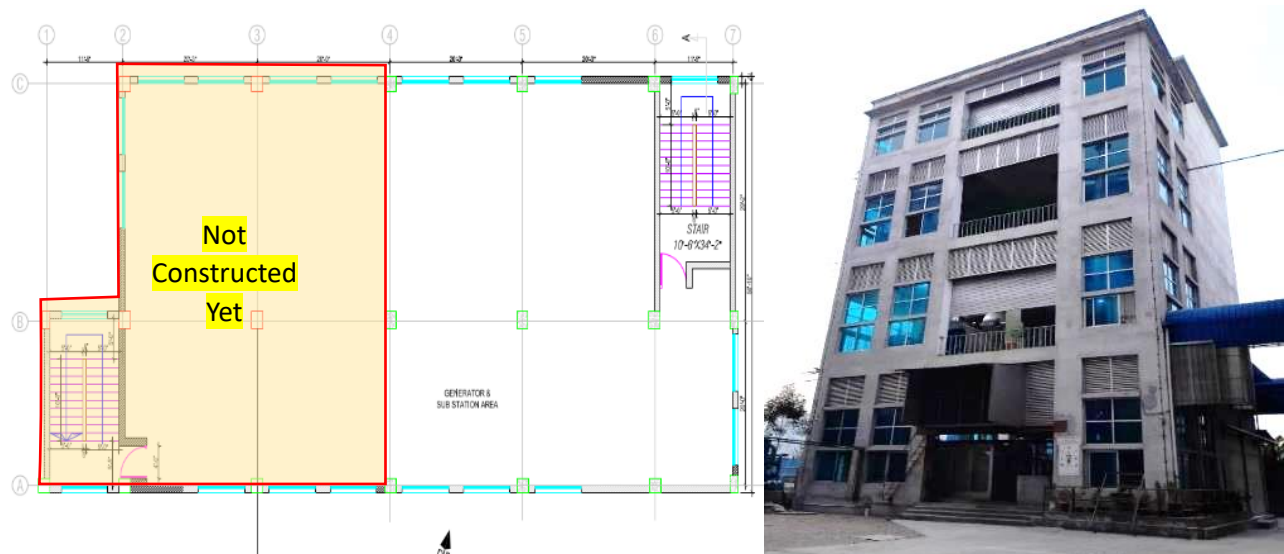
**Observation-15: Possible horizontal expansion (Building-7).**

**Description:** The factory has a plan to conduct horizontal expansion. Projected reinforcement left at west side which indicates possible future horizontal extension. The factory is required to prepare a Detailed Engineering Assessment (DEA) report prior conducting any horizontal expansion.

| Possible horizontal expansion (Building-7) | The factory is required to prepare a Detailed Engineering Assessment (DEA) report prior conducting any horizontal expansion. | within 6 weeks |
| | Carry out suggested remedial works if required. | within 6 months |

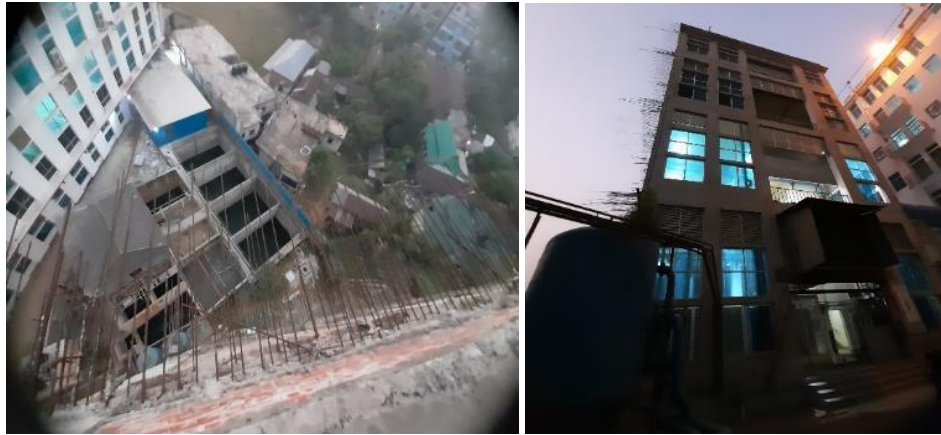
**Observation-16:** Exposed rebar left at roof level and all floor (Building-7).

**Description:** Exposed rebar is left at all floor level which was prone to corrosion. The factory is required to provide rust proof coating on exposed rebar to protect from corrosion.

| Exposed rebar left at roof level and all floor<br>(Building-7) | The factory is required to provide rust proof coating on exposed rebar to protect from corrosion. | within 6 months |

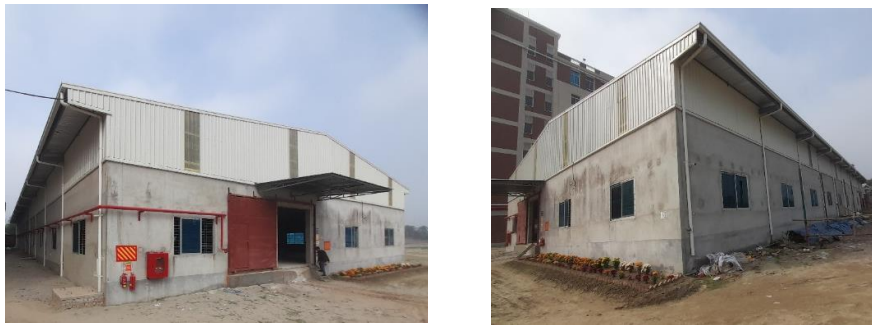
**Observation-17:** Lack of Design Report (Building-8).

**Description:** The design report was not prepared for the mentioned structure. The building engineer is required to prepare a design report following BNBC (part-6, section 1.9.1)

| Lack of Design Report<br>(Building-8) | The building engineer is required to prepare a design report considering BNBC (part-6, Section-1.9.1). | within 6 weeks |
| | Carry out suggested remedial works if required. | within 6 months |

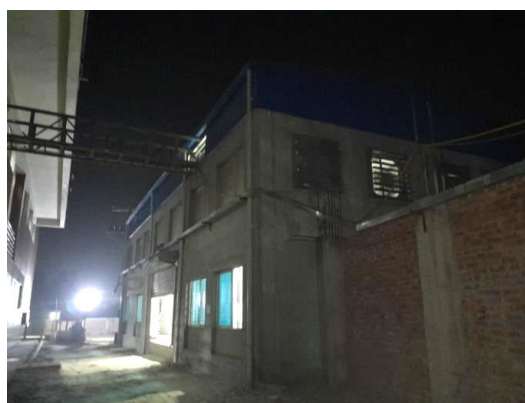
(Buiding-9)

**Observation-18:** Absence of design documents (Building 9)

**Description:** As per BNBC, every building or structure designed shall have its design documents prepared following the provision of Section 1.9.1. The design document shall include a design report, and a set of structural drawings, which shall be prepared in compliance with section 1.9.1.1 and section 1.9.1.2 as per BNBC. At the time of inspection, a design report was not available which is required to be prepared in compliance with BNBC.

| Absence of design documents.<br>(Building 9) | Building is required to prepare a set of design reports in compliance with BNBC. | within 6 weeks |
| | Implement remediation work if required. | within 6 months |

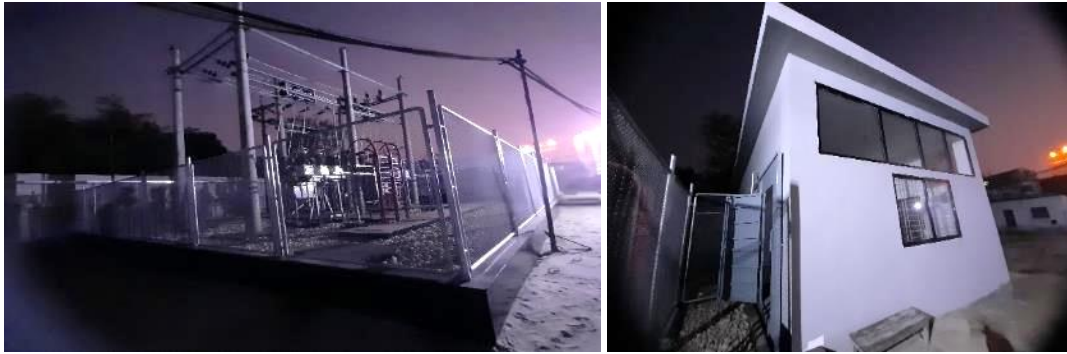
**Observation-19:** Lack of design documents (Building-10).

**Description:** As per BNBC, every building or structure designed shall have its design documents prepared following the provision of Section 1.9.1. The design document shall include a design report, and a set of structural drawings, which shall be prepared in compliance with section 1.9.1.1 and section 1.9.1.2, part 6 of BNBC.

| Lack of design documents<br>(Building-10) | The building engineer is required to prepare a design report considering BNBC (part-6, Section-1.9.1). | within 6 weeks |
| | Carry out suggested remedial works if required. | within 6 months |

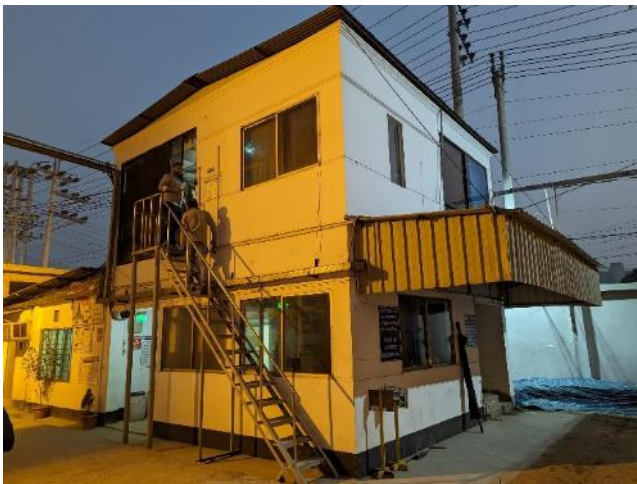
**Observation-20:** Lack of as-built structural drawings (Building-11 & 13).

**Description:** During the inspection, no as-built drawings were available for Building-11 & 13. The building engineer is required to survey the full structure and produce accurate as-built drawings.

| Lack of as-built structural drawings<br>(Building-11 & 13). | The building engineer is required to survey the full structure and produce accurate as-built drawings. | within 6 weeks |

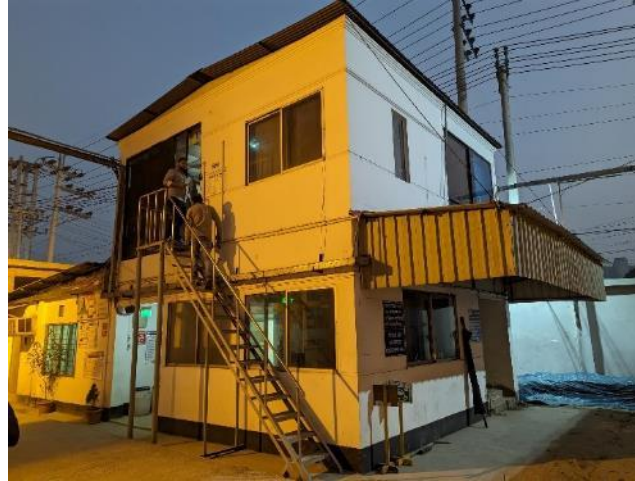
(Building-11)

**Observation-21: Absence of design documents (Building 11)**

**Description:** As per BNBC, every building or structure designed shall have its design documents prepared following the provision of Section 1.9.1. The design document shall include a design report, and a set of structural drawings, which shall be prepared in compliance with section 1.9.1.1 and section 1.9.1.2 as per BNBC. At the time of inspection, a design report was not available which is required to be prepared in compliance with BNBC.

| Absence of design documents.<br>(Building 11) | Building is required to prepare a set of design reports in compliance with BNBC. | within 6 weeks |
| | Implement remediation work if required. | within 6 months |

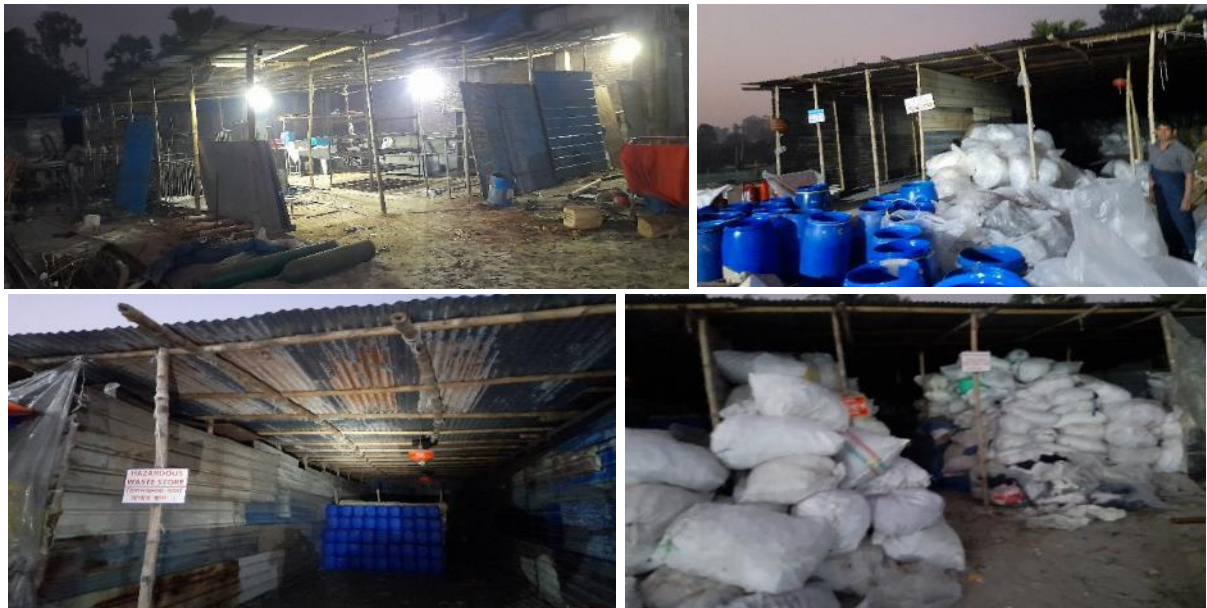
**Observation-22: Apparently non-engineered structure (Building-12).**

Bamboo Supported Tin Shed

**Description:** During the inspection, apparently non-engineered roof and supporting member were observed. The building engineer to provide necessary alternatives to make the structure stable. Otherwise, replace with an engineered one.

| Apparently non-engineered structure<br>(Building-12) | The building engineer to provide necessary alternatives to make the structure stable. Otherwise, replace with an engineered one. | within 6 months |

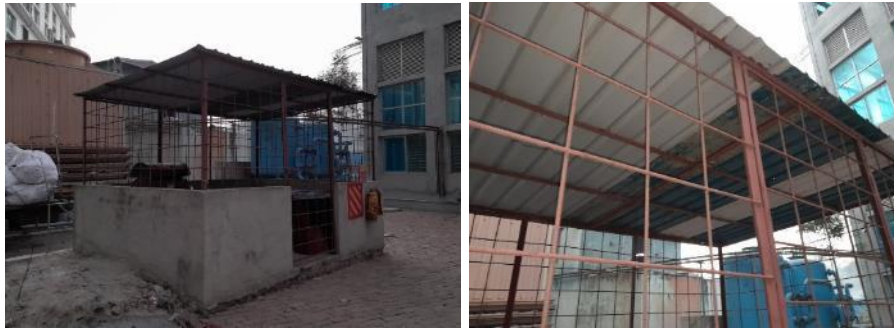
**Observation-23:** Apparently non-engineered structure (Building-14).

**Description:** During the inspection, apparently non-engineered roof framing, connections and inadequate member sizes were observed. The building engineer to provide necessary alternatives to make the structure stable. Otherwise, replace with an engineered one.

| Apparently non-engineered structure<br>(Building-14) | The building engineer to provide necessary alternatives to make the structure stable. Otherwise, replace with an engineered one. | within 6 months |

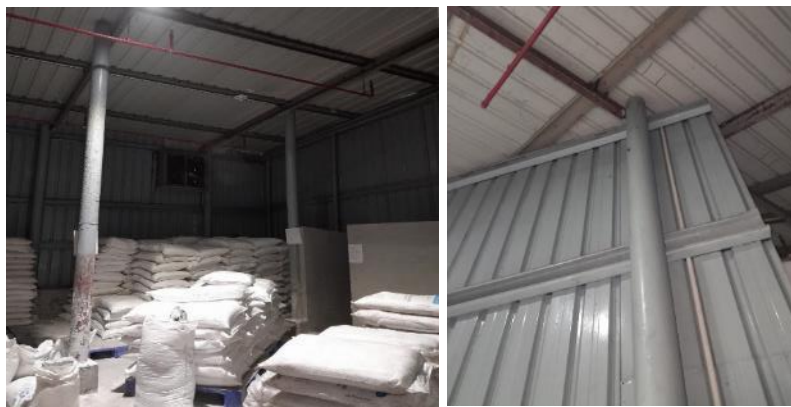
**Observation-24:** Apparently non-engineered structure (Building-15).

**Description:** During the inspection, apparently non-engineered roof framing and connections were observed. The building engineer to provide necessary alternatives to make the structure stable. Otherwise, replace with an engineered one.

| Apparently non-engineered structure<br>(Building-15) | The building engineer to provide necessary alternatives to make the structure stable. Otherwise, replace with an engineered one. | within 6 months |

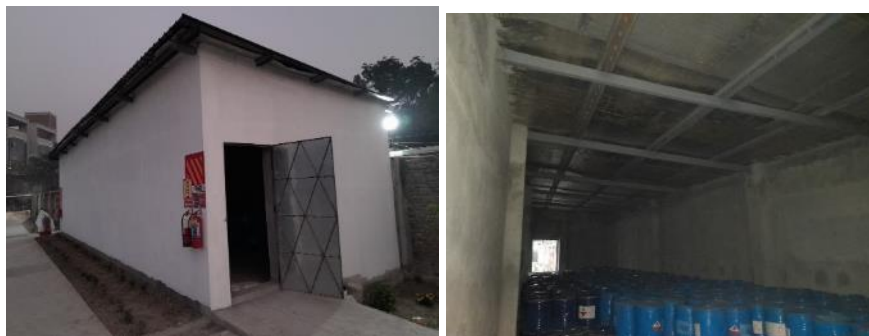
**Observation-25:** Apparently non-engineered structure (Building-16).

**Description:** During the inspection, apparently non-engineered roof framing connections were observed. The building engineer to provide necessary alternatives to make the structure stable. Otherwise, replace with an engineered one.

| Apparently non-engineered structure<br>(Building-16) | The building engineer to provide necessary alternatives to make the structure stable. Otherwise, replace with an engineered one. | within 6 months |
