# INITIAL FIRE SAFETY INSPECTION REPORT

## Chaity Composite Ltd. (Extension 2)

RSC ID: 25497

Date: 22 February 2024

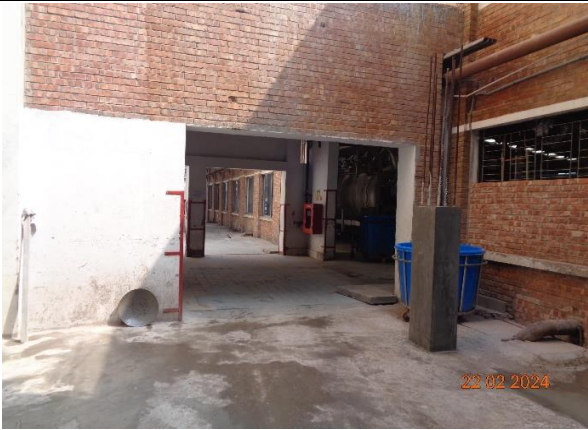
| Sl No. | Category | Findings | Required Action | Remediation Time Frame |
|---|---|---|---|---|
| 1 | Fire Rated Construction | The exit discharge path (Passageway) of the building 01 is not separated by fire-rated construction from the dyeing shed. | Provide minimum 2 hr. fire rated exit discharge path which will lead directly outside. | Within 3 months |

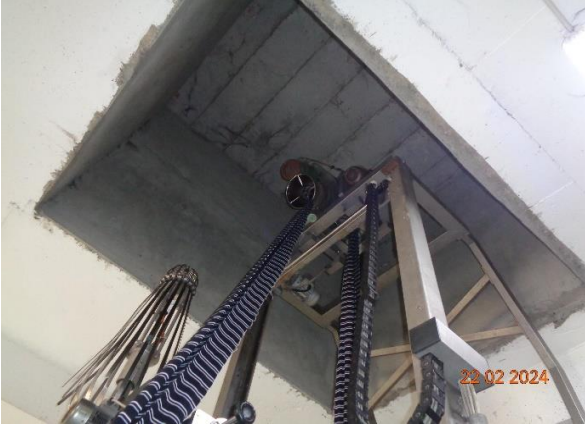
| 2 | Fire Rated Construction | Unsealed penetrations and openings are located in the fire rated floor/ceiling assemblies. Location: Building 01 | Provide a minimum 2-hr fire rated shaft to separate the utility risers from each floor level or seal all penetrations and openings in floors/ceiling assemblies by 3-hr fire rated listed/certified materials. The installation of such fire rated materials shall be following certified design. | Within 3 months |

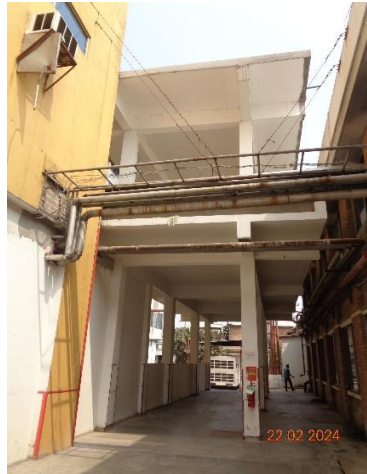
| 3 | Fire Rated Construction | The compressor rooms are not fire separated with fire rated construction barrier or assemblies. Location: Compressor building. | Separate the compressor rooms by a minimum 1-hr fire-rated construction with 0.75-hr fire rated opening protective assemblies like fire rated door. Provide proper ventilation and consult a qualified engineer for overall solution. When located to the exterior of a building by at least 3m (10 ft.) distance from surroundings then fire rated construction barrier is not mandatory. | Within 3 months |

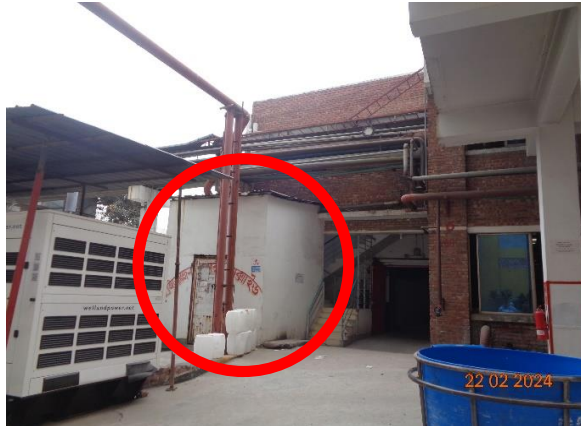
| 4 | Fire Rated Construction | Chemical store room is not properly separated due to unprotected opening & penetrations.<br>Location: Near Building 08 | <p>Separate the chemical storage room by 4-hr fire rated construction. Seal all penetrations and protect the openings to maintain the required fire separations. Keep 16-points MSDS of all chemicals in the storage area.</p> <p><b>** As per BNBC, chemical storage room will be Type-1 construction. Follow section-2.13 and Table 3.2.1 of BNBC-2006 for the guideline</b></p> | Within 3 months |

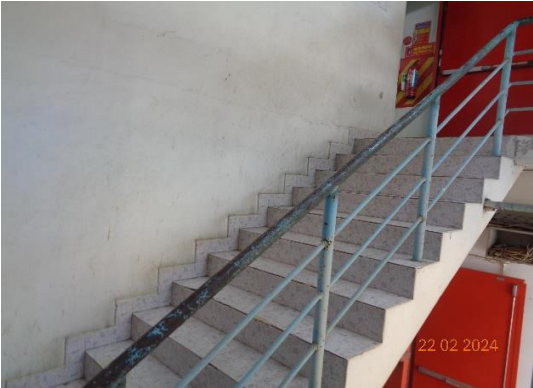
| 7 | Means of egress | Handrails are not provided on both sides of exit stair. Location: Building 08 | Provide handrails on both sides of the exit stair. New handrails shall have a minimum height of 865 mm (34 in.) and a maximum height of 965 mm (38 in.) as measured from the leading edge of the tread. Intermediate handrails shall be provided when the stair width exceeds 2.2 m (87 in.) | Within 3 months |

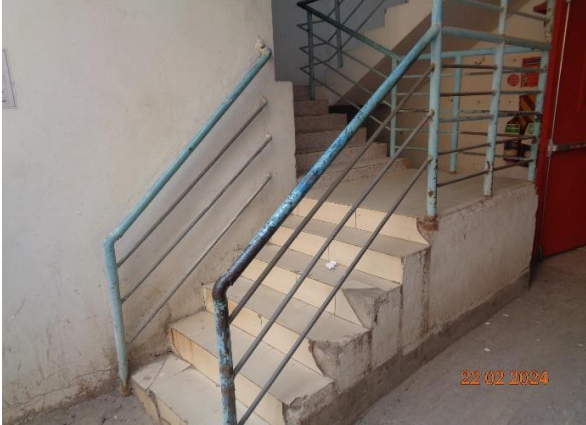
| 8 | Means of egress | The width of the exit stair is less than 1.5 m (60 in.). Location: Building 08 (Training Building) | In new and interim construction and constructed stairs post 24 November 2013, stairs shall have a minimum width of 1.5 m (60 in.) for all industrial occupancies and 2.0 m (79 in.) for all assembly occupancies. For assembly use areas provided for prayer halls, dining halls and like areas that are for integral use by the factory workers, the minimum width for the primary occupancy use of the building shall be permitted to be used. | Within 3 months |

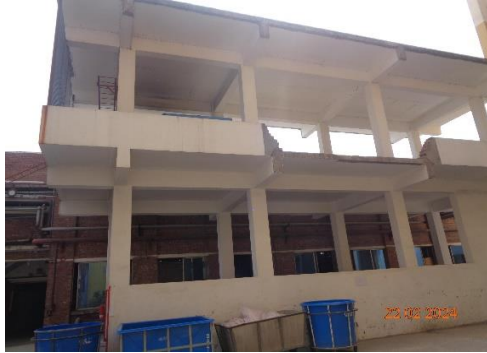
| 10 | Means of egress | There is no means of egress at the two storied compressor building. | <p>The number of means of egress from any floor, story or portion thereof shall not be less than 2 except where a single exit is permitted by RSC Technical Guideline (Standard)-6.6.2, a single means of egress is permitted by RSC Technical Guideline (Standard)-6.6.5 or where a greater number is required by RSC Technical Guideline (Standard)-6.6.3.</p> <p>For Basement/Ground floor:<br/> Maintain maximum 50 occupants having a travel distance of 23m (75 ft).<br/> Or<br/> Provide additional exit.</p> <p>For First Floor:<br/> Maintain maximum 30 occupants having a travel distance of 23m (75 ft) for occupancy F,G &amp; H only.<br/> Or<br/> Provide additional exit.</p> | Within 3 months |

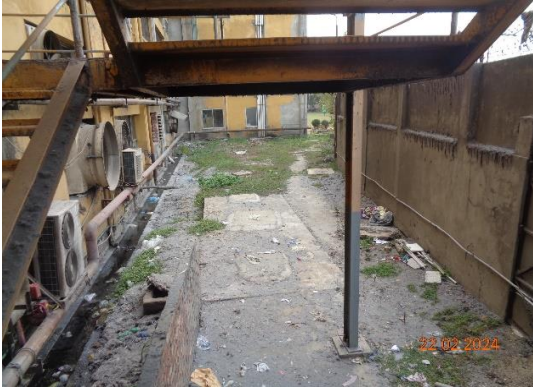
| 11 | Means of Egress | Walking surface were not found level from exit discharge of all stair and are not protected from slip or tripling hazard. Location: Building 1 Stair 06. | Provide an level walking surface in exit discharge in accordance with 6.3.4 of RSC Technical Guidelines (Standard). | Within 3 months |

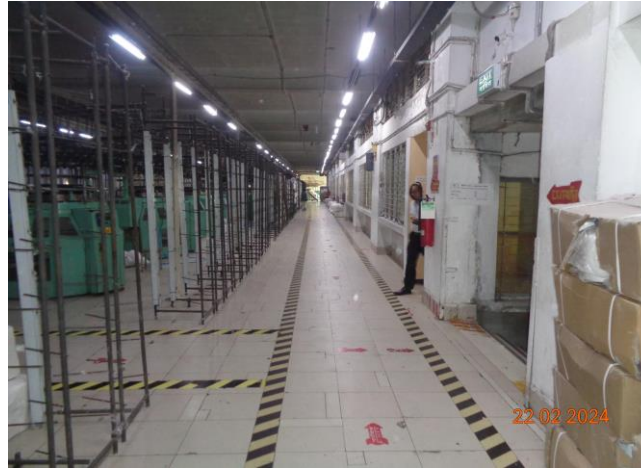
| 12 | Egress Lighting | Directional signs are not provided where direction of the path of travel to an exit has changed. Location: Building 01. | Illuminated directional signs shall be provided where there is a change in the direction for the path of travel and the direction to an exit is not obvious. | Within 1 month |

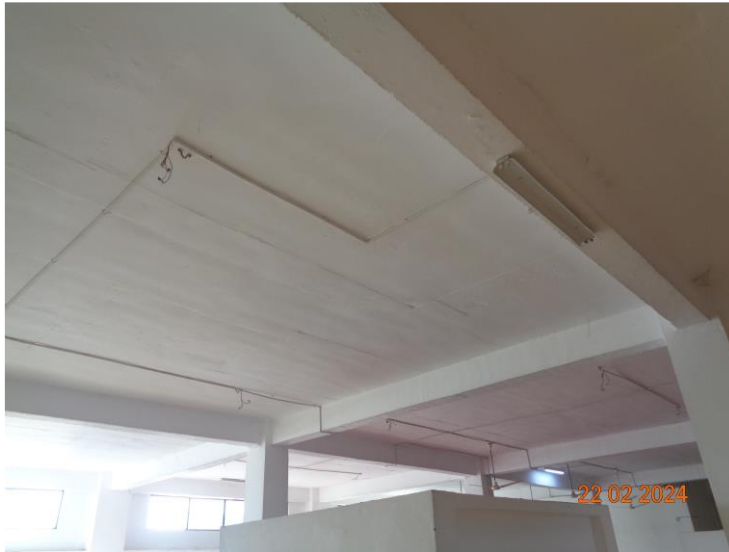
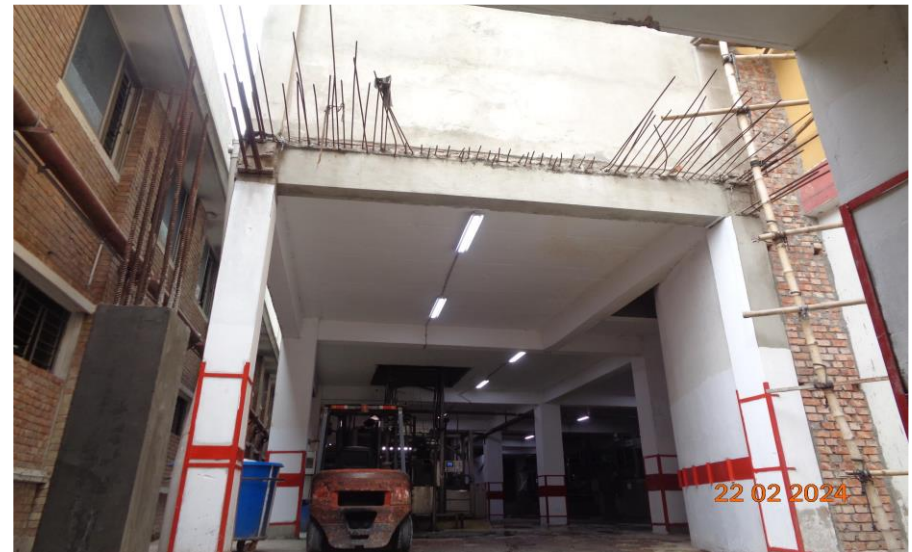
| 16 | Fire Alarm & Detection System (FADS) | Fire detection system installation requires detailed review to confirm compliance with NFPA72 and in accordance with The RSC Technical Guidelines (Standard). | Submit design, drawings and other relevant documentation to the RSC for review. Replace the fire detection system with a new, listed addressable fire detection system in accordance with NFPA 72. | Design within 2 months and installation within 3 months |

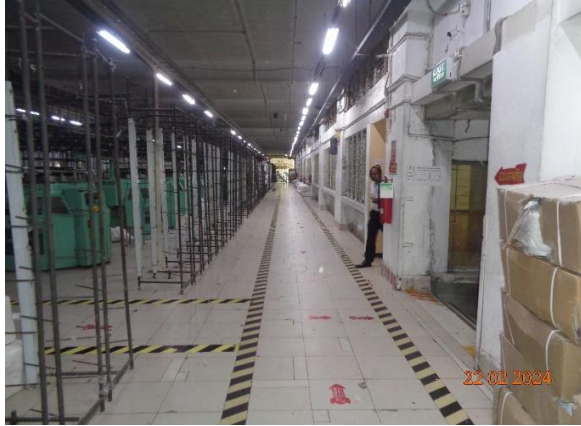
| 18 | Fire Protection System (Sprinkler) | The building is in single fire compartment with the sprinkler required building. Sprinkler system installation requires detailed review to confirm compliance with NFPA 13, 14, 20, 22 and RSC Technical Guideline (Standard). Location: Building 1. | Submit the fire pump, standpipe and sprinkler system drawing to RSC for review. Once reviewed, install or modify the standpipe system throughout the building in accordance with RSC Technical Guideline (Standard) and NFPA 13, 14, 20, 22 and 24. After installation the owner shall contact the RSC for witness of conducting the final acceptance testing of the standpipe system. | Design Review within 2 months and installation within 4 months. |
