# Echotex Ltd. (Extension 2)

Chandra Pollibiddut, Kaliakoir, Gazipur-1751, Bangladesh

11 March 2024

## 2. Observations:

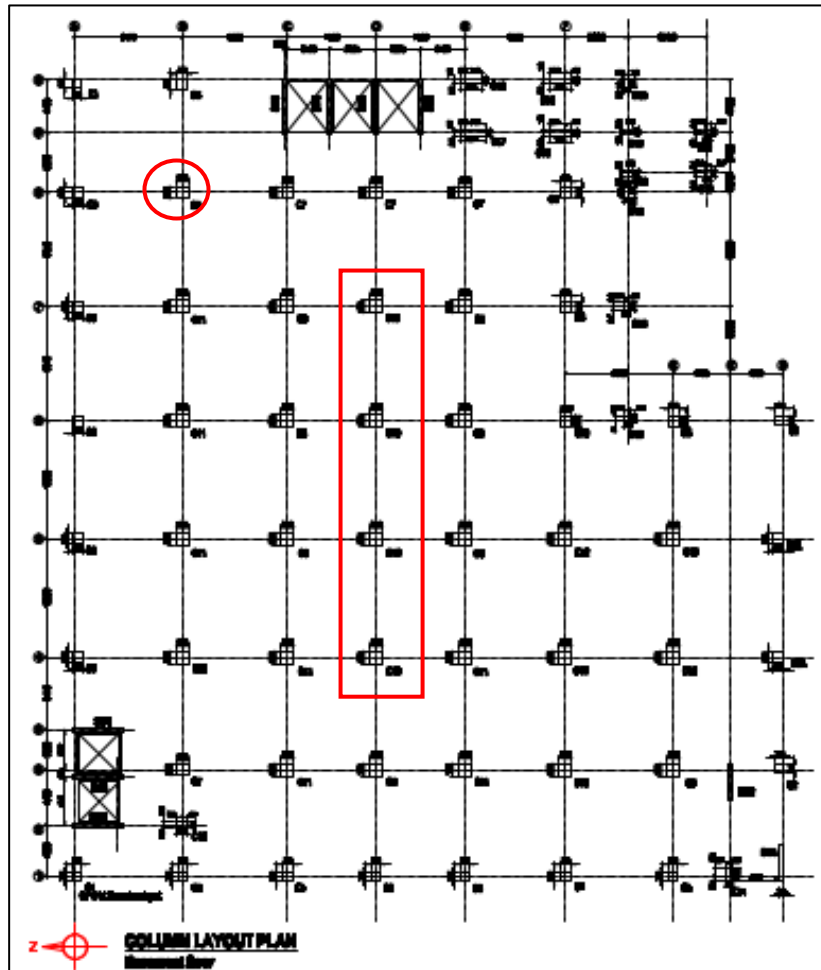
**Observation 1:** Cursory calculation indicates the columns are marginally overstressed (Multi-Purpose Building- 2).

Overstressed columns

**Description:** The cursory calculation indicates that marked columns are stressed above the normal design limit considering floor live load 4kPa for the typical floors and 6kPa for storage floors. We have considered minimum concrete strength (16.3 MPa) based on aggregate type and rebar strength 415 MPa.

The building engineer is required to review the design, load, and column stresses based on-situ material strength and produce an EA report as per BNBC 2020.

| Observation | Action Plan | Timeline |
|---|---|---|
| Cursory calculation indicates the columns are marginally overstressed (Multi-Purpose Building- 2) | Verify in situ concrete strength (100mm dia. cores from 4 columns) from the lower tier of the building. | within 6 weeks |
| | The building engineer is required to review the design, load, and column stresses based on-situ material strength and produce an EA report as per BNBC 2020. | within 6 weeks |
| | Produce and actively manage a loading plan for all floor plates within the factory considering floor capacity and column capacity. | within 6 weeks |
| | Carry out remedial work where required. | within 6 months |

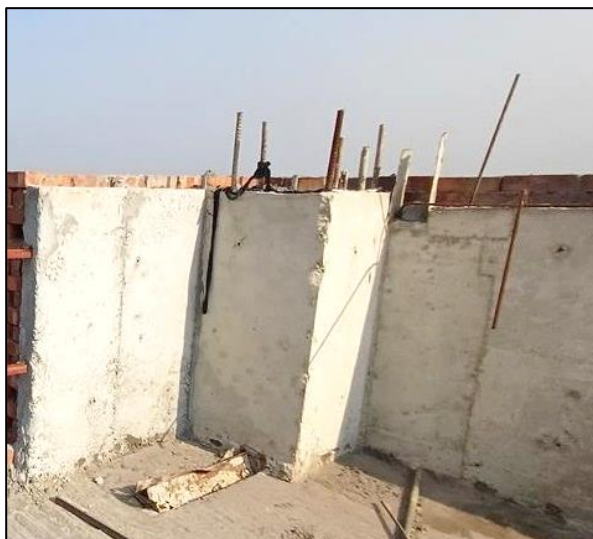
**Observation 2:** Exposed rebar of columns at the roof (Multi-Purpose Building- 2)

Exposed Rebar

**Description:** Exposed rebar was found on the roof. Factory is required to apply rust-proof paint on exposed rebar.

| Observation | Action Plan | Timeline |
|---|---|---|
| Exposed rebar of columns at the roof (Multi-Purpose Building- 2) | Building engineer is required to apply rust-proof paint on exposed rebar. | within 6 weeks |

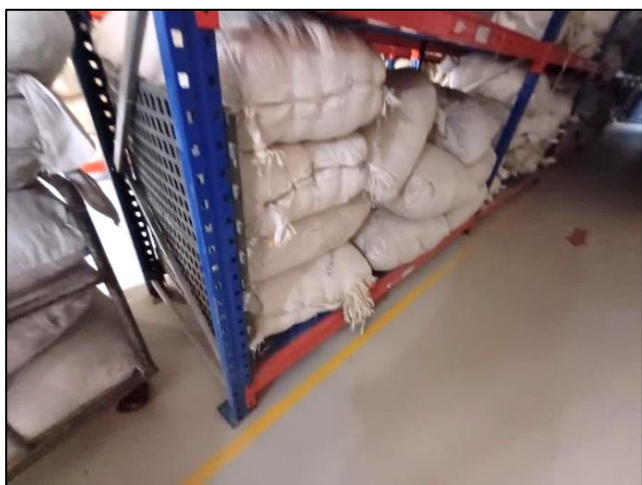
Steel Storage Rack – Not Anchored

**Description:** Steel storage rack on several floor and plastic water tanks at roof were found non-anchored/unbraced. Factory is required to anchor or brace all non-structural elements (rack, plastic water tank etc.).

| Observation | Action Plan | Timeline |
|---|---|---|
| Non-structural elements found unbraced or non-anchored (Multi-Purpose Building- 2) | Building engineer is required to anchor or brace all non-structural elements (rack, plastic water tank etc.). | within 6 weeks |

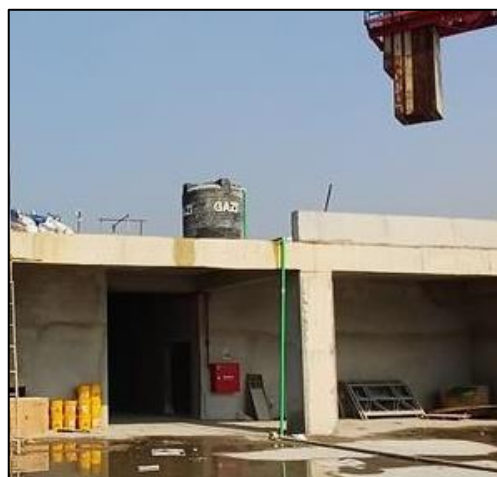
Plastic Water Tank – Not Braced

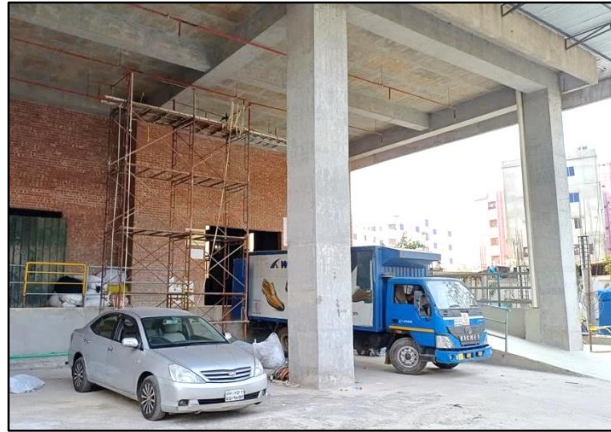
**Observation-4:** Column susceptible to vehicle impact (Multi-Purpose Building- 2).

**Description:** Column at ground floor loading/unloading area was found susceptible to vehicle impact. Building engineer is required to provide barriers around the column to prevent vehicle impact.

| Observation | Action Plan | Timeline |
|---|---|---|
| Column susceptible to vehicle impact (Multi-Purpose Building- 2) | Building engineer is required to provide barriers around the column to prevent vehicle impact. | within 6 weeks |

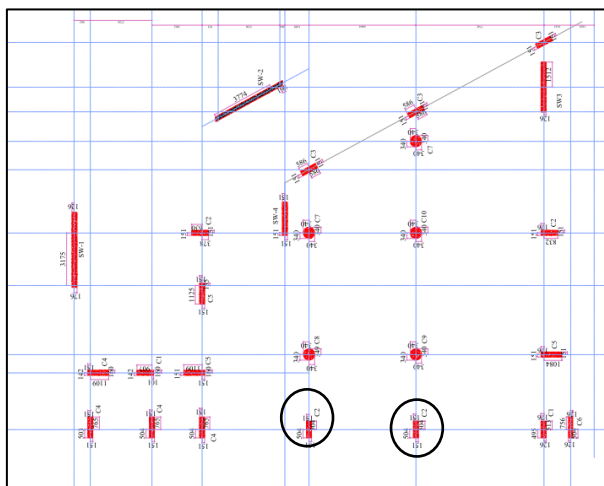
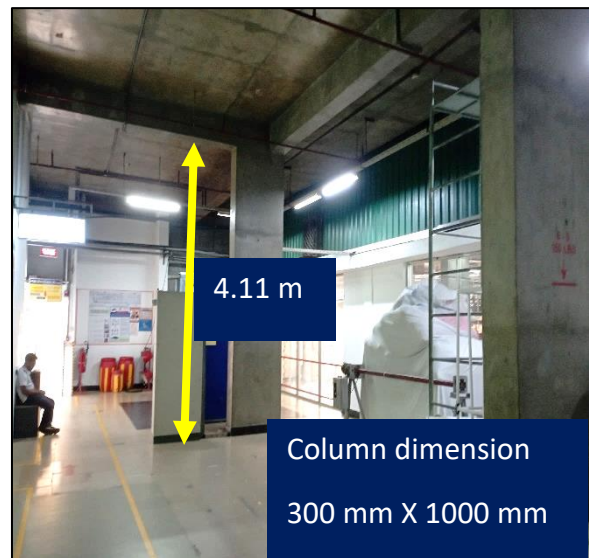
Column layout

**Observation-5:** Column appears to be slender (Office Building).

**Description:** Cursors calculation shows that slenderness in highlighted columns exceeds the normal design limit due to long unsupported lengths. The building engineer is required to carry out an adequacy check of the highlighted columns considering the slenderness effect.

| Observation | Action Plan | Timeline |
|---|---|---|
| Column appears to be slender (Office Building). | The building engineer is required to carry out an adequacy check of the highlighted columns considering the slenderness effect. | within 6 weeks |
| | Implement remediation work if required. | within 6 months |

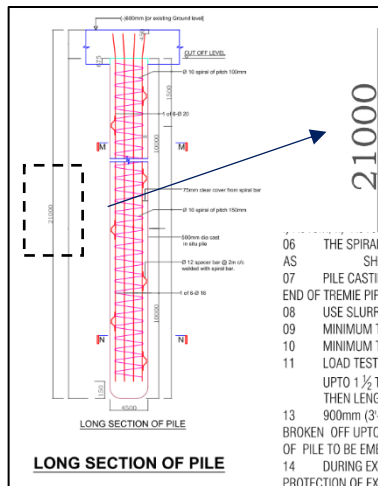
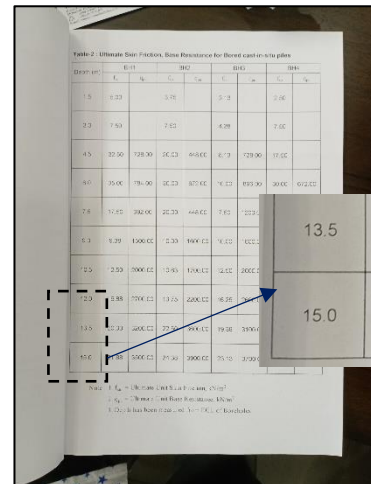
**Observation-6:** Lack of geotechnical data (Office Building).

**Description:** As per the provided drawing, the length of the pile is 21 m, but pile capacity is provided up to 15 m only in the soil test report. A geotechnical engineer is required to investigate this issue and prepare a new soil test report up to 21 m in length.

| Observation | Action Plan | Timeline |
|---|---|---|
| Lack of geotechnical data (Office Building). | A geotechnical engineer is required to investigate this issue and prepare a new soil test report up to 21 m in length. | within 6 weeks |

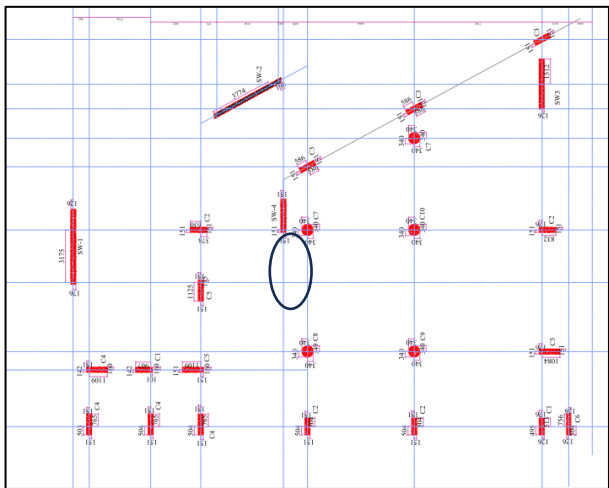
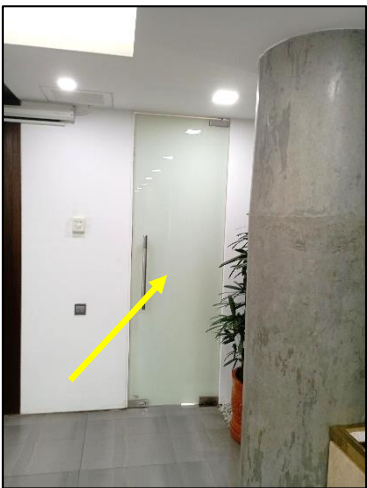
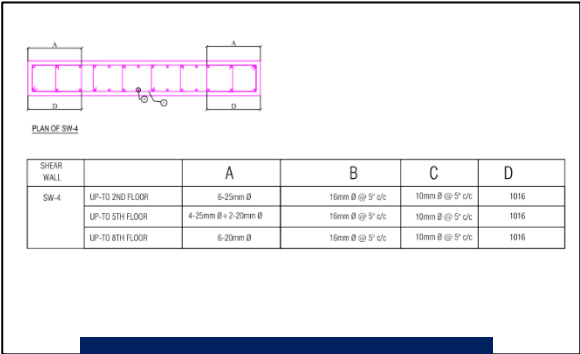
**Observation-8:** Discrepancy and missing information in as-built drawing (Office Building).

Details of shear wall is not provided in drawing.

**Description:** Shear wall at marked location was not found at top floor. No details of shear wall is provided in structural drawing. The depth of beam was measured 600 mm instead of 675mm. Toilet arrangement was not found as per as-built drawing. The building engineer is required to update the as-built drawing.

| Observation | Action Plan | Timeline |
|---|---|---|
| Discrepancy and missing information in as-built drawing (Office Building). | The building engineer is required to update the as-built drawing. | within 6 weeks |

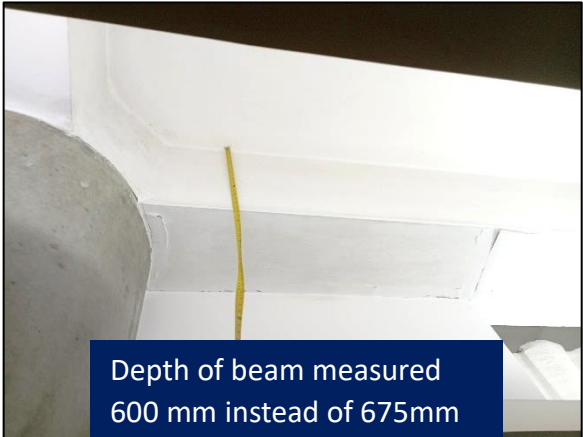
Depth of beam measured 600 mm instead of 675mm

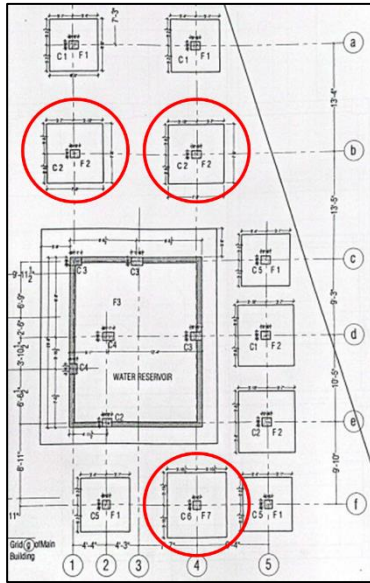
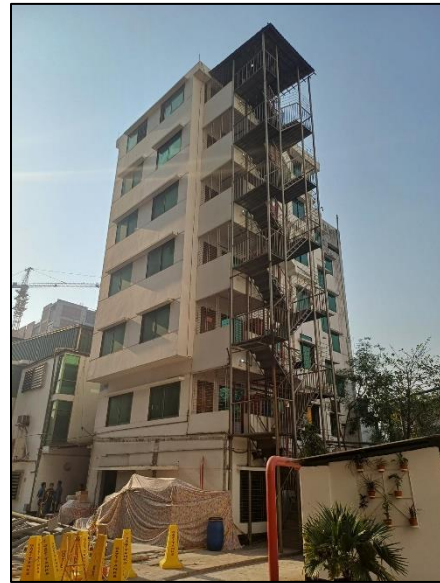
Old Utility Building

**Observation 9:** Cursory calculation indicates the columns and foundations are marginally overstressed (Old Utility Building)

Overstressed columns and footings

**Description:** The cursory calculation indicates that marked columns and foundations are stressed above the normal design limit considering floor live load 2kPa for the typical floors. We have considered minimum concrete strength (14.1 MPa) based on aggregate type and rebar strength 275 MPa.

The foundations are marginally overstressed for punching shear and not checked for bearing as no soil investigation report was available. The building engineer is required to review the design, load, and column-foundation stresses based on-situ material strength at the marked locations.

| Observation | Action Plan | Timeline |
|---|---|---|
| Cursory calculation indicates the columns and foundations are marginally overstressed (Old Utility Building) | The building engineer is required to take minimum 4 number of concrete cores from columns and foundations each to verify in-situ strength of concrete. | within 6 weeks |
| | The building engineer is required to review the design, load, and column-foundation stresses based on-situ material strength. Submit the Detailed Engineering Assessment (DEA) report to the RSC for further review. | within 6 weeks |
| | Produce and actively manage load management plans. | within 6 months |
| | Carry out remedial work where required. | within 6 months |

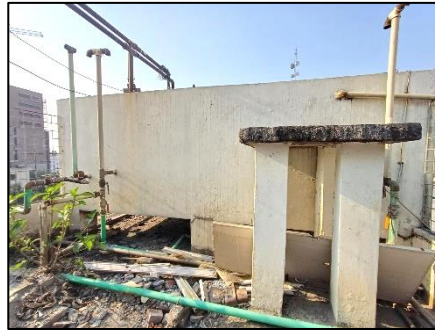
Overhead water tank at roof

**Description:** During the inspection, the mismatch was found in the as-built drawings of the Old Utility building. On the roof, an overhead water tank and a PVC water tank (3000L) were found not mentioned in the drawing. The structural drawing of OHWT was found missing. Floor build-up and false slab are not mentioned in the drawing. The rooftop of the marked portion is a steel shed. No structural details were found for the steel portion. There is a steel stair with the building. No drawing was available for the stairs. There is a discontinuous beam at the rooftop. No rooftop beam layout/structural details were provided. The building engineer is required to survey the structure, prepare accurate as-built drawings, and submit to the RSC.

| Observation | Action Plan | Timeline |
|---|---|---|
| Inconsistencies in the as-built drawing (Old Utility Building) | The building engineer is required to survey the structure, prepare accurate as-built drawings, and submit to the RSC. | within 6 weeks |

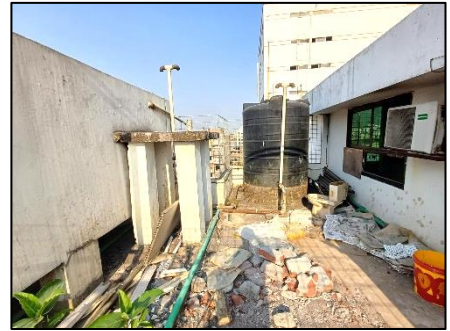
PVC water tank at the roof

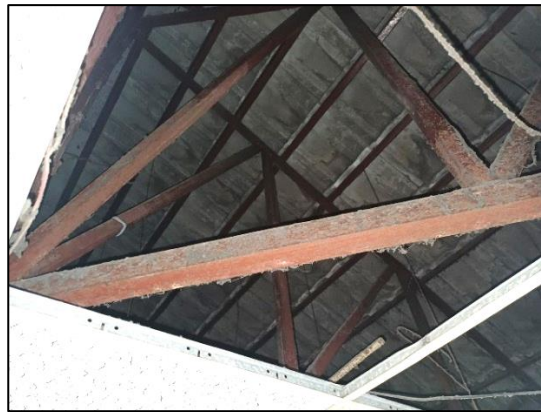
Steel roof top shed

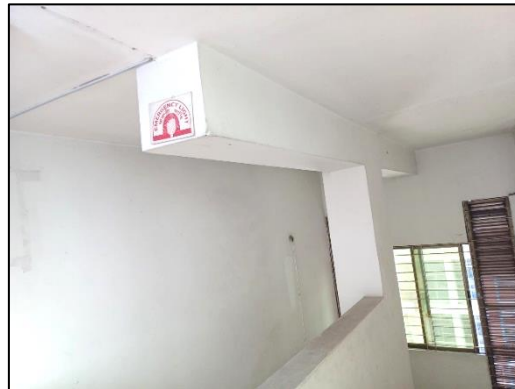
Discontinuous rooftop beam

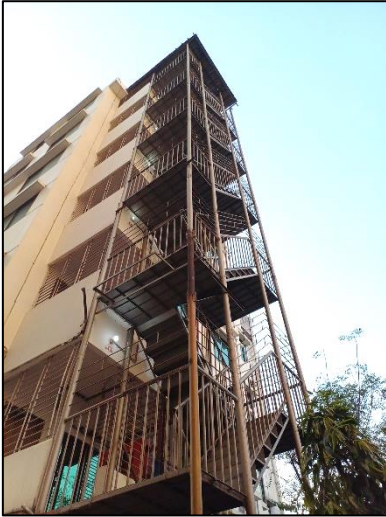
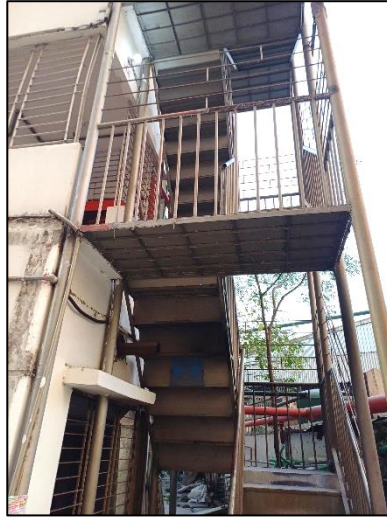
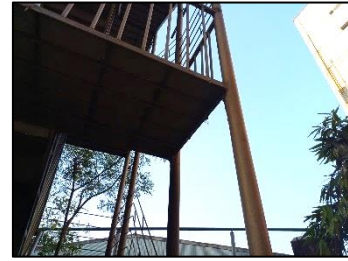
**Observation 11:** Apparently non-engineered steel stairs (Old Utility Building)

**Description:** During the inspection, apparently non-engineered steel stair was found. The members are apparently inadequate, lack of lateral stability and improper steel connections were observed. The foundation of the structure is also not clear. The building engineer is required to check the lateral stability of the structure, prepare an Engineering Assessment (EA) and submit it to the RSC for review.

| Observation | Action Plan | Timeline |
|---|---|---|
| Apparently non-engineered steel stairs (Old Utility Building) | The building engineer is required to check the lateral stability of the structure, prepare an Engineering Assessment (EA) and submit it to the RSC for review. | within 6 weeks |
| | Carry out remedial work where required. | within 6 months |

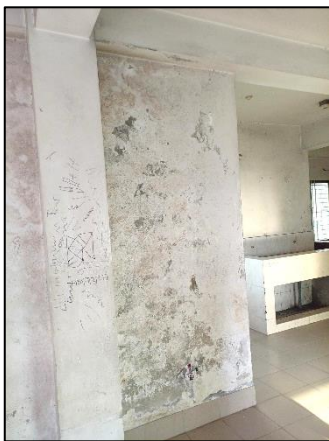
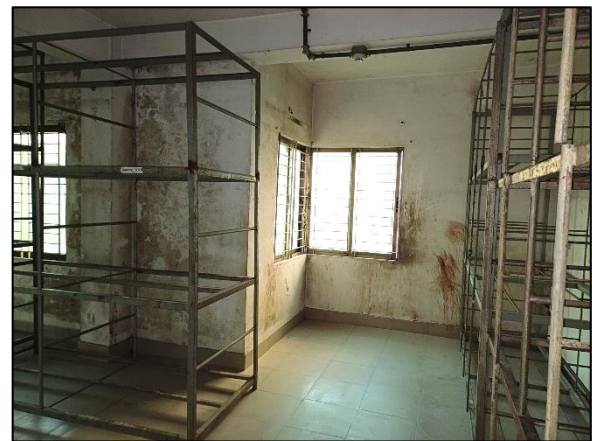
**Observation 12:** Dampness found in the masonry walls (Old Utility Building)

**Description:** During the inspection, dampness was found in the masonry walls. The building engineer is required to repair the walls in a suitable method.

| Observation | Action Plan | Timeline |
|---|---|---|
| Dampness found in the masonry walls (Old Utility Building) | The building engineer is required to repair the walls in a suitable method. | within 6 weeks |

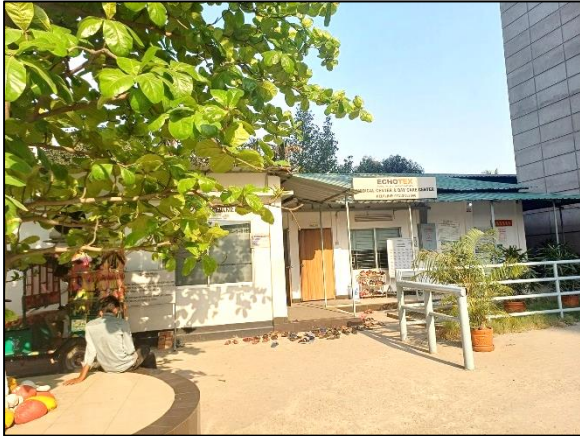
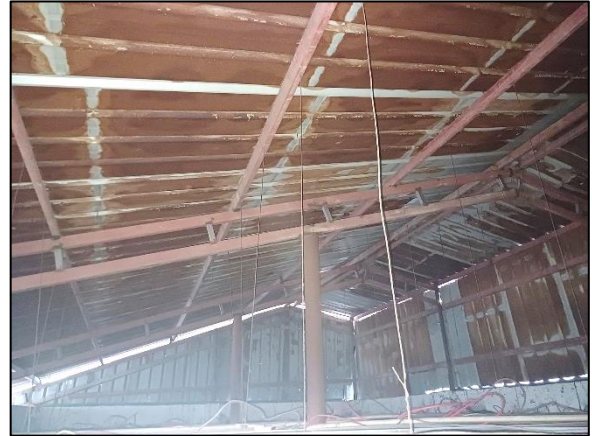
Medical & Childcare Shed

**Observation 13:** Lack of design documents (Medical & Childcare Shed)

**Description:** As per BNBC, every building or structure designed shall have its design documents prepared following the provision of Section 1.9.1. The design document shall include a design report, a set of as-built drawings and load plans which shall be prepared in compliance with section 1.9.1.1 and section 1.9.1.2, part-6 of BNBC.

| Observation | Action Plan | Timeline |
|---|---|---|
| Lack of design documents (Medical & Childcare Shed) | The building engineer is required to prepare a set of design documents in compliance with section 1.9.1, part-6 of BNBC. | within 6 weeks |
| | Carry out remedial work where required. | within 6 months |

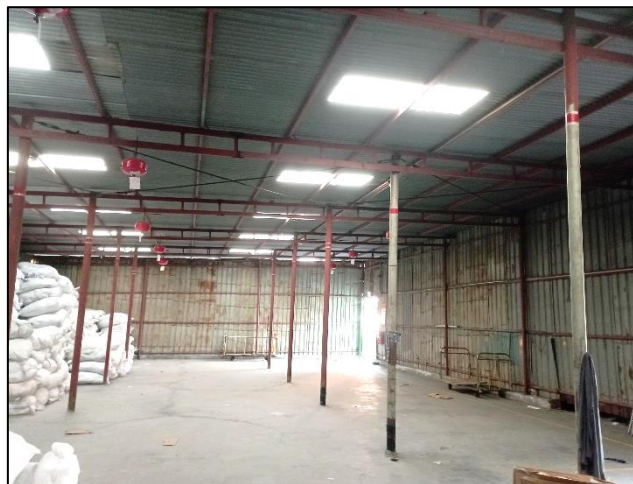
**Observation-14:** Lack of lateral stability (Wastage Shed).

**Description:** No load transfer media/vertical bracing is provided for the structure. The building engineer is required to check the lateral stability of the structure and propose a remediation plan.

| Observation | Action Plan | Timeline |
|---|---|---|
| Lack of lateral stability (Wastage Shed). | The building engineer is required to check the lateral stability of the structure and propose a remediation plan. | within 6 weeks |
| | Carry out remedial work if required. | within 6 months |

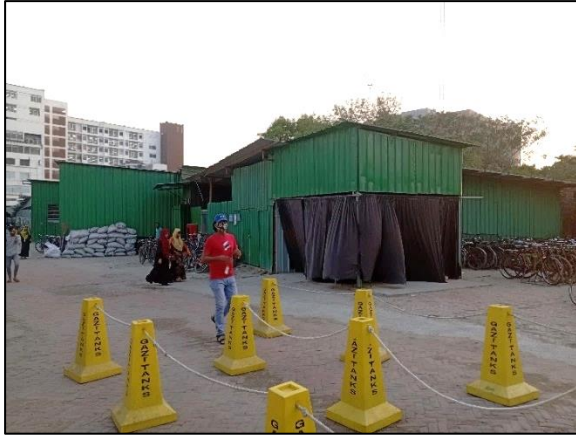
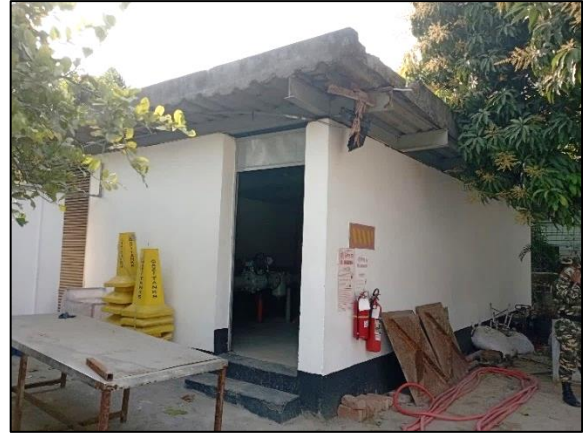
**Observation-15: Lack of as-built drawing (Wastage Shed, RMS Room)**

**Description:** As-built drawing was not available for these structures. The building engineer is required to produce as-built drawings for the structures.

| Observation | Action Plan | Timeline |
|---|---|---|
| Lack of as-built drawing (Wastage Shed, RMS Room) | The building engineer is required to produce as-built drawings for the structures. | within 6 weeks |

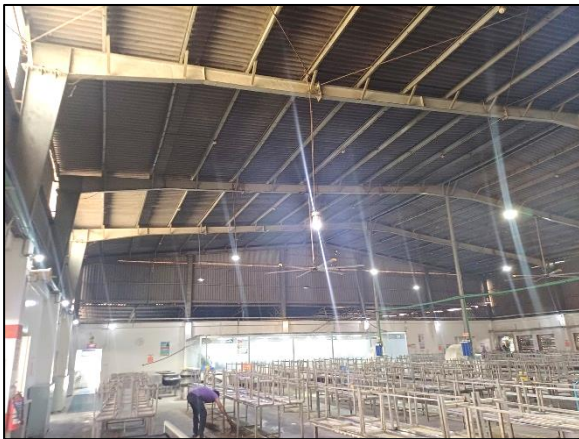
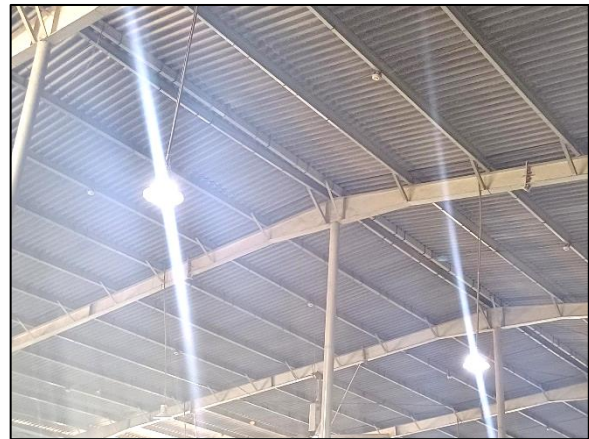
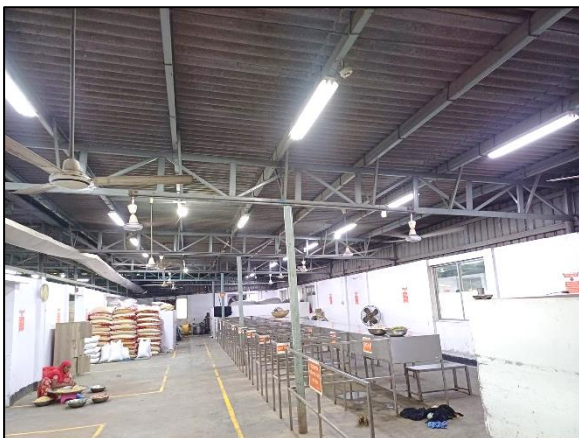
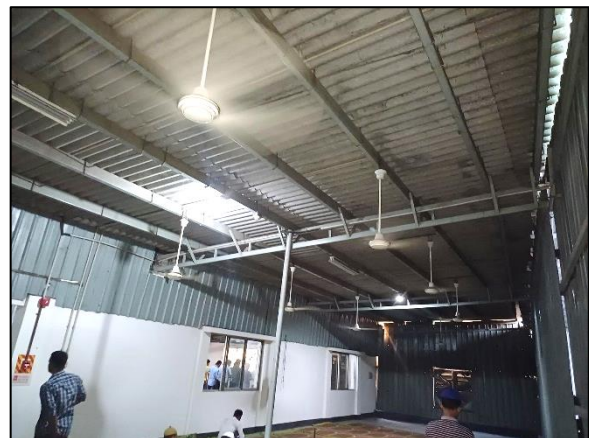
**Observation 16: Lack of lateral stability (Dining Shed)**

**Description:** During the inspection, a lack of lateral stability was found in the Dining Shed. Lateral load transfer media are absent (Compression Strut) along the transverse direction of the rafters. There is no compression strut, vertical and horizontal bracing transverse to the truss members of the shed. The building engineer is required to carry out an Engineering Assessment (EA) to check the lateral stability of the structure and suggest proper remedial actions accordingly. Submit the EA documents to RSC for review.

| Observation | Action Plan | Timeline |
|---|---|---|
| Lack of lateral stability (Dining Shed) | The building engineer is required carry out an Engineering Assessment (EA) to check the lateral stability of the structure and suggest proper remedial actions accordingly. Submit the EA documents to RSC for review. | within 6 weeks |
| | Carry out remedial work where required. | within 6 months |

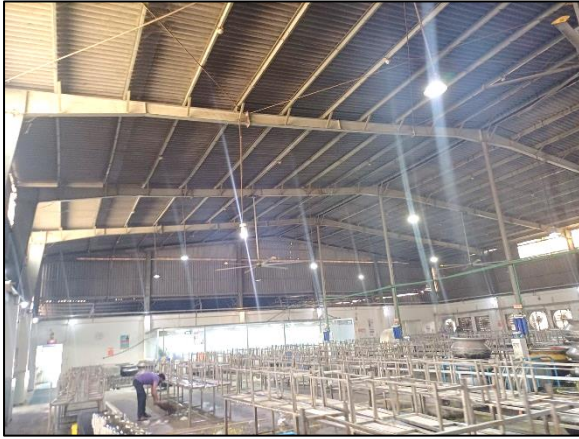
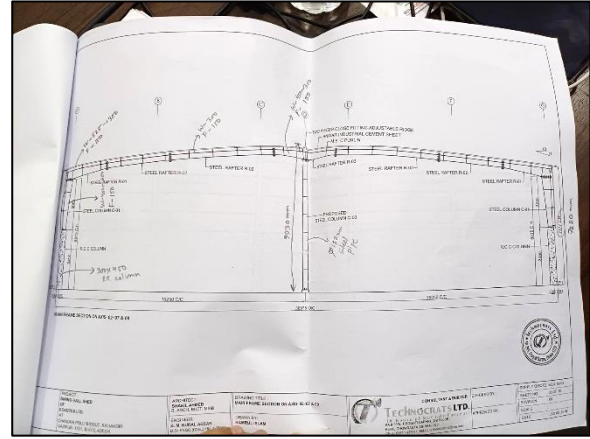
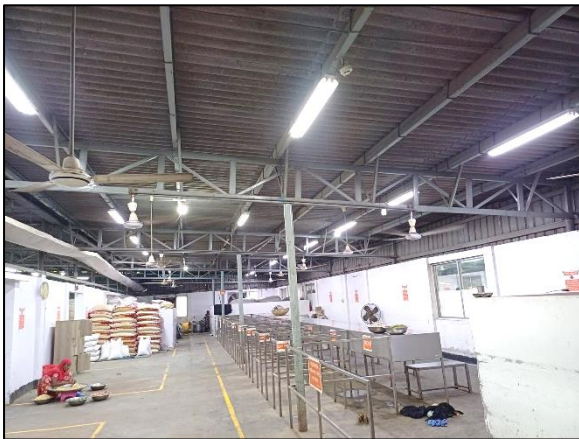
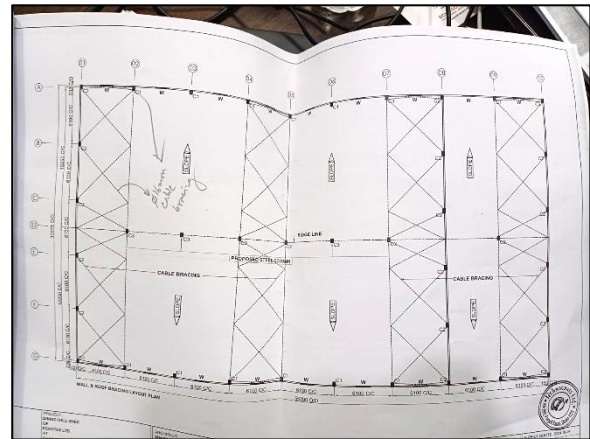
**Observation 17: Lack of information in the as-built drawing. (Dining Shed)**

**Description:** Lack of information was found in the as-built drawings of the Dining Shed. The size of the steel column, rafter, vertical and side wall bracings, RC column and tie beams were found missing in the drawings. Structural details of truss members and supporting steel columns in the dining, prayer and washing sections were not found. There is also the absence of connection details. The building engineer is required to survey the structure, prepare accurate as-built drawings, and submit to the RSC.

| Observation | Action Plan | Timeline |
|---|---|---|
| Lack of information in the as-built drawing. (Dining Shed) | The building engineer is required to survey the structure, prepare accurate as-built drawings, and submit to the RSC. | within 6 weeks |

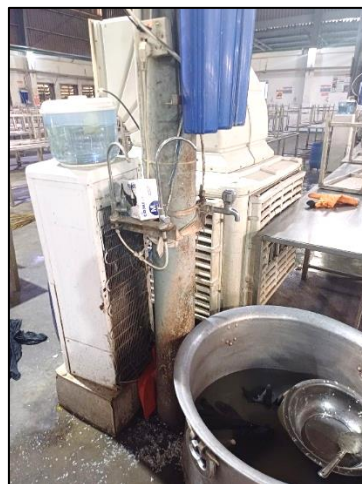
**Observation 18: Corrosion found in the steel sections (Dining Shed)**

**Description:** During the inspection, corrosion was found in the steel section of the Dining Shed. The building engineer is required to remove the rust and apply rust-proof paint.

| Observation | Action Plan | Timeline |
|---|---|---|
| Corrosion found in the steel sections (Dining Shed) | The building engineer is required to remove the rust and apply rust-proof paint. | within 6 weeks |

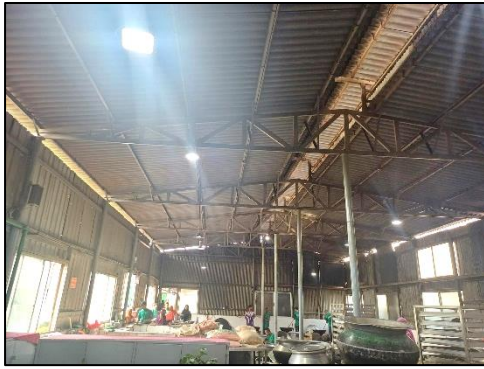
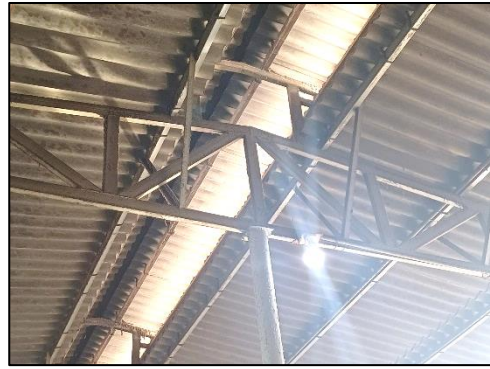
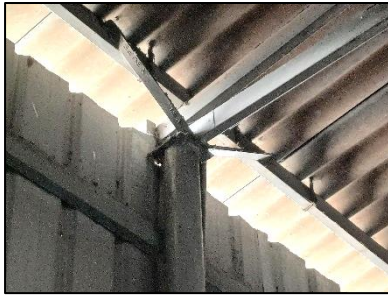
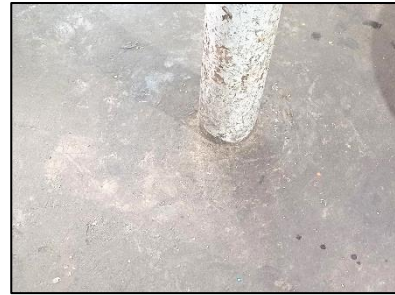
**Observation 19: Lack of lateral stability (Kitchen Shed)**

**Description:** During the inspection, a lack of lateral stability was found in the Kitchen Shed. Lateral load transfer media are absent (Compression Strut, Vertical and Horizontal Bracing) along the transverse direction of the truss. There is an improper steel connection, and the foundation system is also not clear. The building engineer is required to carryout an Engineering Assessment (EA) to check the lateral stability of the structure and suggest proper remedial actions accordingly. Submit the EA documents to RSC for review.

| Observation | Action Plan | Timeline |
|---|---|---|
| Lack of lateral stability (Kitchen Shed) | The building engineer is required to carryout an Engineering Assessment (EA) to check the lateral stability of the structure and suggest proper remedial actions accordingly. Submit the EA documents to RSC for review. | within 6 weeks |
| | Carry out remedial work where required. | within 6 months |

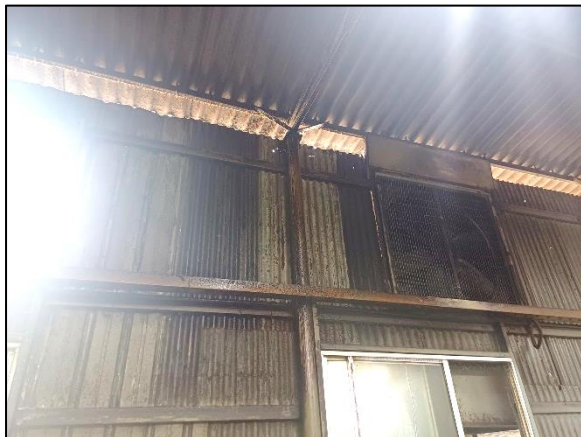
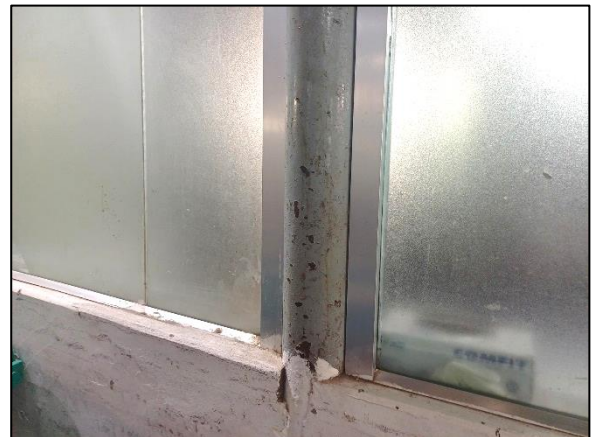
**Observation 20: Corrosion found in the steel sections (Kitchen Shed)**

**Description:** During the inspection, corrosion was found in the steel section of the Kitchen Shed. The building engineer is required to remove the rust and apply rust-proof paint.

| Observation | Action Plan | Timeline |
|---|---|---|
| Corrosion found in the steel sections (Kitchen Shed) | The building engineer is required to remove the rust and apply rust proof paint. | within 6 weeks |

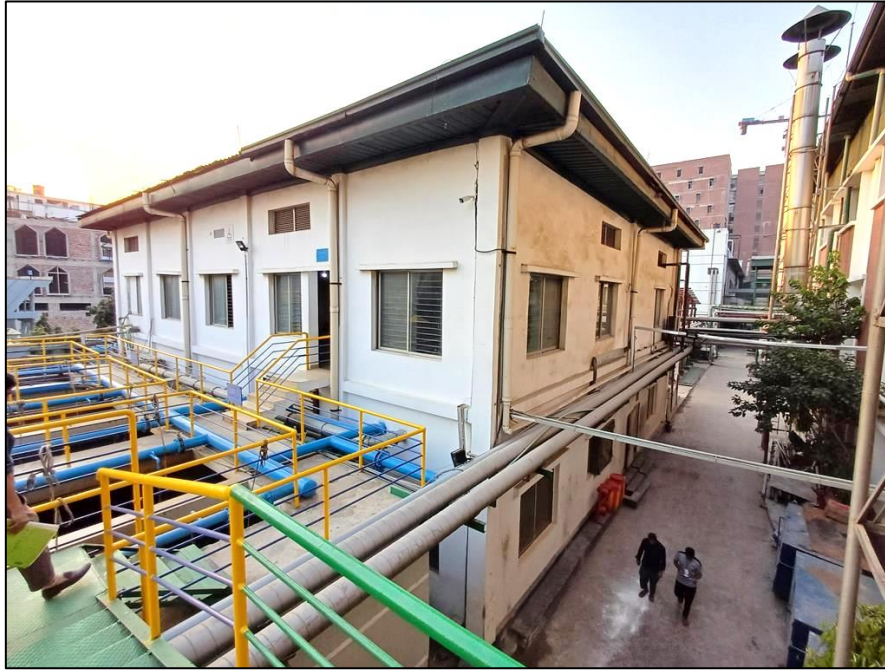
**Observation 21: Lack of design documents (ETP Building)**

**Description:** No design document for the ETP Building was available. The building engineer is required to survey the whole structure and produce a set of as-built drawings along with DEA report.

| Observation | Action Plan | Timeline |
|---|---|---|
| Lack of design documents (ETP Building) | The building engineer is required to prepare a set of design documents in compliance with section 1.9.1, part-6 of BNBC. | within 6 weeks |
| | Carry out remedial work where required. | within 6 months |

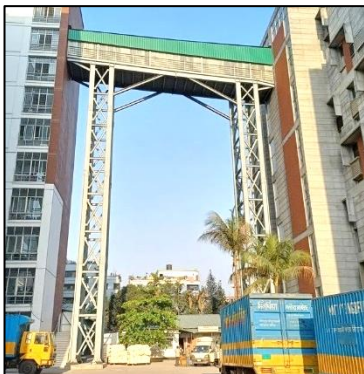
Connecting Bridge 1

**Observation 22: Lack of design documents (Connecting Bridge 1, 2 & 3)**

**Description:** As per BNBC, every building or structure designed shall have its design documents prepared following the provision of Section 1.9.1. The design document shall include a design report, a set of as-built drawings and load plans which shall be prepared in compliance with section 1.9.1.1 and section 1.9.1.2, part-6 of BNBC.

| Observation | Action Plan | Timeline |
|---|---|---|
| Lack of design documents (Connecting Bridge 1, 2 & 3) | The building engineer is required to prepare a set of design documents in compliance with section 1.9.1, part-6 of BNBC. | within 6 weeks |
| | Carry out remedial work where required. | within 6 months |
