# A.K.M. KNIT WEAR LTD. (Extension)

14 No. Genda, Karnopara, Ulail, Savar

24 March 2024

## 1. Building Information

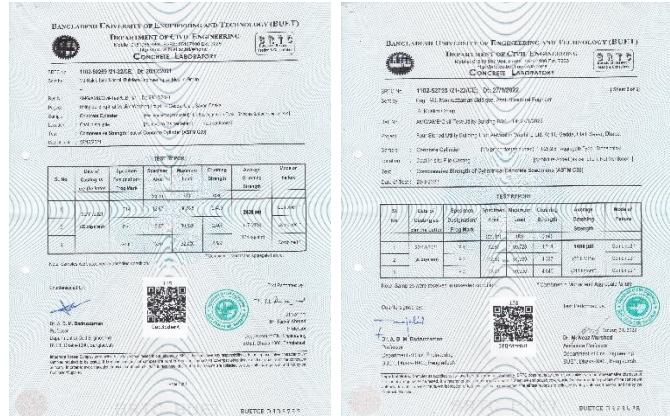
**Observation-1:** The design report required to be revised. (Utility Building II)

**Description:** In the design report, the compressive strength of concrete was considered 4000 psi. The factory has provided only 4 sets of concrete cylinder test reports from the pile, but no cylinder test report was found from the column, beam & slab. Which doesn't comply with the frequency of testing requirement of BNBC (section- 5.12.2).

| SL No. | Observation | Action Plan | Timeline |
|---|---|---|---|
| 01. | The design report required to be revised. (Utility Building II) | The building engineer is required to verify in-situ concrete strength by taking cores from lower-tier columns. Otherwise, consider minimum concrete strength. | within 6 weeks |
| 02. | The design report required to be revised. (Utility Building II) | The building engineer is required to check & confirm the design strength in the design report and submit it to RSC. | within 6 weeks |

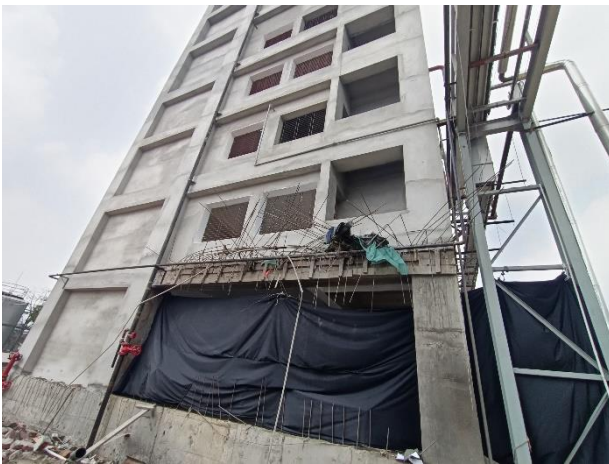
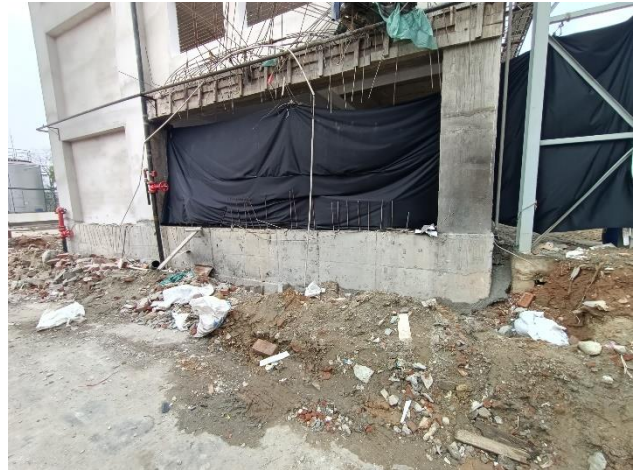
**Observation-3:** Exposed rebar. (Utility Building II)

**Description:** Corrosion was observed on exposed rebars on the 1<sup>st</sup> floor slab. The building engineer is required to provide rust-proof paint on exposed rebars to protect from corrosion.

| SL No. | Observation | Action Plan | Timeline |
|---|---|---|---|
| 05. | Exposed rebar. (Utility Building II) | The building engineer is required to provide rust-proof paint on exposed rebars to protect from corrosion. | within 6 months |

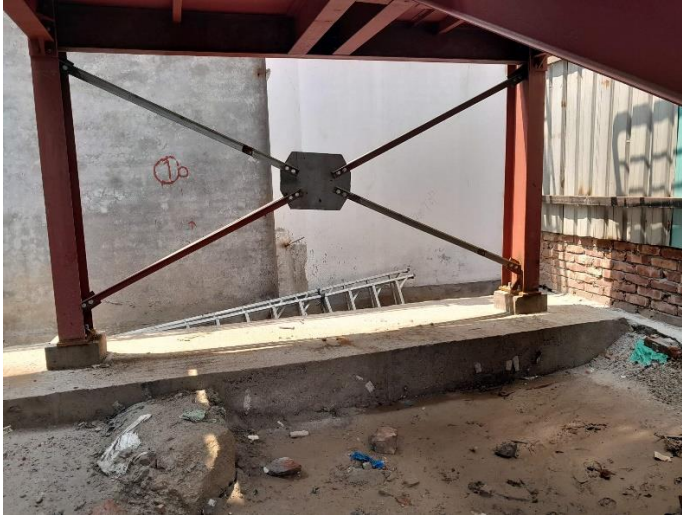
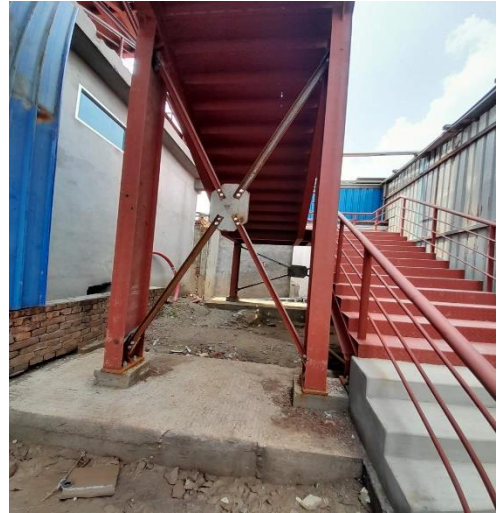
**Observation-3:** Lack of information in the provided drawing. (External Steel Stair, Utility Building II)

**Description:** The steel bracing connection details were not found in the provided drawing. The building engineer is required to prepare as-built drawings mentioning all the connection details.

| SL No. | Observation | Action Plan | Timeline |
|---|---|---|---|
| 06. | Lack of information in the provided drawing. (External Steel Stair, Utility Building II) | The building engineer is required to prepare as-built drawings mentioning all the connection details. | within 6 weeks |

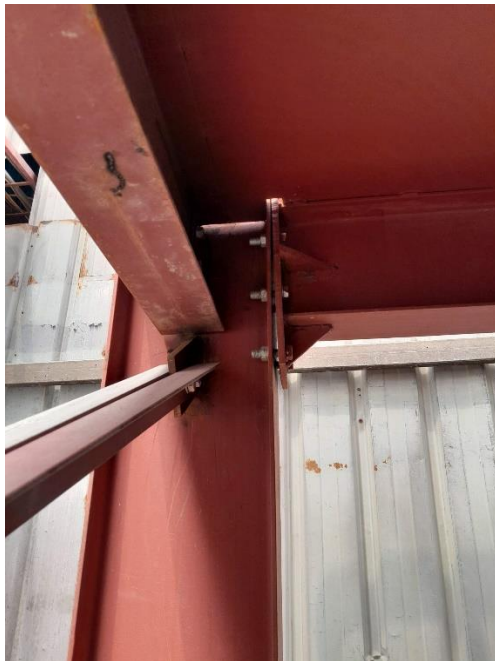
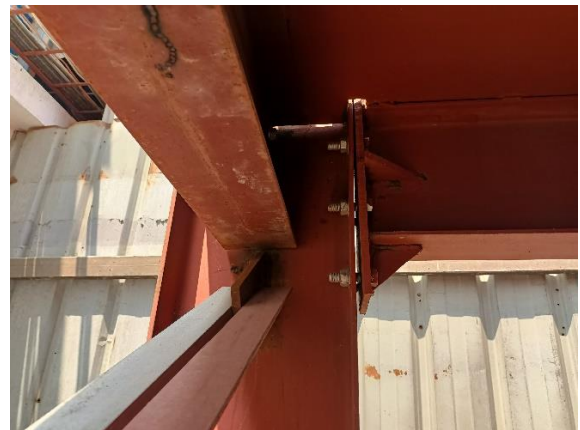
**Observation-4:** Connection Gap. (External Steel Stair, Utility Building II)

**Description:** Connection gaps were observed in the steel beam column joint. The building engineer is required to carry out suitable remedial works.

| SL No. | Observation | Action Plan | Timeline |
|---|---|---|---|
| 07. | Connection Gap. (External Steel Stair, Utility Building II) | The building engineer is required to carry out suitable remedial works. | within 6 weeks |

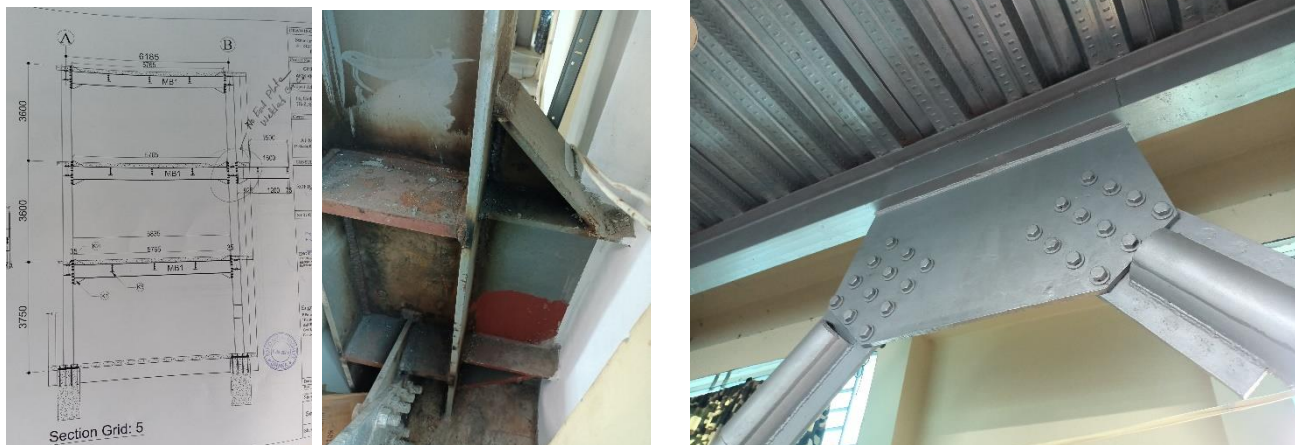
#### Observation-5: Mismatches in as-built drawings. (Childcare Building)

**Description:** The connection between the external steel stair and the steel column of the building was found welded, whereas the drawing shows a bolted connection. Also, the size and thickness of the pipe bracing were missing the as-built drawings. The building engineer is required to prepare as-built drawings reflecting the on-site condition.

| SL No. | Observation | Action Plan | Timeline |
|---|---|---|---|
| 08. | Mismatches in as-built drawings. (Childcare Building) | The building engineer is required to prepare as-built drawings reflecting the on-site condition. | within 6 weeks |

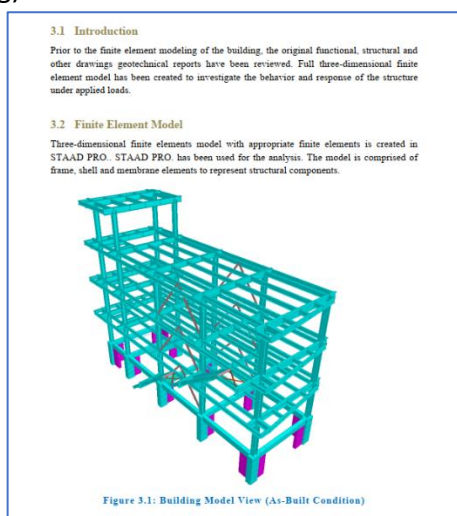
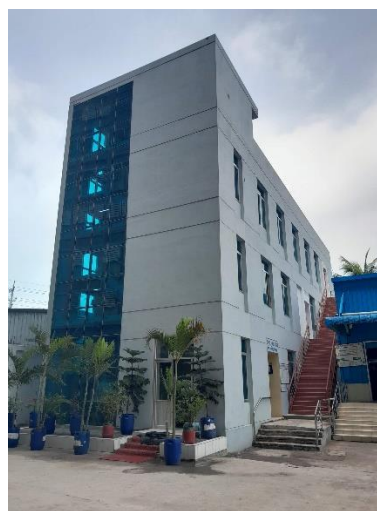
#### Observation-6: The design report required to be reviewed against lateral loading. (Childcare Building)

**Description:** A design report has been prepared for the three-storied (G+2) Childcare Building. The structural design report needs to be reviewed against lateral loading.

| SL No. | Observation | Action Plan | Timeline |
|---|---|---|---|
| 09. | The design report required to be reviewed against lateral loading. (Childcare Building) | Prepared design report to be checked against lateral loads following BNBC 2006 by RSC. | within 6 weeks |
| 10. | The design report required to be reviewed against lateral loading. (Childcare Building) | Carry out remedial works if required. | within 6 months |

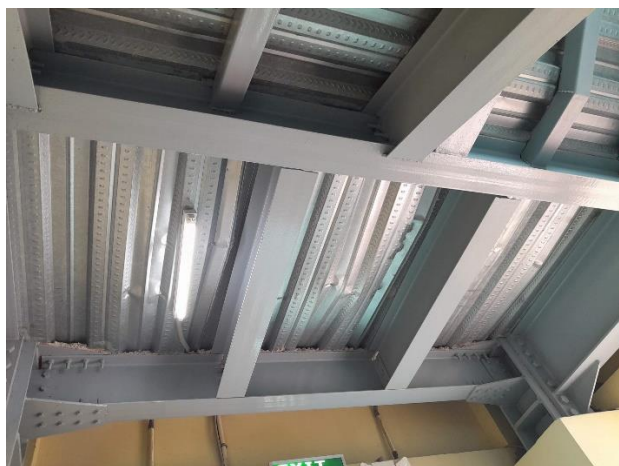
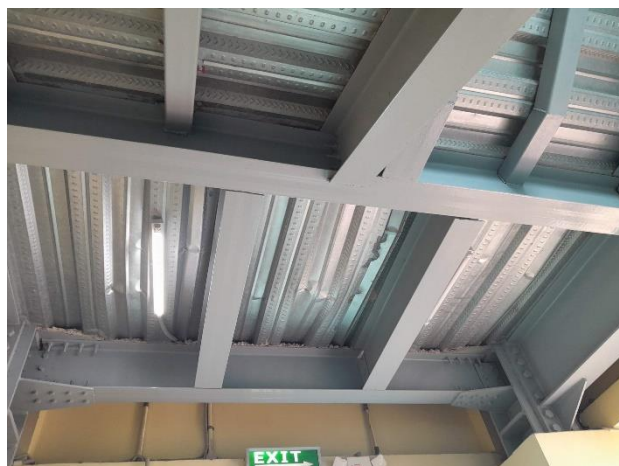
**Observation-7:** Deflected deck slab on the stair. (Childcare Building)

**Description:** The deflected deck slab was found on the stair. The building engineer is required to check the adequacy of the steel deck and suggest proper remedial methods.

| SL No. | Observation | Action Plan | Timeline |
|---|---|---|---|
| 11. | Deflected deck slab on the stair. (Childcare Building) | The building engineer is required to check the adequacy of the steel deck and suggest proper remedial methods. | within 6 weeks |
| 12. | Deflected deck slab on the stair. (Childcare Building) | Carry out remedial works if required. | within 6 months |
