# Valmont Fashions (Extension)

Plot #928-923 Aziz Complex, Vogra, National University, Joydebpur, Gazipur, Dhaka  
(23.827606, 90.261289)

11 March 2024

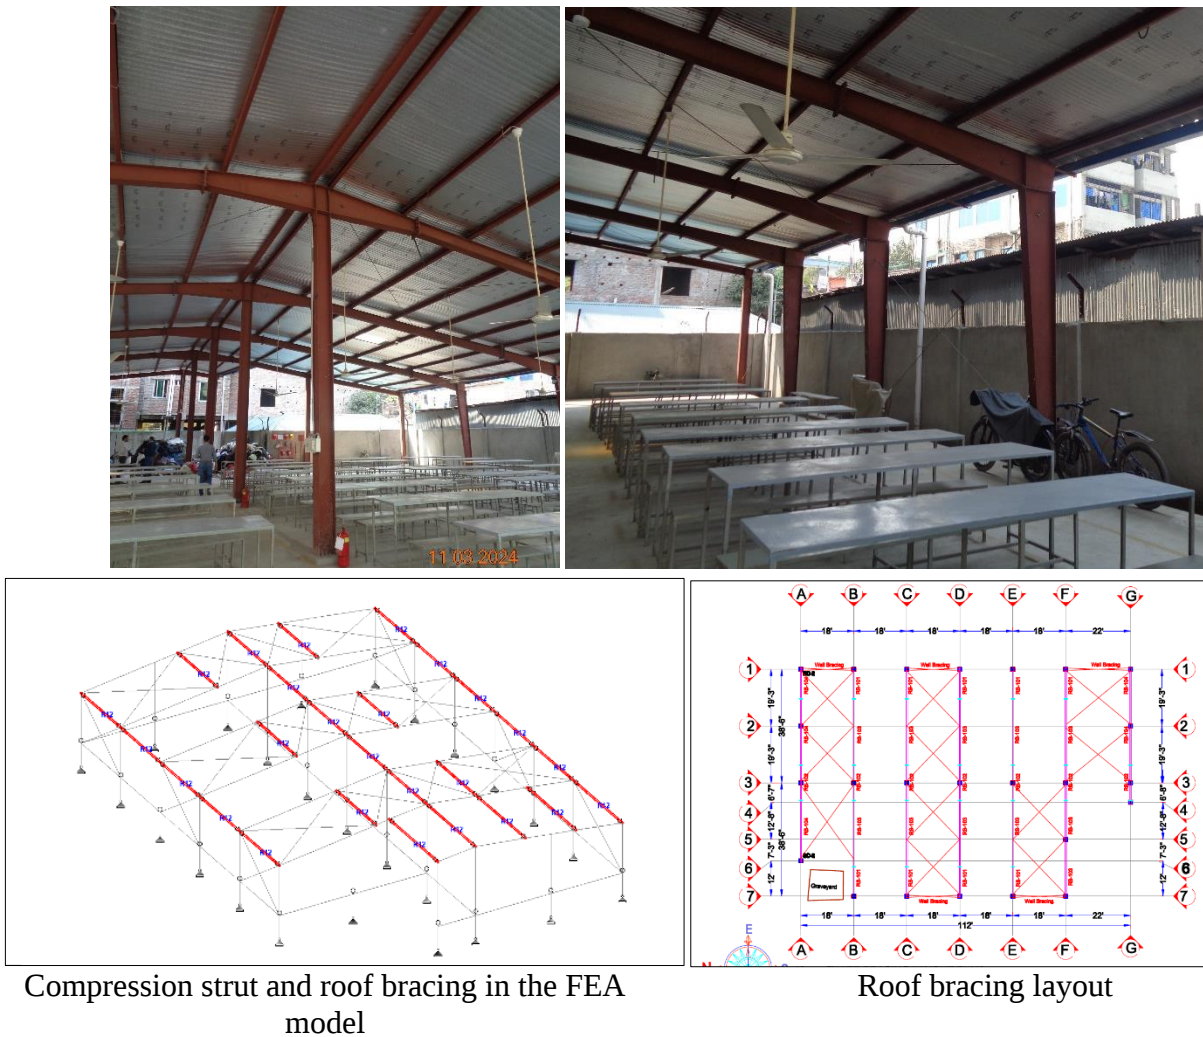
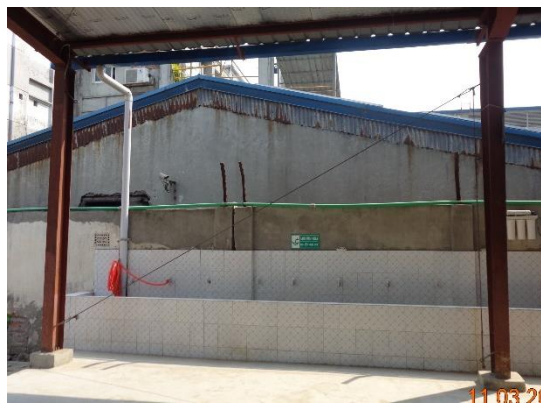
### Observation-1: Lack of lateral stability.

**Description:** During the inspection, Lateral load transfer media (compression strut) along the ridge and eaves were missing. The FEA model has been prepared considering the pipe compression strut, which was not installed at the site. Also, the geometry and roof bracing layout of the FEA model do not match the site drawing. The vertical cable bracing was found missing in one direction. The building engineer must check the lateral load path and revise the design documents based on as-built conditions.

| Serial No | Observation | Action Plan | Timeline |
|---|---|---|---|
| 1 | Lack of lateral stability | The building Engineer is required to confirm the lateral load path & verify the lateral stability of the steel shed. | within 6 weeks |
| 2 | Lack of lateral stability | Implement the remediation if required. | within 6 months |

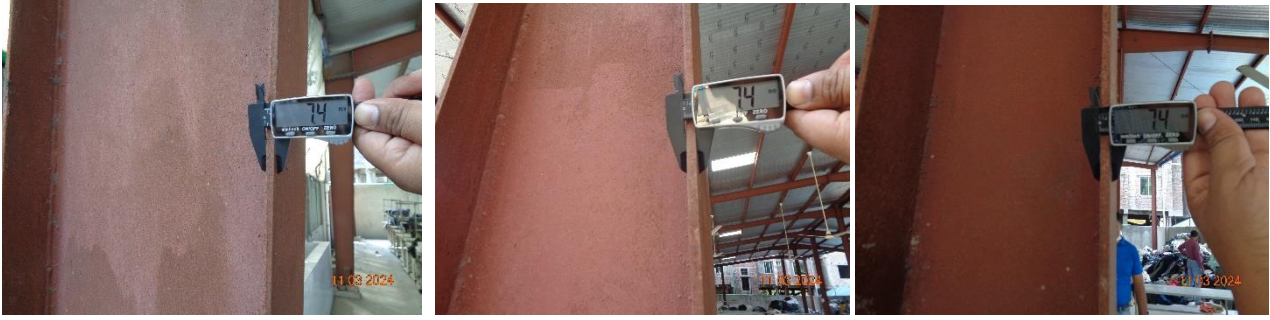
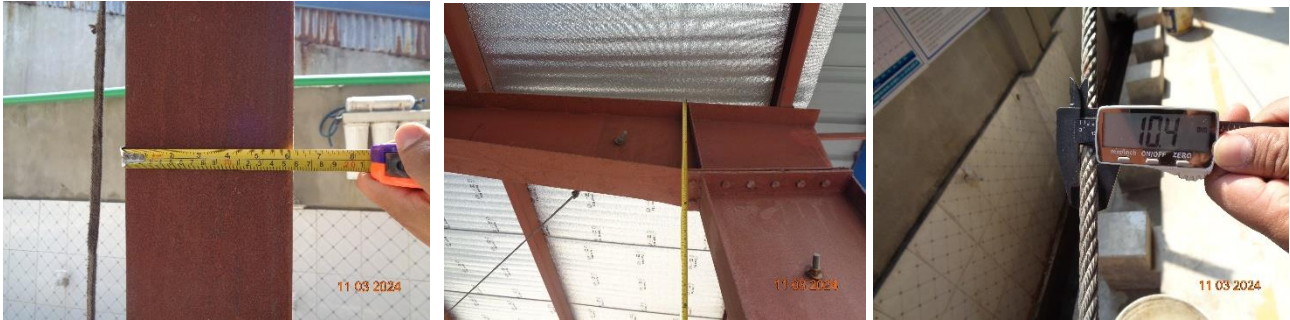
**Observation-2:** Mismatch in as-built drawing.

Flange thickness of SC1, SC2 and SC3 (from left)

**Description:** During the inspection, a mismatch was found between the as-built drawing and the site condition. The flange thickness of the SC-1, SC-2 & SC-3 columns was found to be 7mm instead of 8mm. The flange width of the SC-1 column was found 155mm instead of 175mm. The tapered end of the rafter RB-101 was found to be 460mm instead of 500mm. The diameter of the cable was found to be 10mm instead of 12mm.

Building Engineer is required to survey the whole structure and prepare accurate as-built drawing including the foundation information.

| Serial No | Observation | Action Plan | Timeline |
|---|---|---|---|
| 3 | Mismatch in the as-built drawing. | The building engineer is required to survey the full structure and produce accurate as-built drawings. | within 6 weeks |

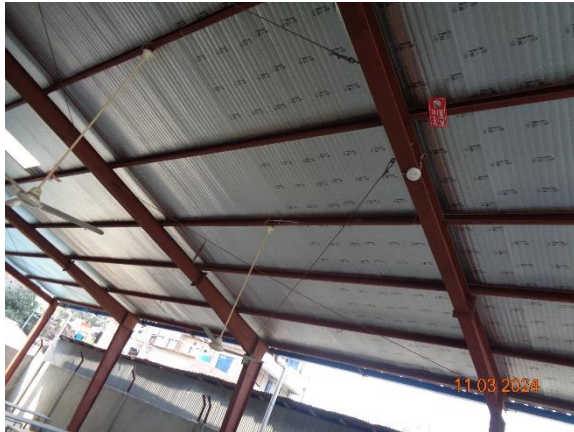
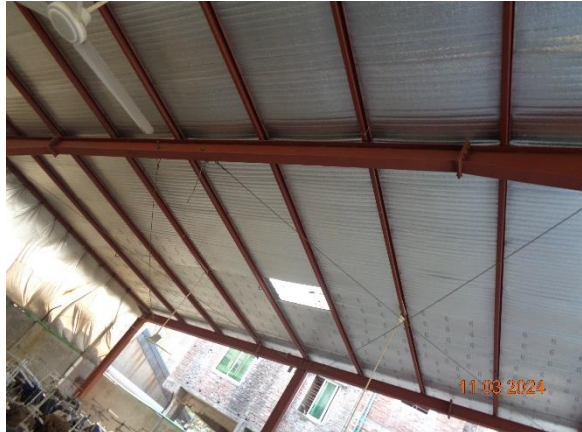
**Observation-3:** Cable bracing found loose.

**Description:** During the inspection, the horizontal and vertical cable bracing was loose. Factory is required to take necessary measures to tighten the loose bracings.

| Serial No | Observation | Action Plan | Timeline |
|---|---|---|---|
| 4 | Cable bracing found loose | The factory is required to tighten the cable bracings. | within 6 weeks |

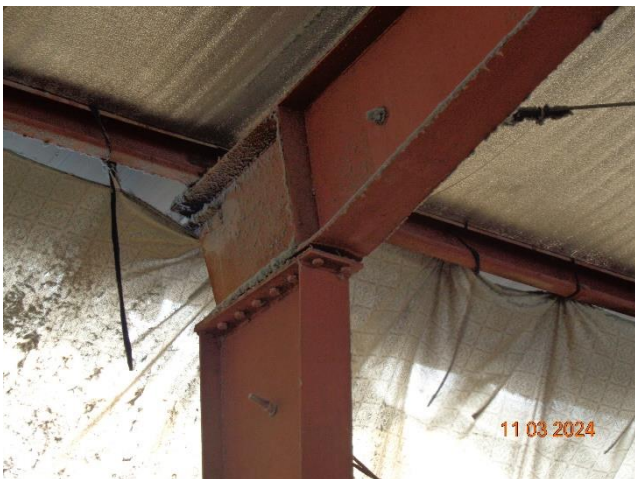
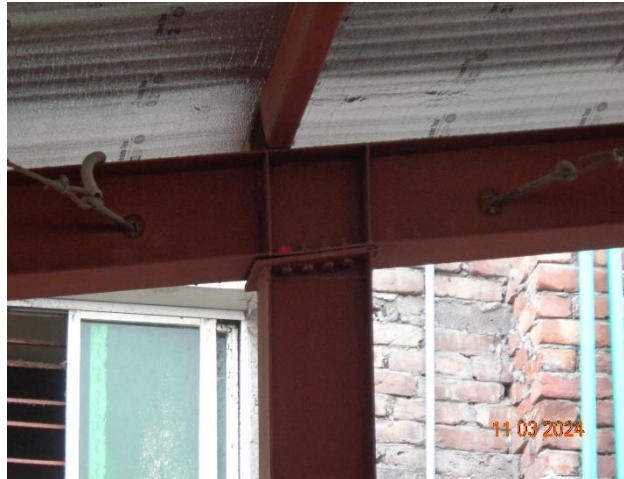
**Observation-4:** Connection gap at several locations.

**Description:** During the inspection, significant gaps and missing bolts were observed at the column rafter joint at several locations. Factory engineer is required to carry out suitable remedial works.

| Serial No | Observation | Action Plan | Timeline |
|---|---|---|---|
| 5 | Connection gaps at several locations | Identify the locations and carry out suitable repair works where necessary. | within 6 weeks |
