# N.K. Sweaters Ltd

10 March 2024

## 2. Observations

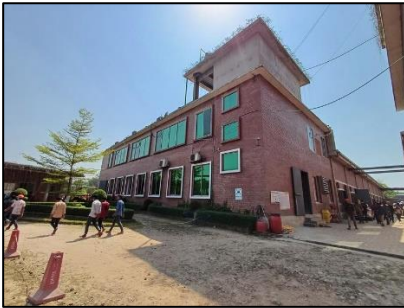
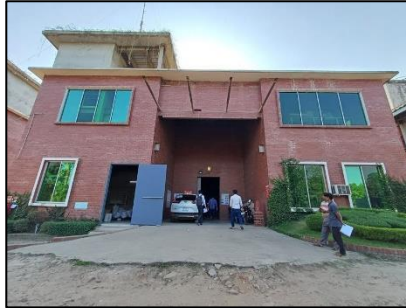
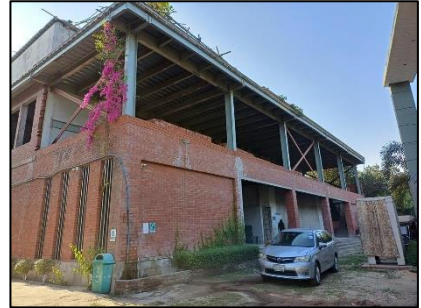
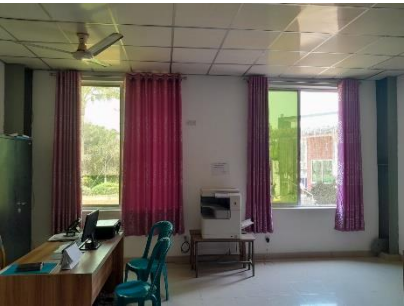
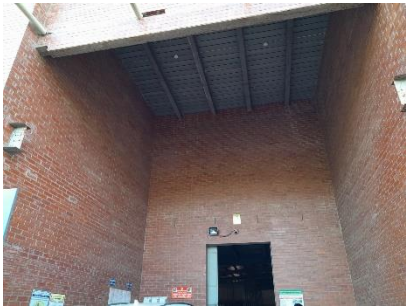
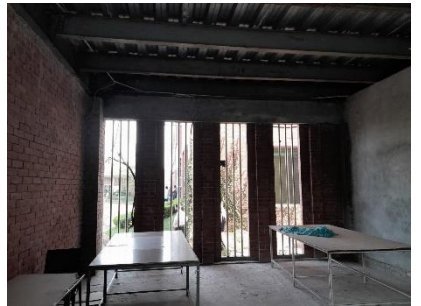
**Observation-01:** Missing bracing and a beam. (Shed-1, Shed-2 & Shed/Building 3)

**Description:** Some vertical bracings are missing in Sheds 1 & 3, and the main beam is missing in Shed 2. So, the lateral stability in these sheds is incomplete.

The building engineer is required to check the lateral stability system & prepare design documents accordingly.

| Observation | Action Plan | Timeline |
|---|---|---|
| Missing bracing.<br>(Shed-1) | The building engineer is required to check the lateral stability system & prepare design documents accordingly. | within 6 weeks |
| Missing beam. (Shed-2) | The building engineer is required to check the lateral stability system & prepare design documents accordingly. | within 6 weeks |

| <b>Building/Shed 3</b> | | |
|---|---|---|
| Missing bracing.<br>(Building/Shed 3) | The building engineer is required to check the lateral stability system & prepare design documents accordingly. | within 6 weeks |

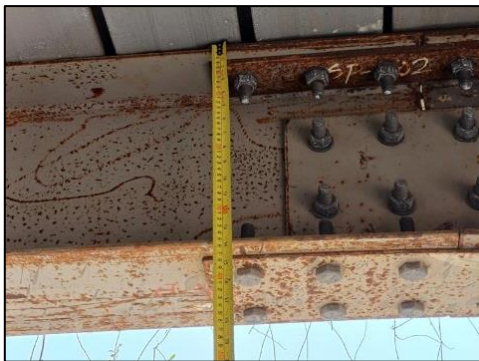
Main Beam

**Observation-02:** Discrepancy in the as-built drawings. (Shed-1, Shed-2 & Shed/Building 3)

**In Shed-2** stair top main beam was found 340X6; 225X8 instead of 445X8; 175X10. The main beam on the ground floor & roof bracing were missing.

The building engineer is required to update the as-built drawings of shed-1, shed-2 & shed-3 as per actual site condition.

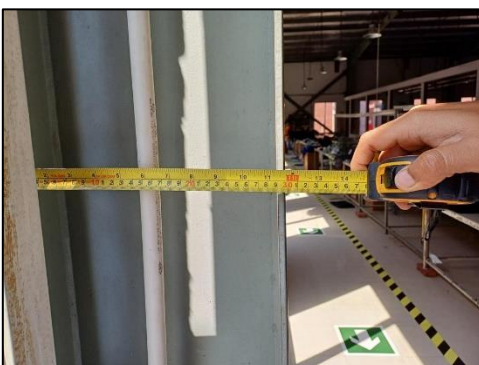
Column

**In Shed-1** column C-104 was found 300X6; 175X8 instead of 348X6; 225X10.

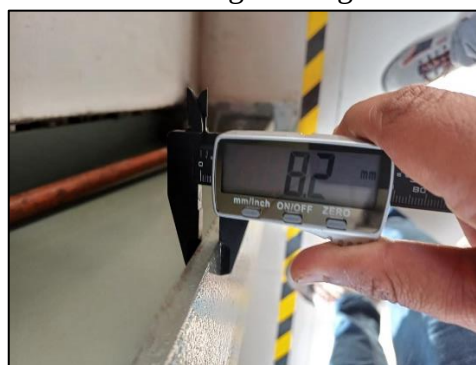
Flange Thickness

**In Shed/Building 3** main beam depth was found 175 instead of 200.

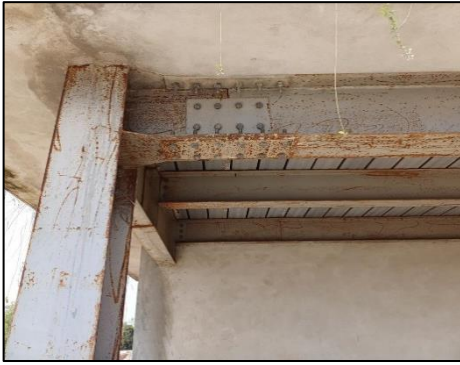
Corrosion at main beam

**Description:** During the inspection, severe corrosions were found in steel members in all sheds. The building is required to identify the location, investigate the reason for corrosion, and prepare an investigation report with remedial actions and repair as per the recommendation of the report.

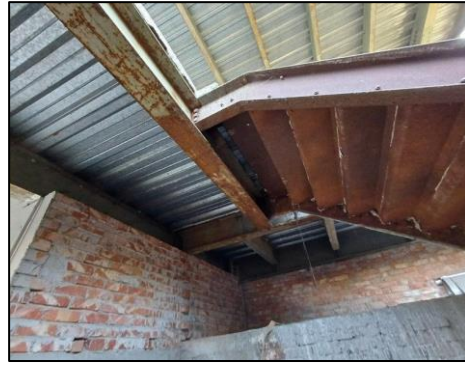
Corrosion at stair

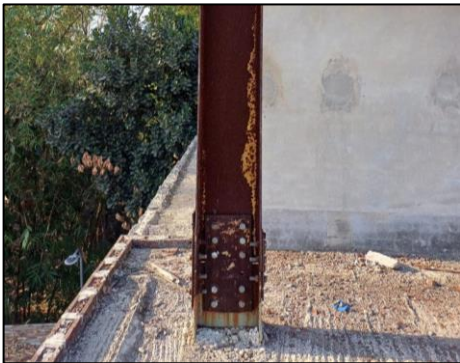
Corrosion at column

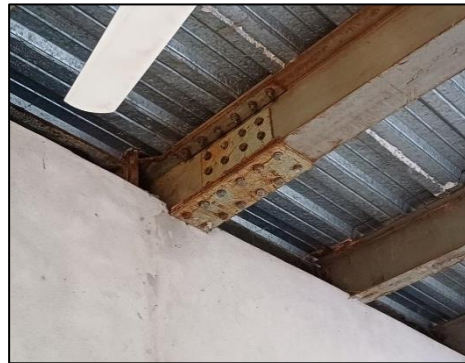
Corrosion at connection

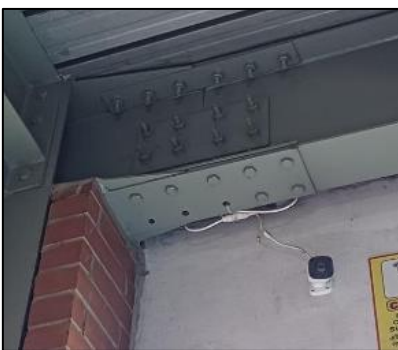
Missing bolt

**Description:** During inspection, some bolts missing, connection gaps & loose cable bracing were found in all sheds. The building engineer is required to install missing bolts, repair connection gaps & tighten cable bracing, and carry out periodic maintenance work.

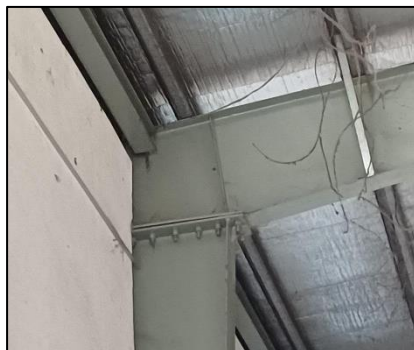
Connection gap

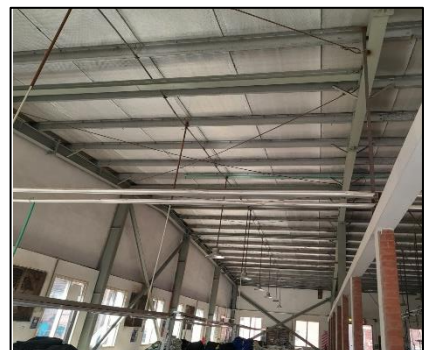
Missing bracing

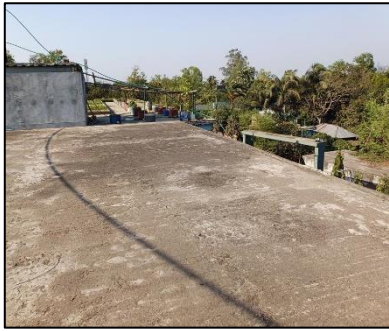
Shed-2

**Observation-05:** Falling hazard. (Shed-2 & Shed-3)

**Description:** During inspection, falling hazards (Missing Parapet, Railing missing around stair) were found in shed-2 & shed-3. The building engineer is required to provide barriers to prevent potential falling hazards.

| Observation | Action Plan | Timeline |
|---|---|---|
| Falling hazard. (Shed-2) | The building engineer is required to provide barriers to prevent potential falling hazards. | within 6 weeks |

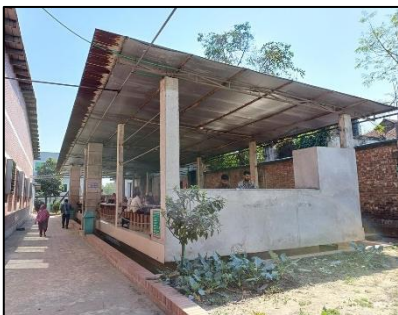
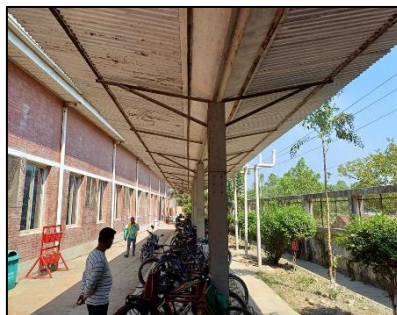
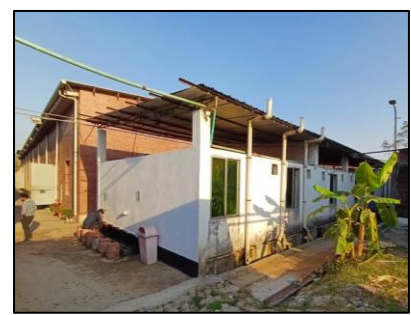
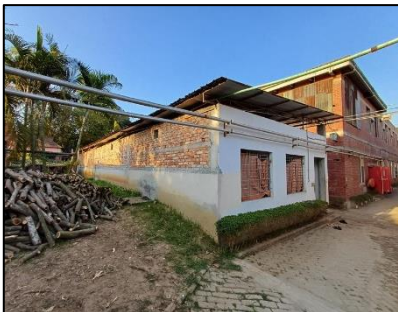
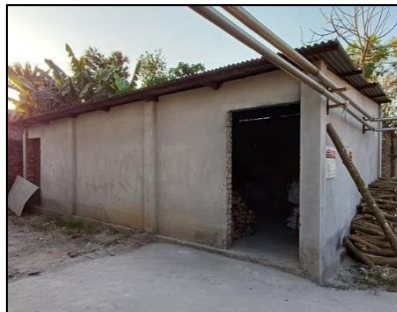
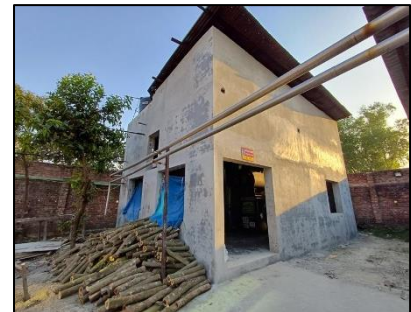
**Observation-06:** Non-engineered structures were found. (Dining Shed, Toilet, Medical & prayer, Boiler Shed, Wastage Shed, Staff Dining and Cycle Shed)

**Description:** During the inspection, some non-engineered structures were found on the factory premises. The building engineer is required to update the connection & prepare as-built documents.

| <b>Building/Shed 3</b> | | |
|---|---|---|
| Non-engineered structures were found. (Dining Shed, Toilet, Medical & prayer, Boiler Shed, Wastage Shed, Staff Dining and Cycle Shed) | The building engineer is required to update the connection & prepare as-built documents. | within 6 weeks |
| | Carry out remediation work if required. | within 6 months |

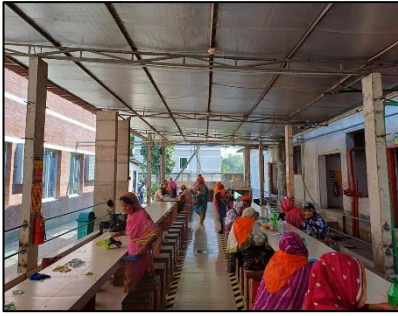
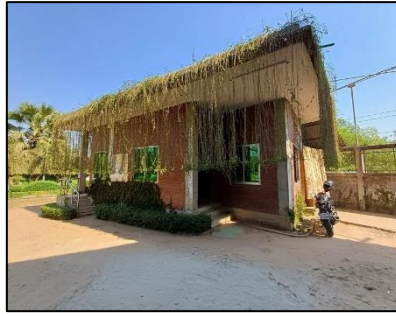
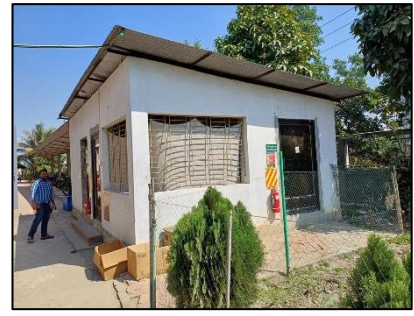
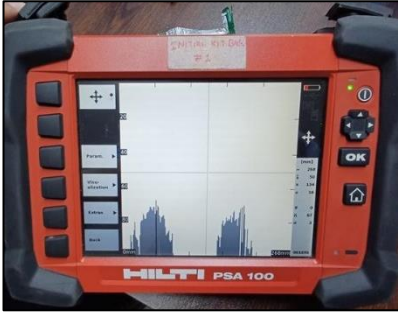
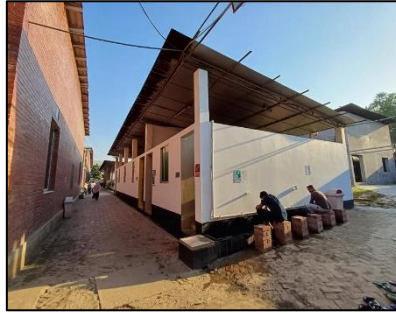
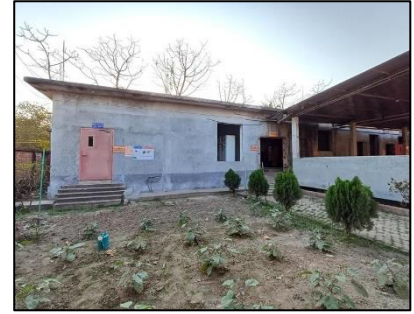
**Observation-07:** Lack of information in as-built drawing. (All ancillary structures)

**Description:** Lack of information was observed in the as-built drawings of the mentioned structures. The building engineer is required to update the as-built drawing as per the actual site condition and comply with BNBC 1.9 requirements.

| <b>Building/Shed 3</b> | | |
|---|---|---|
| Lack of information in as-built drawing.<br>(All ancillary structures) | The building engineer is required to update the as-built drawing as per the actual site condition. | within 6 weeks |

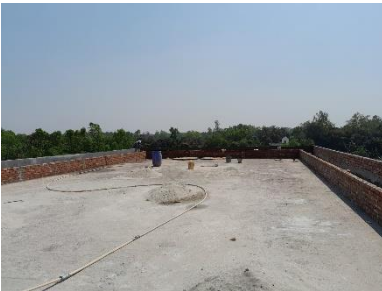
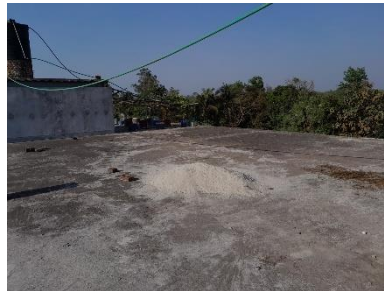
Shed-2

**Observation-08:** Lack of waterproofing on MCAC construction. (Shed 1, Shed 2, Building/Shed 3)

**Description:** During the inspection, lack of waterproofing was observed on the structures mentioned. The deck slab is made of MCAC. The building engineer is required to provide a waterproofing layer on the slab with an adequate slope for roof drainage.

| Observation | Action Plan | Timeline |
|---|---|---|
| Lack of waterproofing on MCAC construction. (Shed 2) | The building engineer is required to provide a waterproofing layer with an adequate slope for roof drainage. | within 6 months |

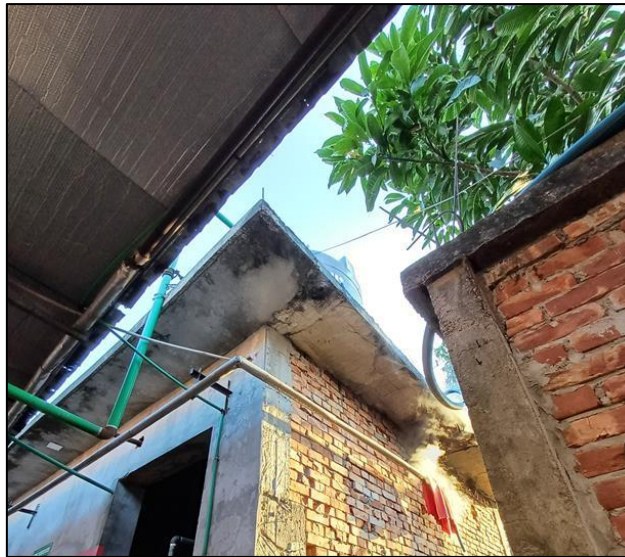
**Observation-09: Dampness. (Utility Building)**

**Description:** During the inspection dampness was found in the roof slab of the utility building. The building engineer is required to seal the water sources and repair the dampness with a suitable method.

| <b>Building/Shed 3</b> | | |
|---|---|---|
| Dampness.<br>(Utility Building) | The building engineer is required to seal the water sources and repair the dampness with a suitable method. | within 6 weeks |

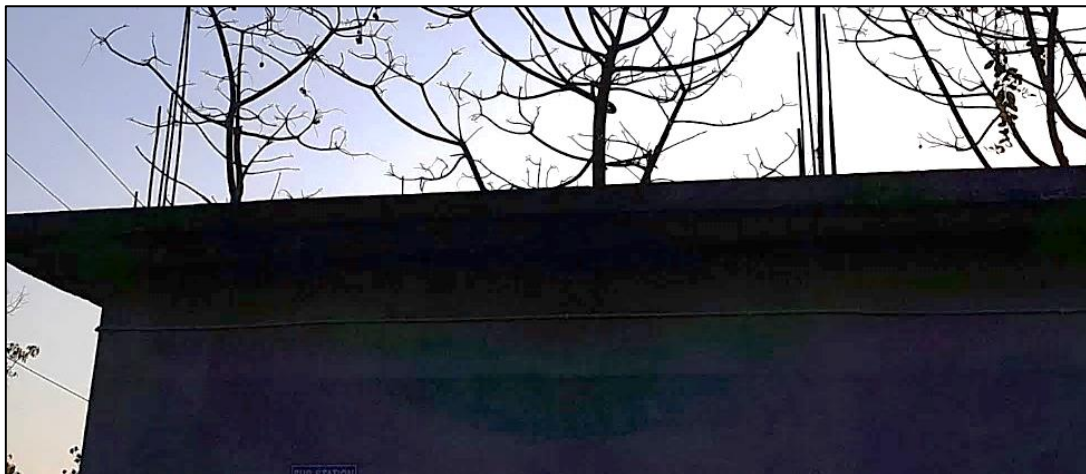
**Observation-10: Exposed rebar. (Utility Building)**

**Description:** During the inspection, exposed rebar was found on the roof of the utility building. The building engineer is required to apply rust-proof coating on the exposed rebar.

| <b>Building/Shed 3</b> | | |
|---|---|---|
| Exposed rebar.<br>(Utility Building) | The building engineer is required to apply rust-proof coating on the exposed rebar. | within 6 months |
