# International Trading Services Ltd (Extension)

Civil Engineers City 4th, 5th & 7th Floors

Jarun Konabari, Gazipur Sadar, Gazipur.

18 March 2024

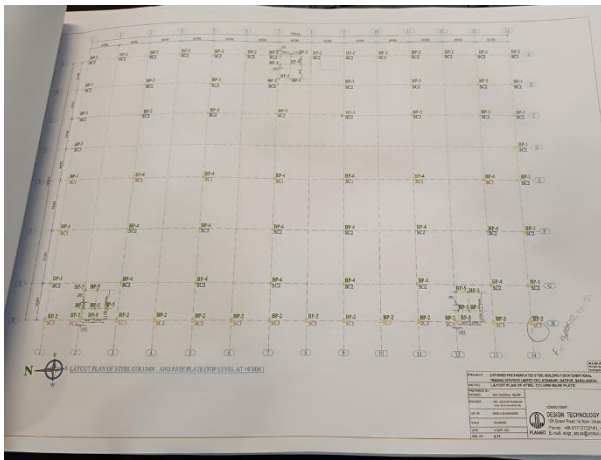
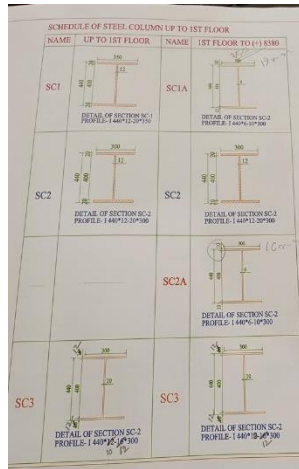
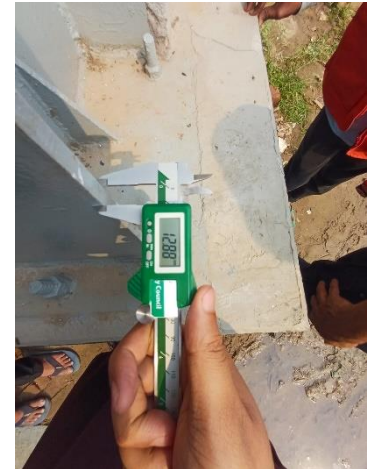
### Observation-1: Mismatch in as-built drawing. (Finishing Shed)

Flange thickness 12 mm instead of 16 mm

**Description:** Periphery steel column (SC2) sizes did not match with the as-built drawings. As per the drawing, the flange thickness of SC2 column is 16 mm, but on-site we measured 12 mm. The building engineer is required to update the as-built drawing and submit it to RSC.

| Observation | Action Plan | Timeline |
|---|---|---|
| Mismatch in as-built drawing. (Finishing Shed) | The building engineer is required to update the as-built drawing as per the existing condition of the building. | within 6 weeks |

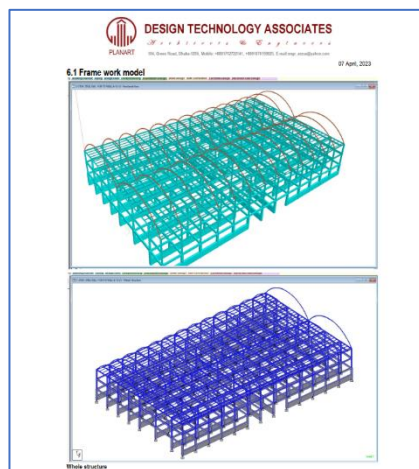
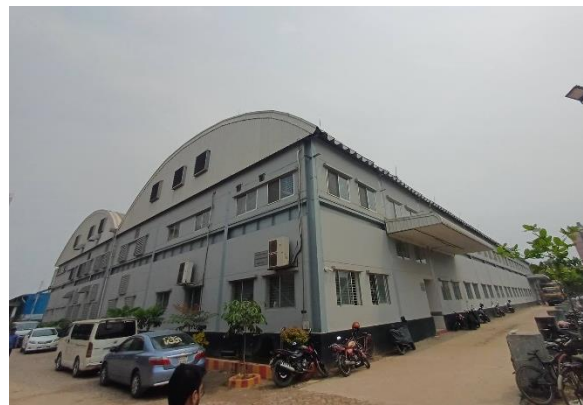
### Observation-2: Design report required to be reviewed by RSC for lateral loading. (Finishing Shed)

**Description:** The design report has been prepared for the 2-storied shed building. On the other hand, some mismatches were found. The building engineer is required to revise the DEA report considering the onsite condition and lateral forces.

| Observation | Action Plan | Timeline |
|---|---|---|
| Design report required to be reviewed by RSC for lateral loading. (Finishing Shed). | The building engineer is required to revise the DEA report as per on-site conditions and for lateral loading. Submit the revised DEA to RSC for review. | within 6 weeks |

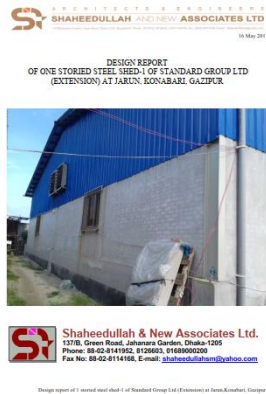
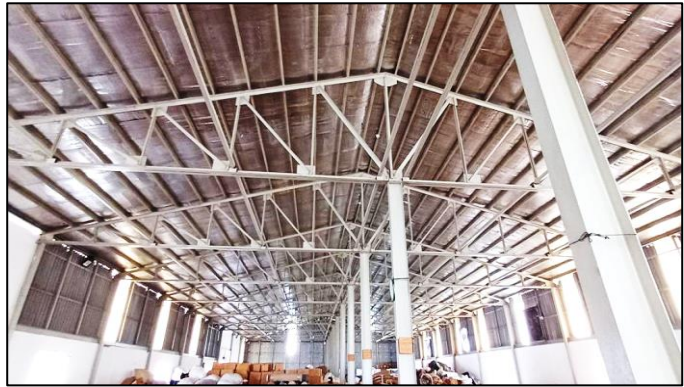
**Observation-3:** Design report required to be reviewed by RSC for lateral loading (Shed-1).

**Description:** Design reports for all structures were available. Factory is required to submit design reports along with other documents (as-built drawing, test reports etc.) to RSC for review.

| Observation | Action Plan | Timeline |
|---|---|---|
| Design report required to be reviewed by RSC for lateral loading (Shed-1). | Factory is required to submit design reports along with other documents (as-built drawing, test reports etc.) to RSC for review. | within 6 weeks |

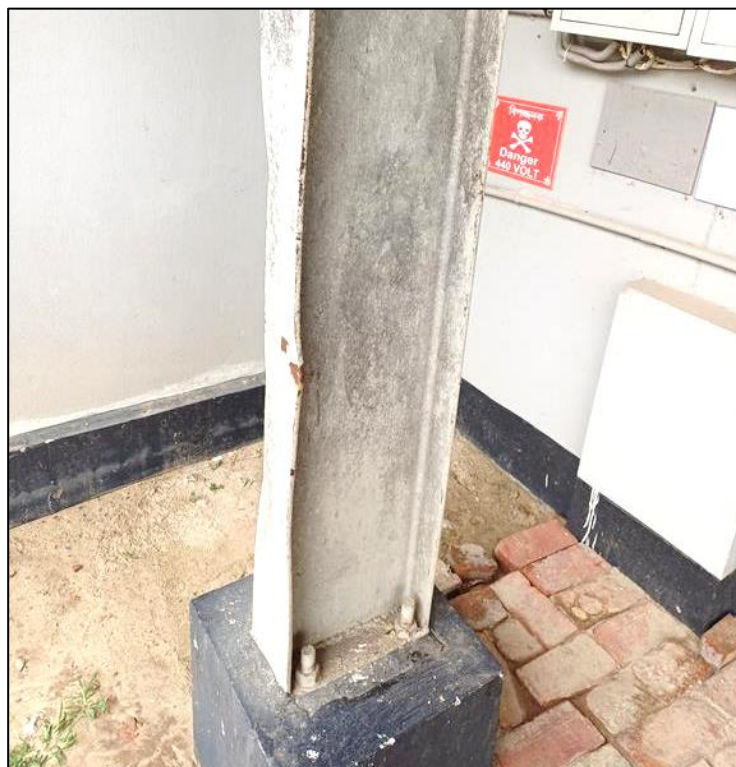
**Observation-4:** Distorted column observed (Shed-1)

**Description:** A column was found as distorted condition. Factory is required to repair the distorted column and provide protection barrier to the column to protect from further vehicle impact.

| Observation | Action Plan | Timeline |
|---|---|---|
| Distorted column observed (Shed-1) | Factory is required to repair the distorted column and provide protection barrier to the column to protect from further vehicle impact. | within 6 weeks |

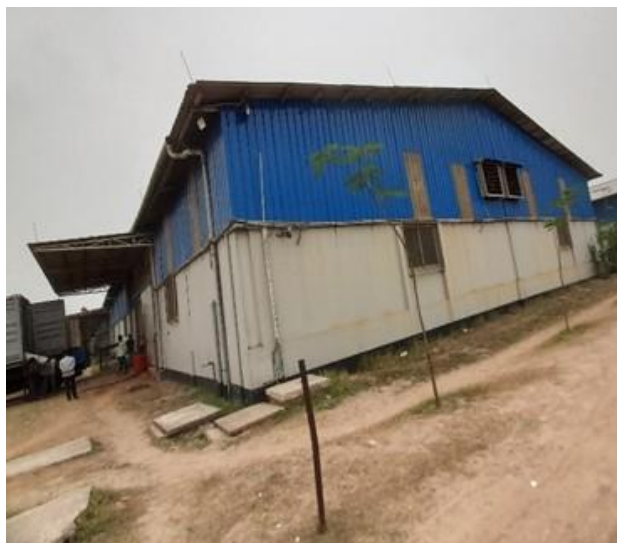
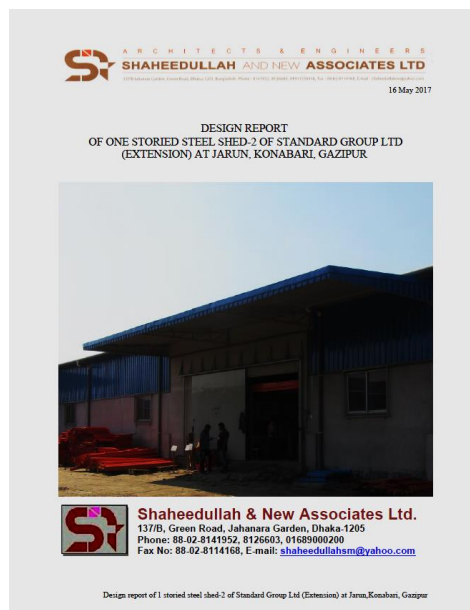
**Observation-5:** Lack of information in design documents. (Shed-2, 3, 5, 6, 9, 10)

**Description:** Design reports were available for the sheds. In the design report, 34.5 kN/cm<sup>2</sup> (50 ksi) steel plate strength was mentioned, but material test reports were not available to verify the strength. Also, the serviceability check was not provided.

The building engineer is required to confirm the material's strength and incorporate the serviceability check in the design report and submit it to the RSC for review.

| Observation | Action Plan | Timeline |
|---|---|---|
| Lack of information in design documents. (Shed-2, 3, 5, 6, 9, 10) | Verify in situ material strength (MS plate tensile strength) | within 6 weeks |

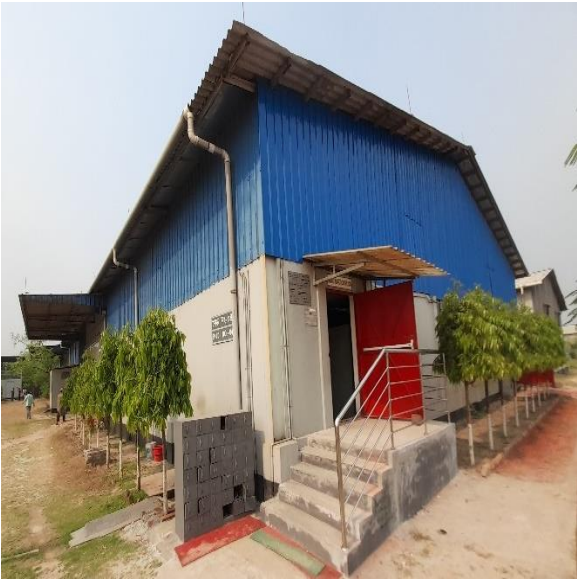
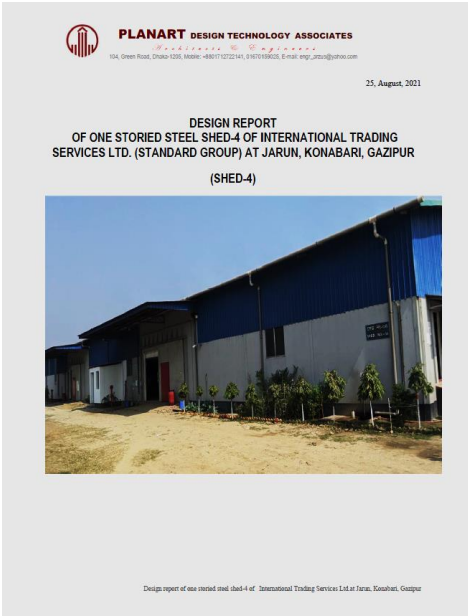
**Observation-6:** Lack of information in design documents. (Shed-4)

**Description:** A design report was available for the shed-4. In the design report, 27.5 kN/cm<sup>2</sup> (40 ksi) strength was mentioned for the roof framework (steel angle) and steel column, but material test reports were not available to verify the strength of the roof framework. Also, the serviceability check was not provided.

The building engineer is required to confirm the material's strength and incorporate the serviceability check in the design report and submit it to the RSC for review.

| Observation | Action Plan | Timeline |
|---|---|---|
| Lack of information in design documents. (Shed-4) | Verify in situ material strength (MS plate tensile strength) | within 6 weeks |

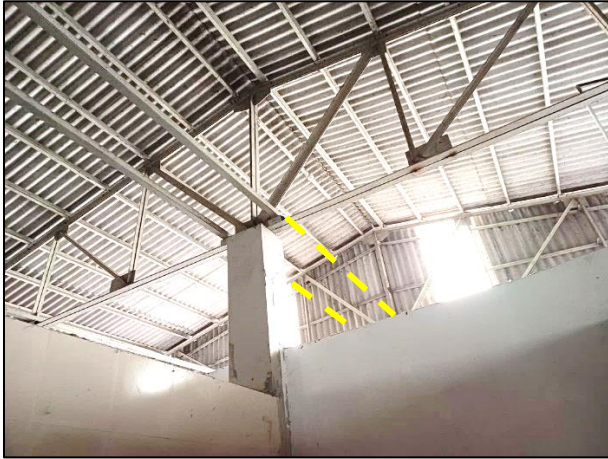
Discontinuous bracing (Shed 5)

**Description:** Discontinuity of bracing at shed 5 and additional pipe columns at Shed-10 were observed. The building engineer is required to survey the whole structure and update the as-built drawing as per site condition.

| Observation | Action Plan | Timeline |
|---|---|---|
| Discrepancy in as-built drawing (Shed-5, Shed-10) | The building engineer is required to survey the whole structure and update the as-built drawing as per site condition. | within 6 weeks |

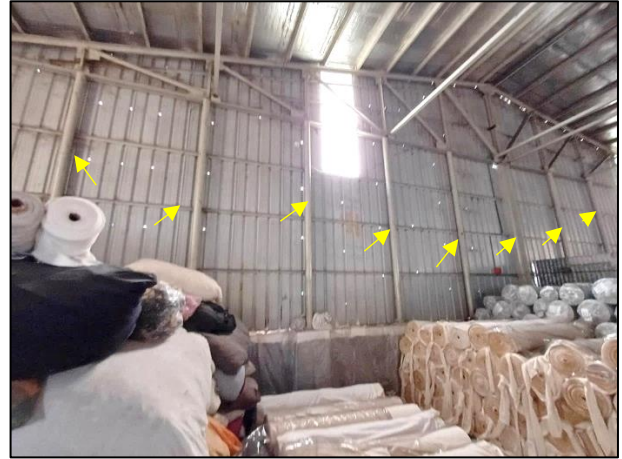
Additional pipe columns (Shed-10)

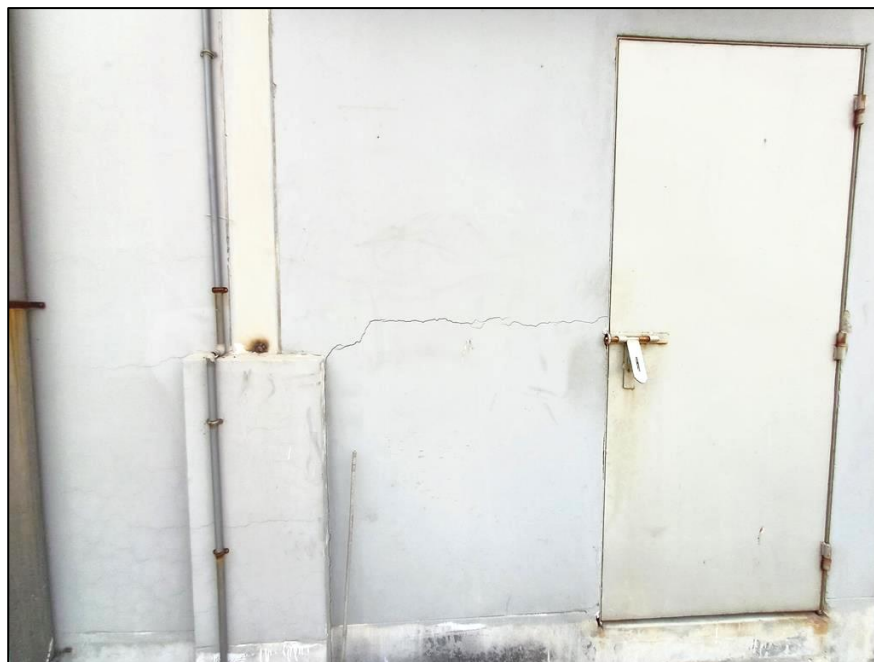
**Observation-8:** Crack on brick wall observed (Shed-10)

**Description:** Crack was observed on brick wall. Factory is required to repair the crack with suitable measures.

| Observation | Action Plan | Timeline |
|---|---|---|
| Crack on brick wall observed (Shed-10) | Factory is required to repair the crack with suitable measures. | within 6 weeks |

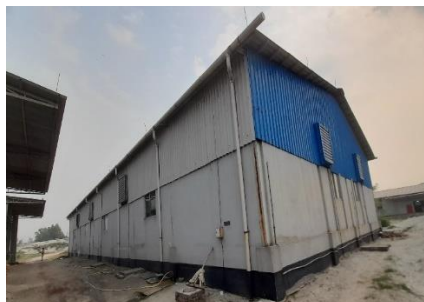
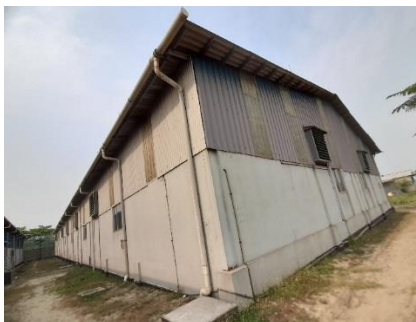
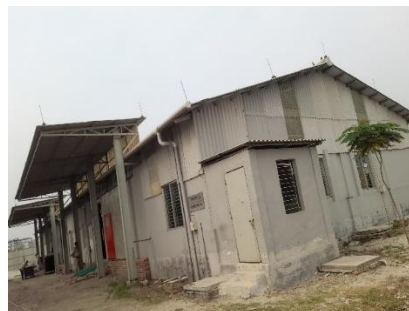
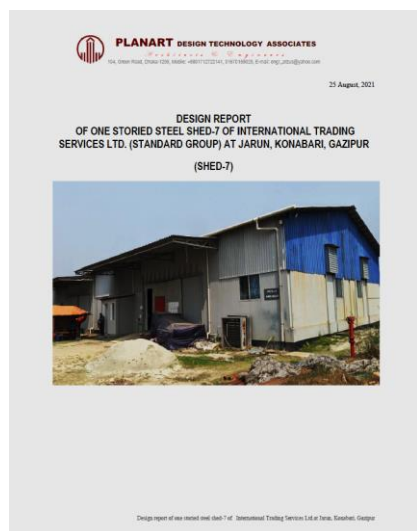
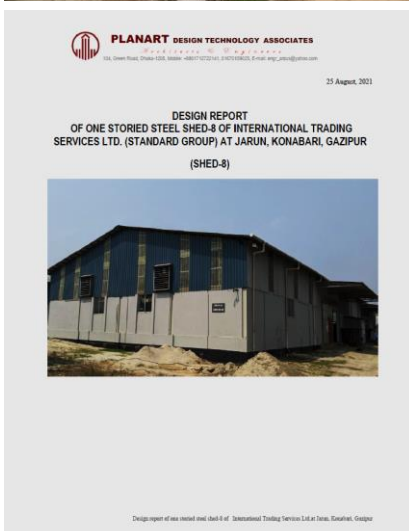
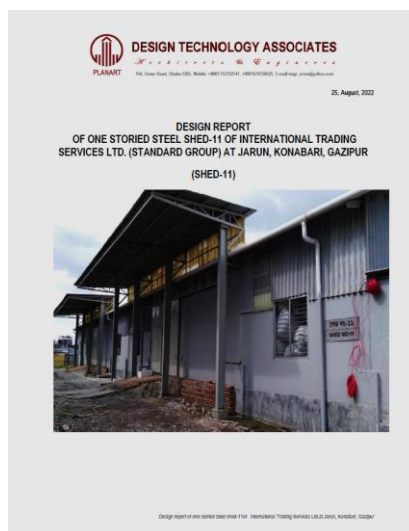
## Observation-9: Lack of information in design documents. (Shed-7, Shed-8, Shed-11)

**Description:** A design report was available for the shed-7, 8, 11. In the design reports, 27.5 kN/cm<sup>2</sup> (40 ksi) steel strength was mentioned, but material test reports were not available to verify the strength. Also, a serviceability check was not provided.

The building engineer is required to confirm the material's strength and incorporate the serviceability check in the design reports and submit it to the RSC for review.

| Observation | Action Plan | Timeline |
|---|---|---|
| Lack of information in design documents. (Shed-7, Shed-8, Shed-11) | Verify in situ material strength (MS plate tensile strength) | within 6 weeks |

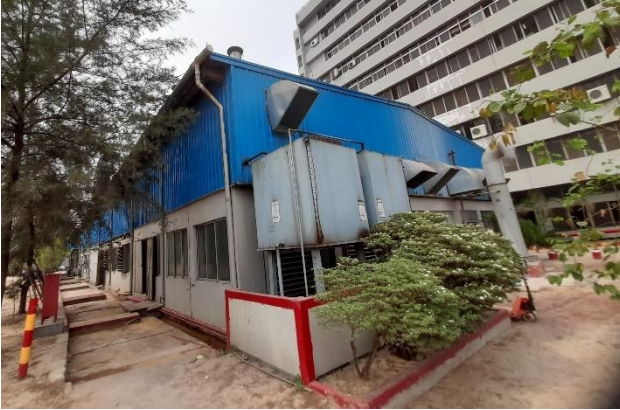
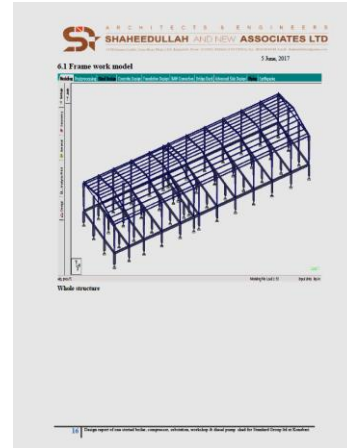
**Observation-10:** Lack of information in design documents. (Utility-1)

**Description:** A Design Report was available for utility-1, which was prepared based on software analysis. Serviceability checks, as per BNBC, were not incorporated in the design report.

The building engineer is required to incorporate a serviceability check in the design report and submit it to the RSC for review.

| Observation | Action Plan | Timeline |
|---|---|---|
| Lack of information in design documents. (Utility-1) | The building engineer is required to incorporate a serviceability check in the design report and submit it to the RSC for review. | within 6 weeks |

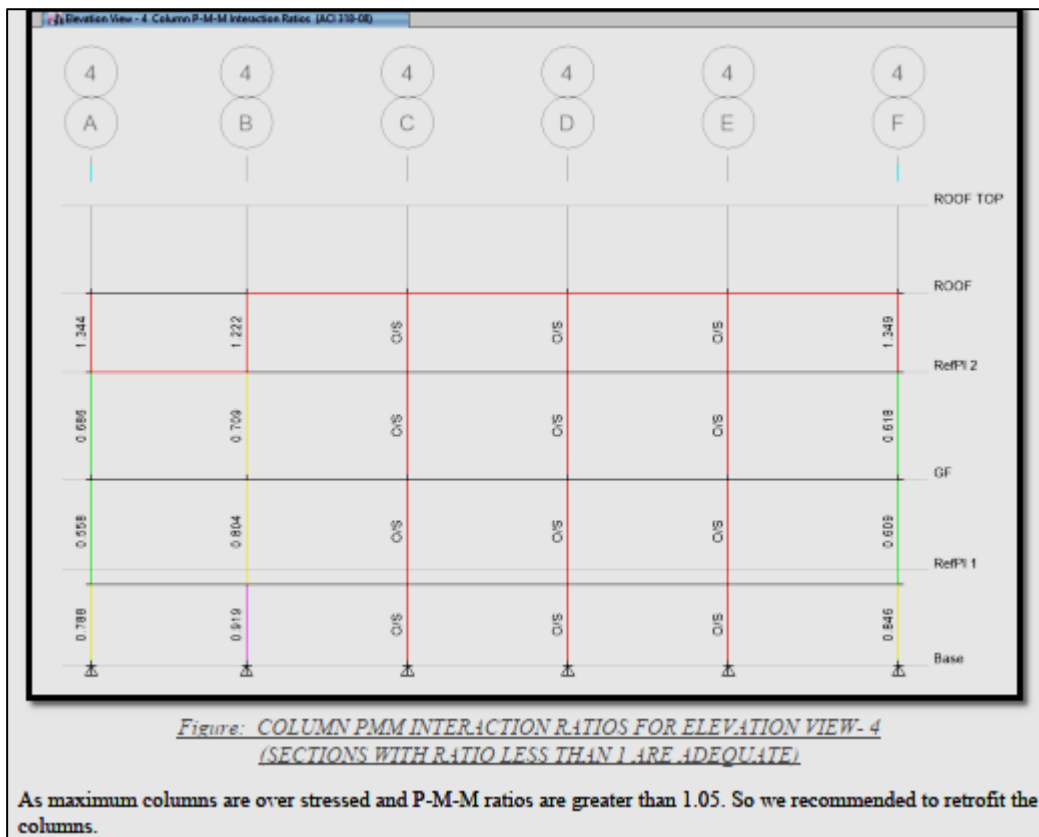
**Observation-11:** Lack of information in design documents. (Utility-2)

**Description:** As per design report, most of the columns are over-stressed, but no remediation plan was available during inspection.

The building engineer is required to prepare remediation plan and submit design report along with other documents (as-built drawing, test report, retrofitting drawing etc.) to RSC for review.

| Observation | Action Plan | Timeline |
|---|---|---|
| Lack of information in design documents. (Utility-2) | The building engineer is required to prepare remediation plan and submit design report along with other documents (as-built drawing, test report, retrofitting drawing etc.) to RSC for review. | within 6 weeks |

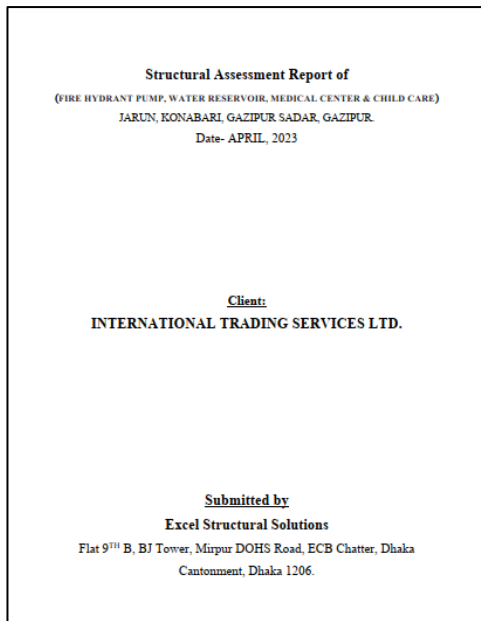
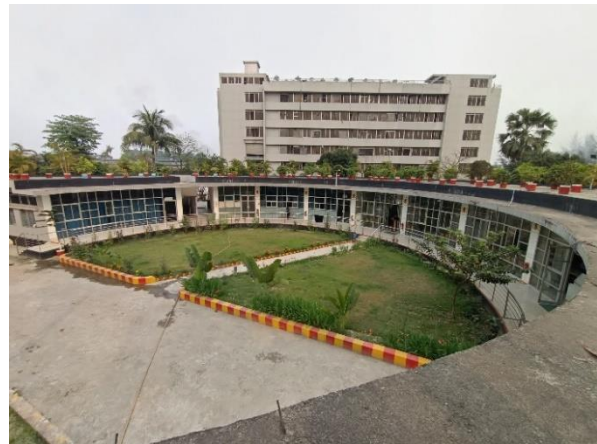
**Observation-12:** Structural Assessment report required to be reviewed against lateral loading. (Medical and Childcare)

**Description:** The Structural Assessment report has been prepared for the single-storied (B+G) Medical and Childcare building with a basement. The structural Assessment report needs to be reviewed against lateral loading.

| Observation | Action Plan | Timeline |
|---|---|---|
| Structural Assessment report required to be reviewed against lateral loading. (Medical and Childcare) | Prepared design report to be checked against lateral loads following BNBC 2006 by RSC. | within 6 weeks |

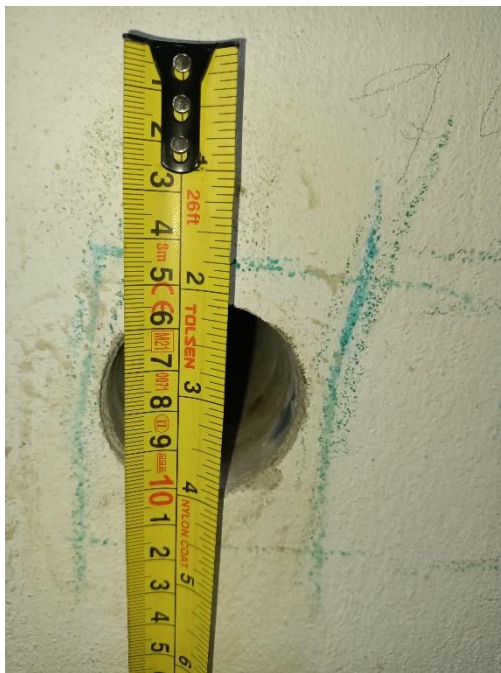
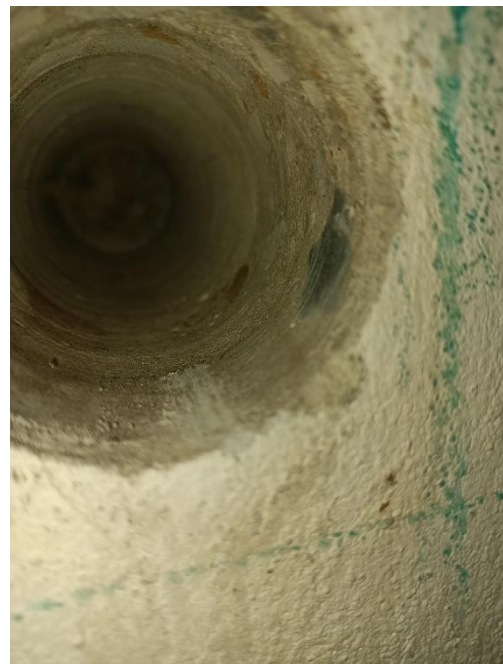
**Observation-13:** Core cutting location not filled up. (Medical and Childcare)

**Description:** Core cutting locations were found exposed. The building engineer is required to fill up all exposed locations with micro concrete.

| Observation | Action Plan | Timeline |
|---|---|---|
| Core cutting location not filled up. (Medical and Childcare) | The building engineer is required to fill up all exposed locations with micro concrete. | within 6 weeks |

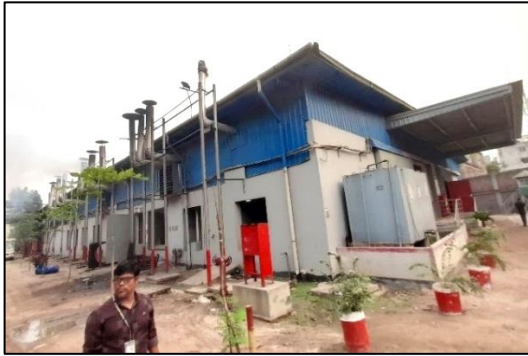
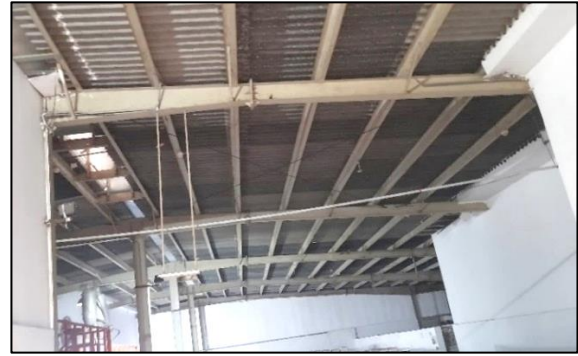
Finished goods store

At the time of inspection, design documents (design report and material test reports) were not available which are required to be prepared in compliance with section 1.9.1 (part-6, BNBC).

| Observation | Action Plan | Timeline |
|---|---|---|
| Lack of design documents. (Finished goods store and Single storied stone station & dry sludge shed) | The building engineer is required to prepare design documents (including design reports and material test reports) in compliance with section 1.9.1 (part 6, BNBC). | within 6 weeks |

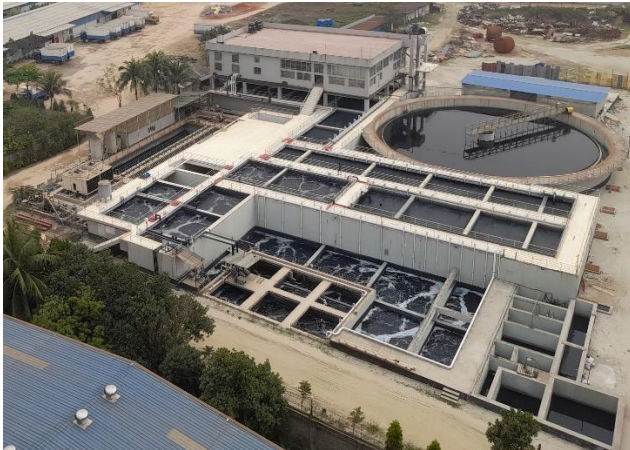
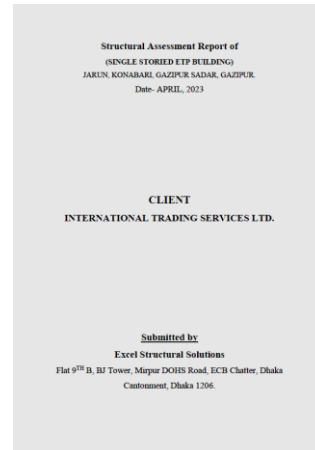
**Observation-15:** Lack of information in design documents. (ETP building)

**Description:** A design report was available for the ETP building. In the design report, the steel yield strength and the concrete compressive strength were considered to be 72.5 ksi and 4.0 ksi, respectively. However, material test reports were not available on-site to verify the strength.

The building engineer is required to confirm the material's strength, update the design report, and submit it to the RSC for review.

| Observation | Action Plan | Timeline |
|---|---|---|
| Lack of information in design documents. (ETP building) | Verify in situ material strength (steel yield strength and the concrete compressive strength) | within 6 weeks |

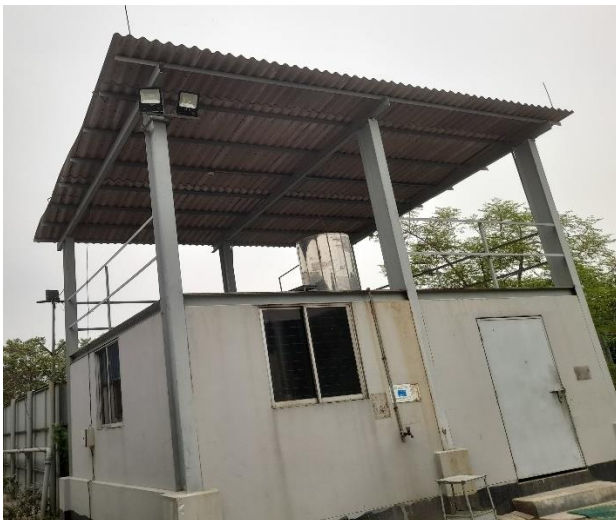
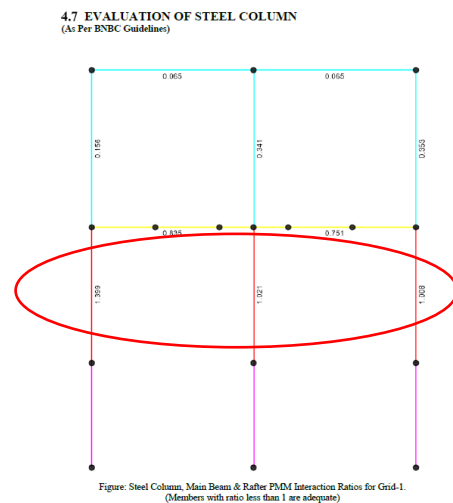
**Observation-16:** Overstressed steel members in the structural assessment report. (WTP)

**Description:** A structural assessment report was prepared based on software analysis and was available on-site for WTP. In the FEA model, some overstressed columns were observed.

The building engineer is required to update the FEA model, assessment report and other requirements as per BNBC.

| Observation | Action Plan | Timeline |
|---|---|---|
| | The building engineer is required to update the FEA model, assessment report and other requirements as per BNBC. | within 6 weeks |

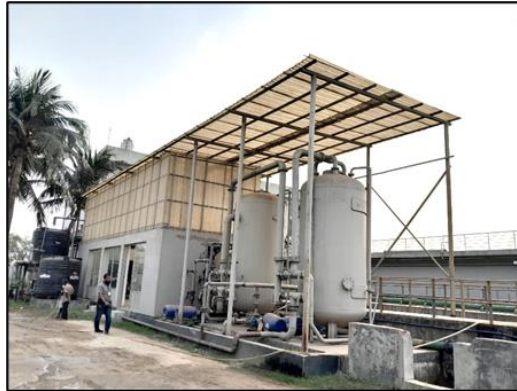
**Observation-17:** Lack of lateral stability system (Single storied recycle & reuse plant).

**Description:** Lack of lateral stability system, apparent inadequate members and non-engineered connection were observed. The building engineer is required to check the member, connection & stability system of the structure and suggest proper remediation accordingly.

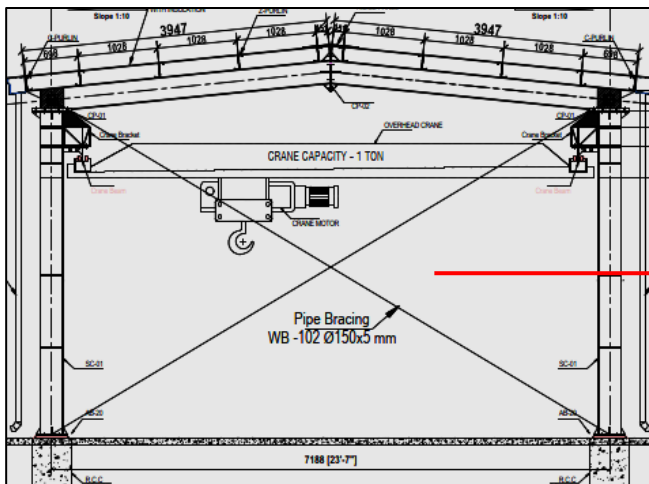
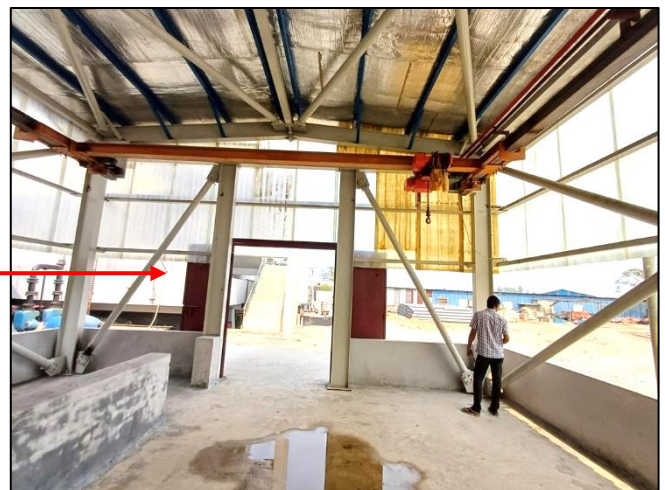
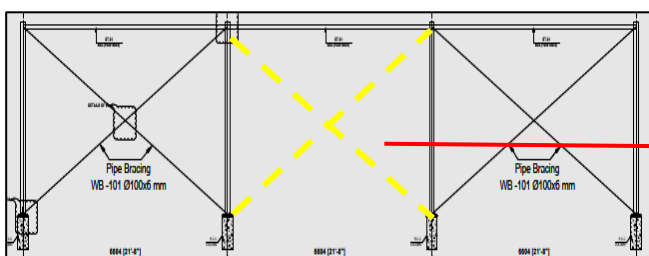
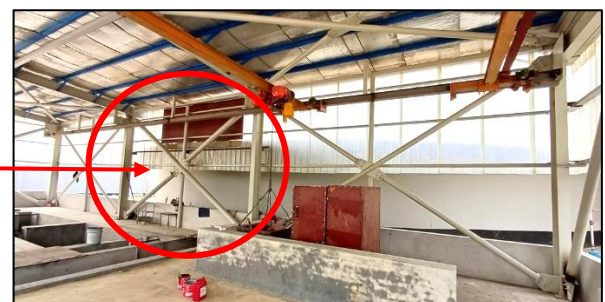
**Observation-18:** Discrepancy in as-built drawing (Single storied stone station & dry sludge shed).

**Description:** Mismatches in bracing arrangement was observed between as-built drawing and onsite condition. The building engineer is required to survey the whole structure and update the as-built drawing as per site condition.

| Observation | Action Plan | Timeline |
|---|---|---|
| Discrepancy in as-built drawing (Single storied stone station & dry sludge shed). | The building engineer is required to survey the whole structure and update the as-built drawing as per site condition. | within 6 weeks |

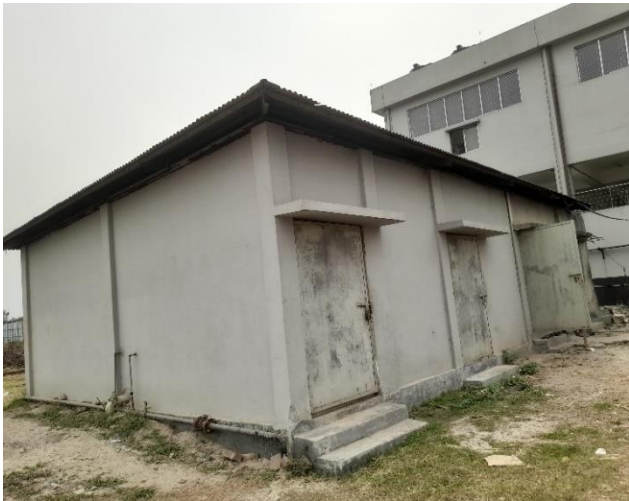
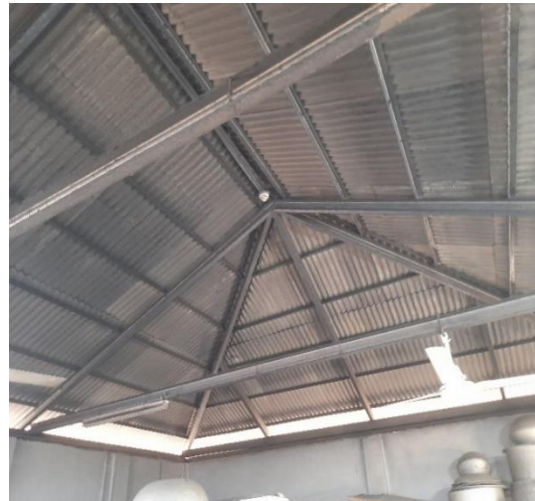
**Observation-19:** Apparently non-engineered roof. (Kitchen shed)

**Description:** The roof of the kitchen shed is apparently non-engineered. Building engineer to check the stability of the lightweight roof structure against uplift forces.

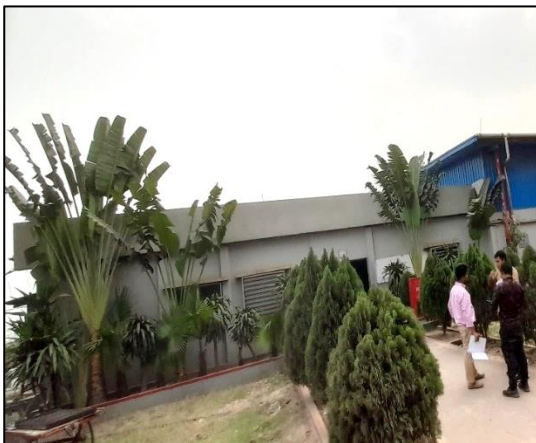
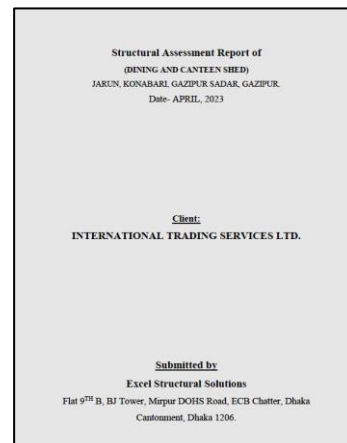
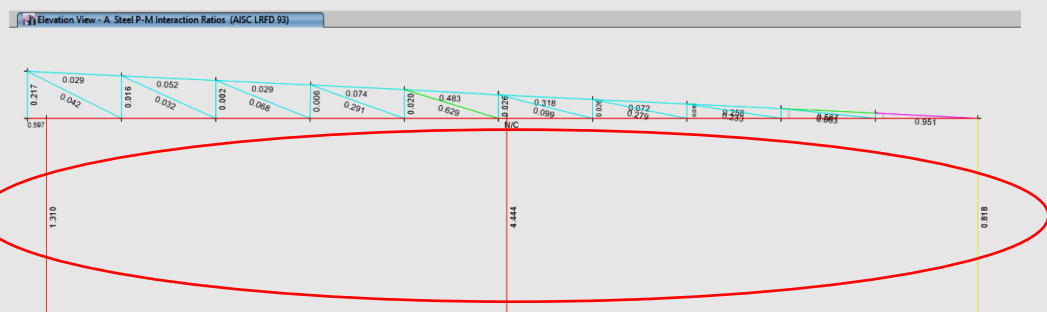
**Observation-20:** Overstressed steel members in the structural assessment report. (Dining & canteen shed)

Figure: Steel Column, Main Beam & Rafter PMM Interaction Ratios for Grid-A.  
(Members with ratio less than 1 are adequate)

**Description:** A structural assessment report was prepared based on software analysis and was available on-site for the dining & canteen shed. In the FEA model, some overstressed columns were observed. The building engineer is required to update the FEA model, assessment report and other requirements as per BNBC.

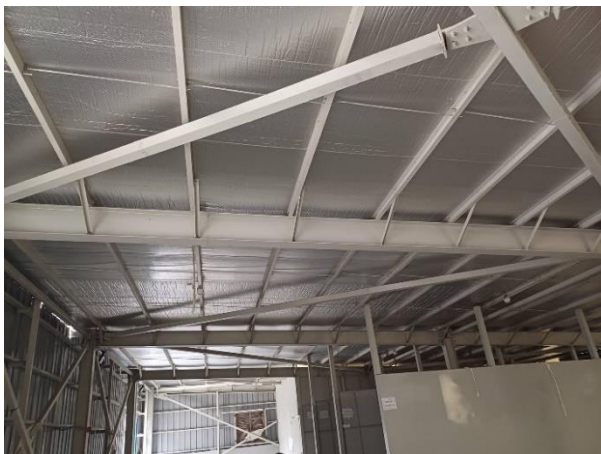
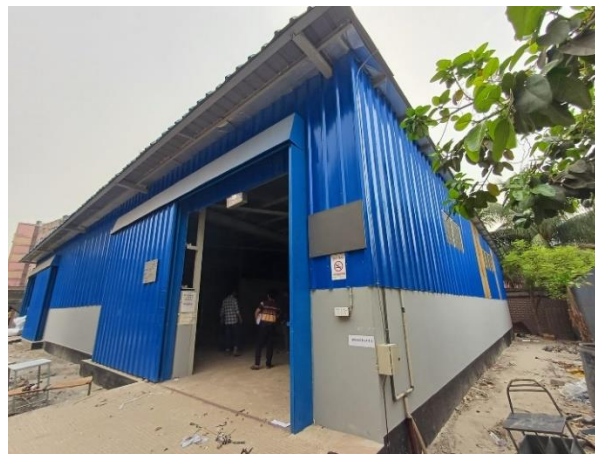
**Observation-21:** Absence of design documents. (Jhute Shed)

**Description:** As per BNBC, every building or structure designed shall have its design documents prepared in accordance with the provision of Section 1.9.1. The design document shall include a design report, and a set of structural drawings, which shall be prepared in compliance with section 1.9.1.1 and section 1.9.1.2, part-6 of BNBC. At the time of inspection, only as-built drawings were available, but no design reports were available, which are required to be prepared in compliance with section 1.9.1.1 (part-6, BNBC).

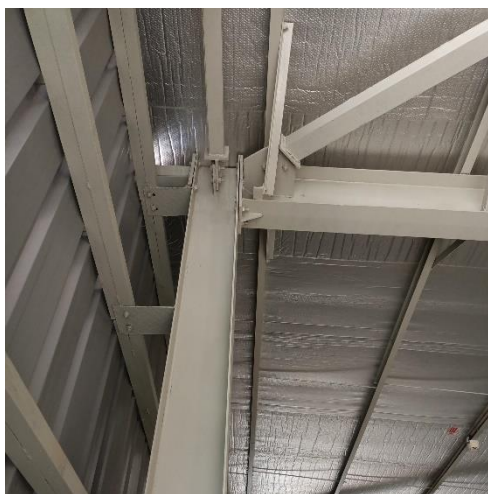
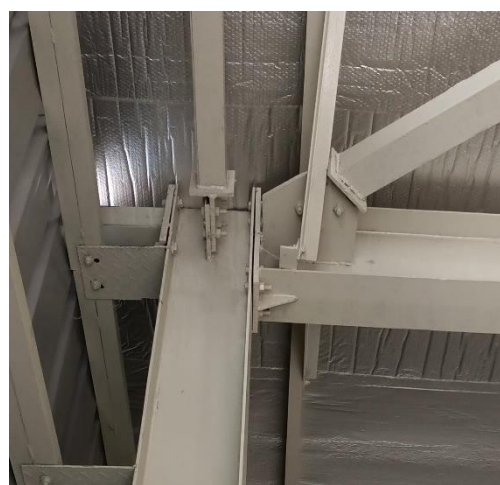
**Observation 22:** Connection Gap. (Jhute Shed)

**Description** Connection gaps observed in strut joint. Building engineer is required to carry out suitable remedial works.

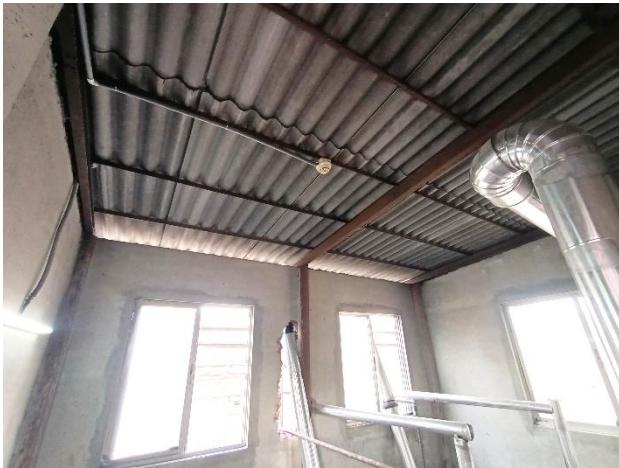
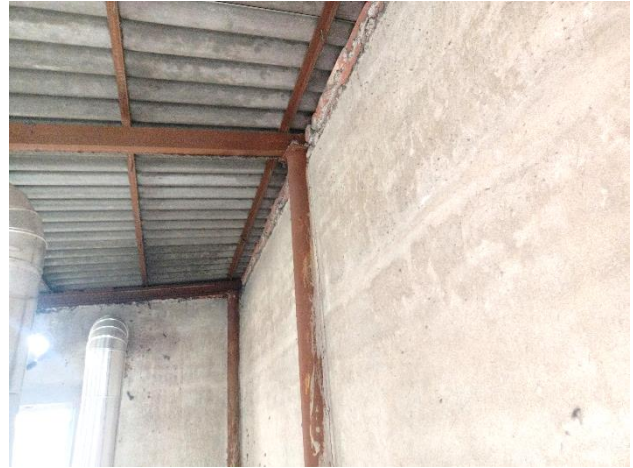
**Observation-23:** Non-engineered connection. (PP Pump Shed)

**Description:** Inadequate connections were observed at the lightweight roof of the single-storied Sheds. The building engineer is required to check the connection adequacy of the lightweight roof against the uplift forces.

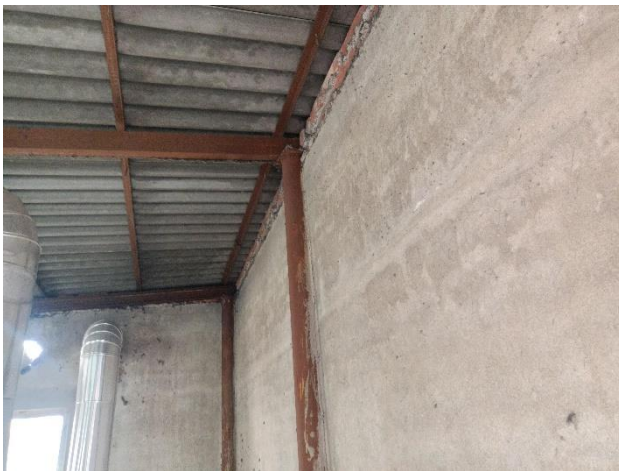
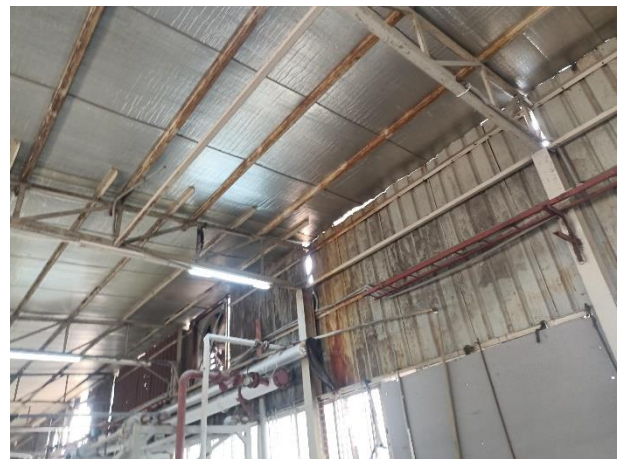
**Observation-24:** Corrosion in steel member (PP Pump Shed, Washing Shed)

**Description:** Corrosion in steel member observed in several locations. The building engineer is required to suggest proper remedial measures accordingly

| Observation | Action Plan | Timeline |
|---|---|---|
| Corrosion in steel member (PP Pump Shed, Washing Shed) | Building engineer to remove the corrosion and apply suitable corrosion resistance coating. | within 6 weeks |

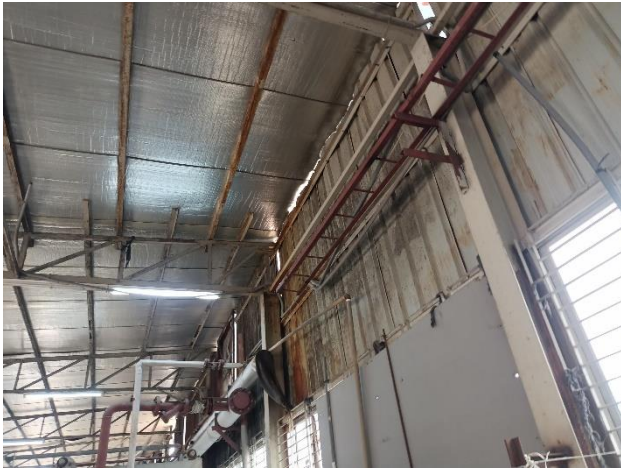
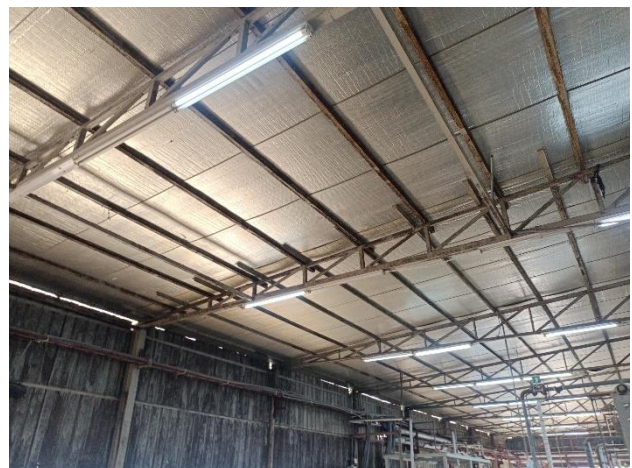
**Observation-25: Lack of lateral stability. (Washing Shed)**

**Description:** Load transfer media is not provided along long direction for this shed. Therefore, lateral stability system of the shed is apparently incomplete. Building engineer is required to check the lateral stability of the structure.

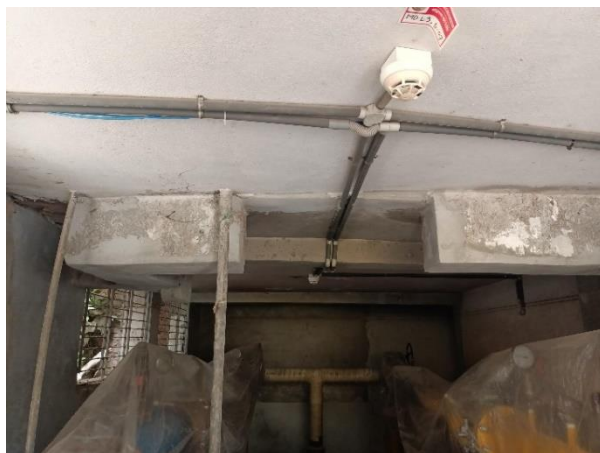
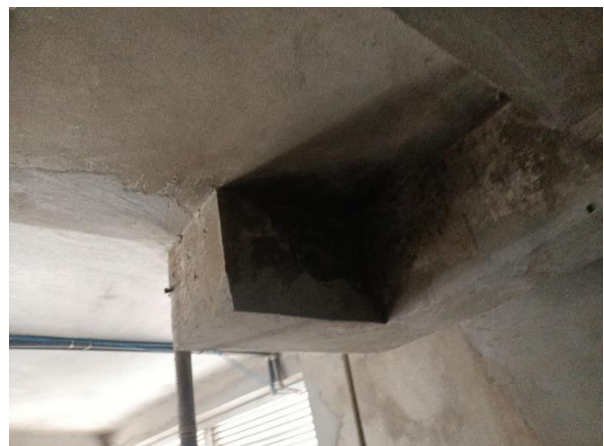
**Observation-26: Hanging Beam. (Guard Room-1)**

**Description:** The floor beam was found discontinued and hanging inside the RMS room. Building engineer is required to provide adequate support for the hanging beam.
