# Al-Muslim Washing Ltd. & Al-Muslim Garments Accessories Ltd (Extension)

24 March 2024

## 1. Building Information:

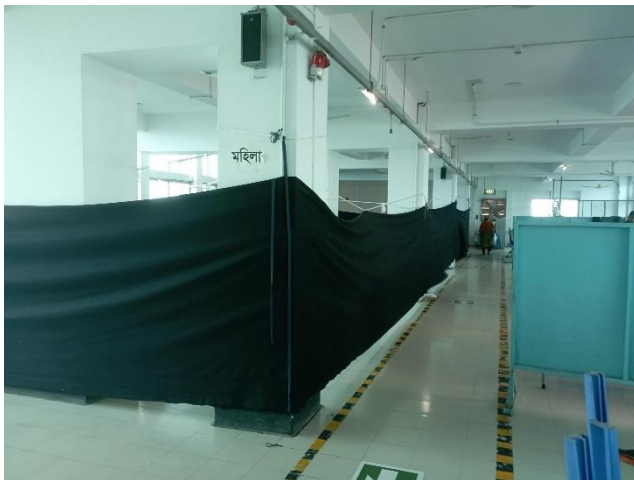
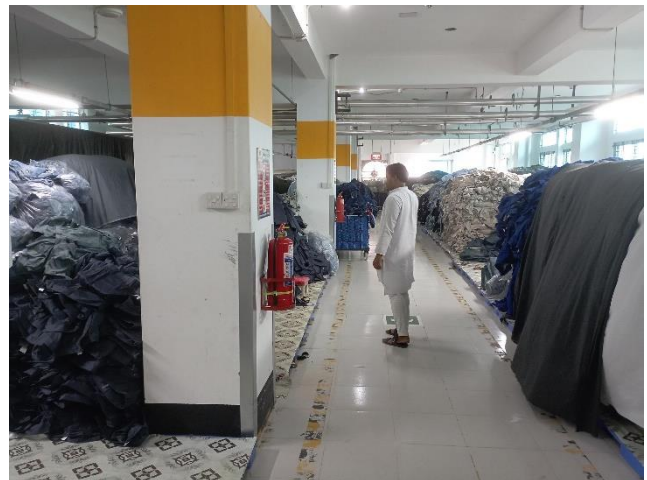
### Observation 2: Change in floor occupancy (Building 5-ETP Building-2).

**Description:** Undesignated prayer room found on 5<sup>th</sup> floor and undesignated storage found on 2<sup>nd</sup> floor. The building engineer is required to update the load plan and check the design as per BNBC requirements.

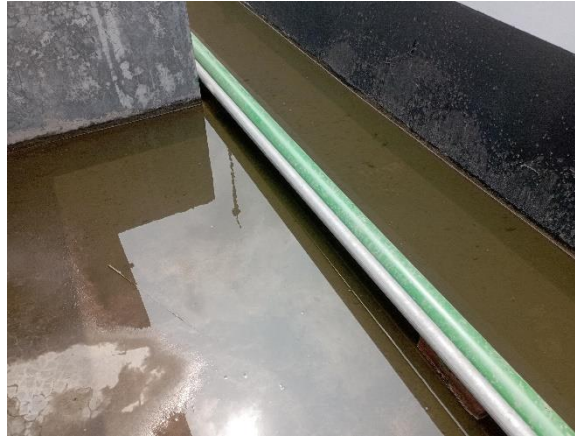
**Observation-3:** Water ponding on roof slab (Building 5: ETP Building-2).

**Description:** Water ponding was found on roof slab. The building engineer is required to improve drainage system on roof slab.

Observation	Action Plan	Timeline
<b>Building 5-ETP Building</b>		
Inadequate number of concrete cylinder test report (Building 5: ETP Building-2)	The building engineer is required to take at least four concrete cores from columns to confirm the design strength and revise the design report based on in-situ material strength and updated floor load plan. Submit the design documents to the RSC for further review.	within 6 weeks
Inadequate number of concrete cylinder test report (Building 5: ETP Building-2)	Implement remediation work if required.	within 6 months
Change in floor occupancy (Building 5: ETP Building-2).	The building engineer is required to update the load plan as per BNBC requirements.	within 6 weeks
Change in floor occupancy (Building 5: ETP Building-2).	Implement floor load management program.	within 6 months
Water ponding on roof slab (Building 5-ETP Building-2).	The building engineer is required to improve the drainage system on the roof slab.	within 6 months

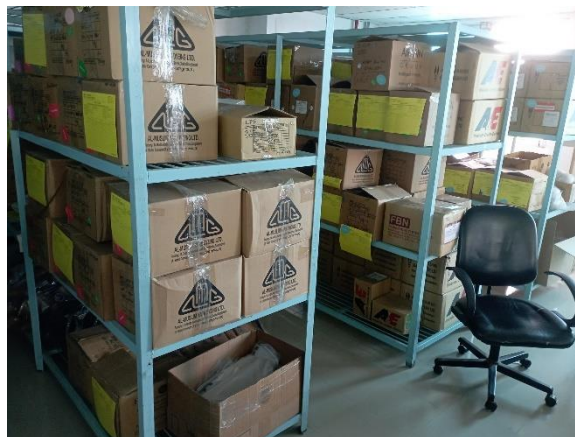
**Observation-4:** Non-structural elements found not anchored (Building 5-ETP Building-2)

**Description:** Nonstructural elements found not anchored. The building engineer is required to anchor/brace all nonstructural elements to resist the earthquake force.

Non-structural elements found not anchored (Building 5: ETP Building-2)	The building engineer is required to anchor/brace all non-structural elements to resist the earthquake force.	within 6 months
Inconsistencies in the design report (Yarn Dyeing Building)	The building engineer is required to take at least four concrete cores from each type of structural member to confirm the design strength and revise the design documents based on in-situ material strength.	within 6 weeks
Inconsistencies in the design report (Yarn Dyeing Building)	Implement remediation work if required.	within 6 months
Construction safety practice (Yarn Dyeing Building).	Building engineer is required to follow the prescribed construction safety practice as per BNBC Part VII Chapter 3.	within 6 weeks
Lateral stability of the shed needs to be reviewed. (Washing Building Unit 5)	The lateral stability of the shed is required to be reviewed in detail.	within 6 weeks

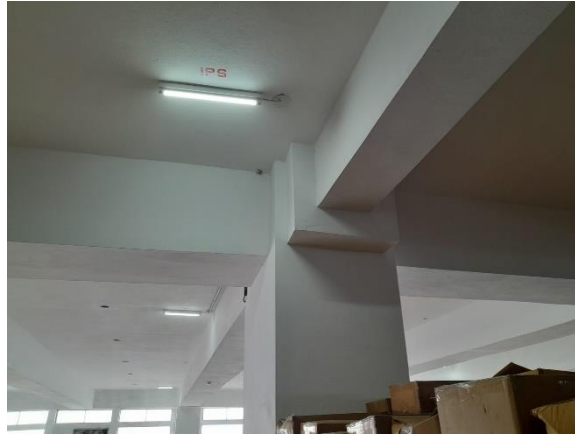
**Observation-5:** Inconsistencies in the design report (Yarn Dyeing Building)

To Assess a structure one of the key inputs is the concrete strength. Concrete strength **5000 psi** is considered for **Footing, Column and Beam** , **2045 psi** for slab & Strength deformed bar with Yield Strength 72,500 psi.

**Description:** The design strength of the column is considered as 34.5 MPa (5000 Psi) however the available concrete cylinder test report doesn't meet the frequency of testing requirement of BNBC. The diaphragm system, load transfer mechanism, integrity of pre-stressed & non-prestressed structural members are not clear. The details of prestressed beam and RC column is required to be incorporated in the design report.

The building engineer is required to take an adequate number of concrete cores from columns to confirm the design strength and revise the design documents accordingly.

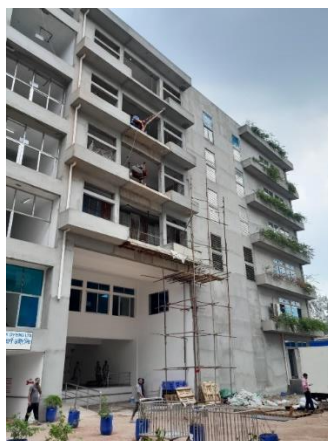
**Observation 6:** Construction safety practice (Yarn Dyeing Building).

**Description:** Lack of construction safety practice observed on the front part of the building.

The building engineer is required to follow the prescribed construction safety practice as per BNBC Part VII Chapter 3.

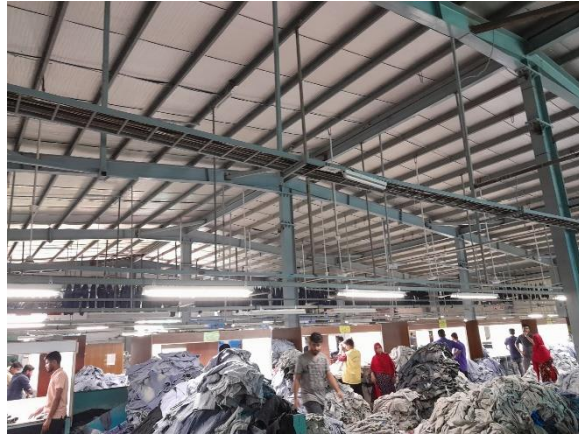
**Observation-6:** Lateral stability of the shed needs to be reviewed. (Washing Building Unit 5)

**Description:** The lateral stability of the shed needs to be reviewed in detail.

Lateral stability of the shed needs to be reviewed. (Washing Building Unit 5)	Implement remediation work if required.	within 6 months
Missing vertical bracing (Shed 2- Chemical Shed).	The building engineer is required to check the lateral stability of the shed.	within 6 weeks
	Install the missing bracing and any sort of alternatives if required.	within 6 months

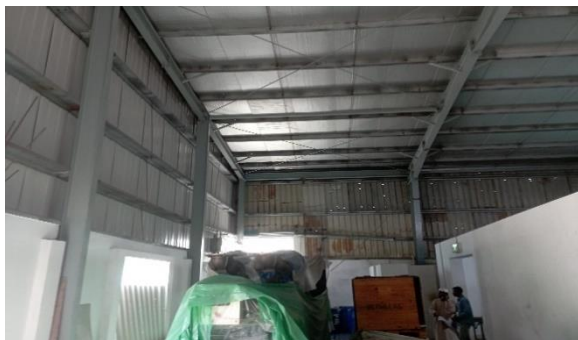
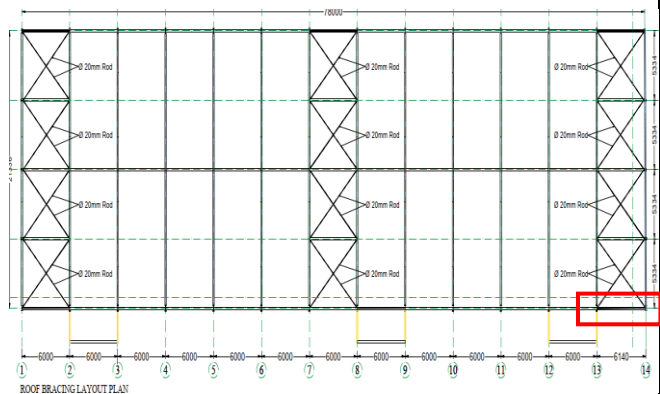
**Observation-8:** Missing vertical bracing (Shed 2- Chemical Shed).

**Description:** Vertical bracing was missing at a marked location. The building engineer is required to check the lateral stability of the shed and install the missing bracing if required.
