# Consist Apparels Ltd. - Extension 2 (previously Workfield Knitwears)

Bawpara, Kaultia, Gazipur Sadar, Gazipur

22 April 2024

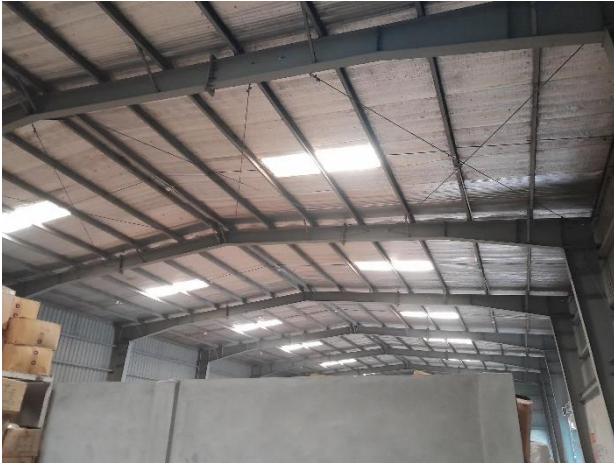
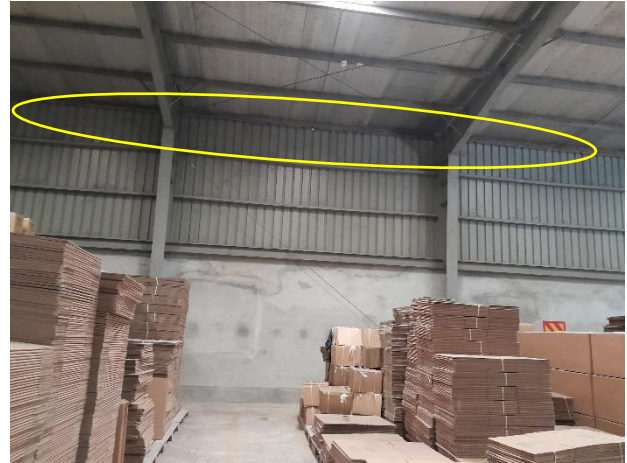
**Observation 1:** Lack of lateral stability (Shed 1). (Finished goods & Leftover store)

**Description:** Load transfer media is not provided along the long direction for this shed. Therefore, the lateral stability system of the shed is incomplete. Building engineer is required to check the lateral stability of the structure.

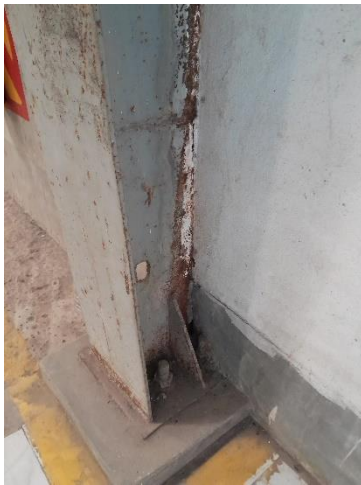
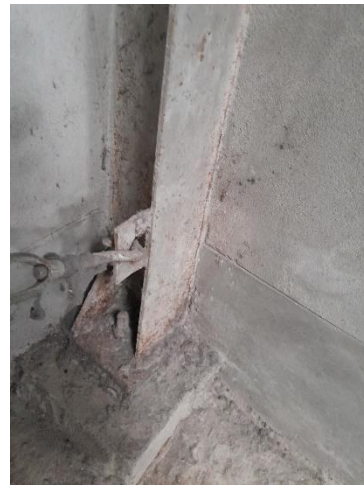
**Observation 2:** Corrosion on steel member. (Finished goods & Leftover store)

**Description:** Corrosion was observed on the ground floor steel column. The building engineer is required to provide rust-proof paint on corroded steel members to protect from corrosion.

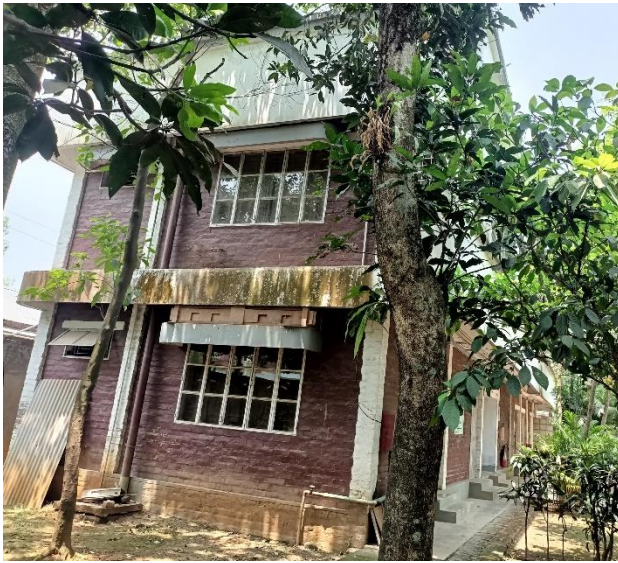
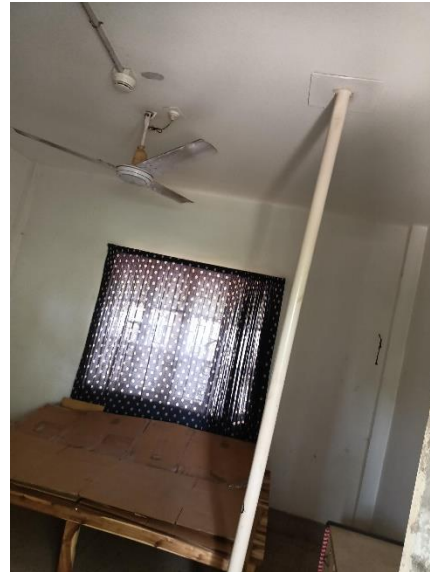
**Observation-3: Absence of design documents. (Guest House)**

**Description:** As per BNBC, every building or structure designed shall have its design documents prepared following the provision of Section 1.9.1. The design document shall include a design report, and a set of structural drawings, which shall be prepared in compliance with section 1.9.1.1 and section 1.9.1.2, part-6 of BNBC. At the time of inspection, only as-built drawings were available, but no design reports were available, which are required to be prepared in compliance with section 1.9.1.1 (part-6, BNBC).

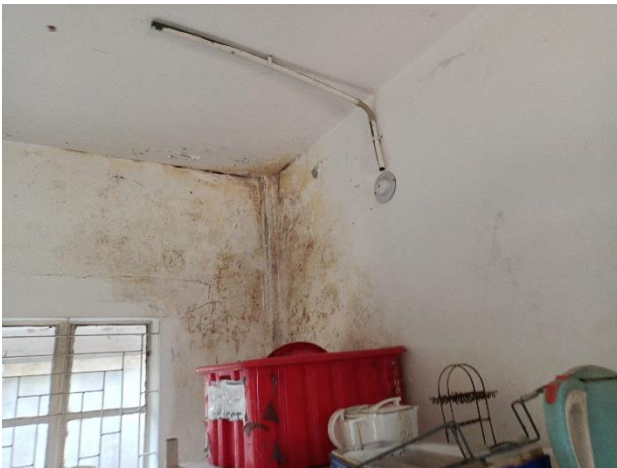
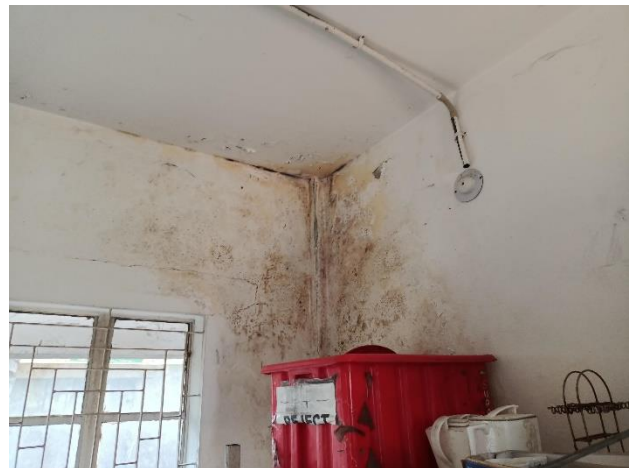
**Observation 4: Dampness on slab and walls. (Guest House)**

**Description:** Severe dampness was on the slab and walls. Building engineer is required to carry out suitable remedial works to remove the dampness.

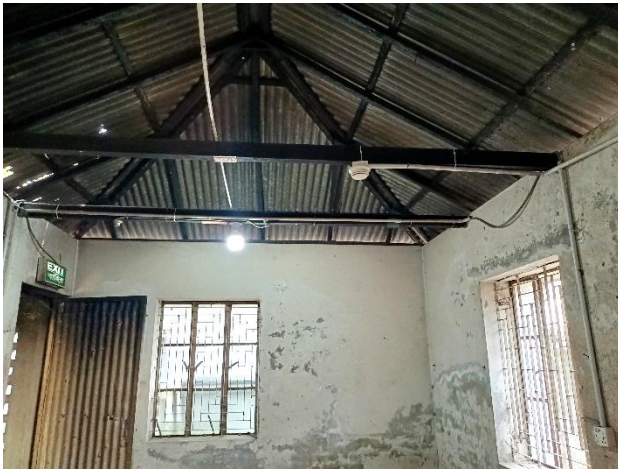
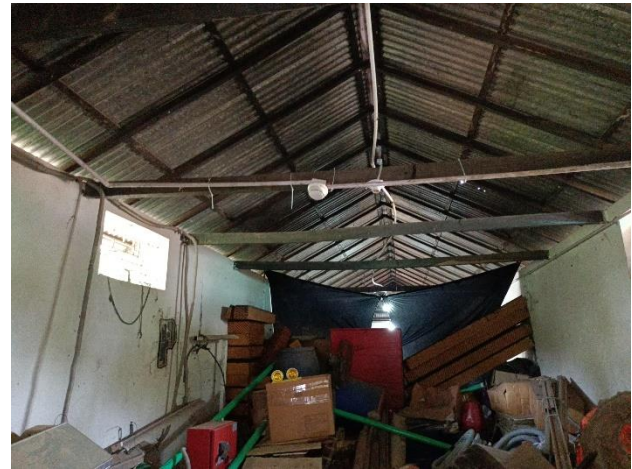
**Observation-5: Apparently non-engineered connection. (Wastage shed)**

**Description:** Inadequate connections were observed at the lightweight roof of the single-storied wooden sheds. The building engineer is required to check the connection adequacy of the lightweight roof against the uplift forces.

7	Apparently non-engineered connection. (Wastage shed)	The building engineer is required to check the connection adequacy of the lightweight roof against the uplift forces.	within 6 weeks
8		Carry out remedial works if required.	within 6 months
9	Lack of as-built drawings (Security Room-1, Security Check post-2, Check Post)	The building engineer is required to survey the whole structure and prepare a full set of as-built drawings.	within 6 weeks

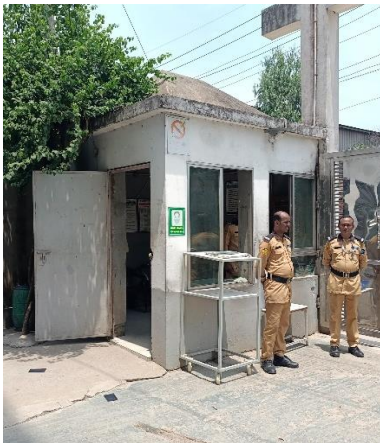
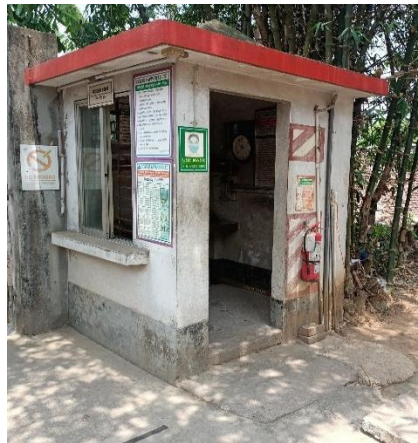
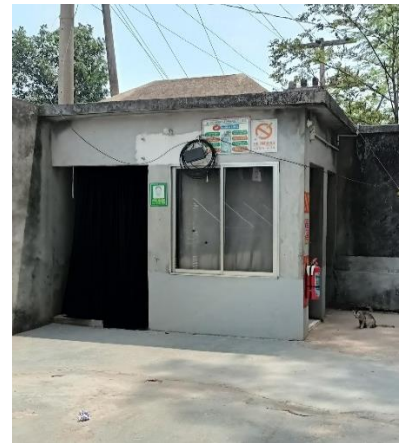
**Observation-6: Lack of as-built drawings (Security Room-1, Check Post)**

**Description:** As-built drawings were not available for the single-storied Security Room-1, Security Room-2, and Check Post. The building engineer is required to survey the whole structure and prepare a full set of as-built drawings.
