# Eusebio Sporting (Bangladesh) Limited

Plot # 38-47, 52-59, 59A, Sector - 03, KEPZ, North Patenga, Chattogram- 4204

8 February 2024

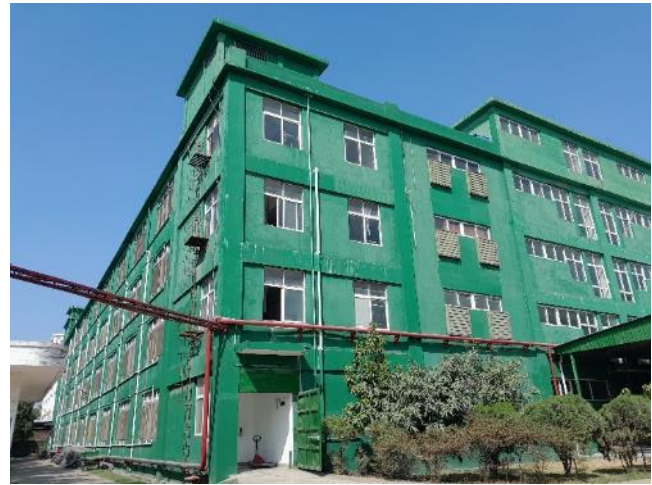
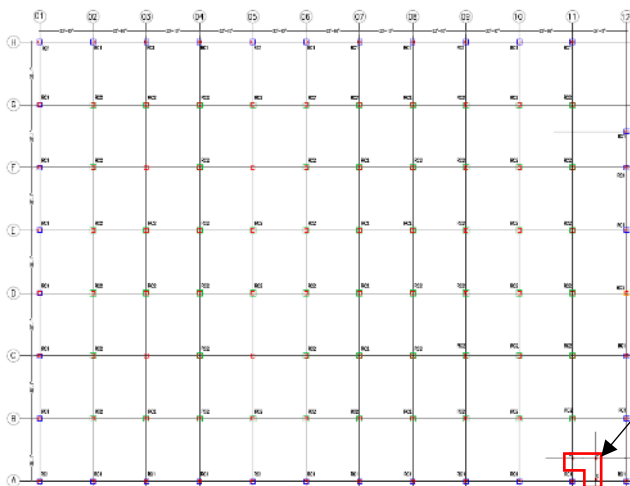
### Observation 1: C-type column not considered in design report. (Building 1)

**Description:** A set of design reports was found on site. As per recommendation of design report remediation was required for foundation, column, and beam. The factory had carried out all remedial works as per retrofitting drawing in 2017. But C type column (250x250 mm) was not considered in the design report. Also, during inspection an adequate amount of retrofitting material test report was not available. The building engineer is required to submit the design documents to the RSC for further review to justify the capacity of foundation, column, and beam & slab against the lateral & vertical loading. Also, verify the retrofitting material strength either from cylinder test report or by taking cores from retrofitted member.

| Observation | Action Plan | Timeline |
|---|---|---|
| C-type column not considered in design report. (Building 1). (Building 1) | The building engineer is required to submit the design documents to the RSC for further review to justify the capacity of foundation, column, and beam & slab against the lateral & vertical loading. | within 6 weeks |

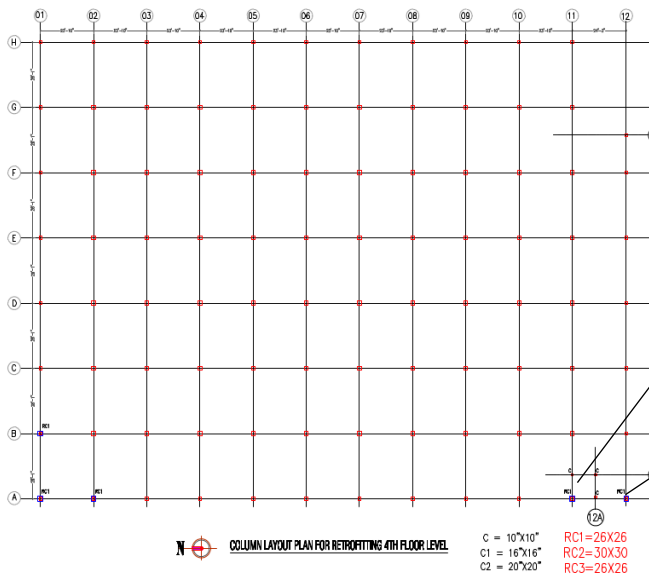
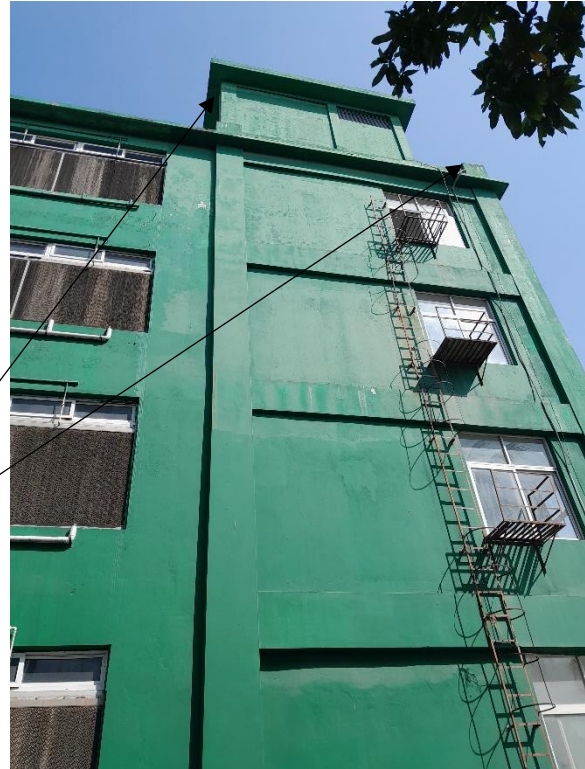
4<sup>th</sup> floor level column layout plan for retrofitting

## Observation 2: Mismatch in retrofitting drawing and as built drawing. (Building 1)

**Description:** During inspection a few mismatches were found in retrofitting drawing and as built drawing which are given below.

- Marked two columns were not retrofitted at 4<sup>th</sup> floor level. However, the corner column was constructed up to 3<sup>rd</sup> floor level, but other column was constructed up to 4<sup>th</sup> floor level but not retrofitted.
- Also, RC overhead water tank details were found missing in structural drawing.

The building engineer is required to survey the full structure and update the retrofitting drawing, as built drawing, and design report accordingly.

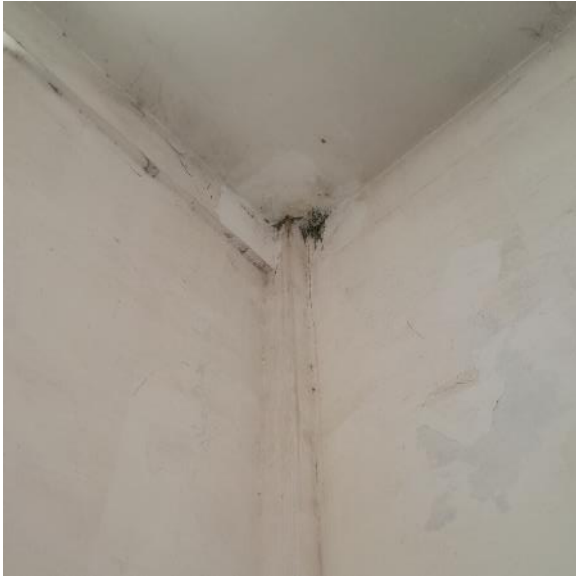
Dampness on stair roof slab

**Description:** Dampness and brick wall cracks were found at several locations. The building engineer is required to identify the reason for the dampness and crack on brick wall. Prepare an investigation report with the necessary repair method. Repair the crack as per the crack investigation report.

| Observation | Action Plan | Timeline |
|---|---|---|
| Dampness and brick wall crack. (Building 1) | The building engineer is required to identify the reason for the dampness and brick wall crack and prepare an investigation report with the necessary repair method and repair the dampness as per the investigation report. | within 6 months |

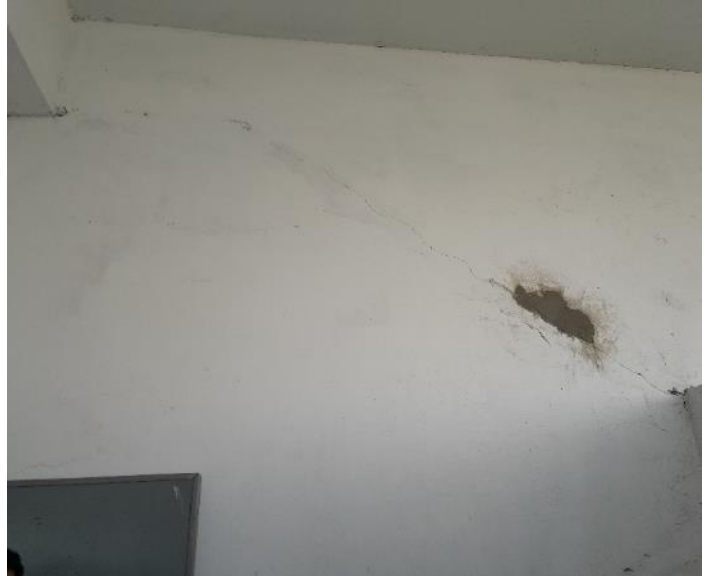
Brick wall crack at toilet zone

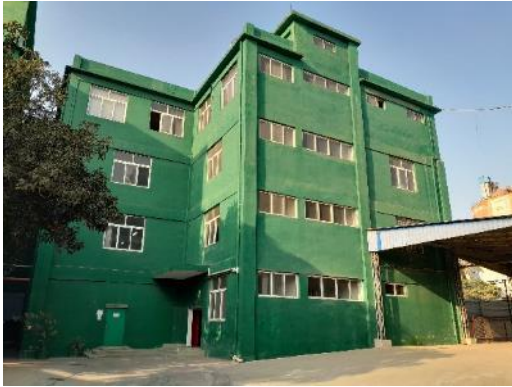
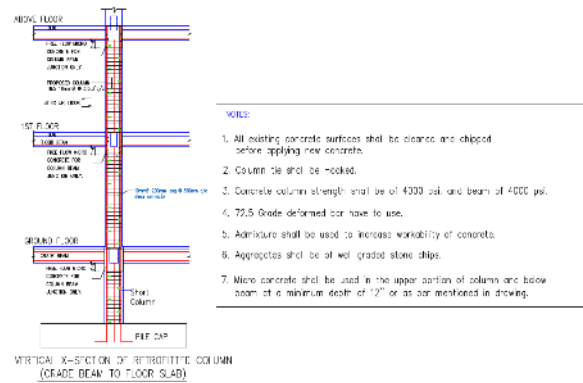
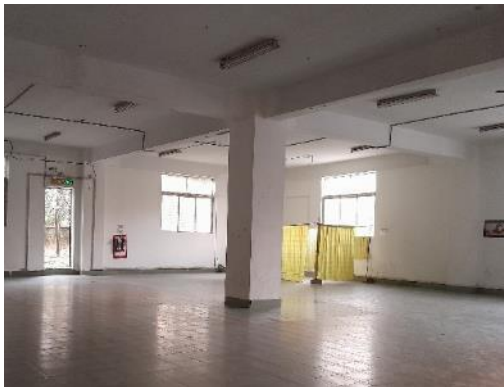
**Observation-4: Lack of retrofitting material test report. (Building 2)**

**Description:** A set of design reports was found on site. As per recommendation of design report remediation was required for foundation & column. The factory had carried out all remedial works as per retrofitting drawing in 2017. During inspection an adequate amount of retrofitting material test report was not available. The building engineer is required to submit the design documents to the RSC for further review to justify the capacity of foundation, column, and beam & slab against the lateral & vertical loading. Also, verify the retrofitting material strength either from cylinder test report or by taking cores from retrofitted member.

| Observation | Action Plan | Timeline |
|---|---|---|
| Lack of retrofitting material test report. (Building 2) | The building engineer is required to submit the design documents to the RSC for further review to justify the capacity of foundation, column, and beam & slab against the lateral & vertical loading. Also, verify the retrofitting material strength either from cylinder test report or by taking cores from retrofitted member. | within 6 weeks |

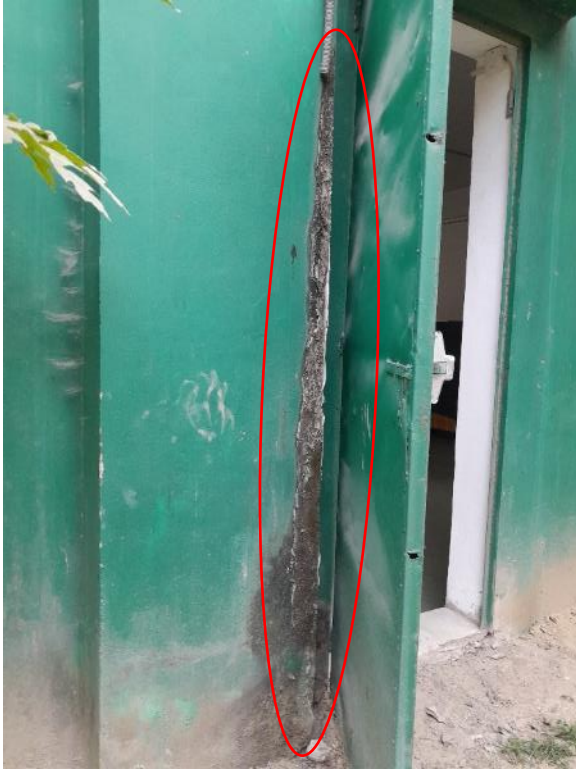
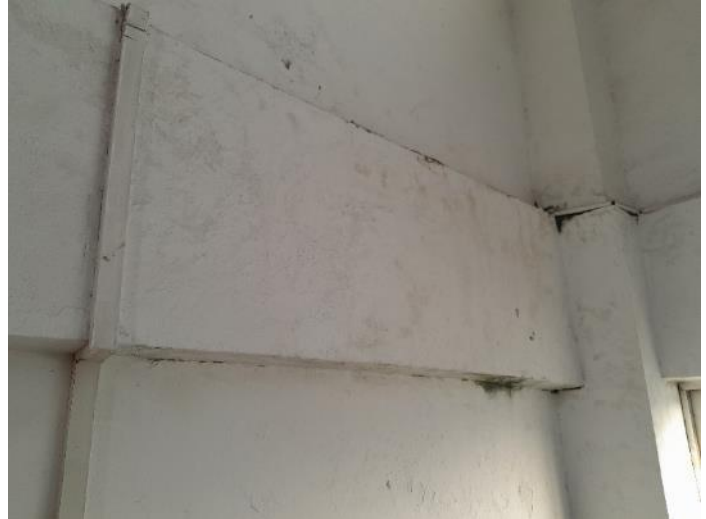
**Observation 5:** Dampness on column and brick wall. (Building 2)

**Description:** Dampness were found at several locations. The building engineer is required to identify the reason for the dampness and prepare an investigation report with the necessary repair method. Repair the dampness as per the investigation report.

| Observation | Action Plan | Timeline |
|---|---|---|
| Dampness on column and brick wall. (Building 2) | The building engineer is required to identify the reason for the dampness and prepare an investigation report with the necessary repair method. Repair the dampness as per the investigation report. | within 6 months |

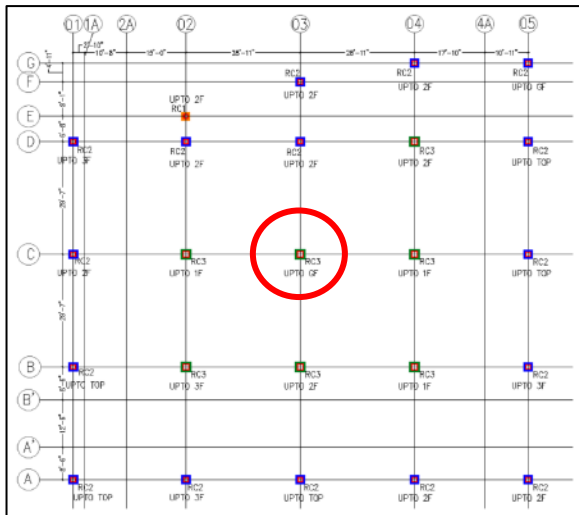
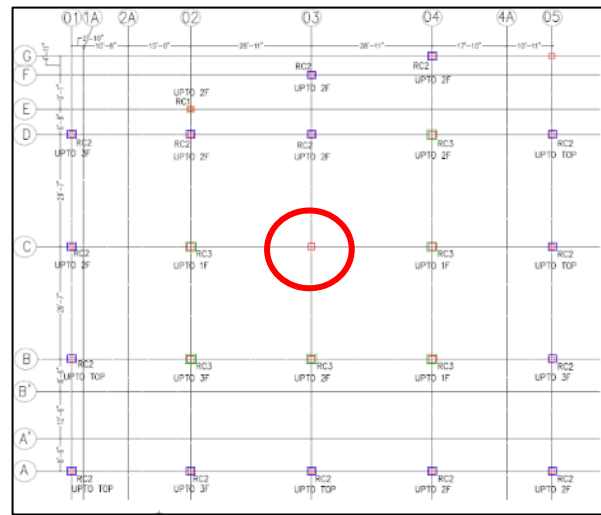
**Observation 6:** Stress in column exceeds normal design limit. (Building-3: Store and Dining Building)

**Description:** The marked column has been retrofitted only on ground floor level. The cursory calculation indicates that stress in the marked column of Grid (C-3) exceeds the normal design limit considering floor live load of 6 kPa for storage & 3 Kpa for canteen, roof live load of 1.5 kPa, and concrete strength of 13.8 MPa. The building engineer is required to review the design, loads, and column stresses for the marked columns based on in-situ material strength.

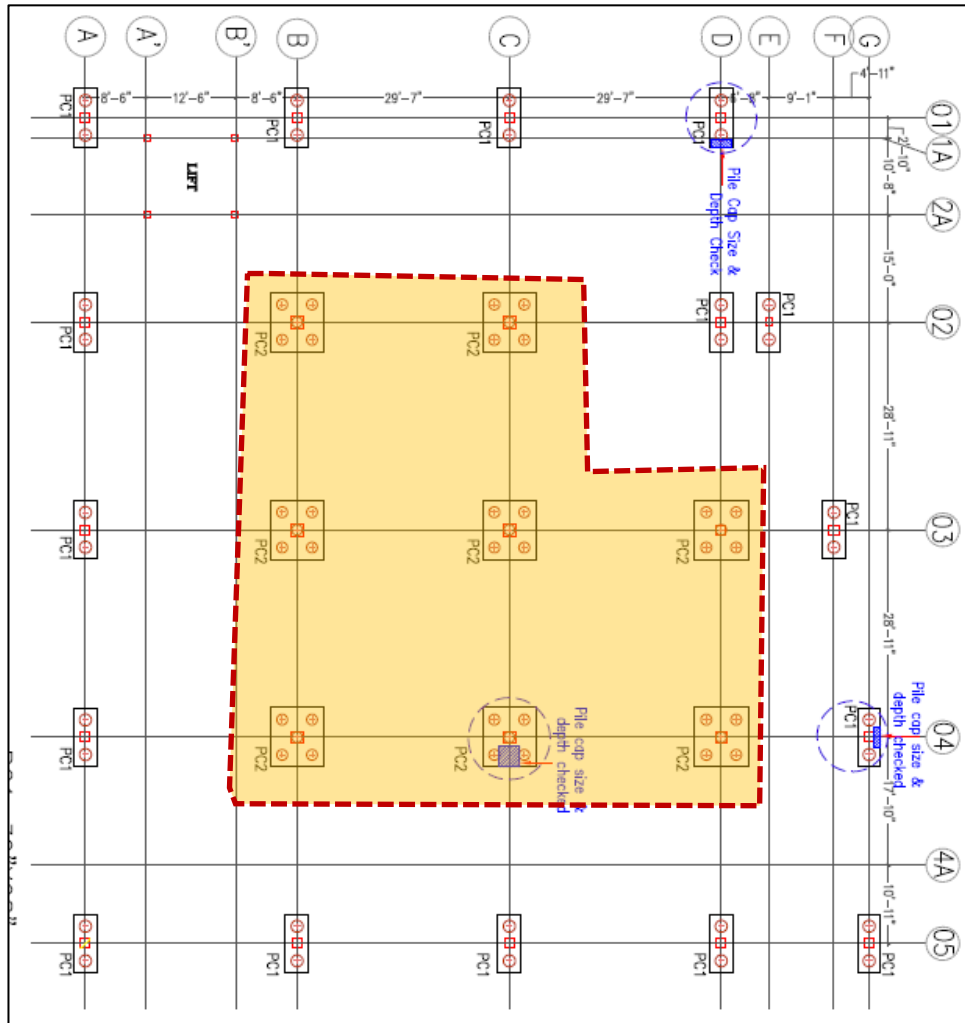
Stressed pile in foundation layout

**Observation 07:** Stress in pile foundation exceeds normal design limit. Building-3: Store and Dining Building)

**Description:** cursory calculation indicates that factor of safety (FoS) of some pile foundations is below the allowable limit considering the floor live load 6 kPa for storage, 3 kPa for cantten & 1.5 kPa for roof. Building engineer is required to review the design, loads and foundation stresses and prepare a remediation plan if required.

| Observation | Action Plan | Timeline |
|---|---|---|
| Stress in pile foundation exceeds normal design limit. Building-3: Store and Dining Building) | The building engineer is required to review the design, loads and foundation stresses and prepare a remediation plan if required. | within 6 weeks |

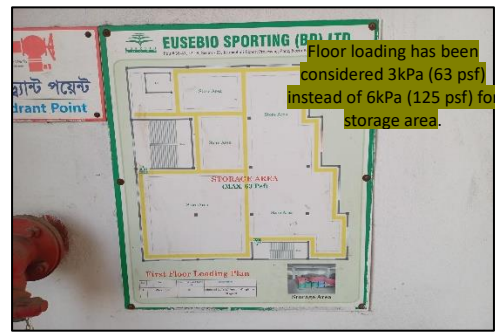
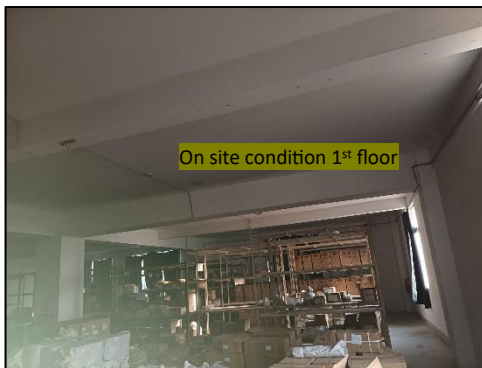
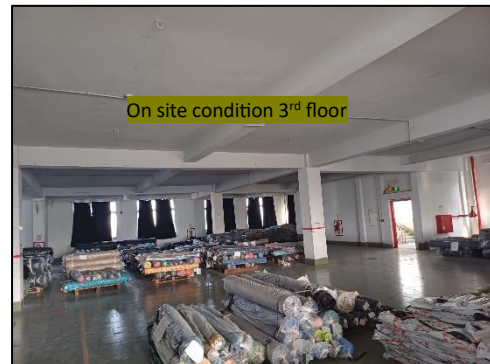
**Observation 08:** Storage live load limit does not comply with BNBC requirement. (Building-3: Store and Dining Building)

**Description:** As per BNBC, 6 kPa is required to consider as floor loading for the light storage facilities. During inspection, the load plan was found posted considering (63 psf) 3kPa at storage area. The Building Engineer is required to update the storage live load limit as per BNBC requirement, revise the structural analysis & design report accordingly.

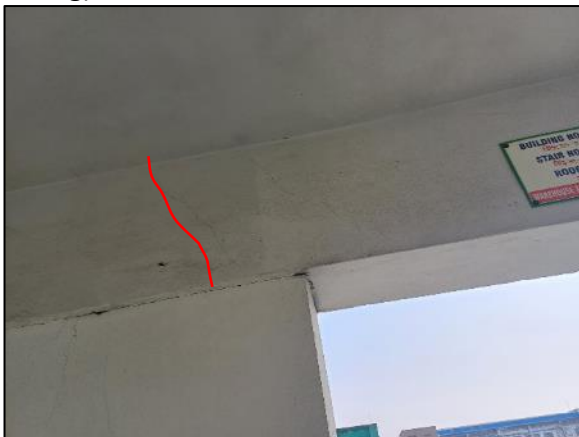
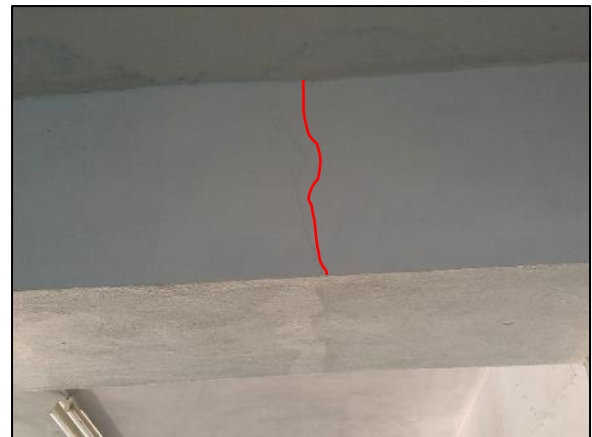
#### Hairline crack on beam at multiple location

**Description:** Hairline cracks were found on beams at several locations of different floors. The building engineer is required to identify the reason for the crack and prepare an investigation report. Factory is required to repair the crack as per the crack investigation report.

| Observation | Action Plan | Timeline |
|---|---|---|
| Hair line cracks in existing beams at multiple locations. (Building-3: Store and Dining Building) | The building engineer is required to identify the reason for the crack and prepare an investigation report with the necessary repair method. | within 6 weeks |
| | Implement remediation work as per crack investigation report. | within 6 months |

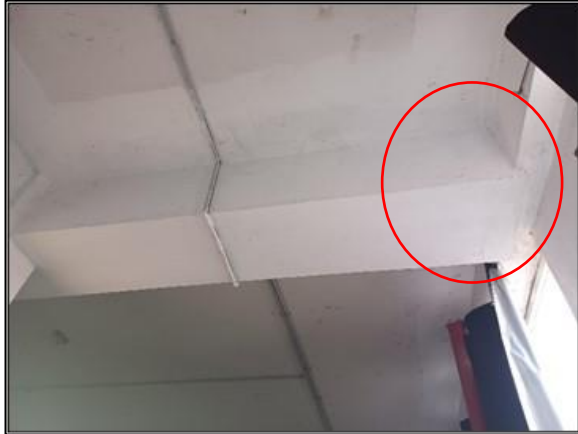
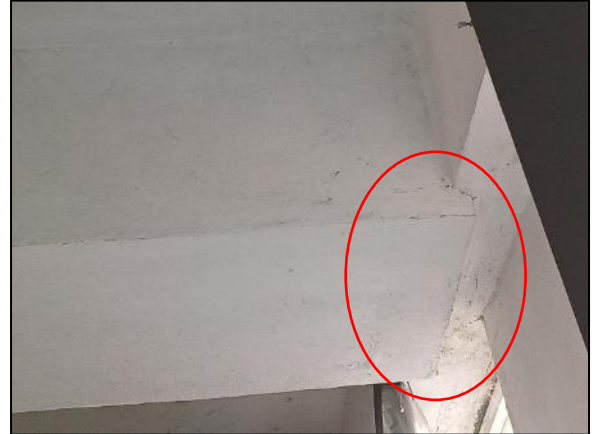
Inadequate joint of beam

**Description:** During inspection, marked joints appeared to be inadequate. The building engineer is required to check the connections adequacy and load path and suggest suitable remedial method if required.

| Observation | Action Plan | Timeline |
|---|---|---|
| Apparently Inadequate Joint of retrofitted beam. (Building-3: Store and Dining Building) | The building engineer is required to investigate and check the connections and load path of beams. | within 6 weeks |

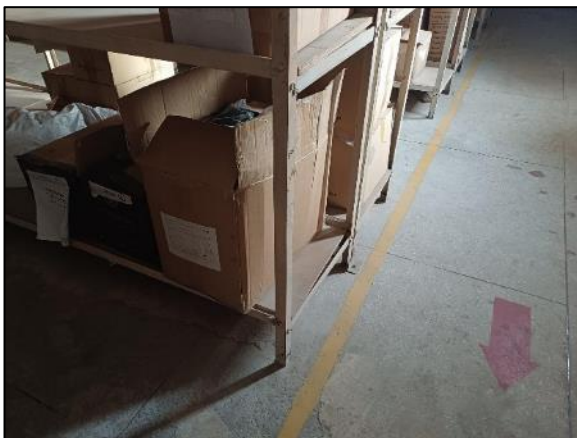
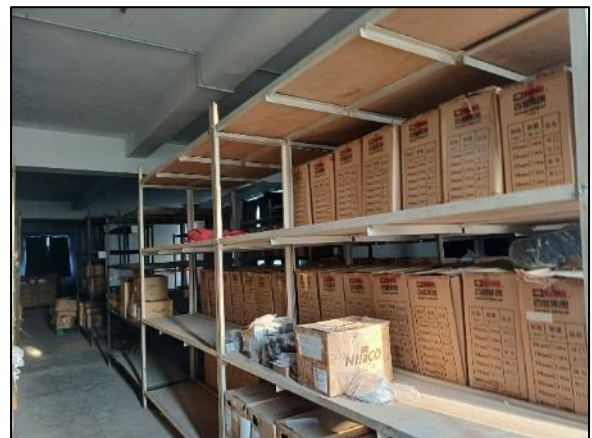
Storage rack without anchorage

**Description:** Racks on different floors are not adequately anchored or braced to resist lateral (earthquake) forces. The factory is required to adequately anchor and brace all non-structural elements to resist earthquake forces to comply with the BNBC.

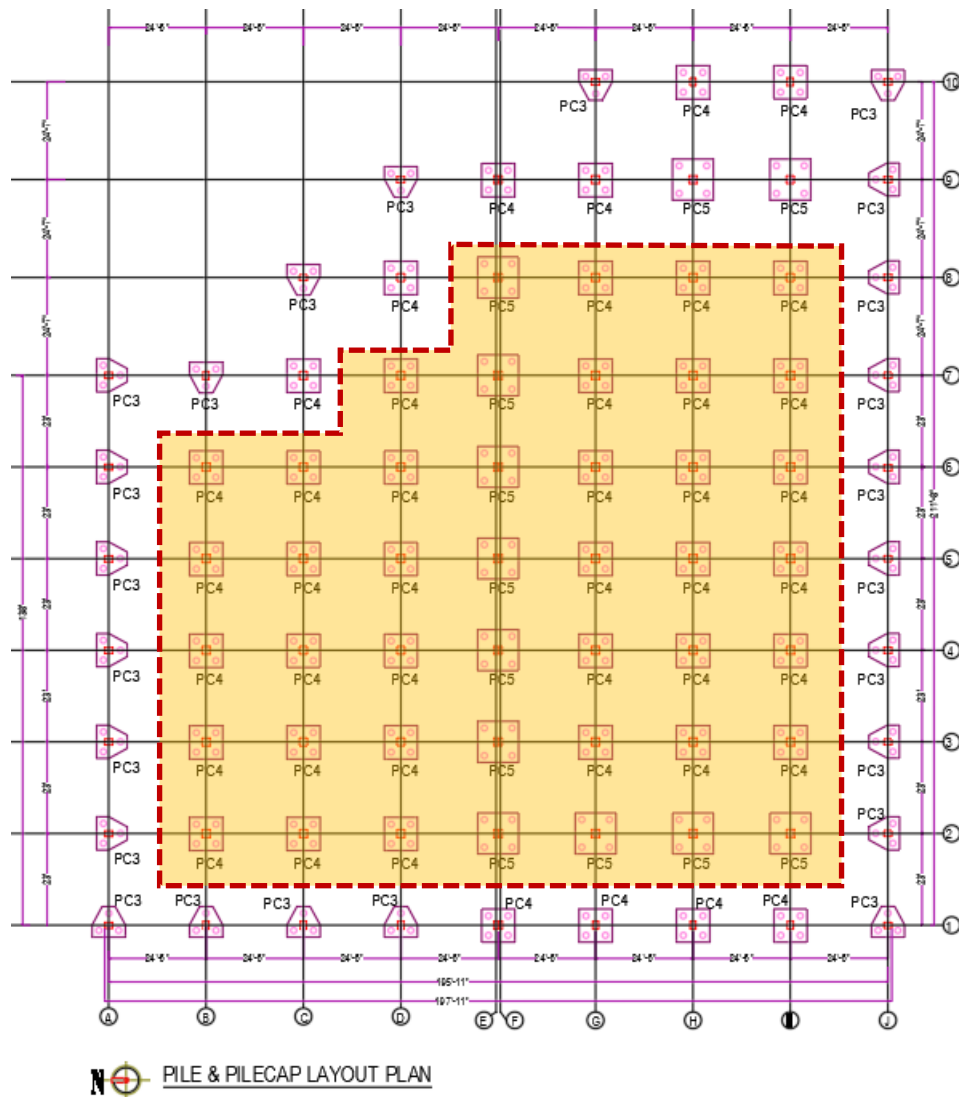
Stressed pile in foundation layout

**Observation 12:** Stress in pile foundation exceeds normal design limit. (Building 04)

**Description:** cursory calculation indicates that factor of safety (FoS) of some pile foundations is below the allowable limit considering the floor live load 6 kPa for 1<sup>st</sup>, 4<sup>th</sup> and 5<sup>th</sup> floor, 3 kPa for 2<sup>nd</sup> and 3<sup>rd</sup> floor, 1.5 kPa for roof, super imposed load from overhead water tank and ultimate pile capacity 142.65 Ton. Building engineer is required to review the design, loads and foundation stresses and prepare a remediation plan.

| Observation | Action Plan | Timeline |
|---|---|---|
| Stress in pile foundation exceeds normal design limit. (Building 04) | The building engineer is required to review the design, loads and foundation stresses and prepare a remediation plan. | within 6 weeks |

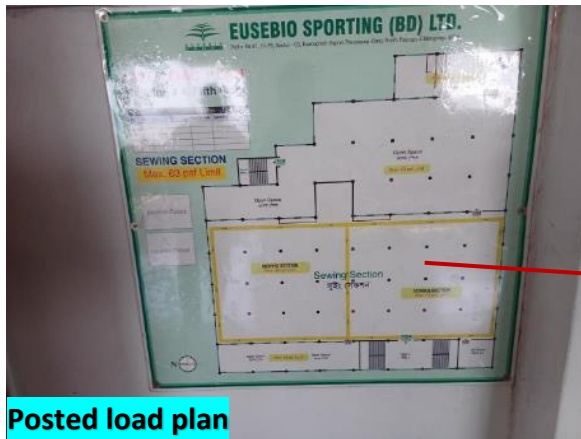
Posted load plan

**Description:** In design report, live load for typical floor was considered 2 kPa and for roof 1kPa. As per BNBC- Part 6, live load for light workspace (without storage) is required to be considered minimum 3 kPa and for light storage to be considered minimum 6 kPa. Also, load plan was not posted in several floors. Therefore, building engineer is required to revise the load plan as per BNBC requirement and check the design accordingly. Also, post and implement the accepted load plan on each floor.

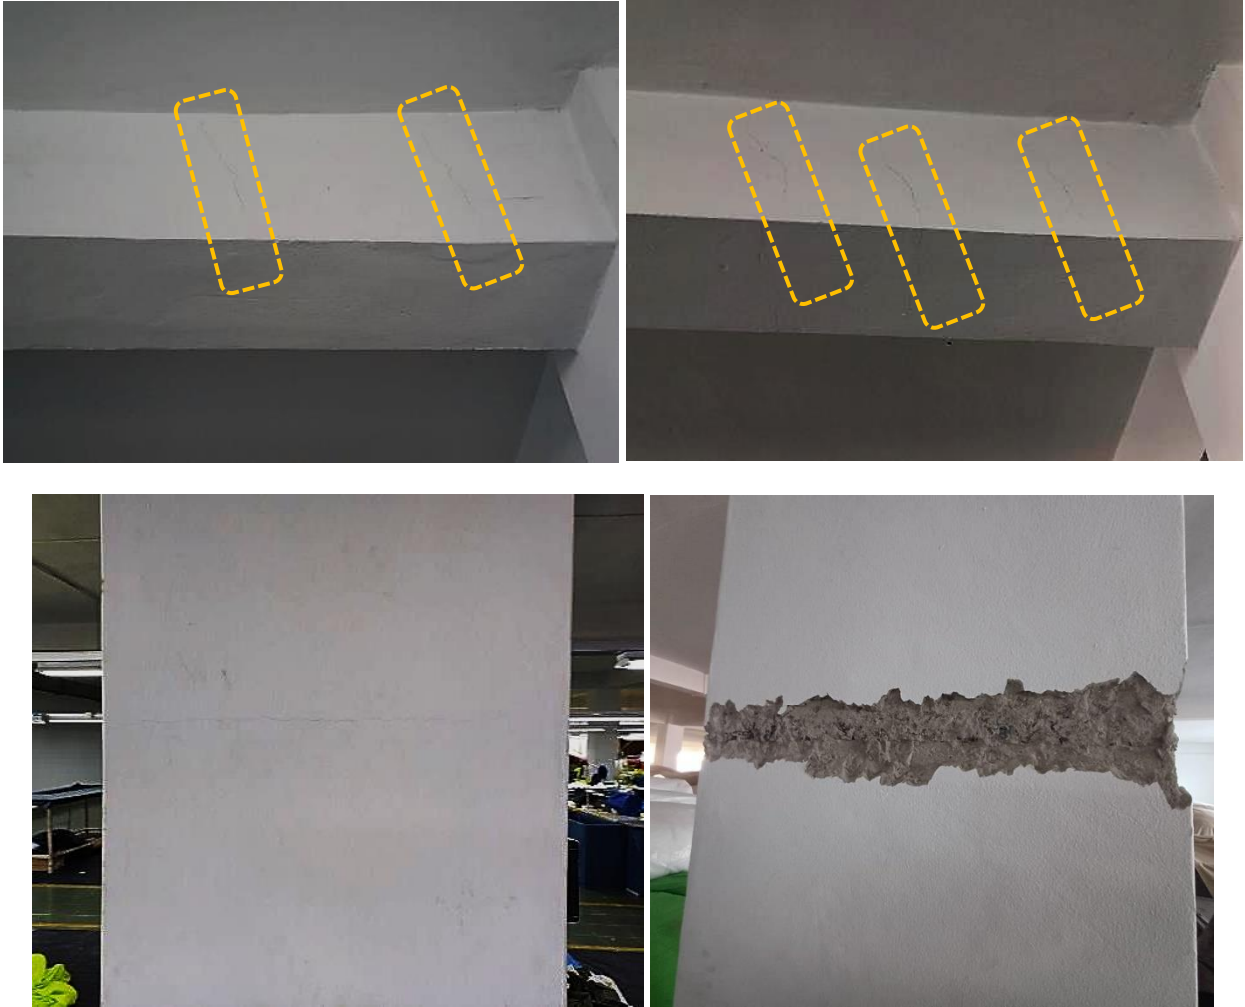
**Observation-15:** Hairline cracks on beams and horizontal hairline cracks on columns (Building-04)

**Description:** Hairline cracks were found on roof level beams at several locations. Also, horizontal hairline cracks were found on retrofitted columns at several locations. The building engineer is required to identify the reason for the crack and prepare an investigation report with the necessary repair method. Also, repair the cracks as per the crack investigation report.

| Hairline cracks in beams and horizontal hairline cracks in columns (Building-04) | The building engineer is required to identify the reason for the crack and prepare an investigation report with the necessary repair method. | within 6 weeks |
| | Repair the cracks as per the crack investigation report. | within 6 months |

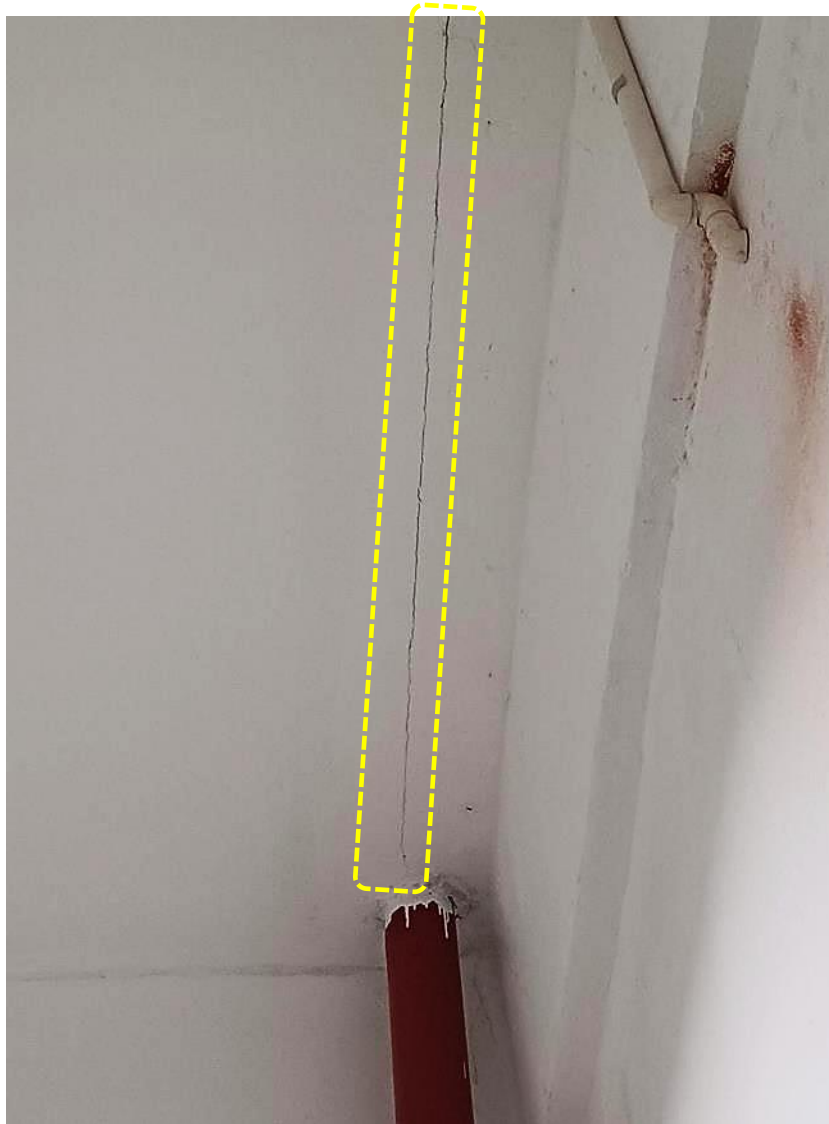
Construction joint with Building-04

**Description:** During inspection, the construction joint between RC Emergency Exit Stair-2 and Building-04 was found filled with cement mortar. Building engineer is required to investigate for any damage due to absence of sealant and suggest & install proper filler material all over the structure & maintain it properly.

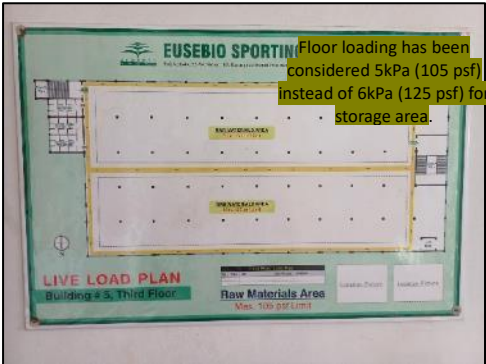
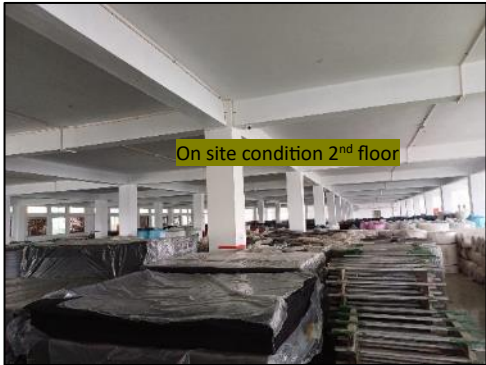
On site condition 2<sup>nd</sup> floor

**Description:** As per BNBC, 6 kPa is required to consider as floor loading for the light storage facilities. During inspection, the load plan was found posted considering (105 psf) 5kPa at storage area. The Building Engineer is required to update the storage live load limit as per BNBC requirement, revise the structural analysis & design report accordingly.

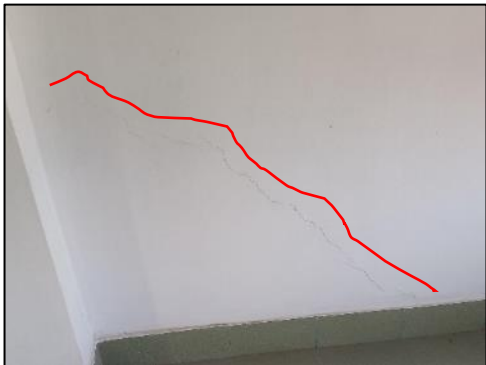
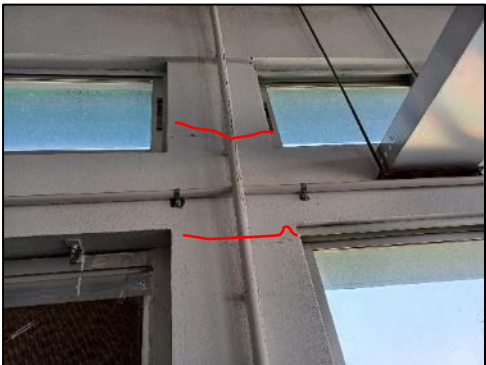
**Observation 20:** Crack on brick wall. (Building-5)

**Description:** Crack was found at several locations in brick wall. The building engineer is required to identify the reason for the crack in all locations of the building and prepare an investigation report with the necessary repair method. The factory is required to repair the crack as per the crack investigation report.

| Crack on brick wall. (Building-5) | The building engineer is required to identify the reason for the crack for all locations of the building and prepare an investigation report with the necessary repair method. | within 6 weeks |
| | The factory is required to repair the crack as per the crack investigation report. | within 6 months |

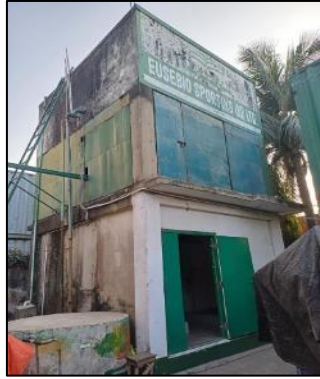
**Observation-21: Lack of design documents (Building-6)**

**Description:** OHWT was found on the building. As-built drawing and design documents were not available for the building.

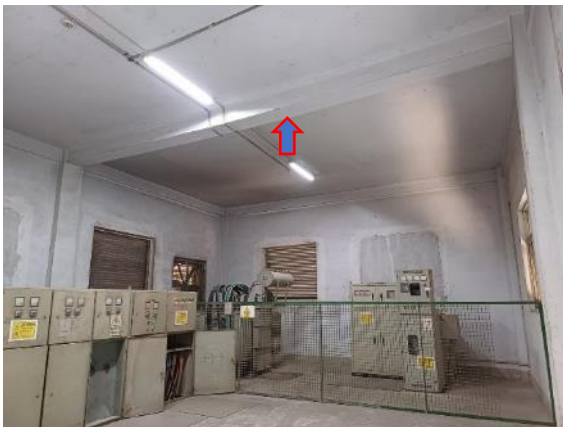
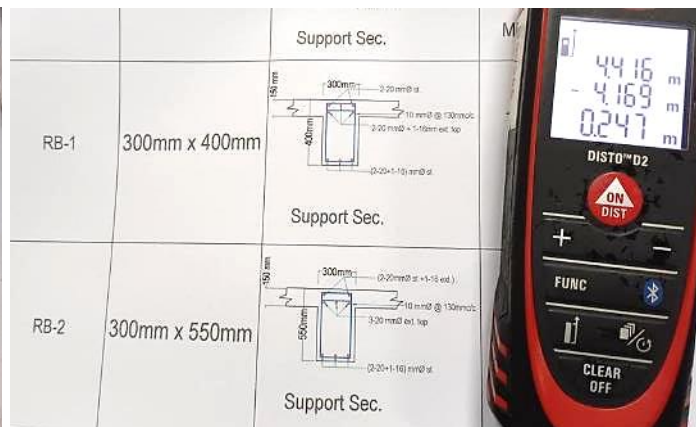
**Observation-22: Mismatch in structural drawing (Building-7)**

**Description:** Beam size was found lower than the size shown in drawing. Down stand of beam was measured 247 mm instead of 400 mm.

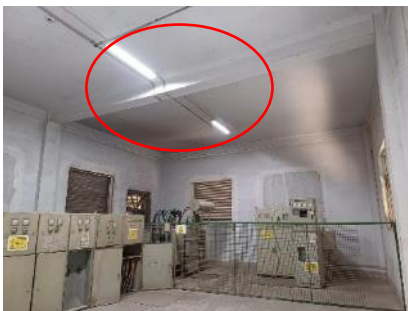
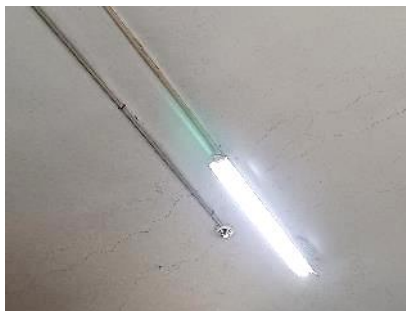
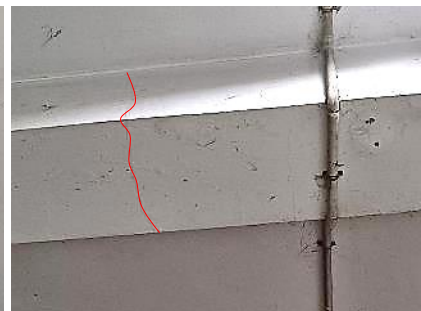
**Observation-23: Hairline crack on the soffit of roof beam & slab (Building-7)**

**Description:** Hairline cracks were found on the soffit of roof beam & slab. The building engineer is required to identify the reason for the crack and prepare an investigation report with the necessary repair method. Repair the crack as per investigation report.

| <b>Building-6</b> | | |
|---|---|---|
| Hairline crack on the soffit of roof beam & slab (Building-7) | The building engineer is required to identify the reason for the crack and prepare an investigation report with the necessary repair method. Repair the crack as per the suggestion of crack investigation report. | within 6 weeks |

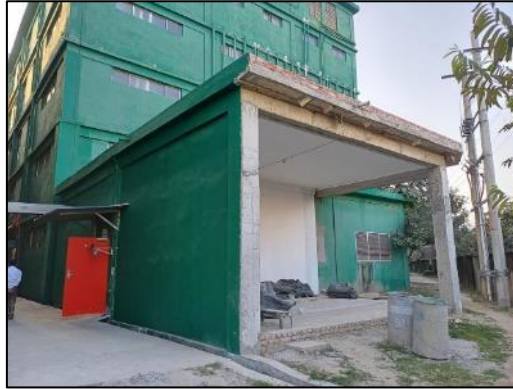
**Observation-24:** Lack of as-built drawing (Building-8)

**Description:** As built was not available for the structure which to be prepared.

| <b>Building-6</b> | | |
|---|---|---|
| Lack of as-built drawing (Building-8) | The building engineer is required to survey the whole structure and prepare the as built drawings as per site condition. | within 6 weeks |

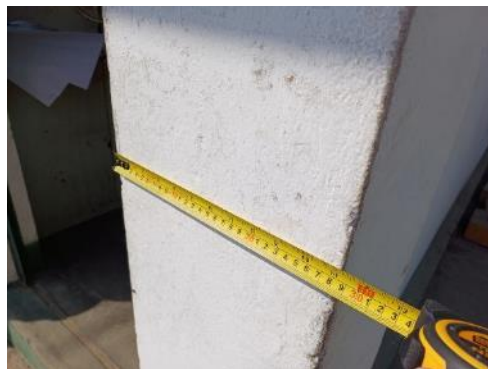
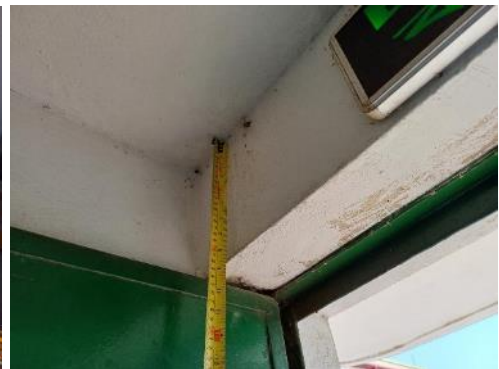
**Observation-25:** Mismatch between drawing and onsite condition (Building-9).

**Description:** The building dimensions, column and beam sizes do not match the provided drawing. The column size was measured 250 mm instead of 300 mm, down stand beam was measured 200 mm instead of 275 mm and building sizes found difference than the dimensions provided in the drawing. Update as-built drawing.

| <b>Building-6</b> | | |
|---|---|---|
| Mismatch between drawing and on-site condition (Building-9). | The building engineer is required to survey the whole structure and update the as built drawings as per site condition. | within 6 weeks |

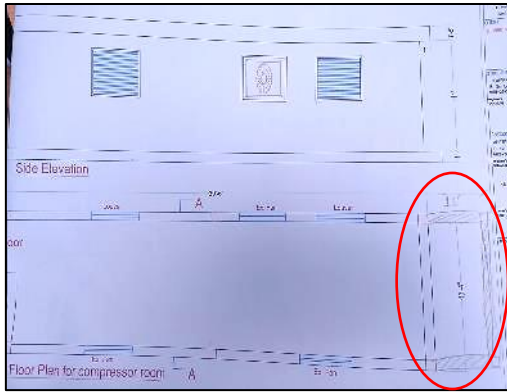
Extension not shown in drawing

**Description:** Horizontal expansion of one bay was found onsite which was not reflected in the drawing. Update as-built drawing.

| <b>Building-6</b> | | |
|---|---|---|
| Horizontal extension not reflected in the drawing. (Building-10) | The building engineer is required to survey the whole structure and update the as built drawings as per site condition. | within 6 weeks |

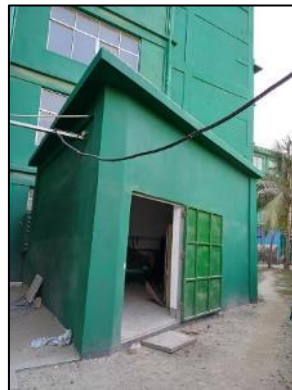
**Description:** As built was not available for the structure which to be prepared. Produce as-built drawing.

| <b>Building-6</b> | | |
|---|---|---|
| Lack of as-built drawing (Building-11) | The building engineer is required to survey the whole structure and update the as built drawings as per site condition. | within 6 weeks |

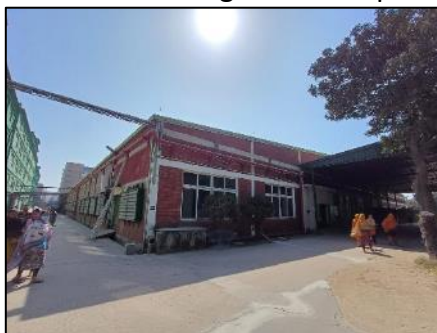
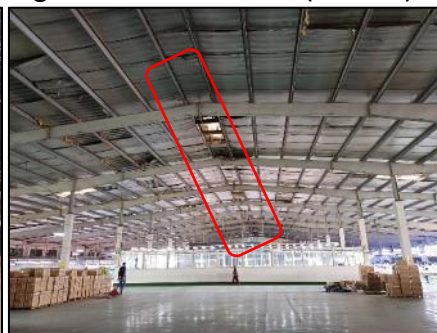
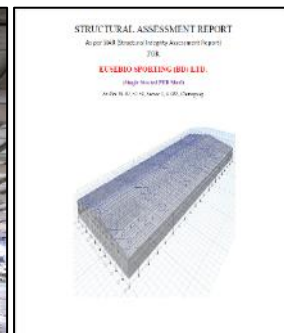
Shed-1

**Observation-28:** Design check required against lateral forces. (Shed-1)

**Description:** There is no lateral load transfer media along the ridge and internal column line of the steel rafter. A set of design documents was available onsite which is required to be submitted to RSC for detailed review against lateral forces. Revise the design documents based on in-situ material strength and submit to the RSC for review.

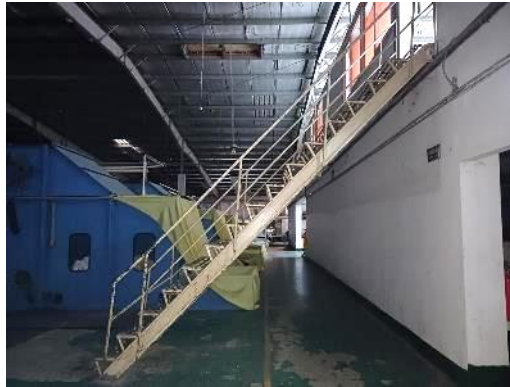
**Observation-29:** Undocumented steel stair. (Shed-1)

**Description:** Undocumented steel stair was found in south mezzanine floor have no drawing documents. Update as-built drawing.

| <b>Building-6</b> | | |
|---|---|---|
| Undocumented steel stair. (Shed-1) | The building engineer is required to survey the whole structure and update the as built drawings as per site condition. | within 6 weeks |

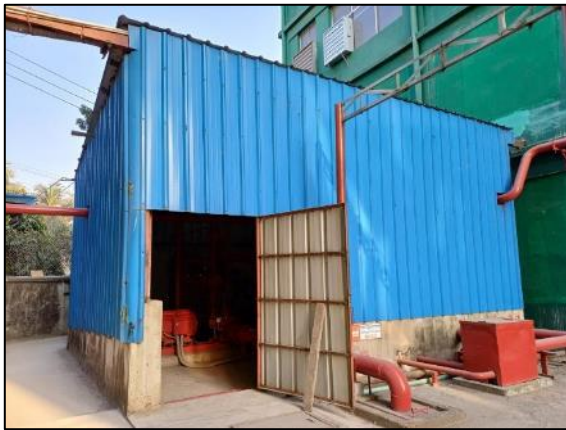
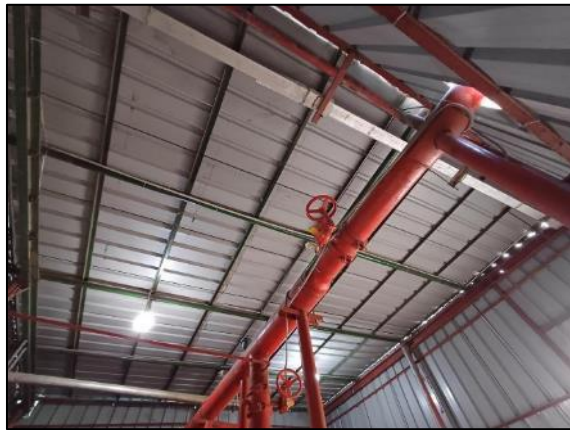
**Observation-30:** Apparent lack of lateral stability. (Shed-2)

**Description:** The stability system of the structure is apparently inadequate. Also, the channel shaped steel rafter was found instead of MS pipe. The building engineer is required to survey the structure, prepare as-built drawings, check the stability of the structure and submit the documents to the RSC.

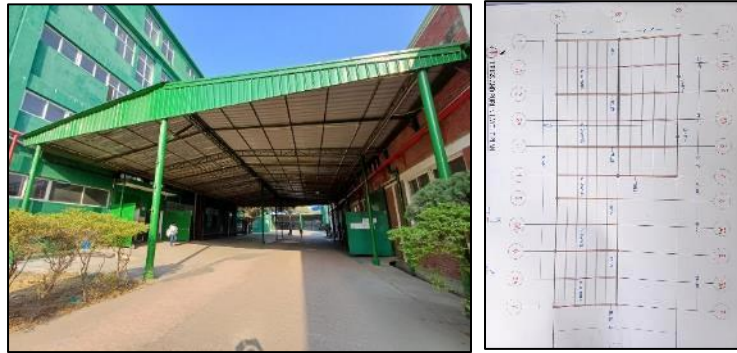
**Observation-31:** Apparently inadequate lateral stability and member sizes. (Shed-3)

**Description:** The roof of the shed is made by 50x50 and 38x38 mm MS angles. The member sizes of the shed are apparently inadequate, and no bracing system is provided. Also, the column layout and roof extent doesn't match with the provided drawings. The building engineer is required to survey the structure, prepare as-built drawings, check the stability of the structure, and submit the documents to the RSC.

| <b>Shed-2</b> | | |
|---|---|---|
| Apparently inadequate lateral stability and member sizes. (Shed-3) | The building engineer is required to survey the structure, prepare as-built drawings, check the stability of the structure, and submit the documents to the RSC. | within 6 weeks |

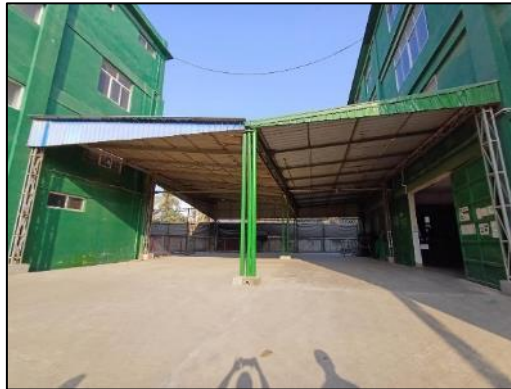
**Observation-32:** Undocumented steel fire pump shed. (Shed-4)

**Description:** Undocumented steel shed observed between Building-2 & 3 has no drawing and design documents. The building engineer is required to survey the structure, prepare as-built drawings, check the stability of the structure, and submit the documents to the RSC.

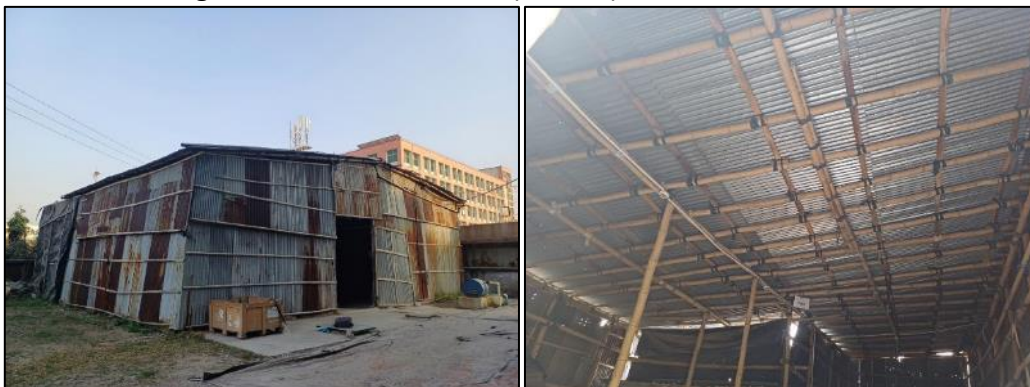
**Observation-33:** Non-engineered bamboo shed. (Shed-5)

**Description:** Non-engineered bamboo shed was found beside Building-5. The building engineer is required to suggest necessary alternatives for the structure.
