# Norban Comtex Ltd. (Extension)

Mouza Sarabo, Chakarborti, Kashimpur, Gazipur

19 February 2024

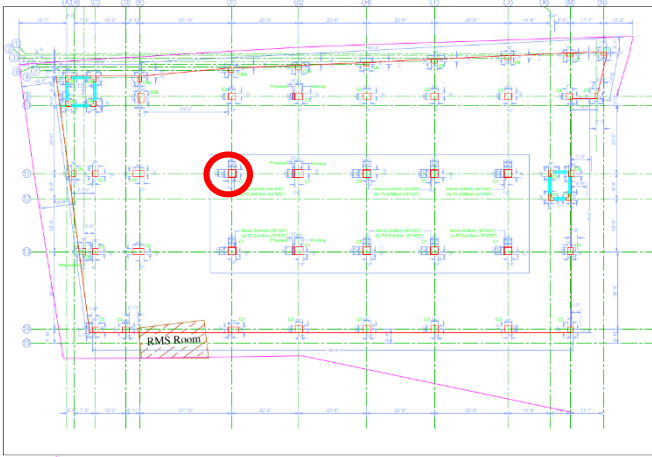
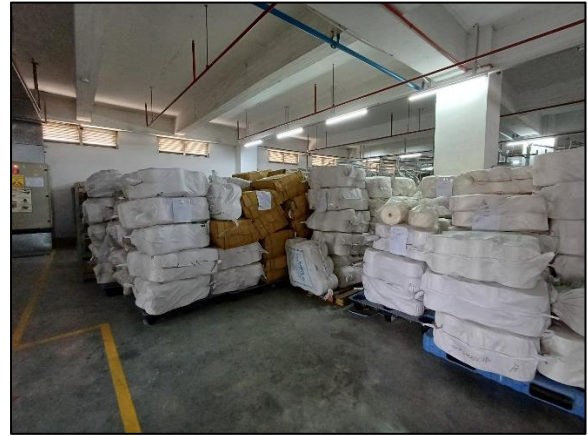
### Observation-1: Stress in column exceeds normal design limit. (Building – 1)

**Description:** The cursory calculation indicates that the red mark column stress exceeds the normal design limit considering a typical floor live load of 6kPa, roof live load of 1.5 kPa, and minimum concrete strength based on aggregate type. The building engineer is required to review the design, loads, and column stresses for the marked columns based on in-situ material strength.

| Observation | Action Plan | Timeline |
|---|---|---|
| Stress in the column exceeds the normal design limit. (Building – 1) | Verify in-situ material strength by taking a minimum 4-100mm dia. core from the lower tier of the building. | within 6 weeks |
| | Building engineer is required to review the design load. | within 6 weeks |
| | Produce and actively manage a loading plan for all floor plates within the factory, considering floor and column capacity. | within 6 weeks |
| | Carry out the suggested remedial works if required. | within 6 months |

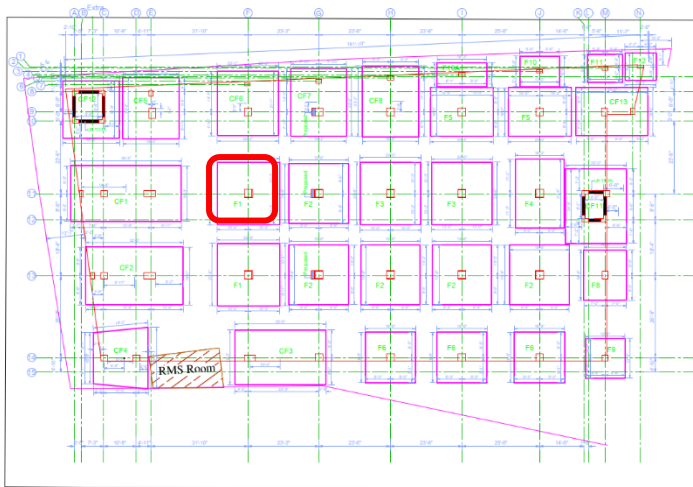
### Observation-2: The foundation found to be stressed. (Building – 1)

**Description:** Cursory calculation indicates the highlighted foundation is inadequate for bearing. The loading is considered 6kPa for a typical floor and the allowable bearing capacity of soil is 1.5 tsf (FS: 2.5) at 2.4 m depth. The building engineer is required to verify in-situ material strength and review the design load and foundation stresses.

| Observation | Action Plan | Timeline |
|---|---|---|
| Foundation found to be stressed. (Building – 1) | Verify in-situ material strength. | within 6 weeks |
| | Building engineer is required to review the design load and foundation stresses. | within 6 weeks |
| | Produce and actively manage a loading plan for all floor plates within the factory, considering floor, column, and foundation capacity. | within 6 weeks |
| | Carry out the suggested remedial works if required. | within 6 months |

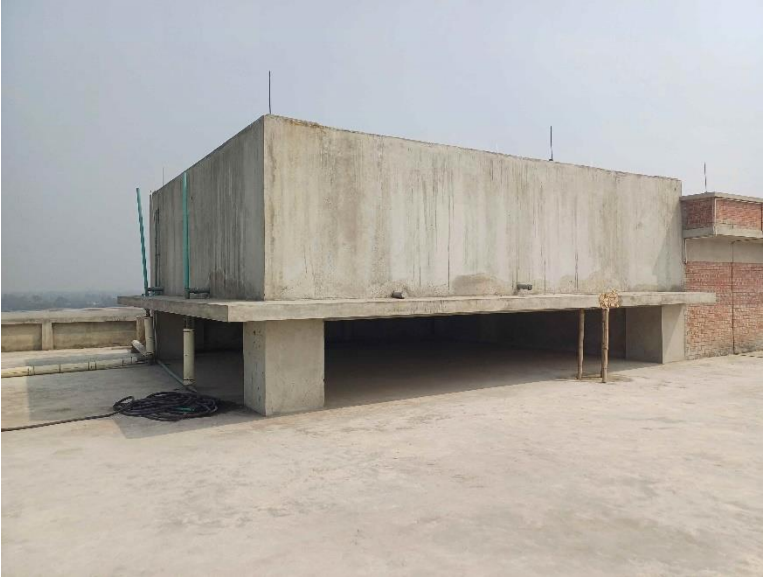
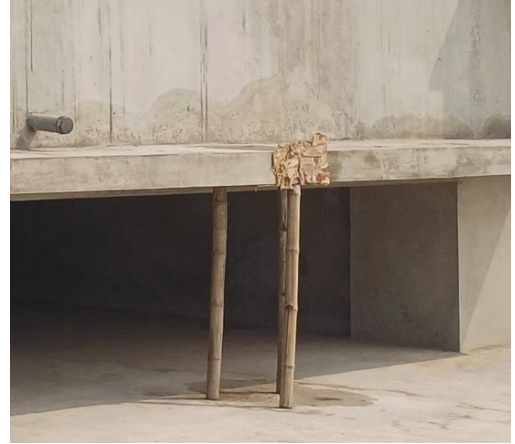
**Observation 3:** Dampness and water leakage from overhead water tank. (Building – 1).

**Description:** During the inspection, Dampness and water leakage from the overhead water tank were observed. The building engineer is required to seal the leakage and repair the damp portion of the wall and slab.

| Observation | Action Plan | Timeline |
|---|---|---|
| Dampness and water leakage from overhead water tank. (Building – 1). | The building engineer is required to seal the leakage and repair the damp portion of the wall and slab. | within 6 weeks |

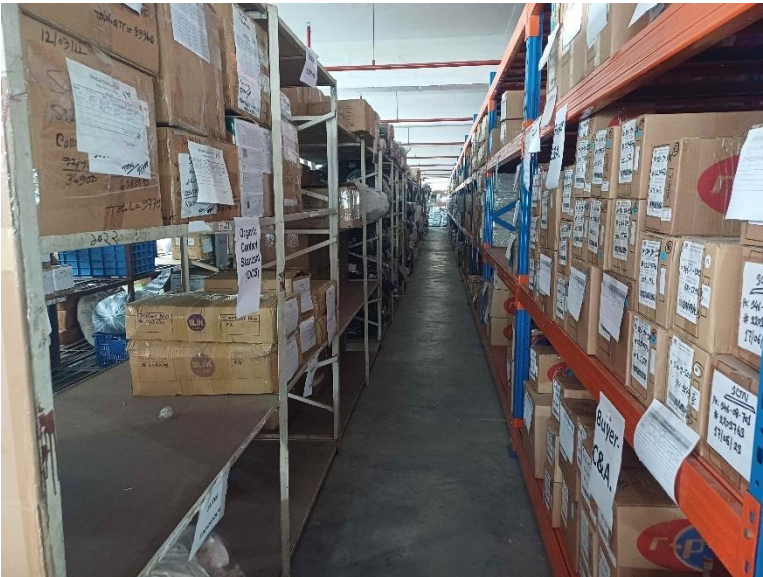
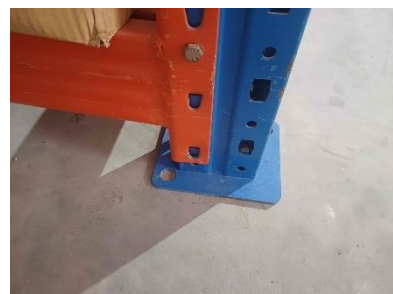
**Observation 4:** Unbraced storage racks (Building – 1).

Unbraced storage racks

**Description:** Storage racks at several locations were found unbraced. The building engineer is required to brace/anchor all the non-structural elements including the storage racks.

| Observation | Action Plan | Timeline |
|---|---|---|
| Unbraced storage racks (Building – 1). | The building engineer is required to brace/anchor all the non-structural elements including the storage racks. | within 6 weeks |

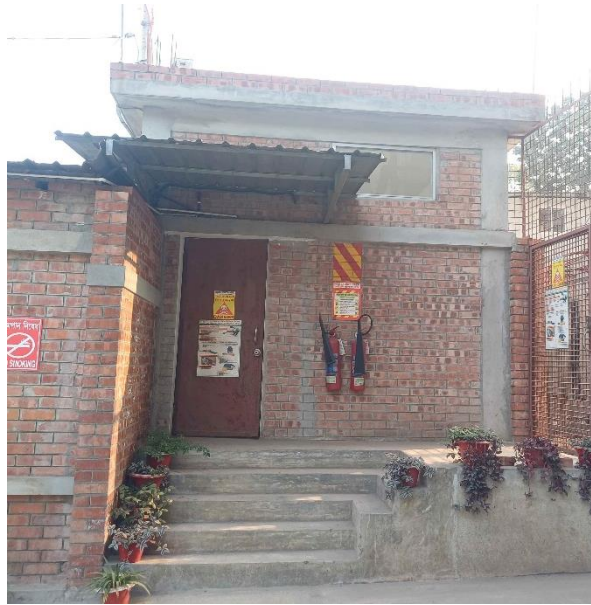
**Observation 5: Lack of design report (Building – 2)**

**Description:** As per BNBC, every building or structure designed shall have its design documents prepared following the provision of Section 1.9.1. The design document shall include a design report, and a set of structural drawings, which shall be prepared in compliance with section 1.9.1.1 and section 1.9.1.2 as per BNBC. At the time of inspection, a design report was not available which is required to be prepared in compliance with section 1.9.1.1 (part 6, BNBC).

| Observation | Action Plan | Timeline |
|---|---|---|
| Lack of design report (Building – 2) | The building engineer is required to prepare design documents and submit to RSC for review. | within 6 weeks |
| | Carry out remedial work where required. | within 6 months |

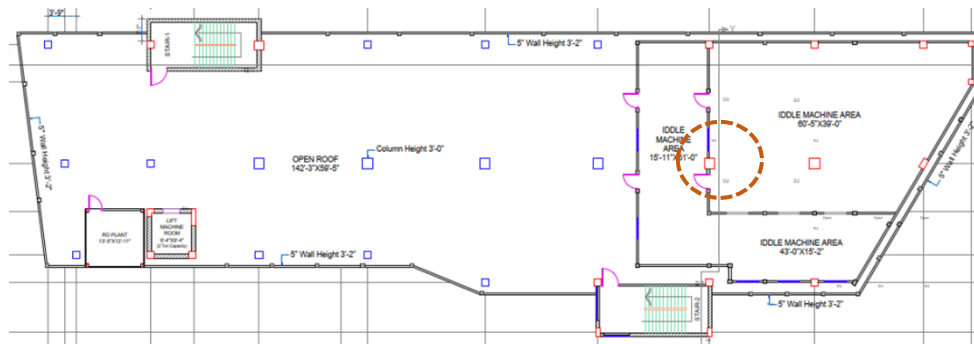
**Observation-6: Stress in the column and foundation exceeds the normal design limit (Building – 4).**

**Description:** Cursory calculation shows that stress in marked column and pile exceeds normal design limit considering dead load and live load (as per load plan) and minimum concrete strength (16.3 MPa) based on aggregates type, 415MPa rebar strength. The building engineer is required to review the design, load and column stress based on the in-situ material strength by taking a minimum of 4 numbers of 100mm dia. core from the lower tier of the building.

| Observation | Action Plan | Timeline |
|---|---|---|
| Stress in the column and foundation exceeds the normal design limit (Building – 4). | Verify in-situ material strength by taking a minimum 4-100mm dia. core from the lower tier of the building. | within 6 weeks |
| | The building engineer is required to review the design, loads, and column stresses based on in-situ material strength. | within 6 weeks |
| | Carry out suggested remedial works if required. | within 6 months |

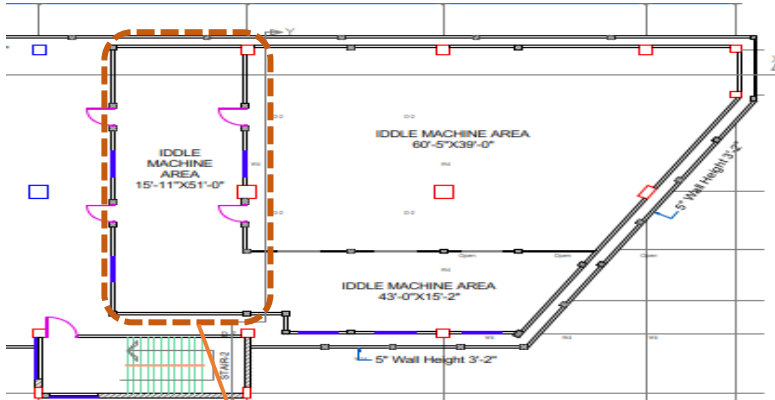
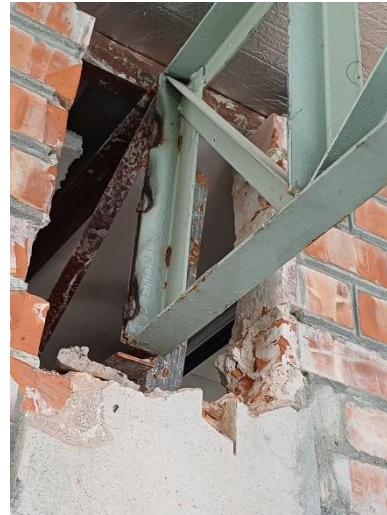
**Observation-7:** Apparently inadequate connection in the roof shed (Building – 4).

Non-engineered shed over idle machine room.

**Description:** During the inspection, a non-engineered shed and inadequate truss-to-wall connection were observed on the roof shed. The building engineer is required to check the connection adequacy of the truss and non-engineered shed.

| Observation | Action Plan | Timeline |
|---|---|---|
| Apparently inadequate connection in the roof shed. (Building – 4). | The building engineer is required to check the connection adequacy of the truss and non-engineered shed. | within 6 weeks |
| | Carry out suggested remedial works if required. | within 6 months |

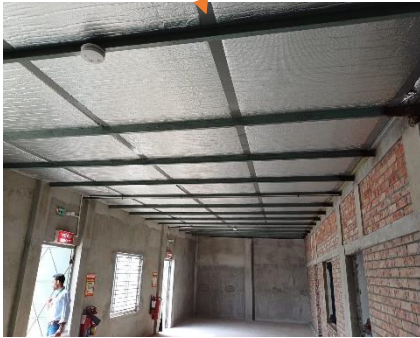
Roof truss to wall connection

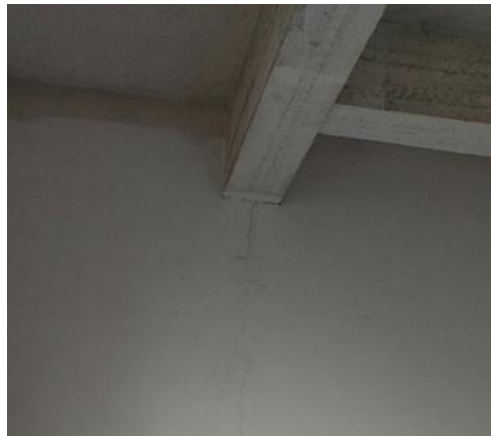
**Observation-8:** Crack in the Brick wall (Building – 4).

**Description:** During the inspection, cracks were observed in the connection between the brick wall and structural elements. The building engineer is required to investigate the crack and repair the crack appropriately.

| Crack in Brick wall (Building – 4). | The building engineer is required to investigate the crack and repair the crack appropriately. | within 6 weeks |

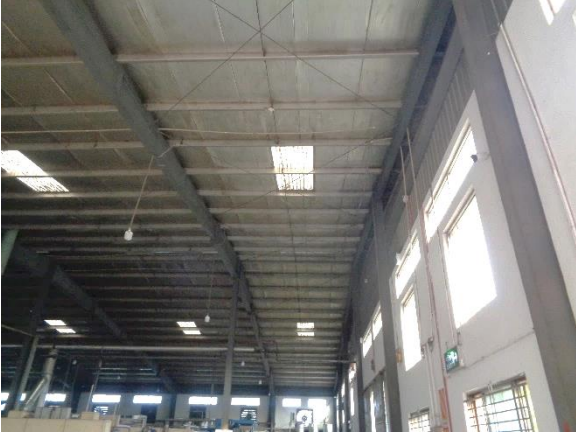
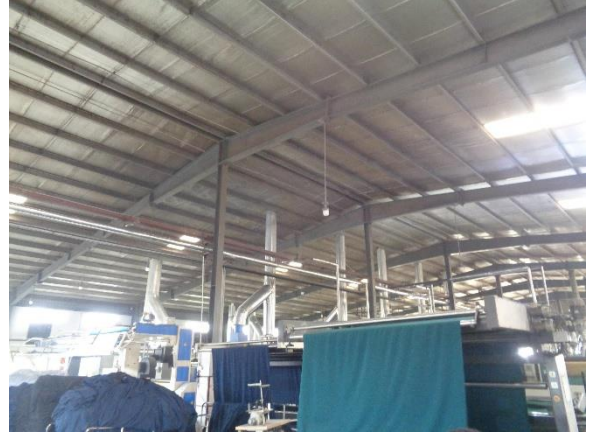
**Observation-9:** Lack of lateral stability (Shed-1).

**Description:** Load transfer media is not provided along the ridge and at end bays. The building engineer is required to check the lateral stability of the structure.

| Lack of lateral stability (Shed-1). | The building engineer is required to check the lateral stability of the structure. | within 6 weeks |
| | Implement remediation work if required. | within 6 months |

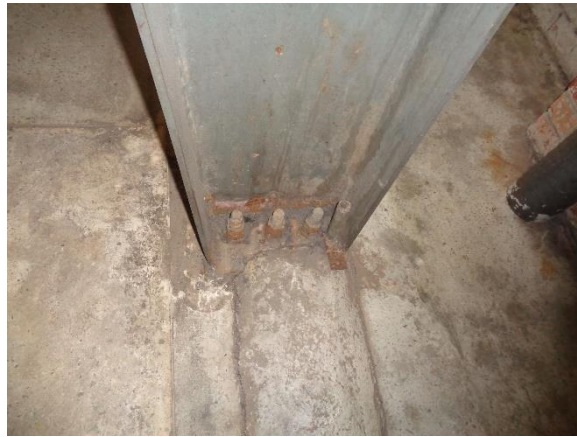
**Observation-10:** Corrosion on steel members (Shed-1).

**Description:** Corrosion was found on steel members at several locations. The building engineer is required to provide rust-proof paint on steel members.

| Corrosion on steel members (Shed-1). | The building engineer is required to provide rust-proof paint on steel members. | within 6 weeks |

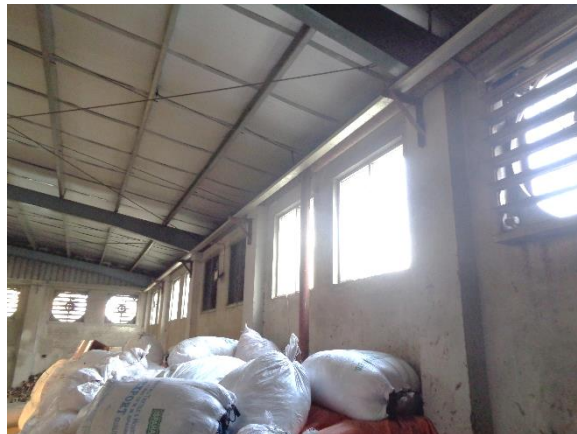
**Observation-11:** Lack of lateral stability (Shed-3).

**Description:** Load transfer media is not provided along the periphery on the east side. The building engineer is required to check the lateral stability of the structure.

| Lack of lateral stability (Shed-3). | The building engineer is required to check the lateral stability of the structure. | within 6 weeks |
| | Implement remediation work if required. | within 6 months |

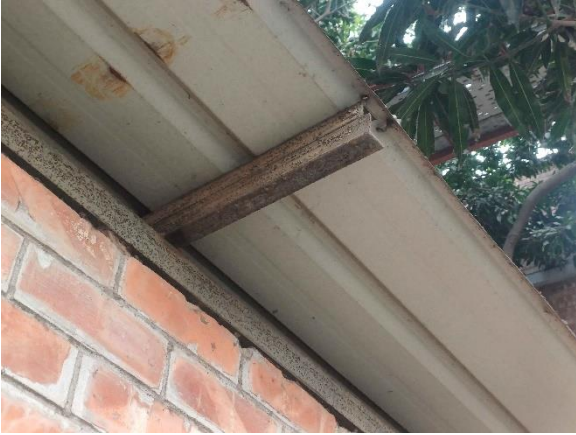
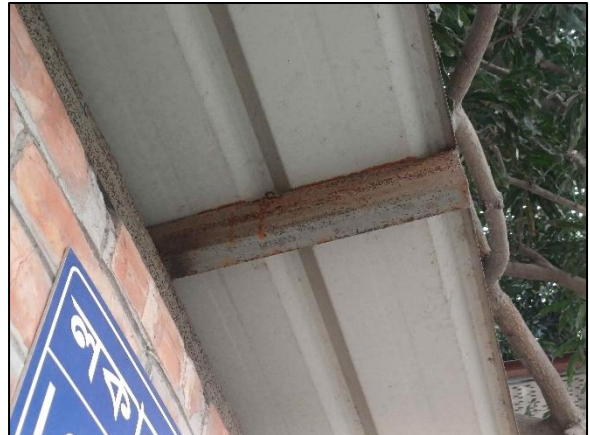
**Observation 12:** Corrosion on steel member. (Shed – 5 & Shed – 2)

**Description:** Severe corrosion was observed on steel members. The building engineer is required to remove the corrosion and provide a rust-proof coating on all steel members to protect from corrosion.

| Corrosion on steel member. (Shed – 5 & Shed – 2) | The building engineer is required to remove the corrosion and provide a rust-proof coating on all steel members to protect from corrosion. | within 6 weeks |

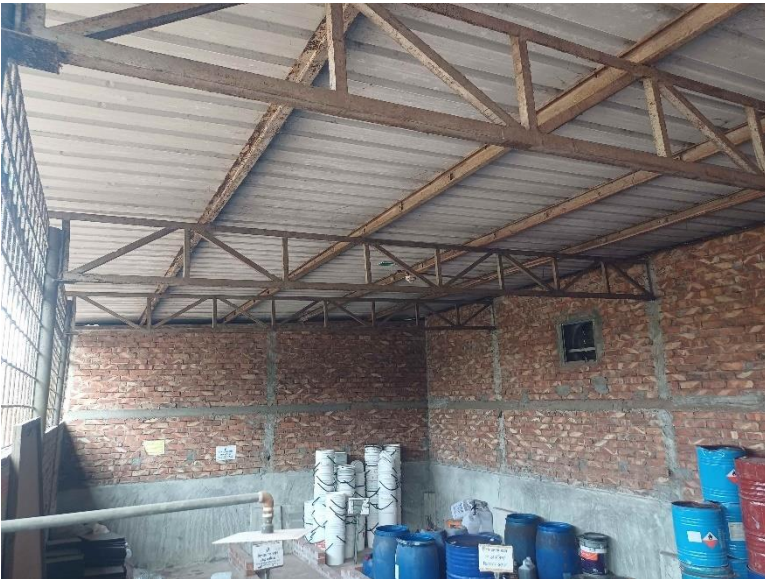
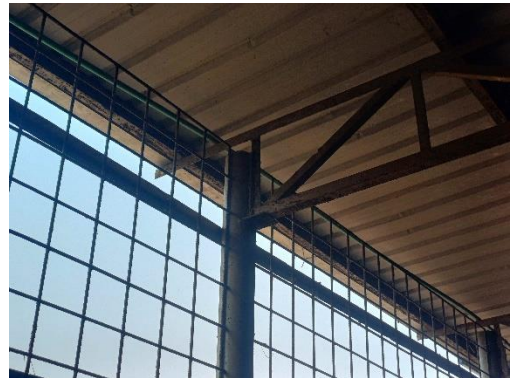
**Observation 13:** Lack of lateral stability. (Shed – 4)

**Description:** Lack of lateral stability system (absence of load transfer media) & improper connections were observed in the structure. The building engineer is required to check the lateral stability of the structure

| Lack of lateral stability. (Shed – 4) | The building engineer is required to check the lateral stability of the structure | within 6 weeks |
| | Carry out remedial work where required. | within 6 months |

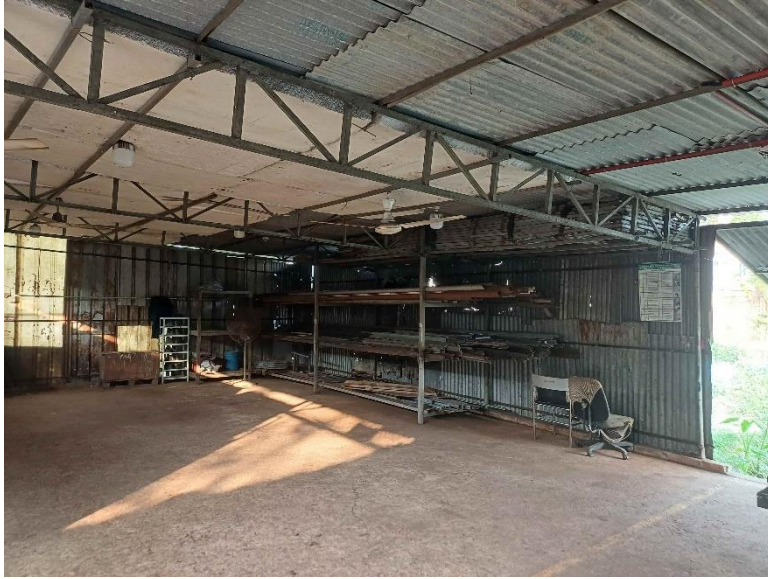
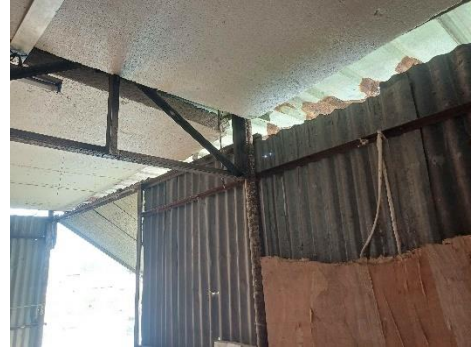
**Observation 14:** Lack of lateral stability. (Shed – 6)

**Description:** Lack of lateral stability system (absence of load transfer media) & improper connections were observed in the structure. The building engineer is required to check the lateral stability of the structure

| Lack of lateral stability. (Shed – 6) | The building engineer is required to check the lateral stability of the structure | within 6 weeks |
| | Carry out remedial work where required. | within 6 months |

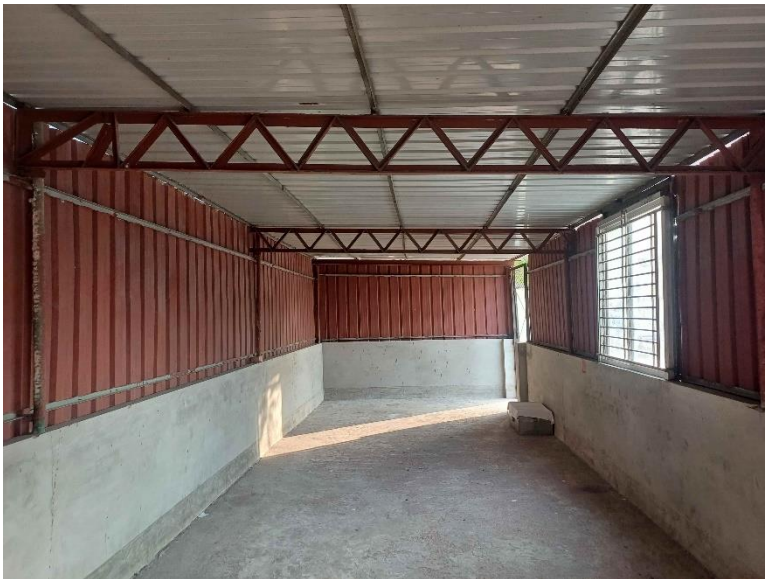
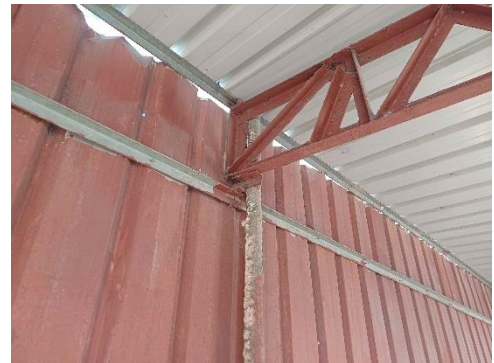
**Observation 15:** Lack of lateral stability. (Shed – 7)

**Description:** Lack of lateral stability system (absence of load transfer media) & improper connections were observed in the structure. The building engineer is required to check the lateral stability of the structure

| Lack of lateral stability. (Shed – 7) | The building engineer is required to check the lateral stability of the structure | within 6 weeks |
| | Carry out remedial work where required. | within 6 months |
