# Robintex (Bangladesh) Ltd. (Extension)

Vulta, Rupgonj, Narayanganj

21 April 2024

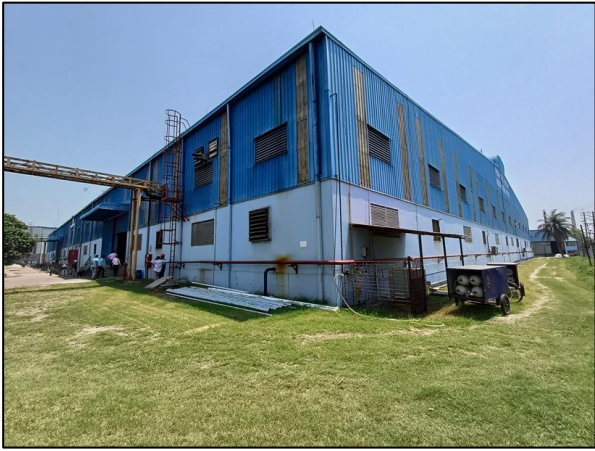
**Observation-1:** Lack of design documents. (All Over Print Shed, Jhut Boiler Room, AOP Utility Building, Central Warehouse Shed)

At the time of inspection, design documents (design report, structural drawings, and material test reports) were not available, which are required to be prepared in compliance with section 1.9.1 (part 6, BNBC). However, as-built drawings are available only for the All Over Print Shed and Central Warehouse Shed.

| Observation | Action Plan | Timeline |
|---|---|---|
| Lack of design documents.<br>(All Over Print Shed) | The building engineer is required to prepare design documents (including design reports, structural drawings, and material test reports) in compliance with section 1.9.1 (part 6, BNBC). | within 6 weeks |
| | Carry out the suggested remedial works. | within 6 months |

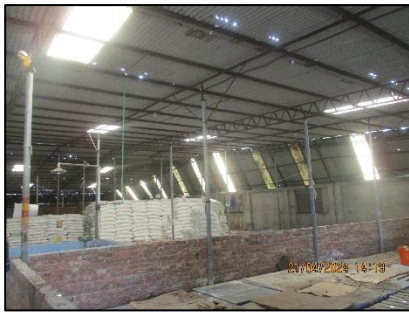
Wastage warehouse shed

**Observation-2:** Lack of lateral stability system. (Wastage Warehouse Shed, Chemical Store Shed, And Ansar Camp Shed)

**Description:** Lack of lateral stability system, apparent inadequate members, and non-engineered connections were observed. The building engineer is required to check the structure's members, connections, and stability system and suggest proper remediation accordingly.

| Observation | Action Plan | Timeline |
|---|---|---|
| Lack of lateral stability system.<br>(Wastage Warehouse Shed) | The building engineer is required to check the structure's members, connection & stability system and suggest proper remediation accordingly. | within 6 weeks |
| | Carry out remedial work if required. | within 6 months |

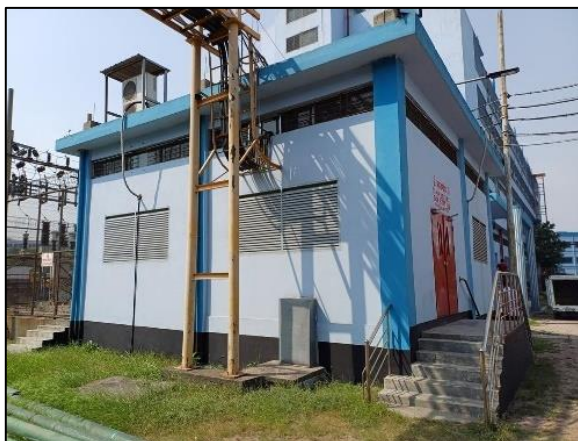
33 KV Sub-Station Room

**Observation-3:** Lack of as-built drawing. (33 KV Substation Room And Fire Control Room).

**Description:** The as-built drawings of the 33 KV Substation and Fire control room were not available on site. The building engineer is required to prepare the as-built drawing of these structures.

| Observation | Action Plan | Timeline |
|---|---|---|
| Lack of as-built drawing. (33 KV Substation room) | The building engineer is required to prepare as-built drawings. | within 6 weeks |

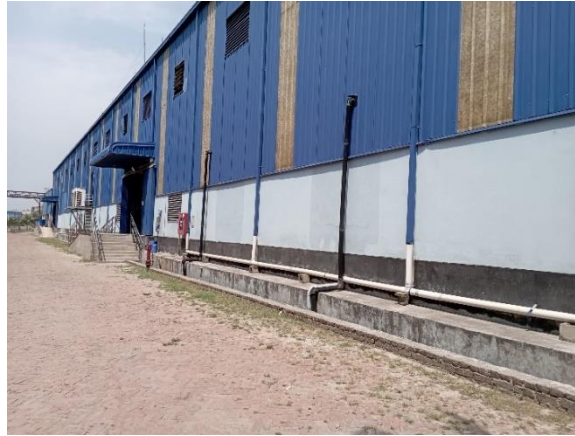
**Observation-4:** Lack of design report (Digital Printing-01 Shed).

**Description:** As per BNBC, every building or structure designed shall have its design documents prepared following the provision of Section 1.9.1. During the inspection, the design report was not available on site. The building engineer is required to prepare a design report in compliance with BNBC (Part-6).

| Lack of design report (Digital Printing-01 Shed). | The building engineer is required to prepare a design report in compliance with BNBC (Part-6). | within 6 weeks |
| | Implement remediation work if required. | within 6 months |

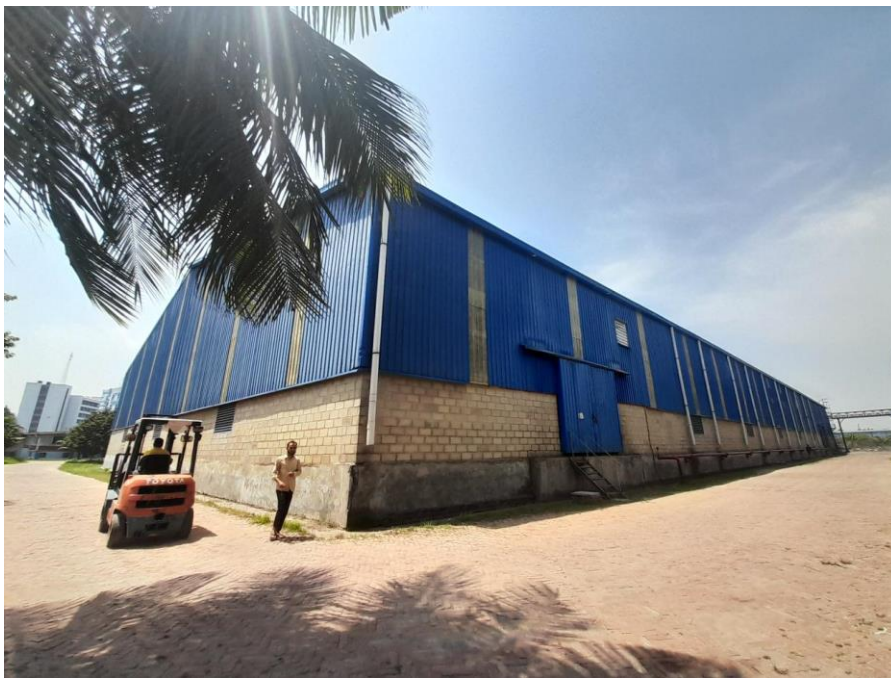
**Observation-5:** Lack of design report (Digital Printing-02 Shed).

**Description:** As per BNBC, every building or structure designed shall have its design documents prepared following the provision of Section 1.9.1. During the inspection, the design report was not available on site. The building engineer is required to prepare a design report in compliance with BNBC (Part-6).

| Lack of design report (Digital Printing-02 Shed). | The building engineer is required to prepare a design report in compliance with BNBC (Part-6). | within 6 weeks |
| | Implement remediation work if required. | within 6 months |

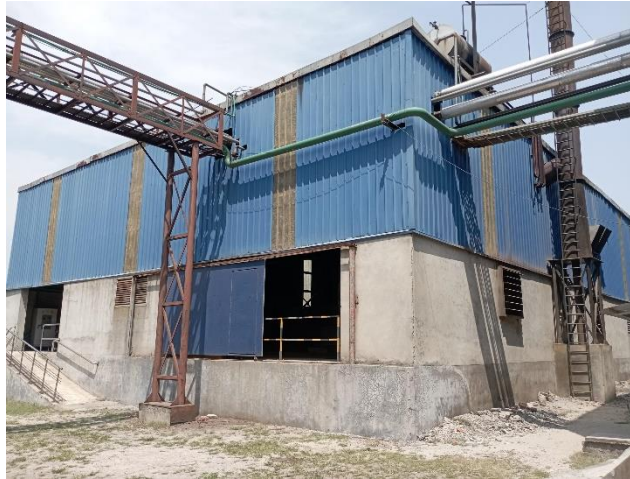
**Observation-6:** Lack of design documents (New Utility (MS Lario) Shed).

**Description:** As per BNBC, every building or structure designed shall have its design documents prepared following the provision of Section 1.9.1. During the inspection, the design report/as-built drawing/geotechnical investigation report was not available on site. The building engineer is required to prepare a design report with as-built structural drawings in compliance with BNBC (Part-6).

| Lack of design documents (New Utility (MS Lario) Shed). | The building engineer is required to prepare a design report in compliance with BNBC (Part-6). | within 6 weeks |
| | Implement remediation work if required. | within 6 months |

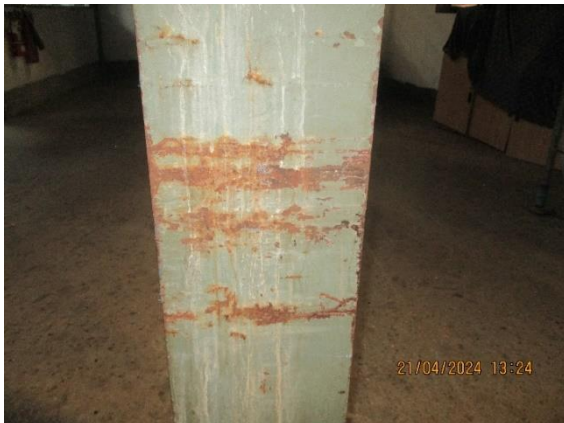
All over print shed

**Observation 7:** Corrosion on steel members (All Over Print Shed And Chemical Store Shed), Digital Printing-02 Shed & New Utility (MS Lario) Shed).

**Description:** Corrosion was found on steel members at several locations. The building engineer is required to provide rust-proof paint on steel members to protect them from corrosion.

| Corrosion on steel members (All over the print shed and Chemical store shed), Digital Printing-02 Shed & New Utility (MS Lario) Shed). | The building engineer is required to provide rust-proof paint on steel members to protect them from corrosion. | within 6 months |

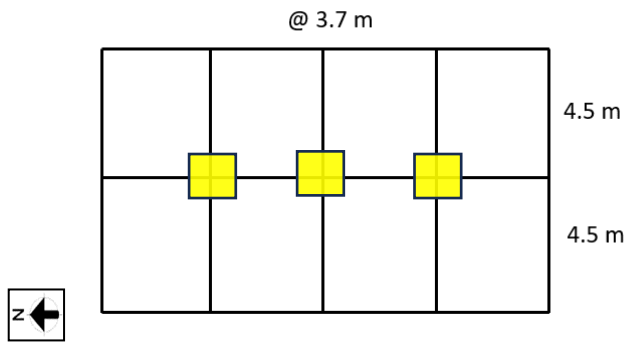
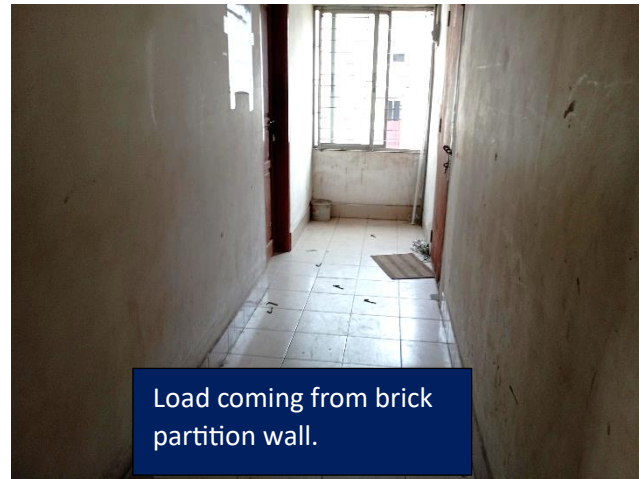
**Observation-08:** Stress in column exceeds normal design limit (Workshop Building).

**Description:** No design documents & geotechnical investigation reports were available on site. The cursory calculation indicates that stress in the marked columns exceeds the normal design limit considering the live load of 2 kPa for typical floors (rest house). We have considered minimum concrete strength (14.10 MPa) based on aggregate type.

The building engineer is required to review, design, and column stresses based on in-situ concrete strength. Produce and actively manage load plans for all floor plates based on floor, column, and foundation capacities.

| Stress in columns exceeds the normal design limit (Workshop Building). | The building engineer is required to review, design, and column stresses based on in-situ concrete strength. | within 6 weeks |
| | Take a minimum of 4 concrete cores from the columns. | within 6 weeks |
| | Produce and actively manage load plans for all floor plates based on floor, column, and foundation capacities. | within 6 weeks |
| | Implement remedial works. | within 6 months |

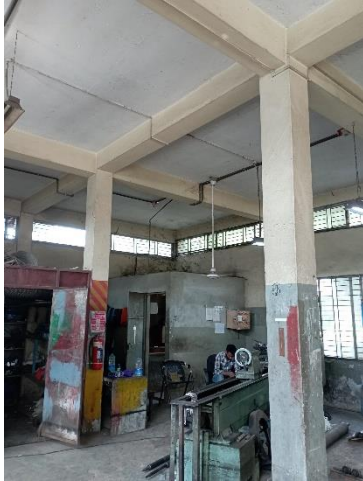
**Observation-09:** Columns appear to be slender (Workshop Building).

Unsupported length 3.8m  
Column size: 300X250 mm

**Description:** Cursory calculation shows that slenderness in all columns exceeds the normal design limit due to long unsupported lengths. The building engineer is required to carry out an adequacy check of all the considering slenderness effect.

| Columns appear to be slender (Workshop Building). | Factory engineer is required to carry out adequacy check of all the considering slenderness effect. | within 6 weeks |

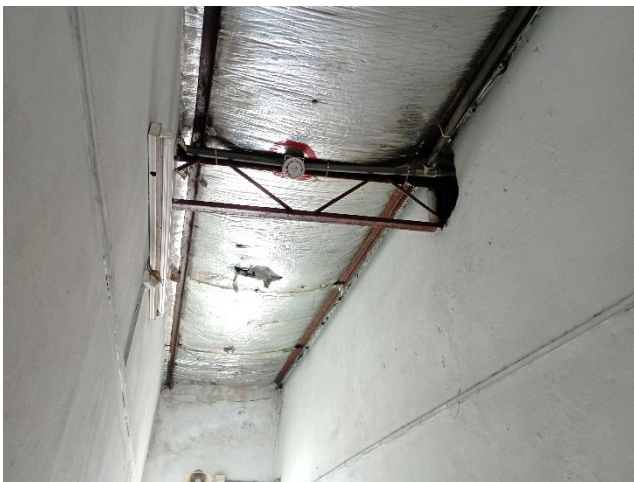
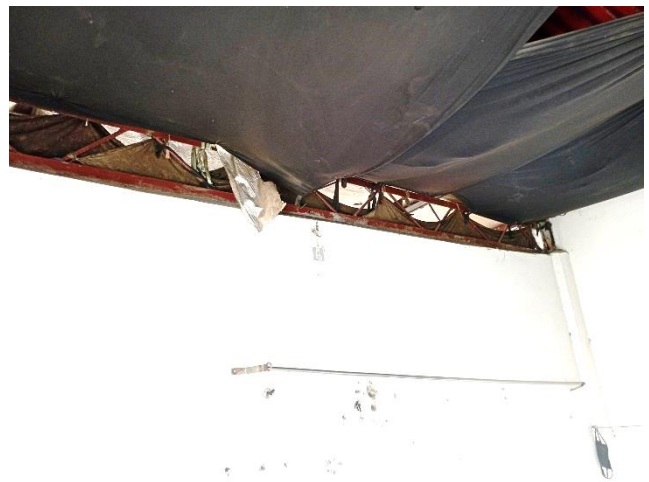
**Observation-10:** Lack of lateral stability of truss roof (Workshop Building).

**Description:** Stability is provided through truss action only. No bracing system is provided for the shed and the size of the truss is apparently inadequate. The building engineer is required to check the lateral stability of the shed.

| Lack of lateral stability of truss roof (Workshop Building). | The building engineer is required to check the lateral stability of the roof shed. | within 6 weeks |
| | Implement remediation work if required. | within 6 months |

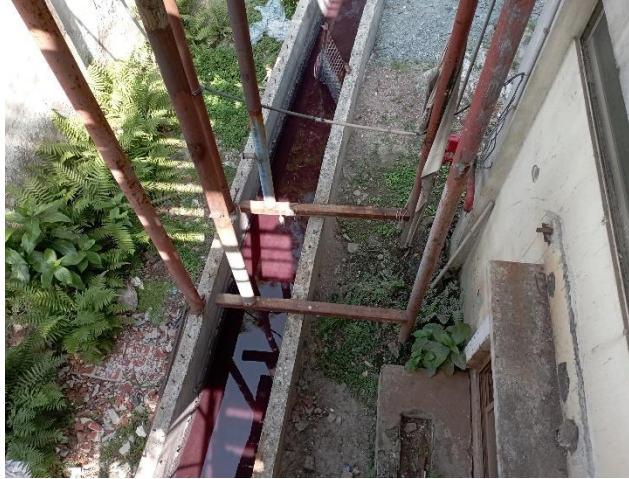
**Observation-11:** Incomplete load path of steel stair (Workshop Building).

**Description:** The load path of the vertical load-bearing member was incomplete. The building engineer is required to check the load path and the structural stability of the steel stair.

| Incomplete load path of steel stair (Workshop Building). | The building engineer is required to check the load path and the structural stability of the steel stair. | within 6 weeks |
| | Implement remediation work if required. | within 6 months |

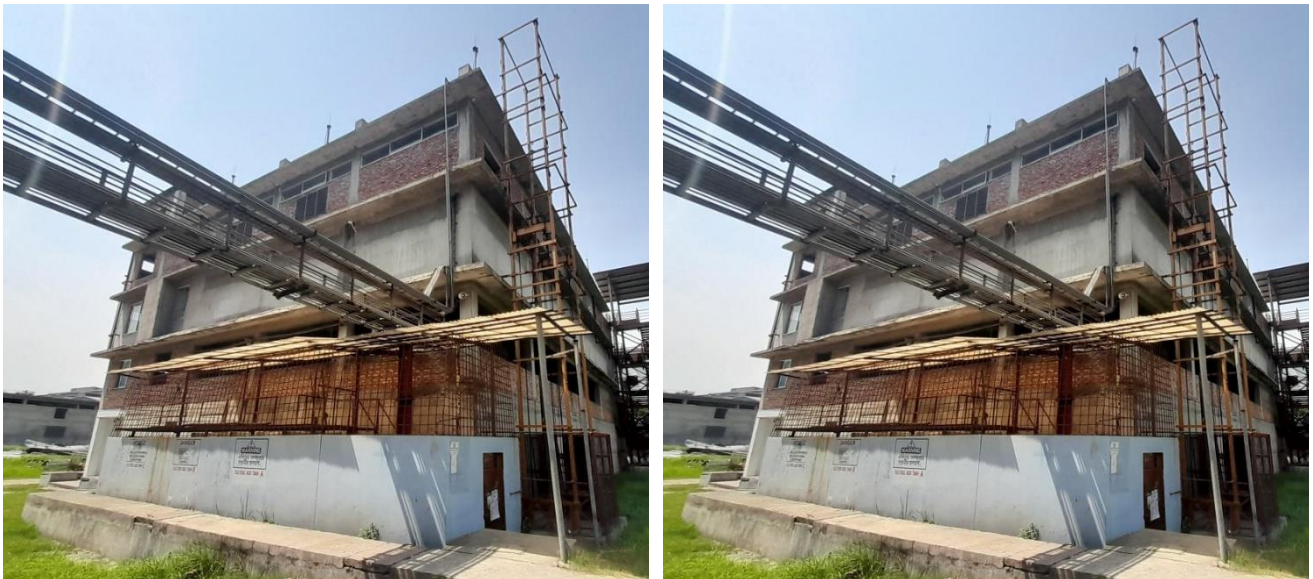
**Observation-12:** Lack of design report (ETP Building 1).

**Description:** As per BNBC, every building or structure designed shall have its design documents prepared following the provision of Section 1.9.1. During the inspection, the design report was not available on site for ETP building 1 and external steel stairs. The building engineer is required to prepare a design report in compliance with BNBC (Part-6).

| Lack of design report (ETP Building 1). | The building engineer is required to prepare a design report in compliance with BNBC (Part-6). | within 6 weeks |
| | Implement remediation work if required. | within 6 months |

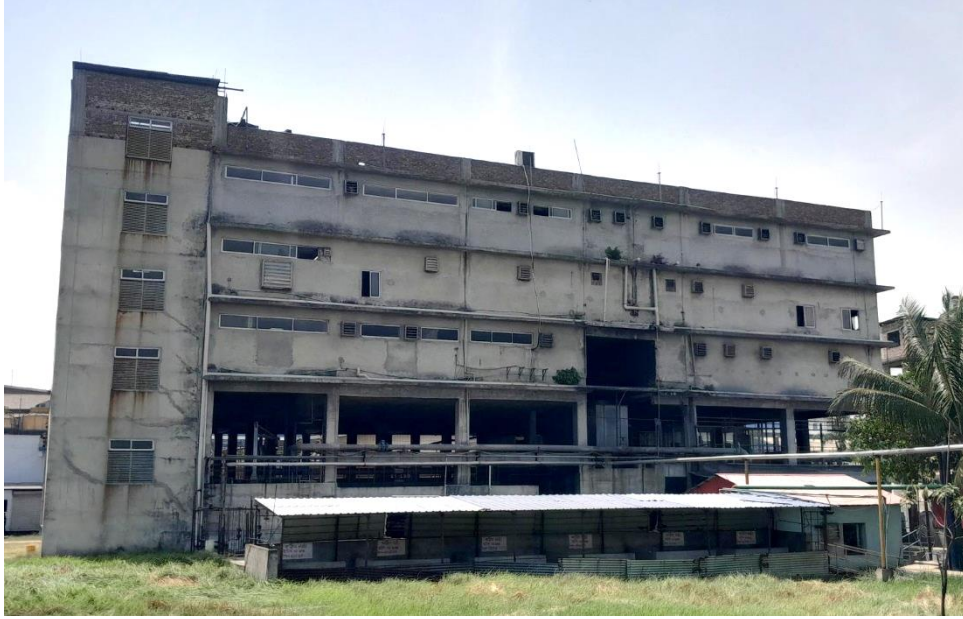
**Observation-13:** Lack of design report (ETP Building 2).

**Description:** As per BNBC, every building or structure designed shall have its design documents prepared following the provision of Section 1.9.1. During the inspection, the design report was not available on site. The building engineer is required to prepare a design report in compliance with BNBC (Part-6).

| Lack of design report (ETP Building 2). | The building engineer is required to prepare a design report in compliance with BNBC (Part-6). | within 6 weeks |
| | Implement remediation work if required. | within 6 months |

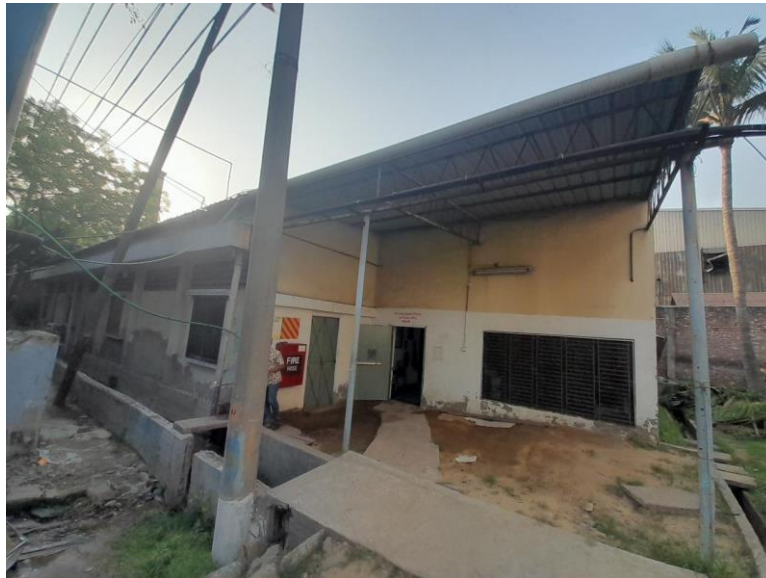
**Observation-14:** Lack of design documents (General Store).

**Description:** As per BNBC, every building or structure designed shall have its design documents prepared following the provision of Section 1.9.1. During the inspection, the design report/as-built drawing/geotechnical investigation report was not available on site. The building engineer is required to prepare a design report with as-built structural drawing in compliance with BNBC (Part-6).

| Lack of design documents (General Store). | A geotechnical engineer is required to prepare a geotechnical investigation report. | within 6 weeks |
| | Carry out a Detailed Engineering Assessment (DEA) including as-built drawing and design report as per BNBC (Part-6). | within 6 months |
| | Implement remediation work if required. | within 6 months |

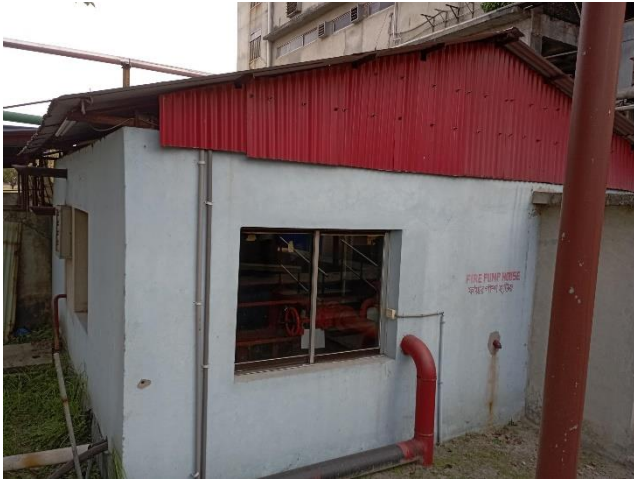
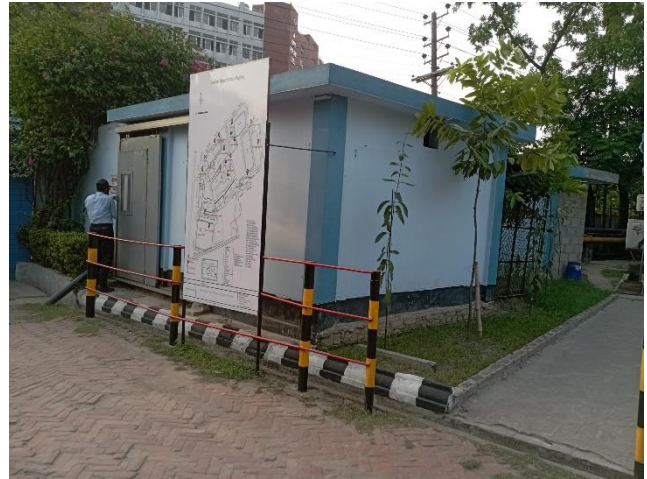
**Observation-15:** Lack of as-built drawing (Fire Pump Room, RMS Room).

**Description:** As-built drawing of the Fire Pump Room and RMS Room were not available on site. The building engineer is required to prepare the as-built drawing of these structures.

| Lack of as-built drawing (Fire Pump Room, RMS Room). | The building engineer is required to prepare an as-built drawing. | within 6 weeks |

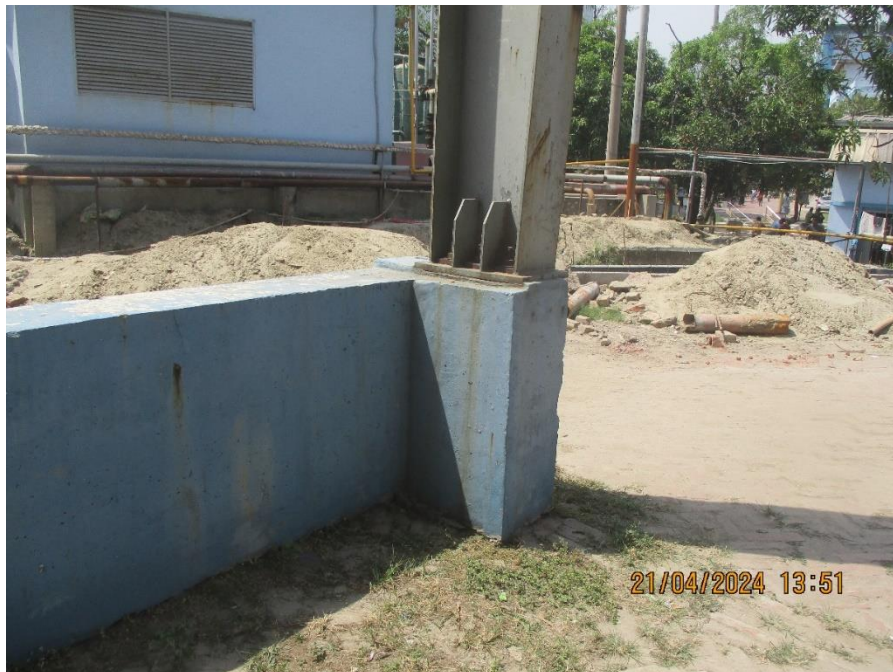
**Observation-16:** Column susceptible to vehicle impact. (Central warehouse shed)

**Description:** Columns in the loading/unloading area were found susceptible to vehicle impact. The building engineer is required to provide barriers around the columns to prevent vehicle impact.

| The column is susceptible to vehicle impact. (Central warehouse shed) | The building engineer is required to provide barriers around the column to prevent vehicle impact. | within 6 weeks |
