# Square Fashions Limited (New Extension)

Rokeyapur, Jamirdia, Habirbari, Valuka, Mymensingh.

21 March 2024

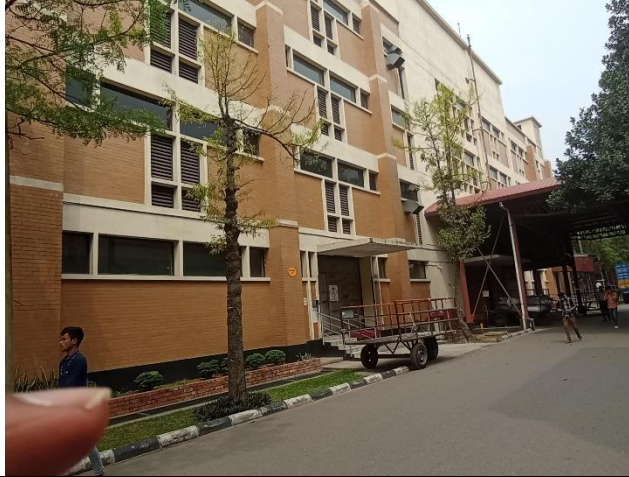
**Observation-1:** Lack of design report (Building-3).

**Description:** As per BNBC, every building or structure designed shall have its design documents prepared in accordance with the provision of Section 1.9.1. The design document shall include a design report, and a set of structural drawings, which shall be prepared in compliance with section 1.9.1.1 and section 1.9.1.2 as per BNBC. At the time of inspection, design report was not available which is required to be prepared in compliance with section 1.9.1.1 (part-6, BNBC).

| Observation | Action Plan | Timeline |
|---|---|---|
| Lack of design report (Building-3). | At the time of inspection, a design report was not available, which is required to be prepared in compliance with section 1.9.1.1 (part-6, BNBC). | within 6 weeks |
| Lack of design report (Building-3). | Implement remedial work if required. | within 6 months |

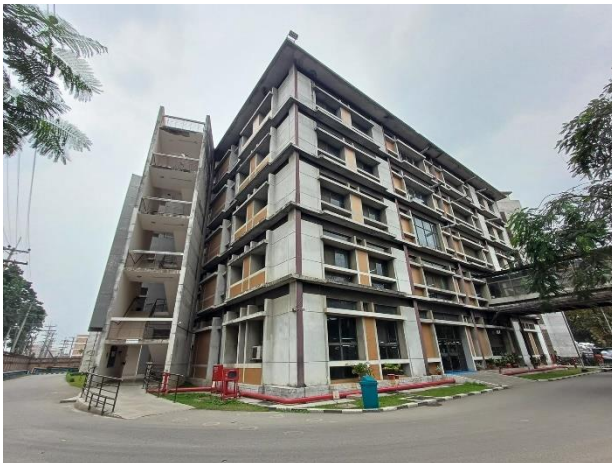
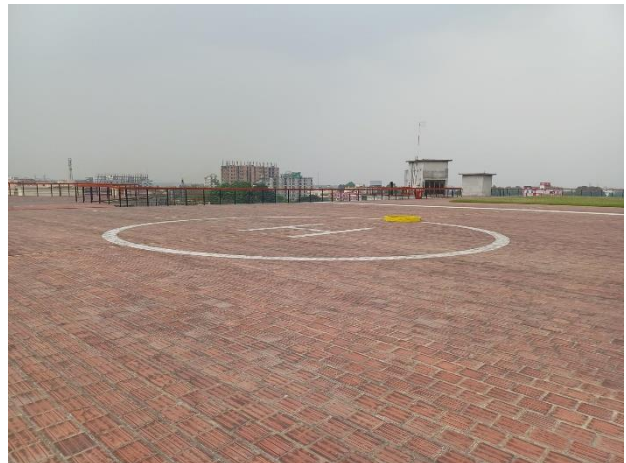
**Observation-2:** Lack of design report (Building-8).

**Description:** As per BNBC, every building or structure designed shall have its design documents prepared in accordance with the provision of Section 1.9.1. The design document shall include a design report, and a set of structural drawings, which shall be prepared in compliance with section 1.9.1.1 and section 1.9.1.2 as per BNBC. At the time of inspection, any design report was not available, which is required to be prepared in compliance with section 1.9.1.1 (part-6, BNBC). The rooftop helipad and raised floor are to be considered in the design report.

| Observation | Action Plan | Timeline |
|---|---|---|
| Lack of design report (Building-8). | At the time of inspection, design report was not available which is required to be prepared in compliance with section 1.9.1.1 (part-6, BNBC). The rooftop helipad and raised floor are to be considered in the design report. | within 6 weeks |
| Lack of design report (Building-8). | Implement remedial work if required. | within 6 months |

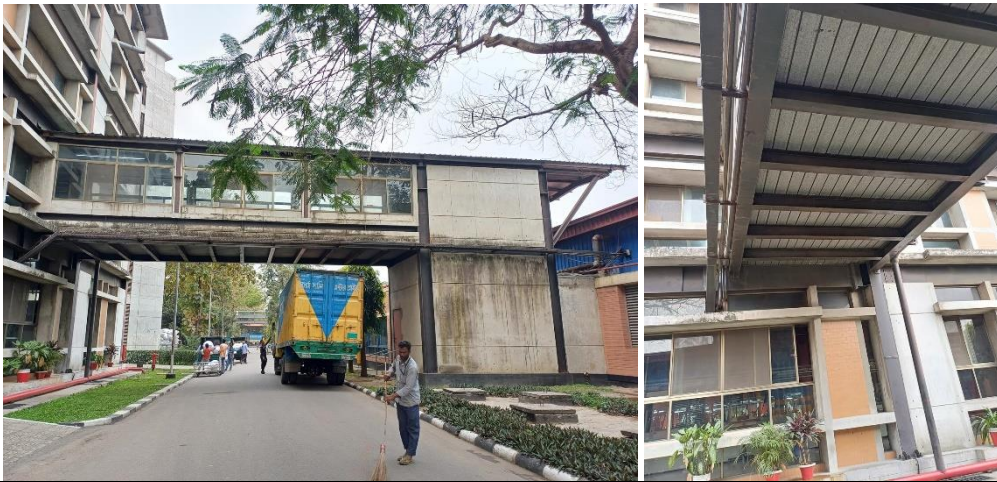
**Observation 3:** Undocumented steel connection bridge (Building-8).

**Description:** The connection bridge is structurally connected to the building on the east, which is not shown in the drawing. The building engineer is required to update the drawing and check the connection and lateral stability of the bridge along with the main building.

| Observation | Action Plan | Timeline |
|---|---|---|
| Undocumented steel connection bridge (Building-8). | The building engineer is required to update the drawing and check the connection and lateral stability of the bridge along with the main building | within 6 weeks |
| Undocumented steel connection bridge (Building-8). | Implement remedial work if required. | within 6 months |

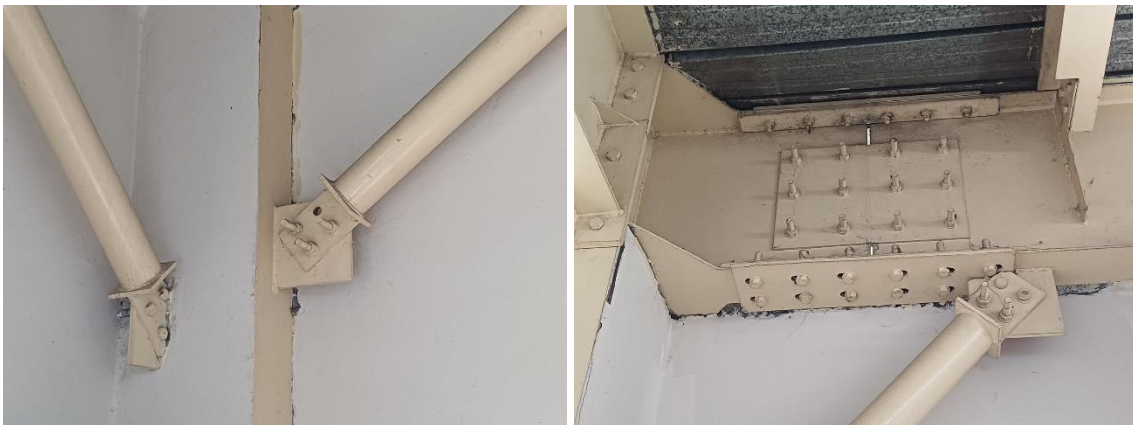
**Observation 4:** Missing nut/bolts and over-slotted connections (Building-8).

**Description:** Missing nuts/bolts and over-slotted connections were observed in several locations of the building. The building engineer is required to repair the connections and check the adequacy as well.

| Observation | Action Plan | Timeline |
|---|---|---|
| Missing nuts/bolts and over-slotted connections (Building-8). | The building engineer is required to repair the connections and check the adequacy as well. | within 6 weeks |

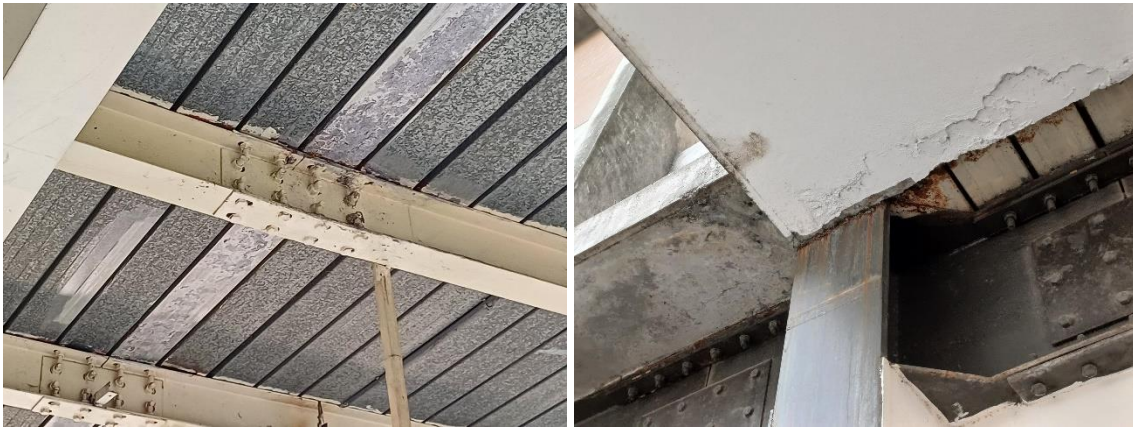
**Observation 5:** Dampness and corrosion on steel deck floor/beams (Building-8).

**Description:** Dampness and corrosion on steel deck floor/beams were observed in several locations of the building. The building engineer is required to repair these with a suitable method.

| Observation | Action Plan | Timeline |
|---|---|---|
| Dampness and corrosion on steel deck floor/beams (Building-8). | The building engineer is required to seal the source of water and repair the dampness/corrosion with a suitable method. | within 6 weeks |

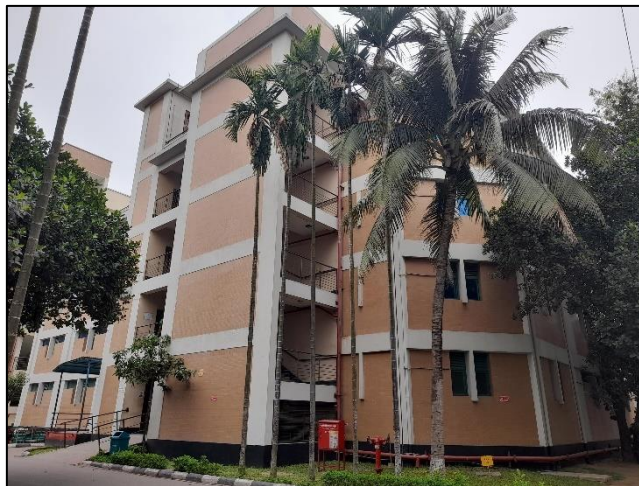
**Observation-6:** Lack of design documents (Building-9).

**Description:** As per BNBC, every building or structure designed shall have its design documents prepared in accordance with the provision of Section 1.9.1. The design document shall include a design report, and a set of structural drawings, which shall be prepared in compliance with section 1.9.1.1 and section 1.9.1.2 as per BNBC. At the time of inspection, design report was not available which is required to be prepared in compliance with section 1.9.1.1 (part-6, BNBC).

| Observation | Action Plan | Timeline |
|---|---|---|
| Lack of design documents (Building-9). | At the time of inspection, design report was not available which is required to be prepared in compliance with section 1.9.1 (part-6, BNBC). | within 6 weeks |
| Lack of design documents (Building-9). | Implement remedial work if required. | within 6 months |

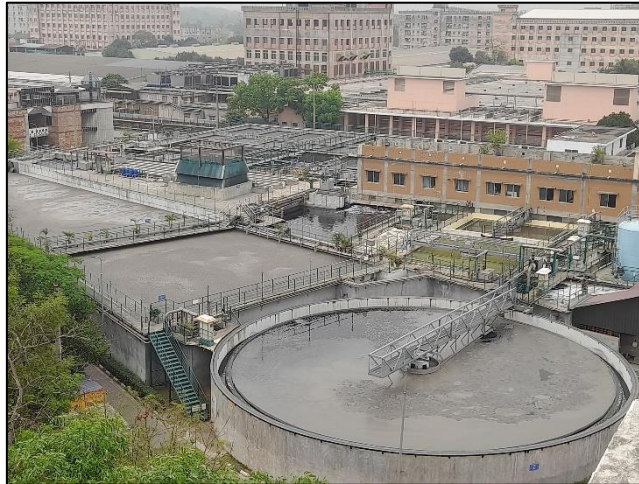
**Observation 7:** Lack of design documents (Building-11).

**Description:** As per BNBC, every building or structure designed shall have its design documents prepared in accordance with the provision of Section 1.9.1. The design document shall include a design report, and a set of structural drawings, which shall be prepared in compliance with section 1.9.1.1 and section 1.9.1.2 as per BNBC. At the time of inspection, design report/as-built drawing was not available which is required to be prepared in compliance with section 1.9.1 (part-6, BNBC).

| Observation | Action Plan | Timeline |
|---|---|---|
| Lack of design documents (Building-11). | At the time of inspection, design report was not available which is required to be prepared in compliance with section 1.9.1 (part-6, BNBC). | within 6 weeks |
| Lack of design documents (Building-11). | Implement remedial work if required. | within 6 months |

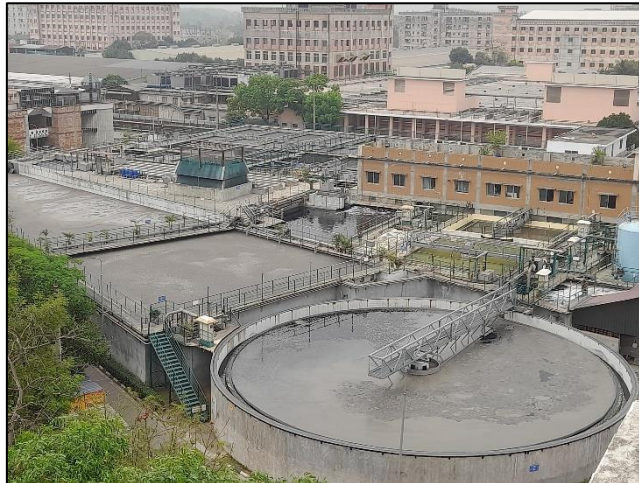
**Observation-8:** Lack of as-built drawing (Building-11).

**Description:** During inspection, only partial construction drawing was available. However, no as-built drawing for Building-11 was available on site. The building engineer is required to prepare as-built drawings as per accurate on-site conditions.

| Lack of as-built drawing (Building-11). | The building engineer is required to prepare as-built drawings as per accurate on-site condition. | within 6 weeks |

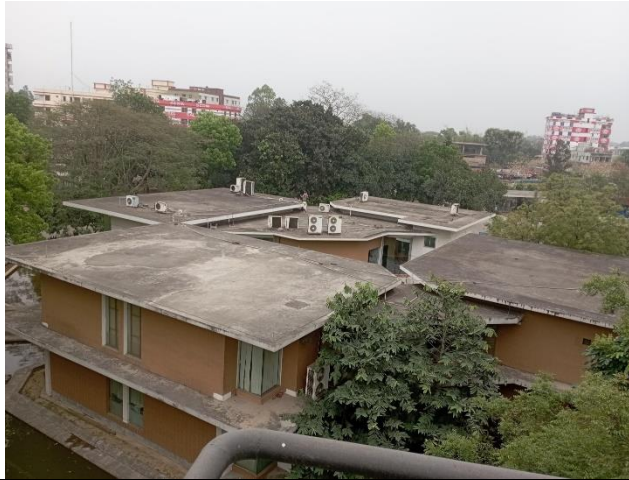
**Observation 9:** Lack of design documents (Building-12).

**Description:** As per BNBC, every building or structure designed shall have its design documents prepared in accordance with the provision of Section 1.9.1. The design document shall include a design report, and a set of structural drawings, which shall be prepared in compliance with section 1.9.1.1 and section 1.9.1.2 as per BNBC. At the time of inspection, design report/as-built drawing was not available which is required to be prepared in compliance with BNBC.

| Lack of design documents (Building-12). | At the time of inspection, design report/as-built drawing was not available which is required to be prepared in compliance with section 1.9.1 (part-6, BNBC). | within 6 weeks |
| Lack of design documents (Building-12). | Implement remedial work if required. | within 6 months |

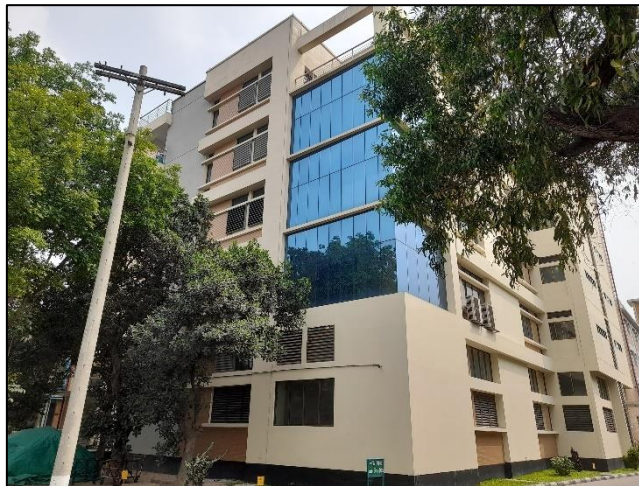
**Observation 10:** Lack of design documents (Building-14).

**Description:** As per BNBC, every building or structure designed shall have its design documents prepared in accordance with the provision of Section 1.9.1. The design document shall include a design report, and a set of structural drawings, which shall be prepared in compliance with section 1.9.1.1 and section 1.9.1.2 as per BNBC. At the time of inspection, design report/as-built drawing was not available which is required to be prepared in compliance with section 1.9.1 (part-6, BNBC).

| Lack of design documents (Building-14). | At the time of inspection, design report/as-built drawing was not available which is required to be prepared in compliance with section 1.9.1 (part-6, BNBC). | within 6 weeks |
| Lack of design documents (Building-14). | Implement remedial work if required. | within 6 months |

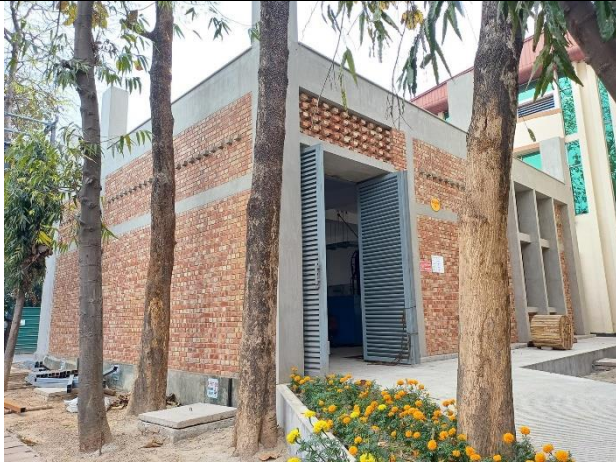
**Observation-11:** The building is to be checked against lateral loading (Building-18).

**Description:** A design report was available on-site at the time of inspection. Because of the requirement of lateral loading, the building engineer is required to submit the design report to RSC for further review.

| The building is to be checked against lateral loading (Building-18). | The building engineer is required to submit the design report to RSC for further review for the requirement of lateral loading. | within 6 weeks |
| The building is to be checked against lateral loading (Building-18). | Implement remedial work if required. | within 6 months |

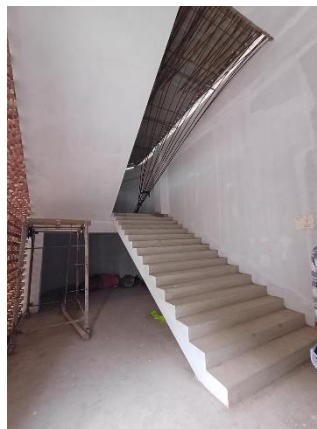
**Observation 12:** Falling hazard (Building-18).

**Description:** The stair railing was missing. The building engineer is required to provide a railing to protect against falling hazards.

| Falling hazard (Building-18). | The building engineer is required to provide a railing to protect against falling hazards. | within 6 weeks |

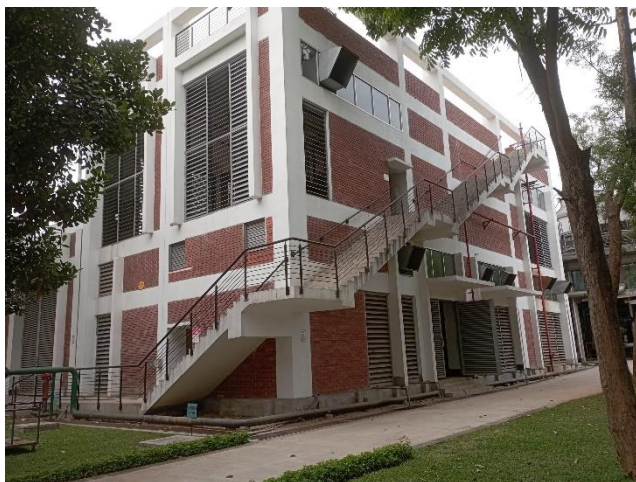
**Observation-13:** The building to be checked against lateral loading (Building-19).

**Description:** At the time of inspection, a design report was available on site. The building engineer is required to submit the design report to RSC for further review for the requirement of lateral loading.

| The building to be checked against lateral loading (Building-19). | The building engineer is required to submit the design report to RSC for further review for the requirement of lateral loading. | within 6 weeks |
| The building to be checked against lateral loading (Building-19). | Implement remedial work if required. | within 6 months |
