Fakir Apparels Ltd. (Extension)

A-127-131,135-138,142-145, B-501-503, BSCIC Hosiery Ind. Estate, Fatullah, Narayanganj
(23.622441, 90.480205)

14 November 2023 & 1 January 2024

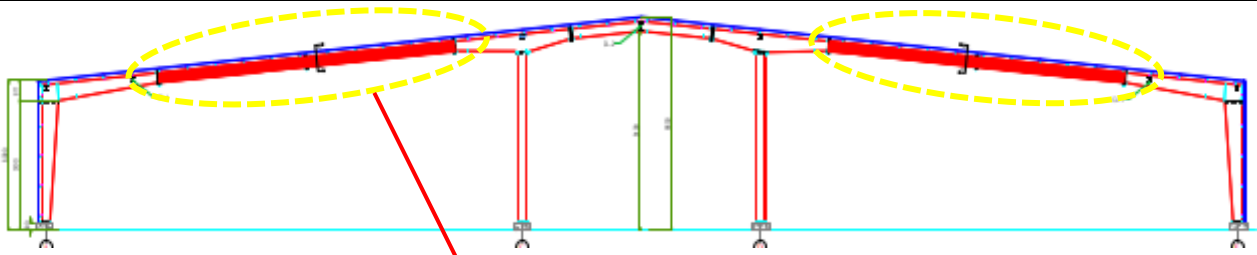
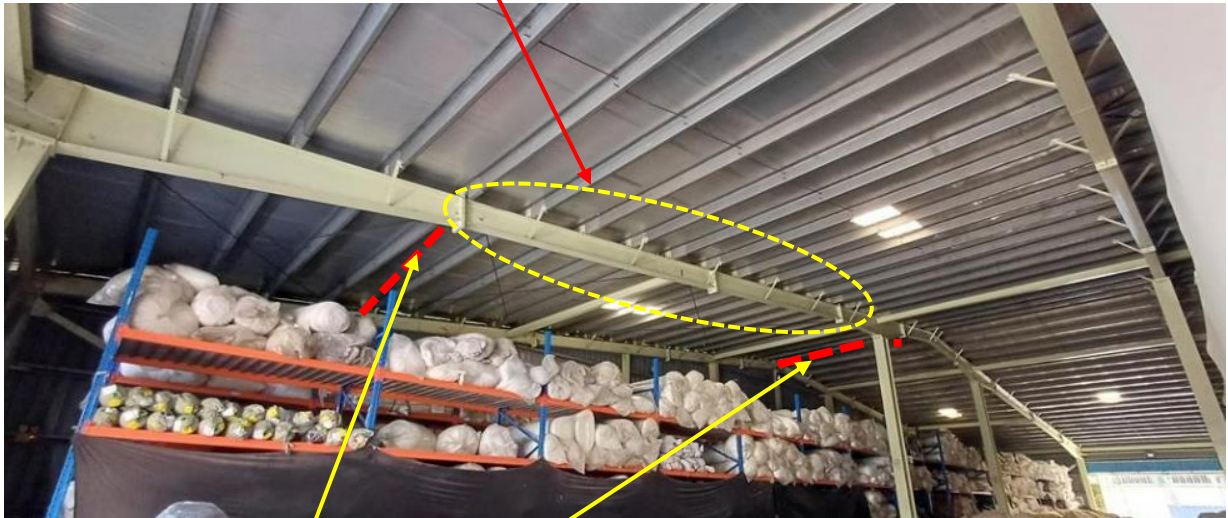
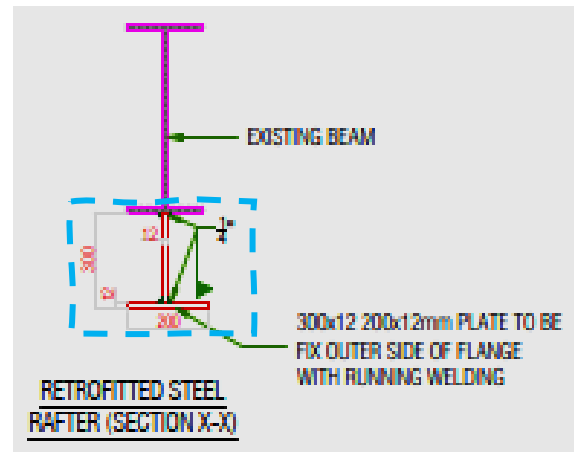
Observation-3: Incomplete retrofitting works (FAL-27A).

Proposed retrofitting on rafter in interior grid

Proposed strut layout

Proposed additional tee bottom of the rafter

Description: The factory has prepared the DEA of the shed. As per the recommendation of the DEA, some retrofitting works are suggested but no retrofitting work was carried out. The building engineer is required to submit the DEA report to RSC for review before the start of retrofitting work.

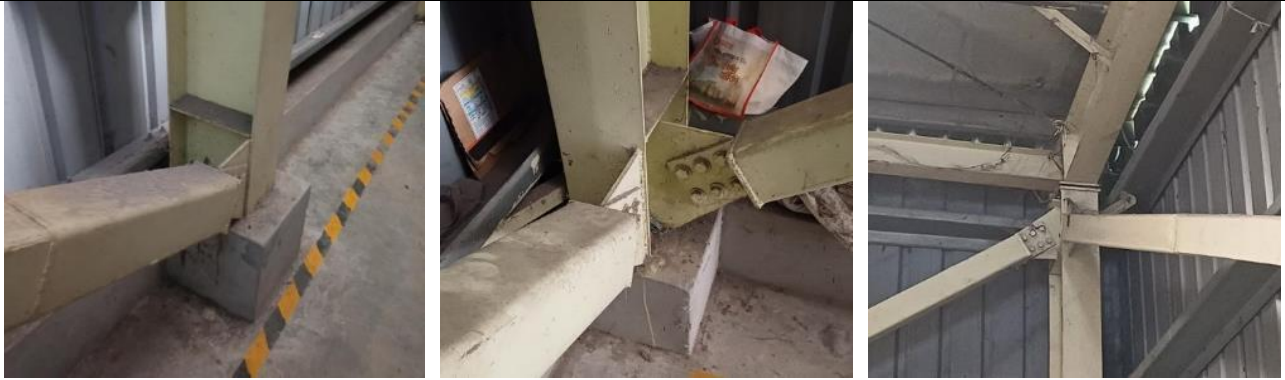
Observation-4: Faulty installation of bracings (FAL-27A).

Description: During the inspection, faulty installation of bracings was observed. The building engineer is required to reinstall the bracings in the right position.

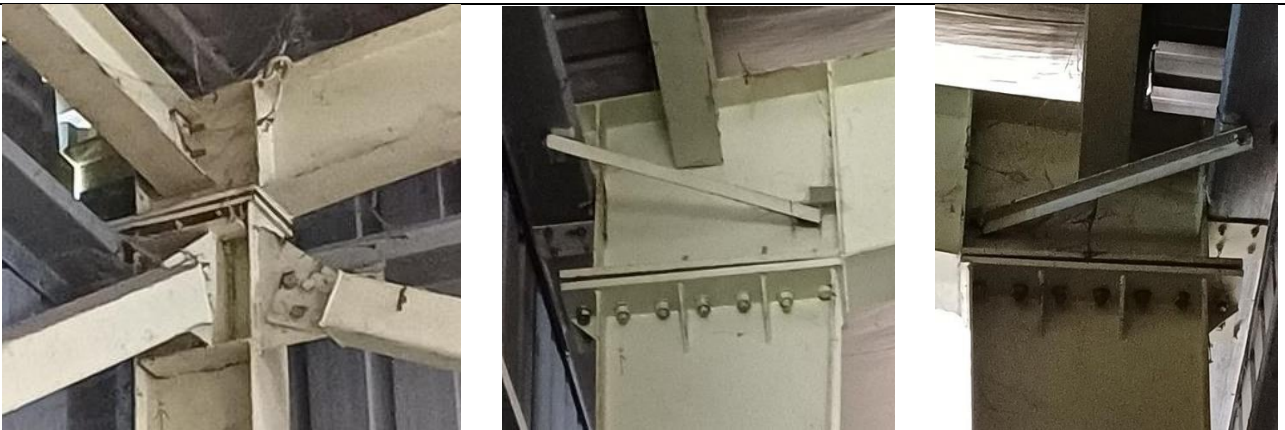
Observation-5: Connection gap between connection plates (FAL-27A).

Description: During inspection, connection gap was observed at some locations. The building engineer is required to fill the gaps with shim plate.

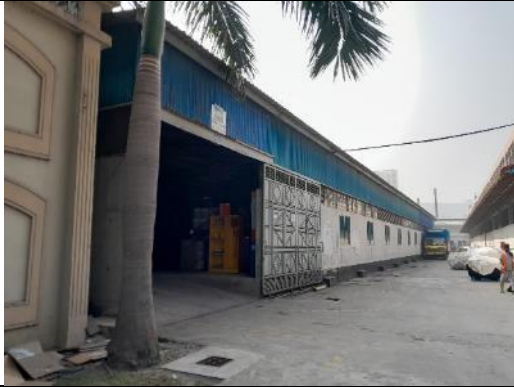
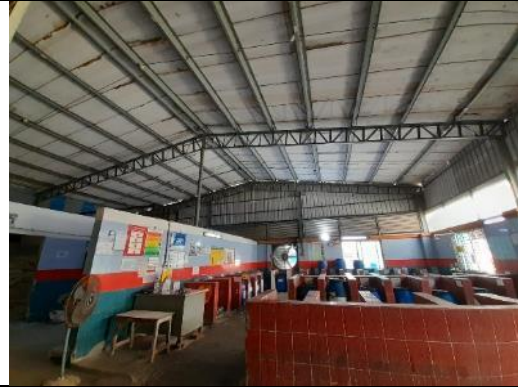
Observation-6: Lack of lateral stability. (FAL 28- Central Chemical Store)

Description: The structure has no lateral load transfer media (compression strut) along long direction. During the inspection no design documents were available for this shed.

The building engineer is required to carry out Engineering Assessment (EA) to check the lateral stability and adequacy of all structural elements of the structure based on in-situ material strength and software-based analysis which shall be prepared in compliance with section 1.9.1, part-6 of BNBC.

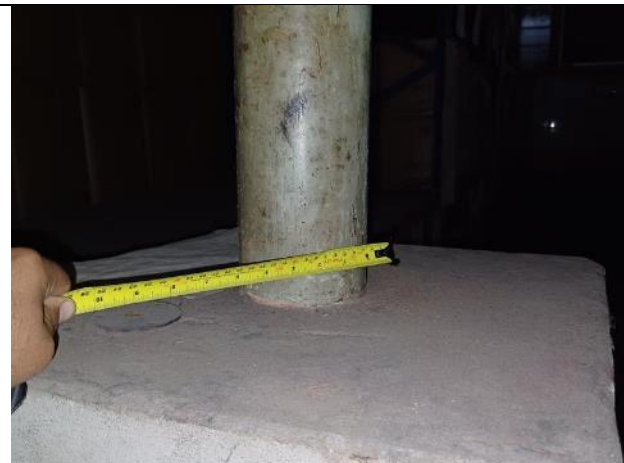
Observation-7: Discrepancies in as built drawings. (FAL 28- Central Chemical Store)

Description: During inspection, mismatches were found between onsite condition and as-built drawing. Steel pipe column SC2 was found dia 115 mm instead of dia 100 mm. The building engineer is required to survey the full structure and produce accurate as-built drawings.

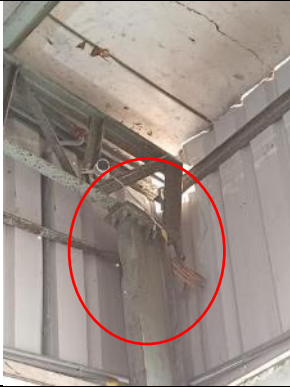
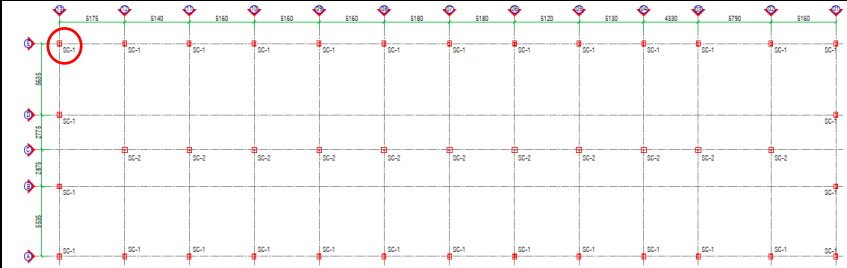
Observation-9: Distorted steel column. (FAL 28- Central Chemical Store)

Description: The corner steel column was found distorted. The building engineer is required to investigate the reason for such distortion and take necessary action for remedial procedures.

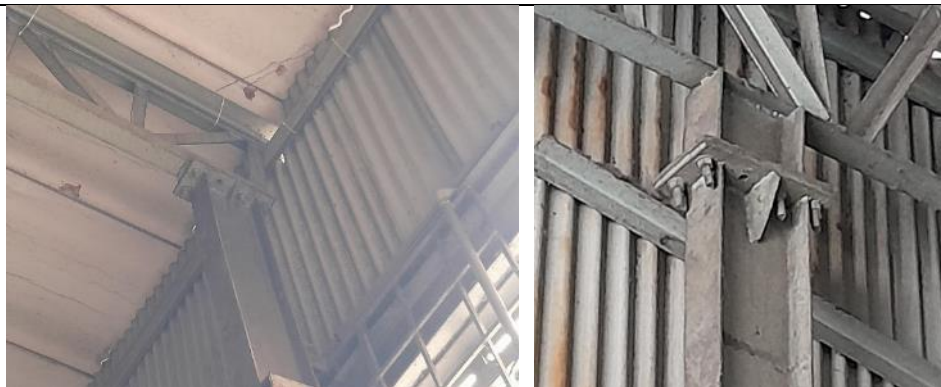
Observation-10: Missing bolts. (FAL 28- Central Chemical Store)

Description: During the inspection, missing bolts were observed at several places in this structure. The building engineer is required to identify all the missing bolts and provide adequate bolts as required.

13	Missing bolts. (FAL 28- Central Chemical Store)	The factory is required to identify all the missing bolts and provide adequate bolts as required.	within 6 months
14	Lack of design report (FAL 28- Office & Maintenance Workshop).	The building engineer is required to prepare a set of design documents including as built drawings, live load plan at roof and a design report based on in-situ material strength and software-based analysis which shall be prepared in compliance with section 1.9.1, part-6 of BNBC.	within 6 weeks
15	Lack of design report (FAL 28- Office & Maintenance Workshop).	Carry out remedial work if required.	within 6 months
16	Apparently non engineered roof shed (FAL 30- ETP chemical & sludge storage area)	The building engineer is required to check the member, connection & stability system of the structure and suggest proper alternatives accordingly.	within 6 weeks
17	Apparently non engineered roof shed (FAL 30- ETP chemical & sludge storage area)	Carry out remedial work if required.	within 6 months

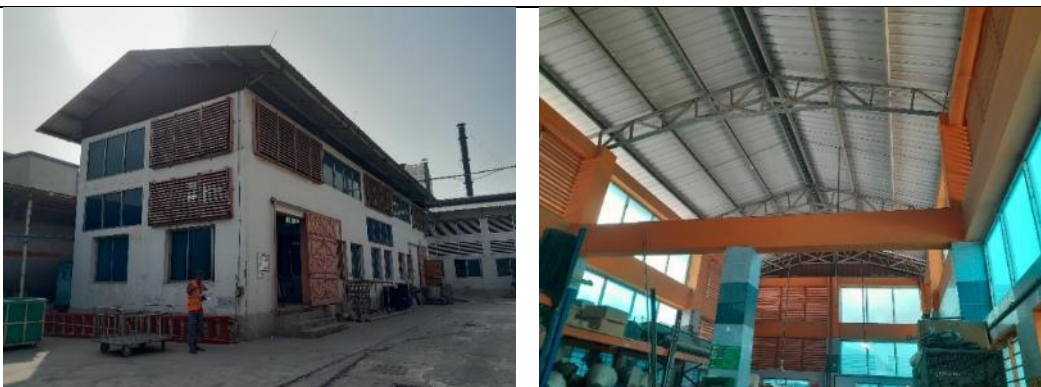
Observation-11: Lack of design report (FAL 28- Office & Maintenance Workshop).

Description: As per BNBC, every building or structure designed shall have its design documents prepared following the provision of Section 1.9.1. During inspection, the design report was not available on site.

The building engineer is required to prepare a set of design documents including as-built drawings, a live load plan at the roof and a design report based on in-situ material strength and software-based analysis which shall be prepared in compliance with section 1.9.1, part-6 of BNBC.

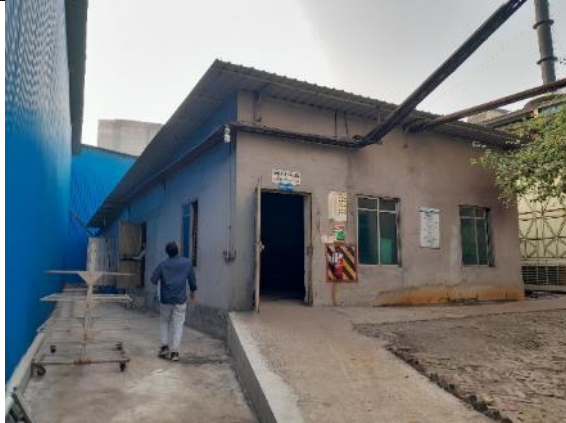
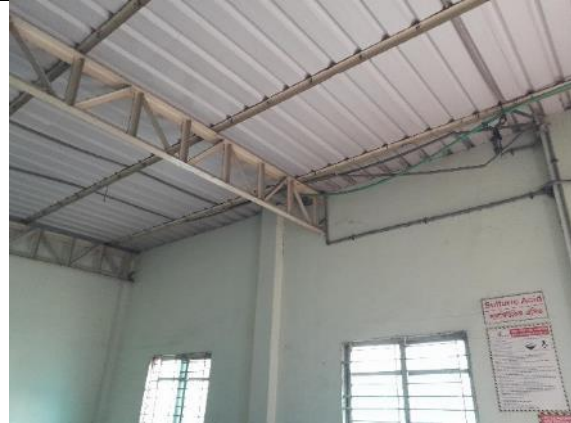
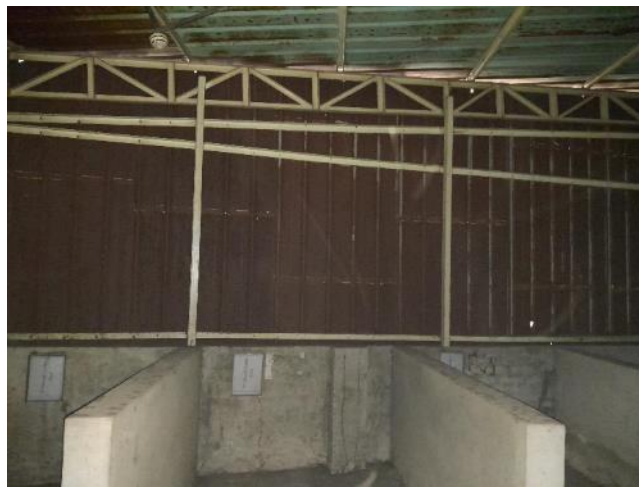
Observation-12: Apparently non-engineered roof shed (FAL 30- ETP chemical & sludge storage area)

Description: Lack of lateral stability system (strut and bracing), apparent inadequate members and non-engineered connection were observed. The building engineer is required to check the member, connection and stability system of the structure and suggest proper alternatives accordingly.

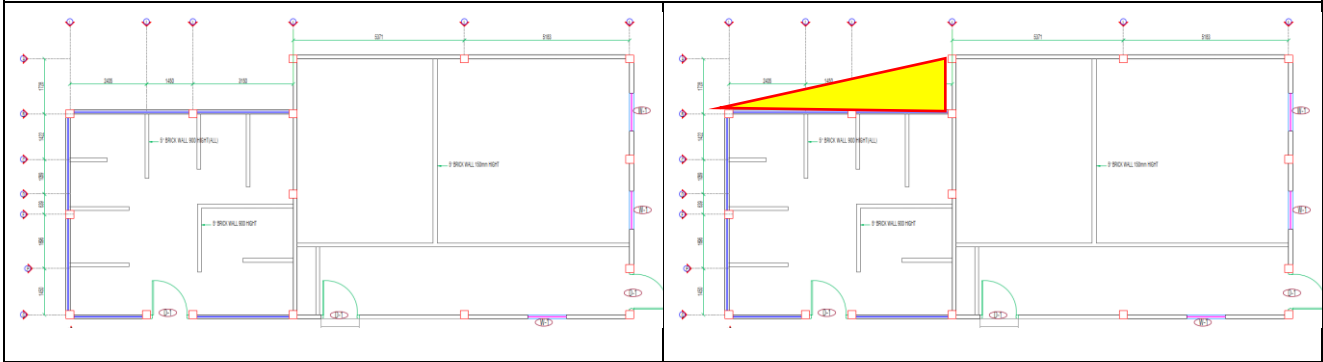
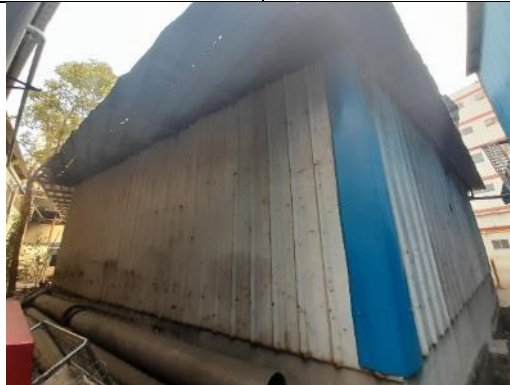
Observation 13: Discrepancies in as-built drawings. (FAL 30- ETP chemical & sludge storage area)

Actual shape of FAL 30

Description: During the inspection, a mismatch was found in the building plan shape. The building engineer is required to survey the full structure and produce accurate as-built drawings.

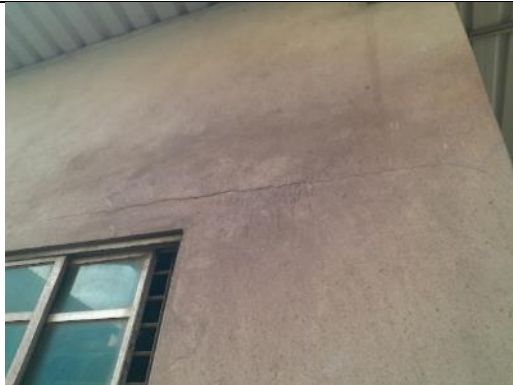
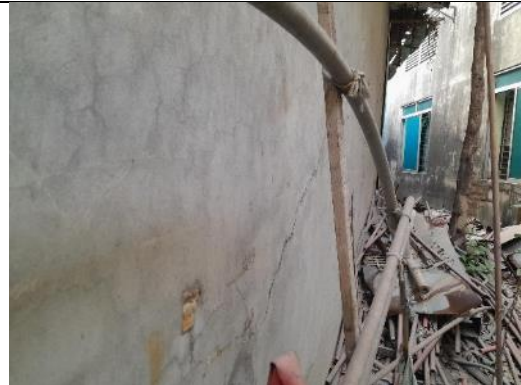
Observation-14: Brick wall crack. (FAL 30- ETP chemical & sludge storage area)

Description: During inspection, a brick wall crack was observed at FAL 30- ETP chemical & and sludge storage area. The building engineer is required to investigate the reason for the crack and suggest remedial measures as required.

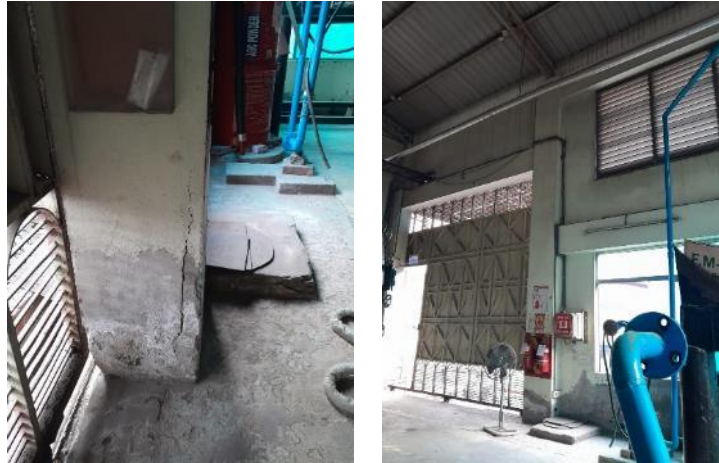
Observation-15: RC Column crack. (FAL 31- Boiler shed)

Description: During the inspection, a cracked RC column (Grid-B, 3) was observed at FAL 31- Boiler shed. The factory must immediately engage a consultant to investigate the crack. Any safety measures, if required as suggested by the consultant, must be taken immediately to ensure safety.

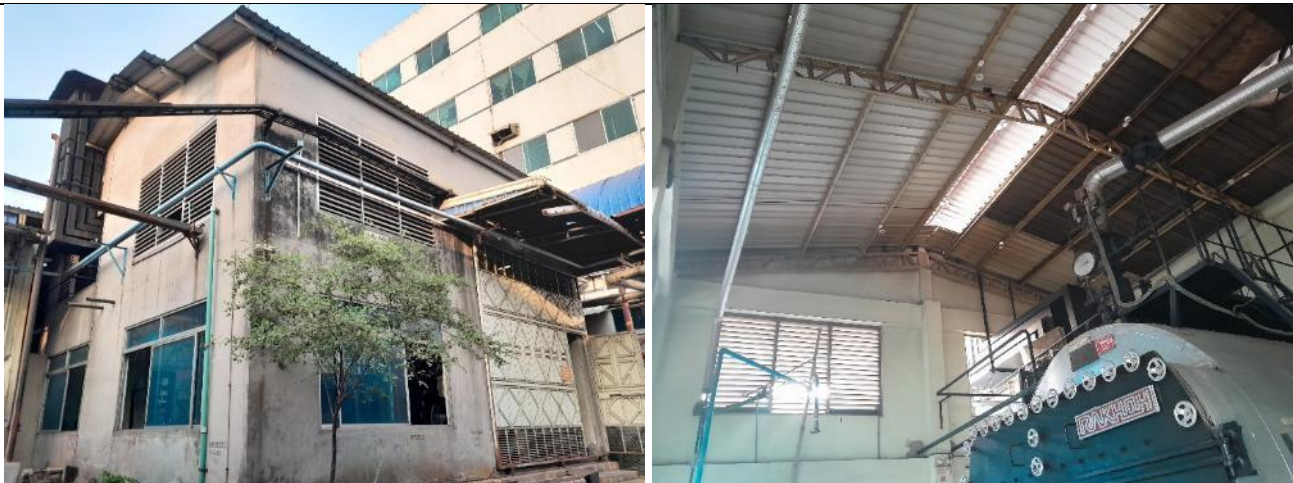
Observation-16: Lack of design report. (FAL 31- Boiler shed)

Description: As per BNBC, every building or structure designed shall have its design documents prepared following the provision of Section 1.9.1. During inspection, the design report was not available on site.

The building engineer is required to prepare a set of design documents including as-built drawings, a live load plan at the roof and a design report based on in-situ material strength and software-based analysis which shall be prepared in compliance with section 1.9.1, part-6 of BNBC.

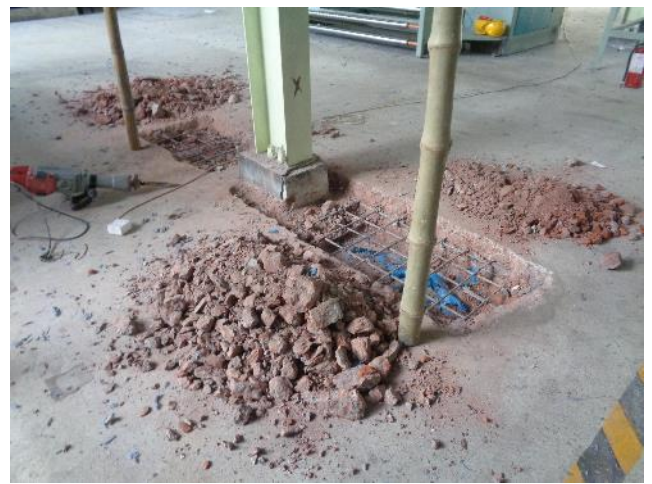
Observation-19: Remediation work raised from fire incident (FAL-33, Washing and Dyeing Finishing)

Description: At the time of inspection remediation work due to the fire incident was ongoing at the time of inspection. The building engineer is required to complete the remediation work as per RSC accepted drawing and timeline.

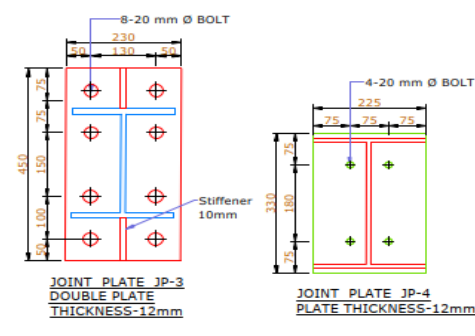
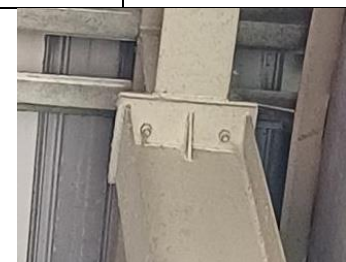
Observation-20: Discrepancies in as-built drawing (FAL-34).

Actual flange thickness

Description: During the inspection, the flange thickness of the marked steel column was found 8mm instead of 10 mm and the bolt diameter of connection JP3 & JP4 were observed below 16mm instead of 20 mm. The building engineer is required to survey the whole structure and produce as-built drawings as per actual site conditions.

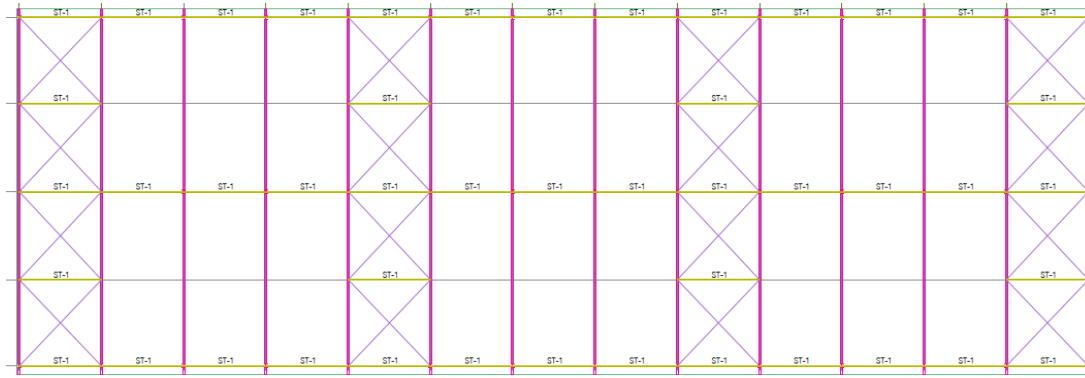
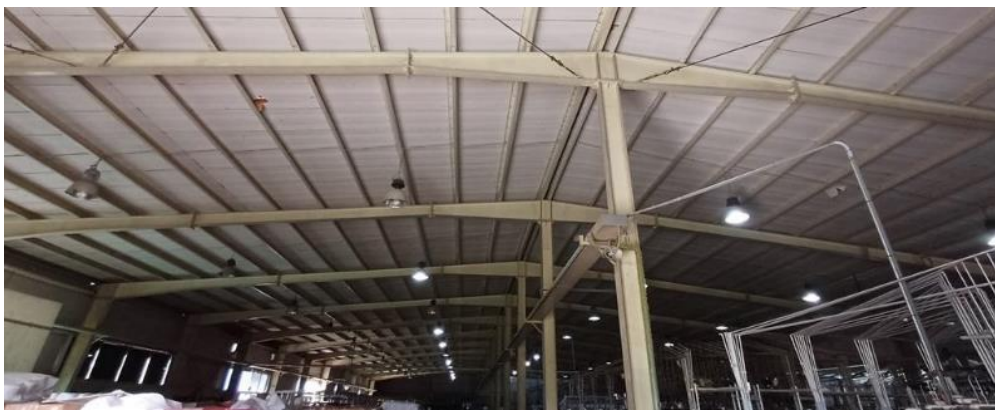
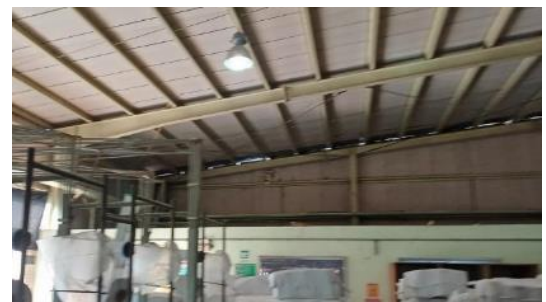
Observation-21: Incomplete retrofitting works (FAL-34).

No compression strut in the long direction

No wall bracing and rafter retrofitting

Description: The factory has prepared the DEA of the shed. As per the recommendation of DEA, some retrofitting works were suggested but no retrofitting work was carried out.

Building engineer is required to submit the DEA report to RSC for review before the start of retrofitting work.

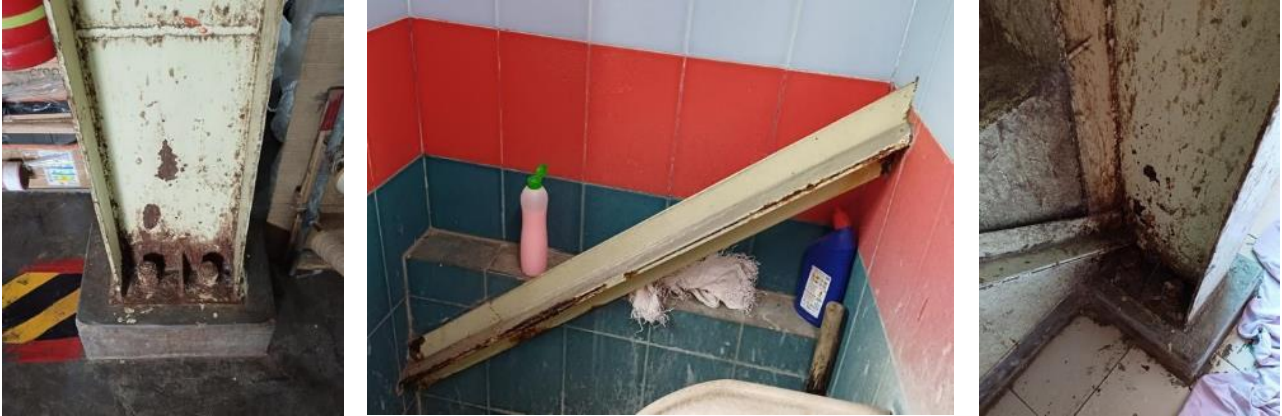
Observation-22: Corrosion on steel member (FAL-34).

Description: During inspection, corrosion was found on several steel members. Factory is required to remove rust and apply rust-proof paint on steel members.

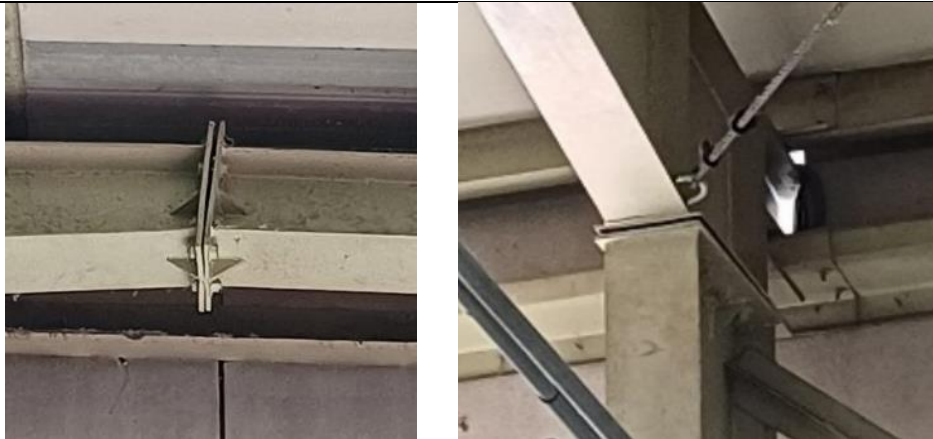
Observation-23: Connection gap between connection plates (FAL-34).

Description: During the inspection, a connection gap was observed at some locations. The building engineer is required to fill the gaps with shim plate.

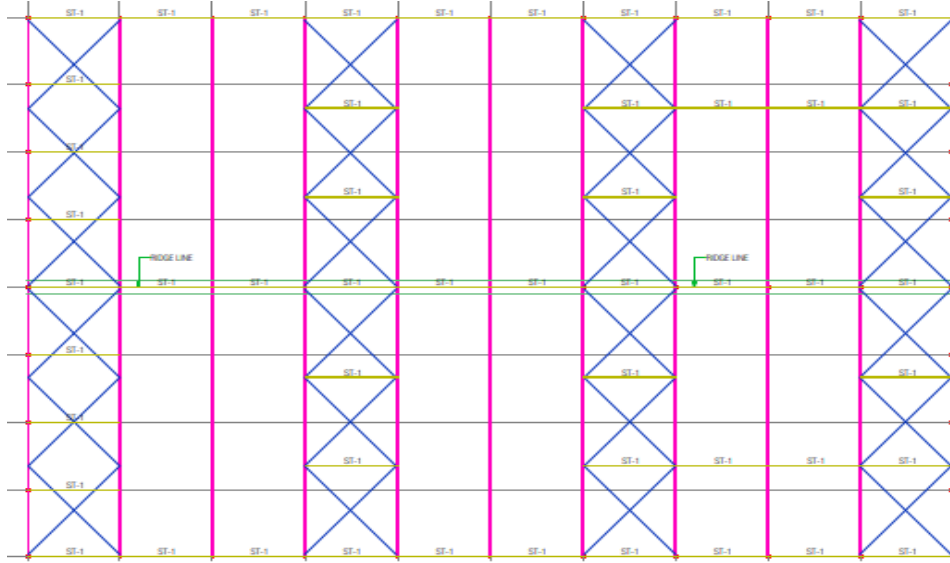
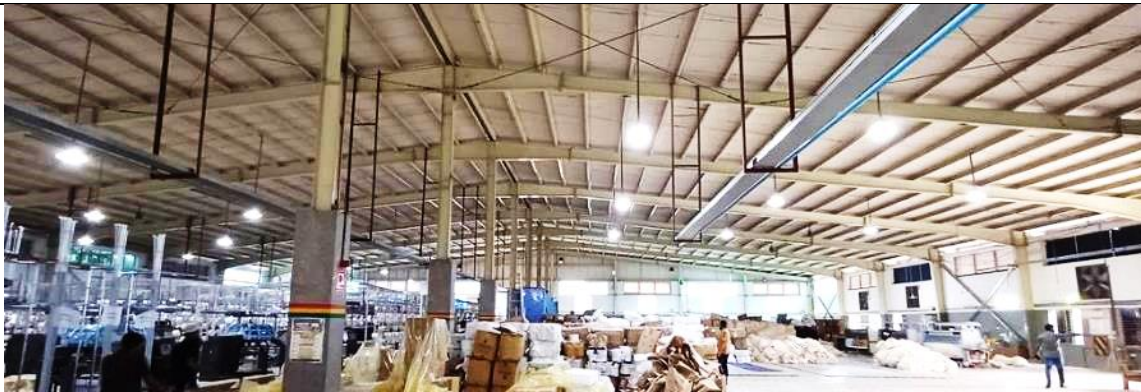
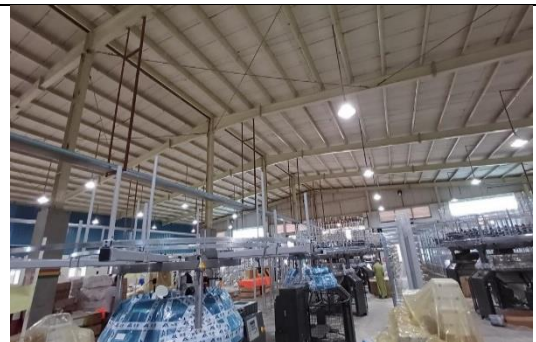
Observation-24: Incomplete retrofitting works (FAL-35).

No compression strut in the long direction

No wall bracing and rafter retrofitting

Description: The factory has prepared the DEA of the shed. As per the recommendation of the DEA, some retrofitting works were suggested but no retrofitting work was carried out.

Building engineer is required to submit the DEA report to RSC for review before the start of retrofitting work.

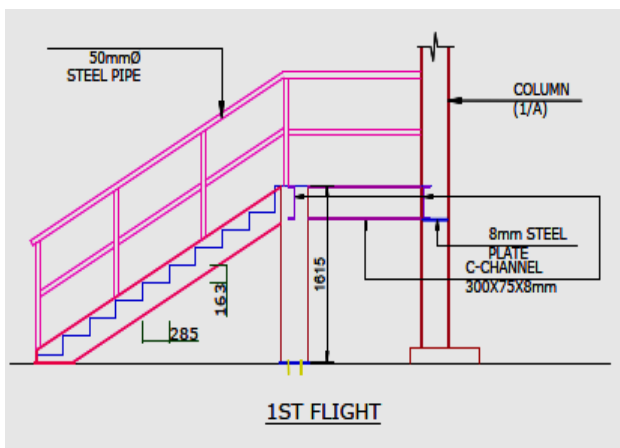
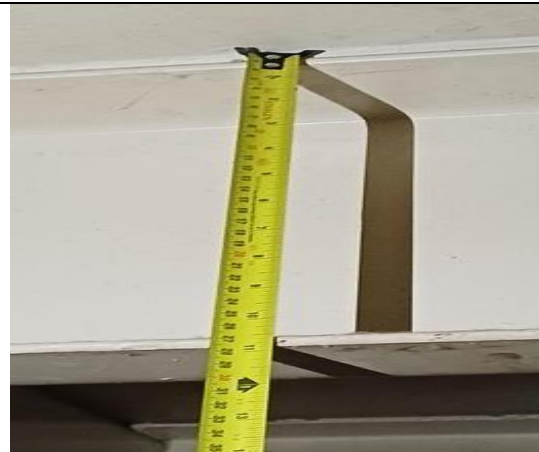
Observation-26: Discrepancies in as-built drawing (FAL-37).

Description: During the inspection, the C-channel depth of the stairs was found 275mm instead of 300 mm. The building engineer is required to survey the whole structure and produce an as-built drawing as per actual site condition.

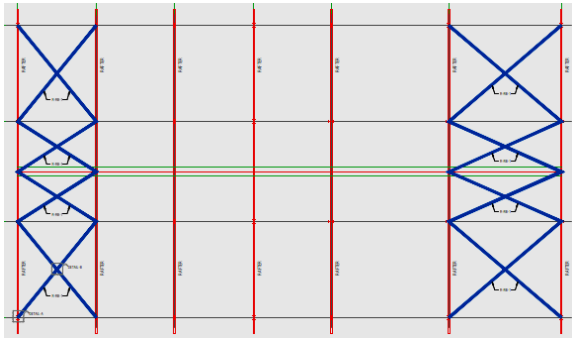
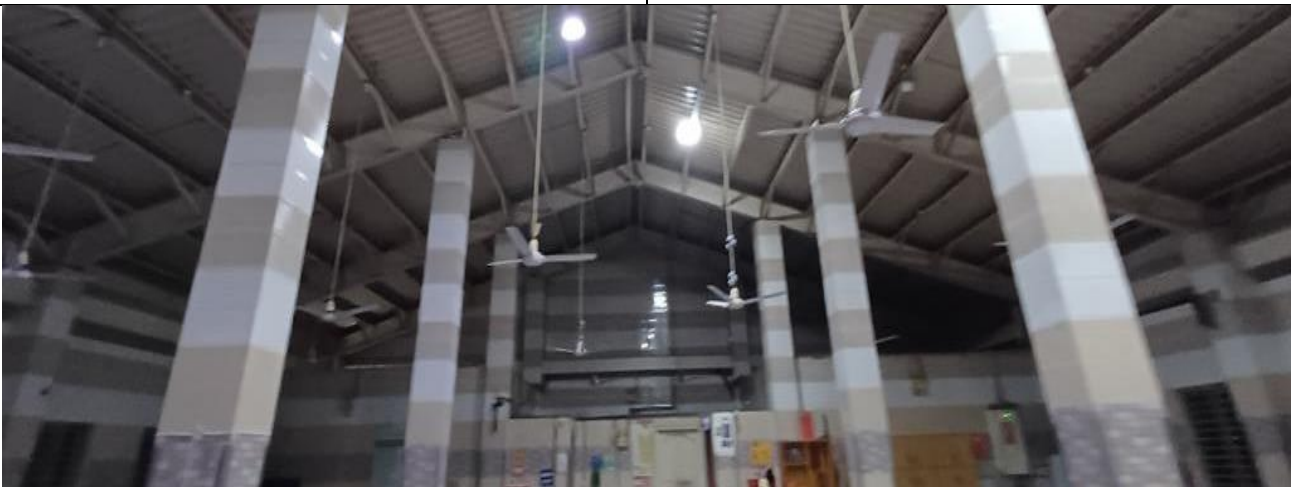
Observation-27: Incomplete retrofitting works (FAL-37).

No roof or wall bracing

Description: The factory has prepared the DEA of the shed. As per the recommendation of the DEA, some retrofitting works are suggested but no retrofitting work was carried out.

Building engineer is required to submit the DEA report to RSC for review before the start of retrofitting work.

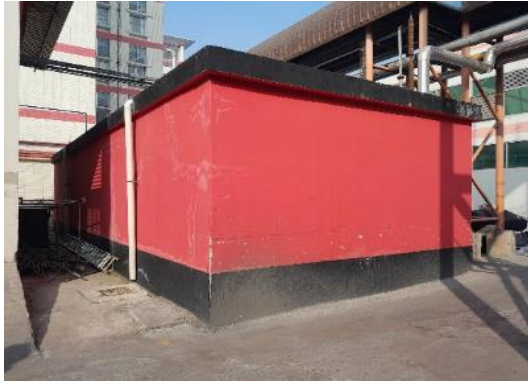
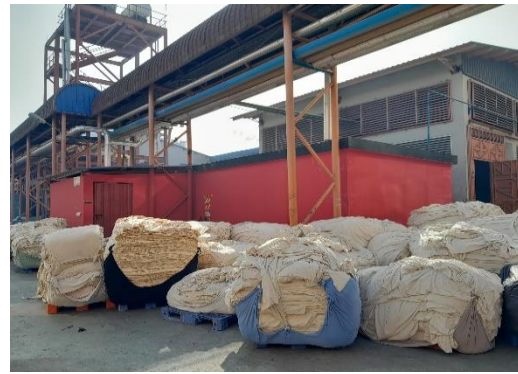
Observation-28: Absence of as built drawing. (FAL 39- RCC water tank)

Description: During inspection, no as-built structural drawing was found on site. The building engineer is required to prepare accurate as-built drawings for the structure.

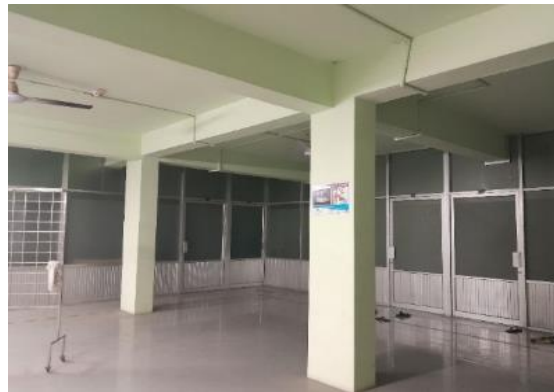
Observation-29: Lack of design report. (FAL 40- Medical & daycare)

Description: As per BNBC (part 6), every building or structure designed shall have its design documents prepared following the provision of Section 1.9.1. The design document shall include a design report, and a set of structural drawings, which shall be prepared in compliance with section 1.9.1.1 and section 1.9.1.2 of BNBC (part 6).

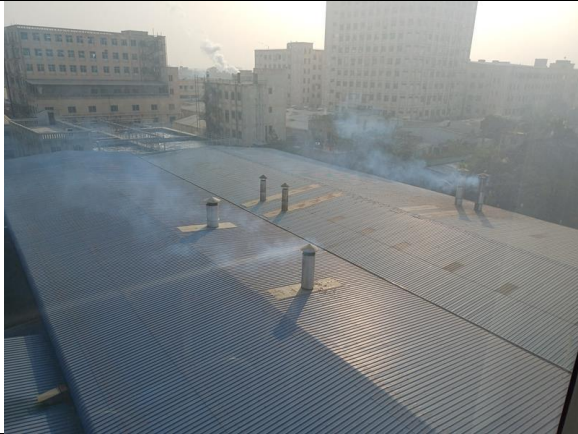
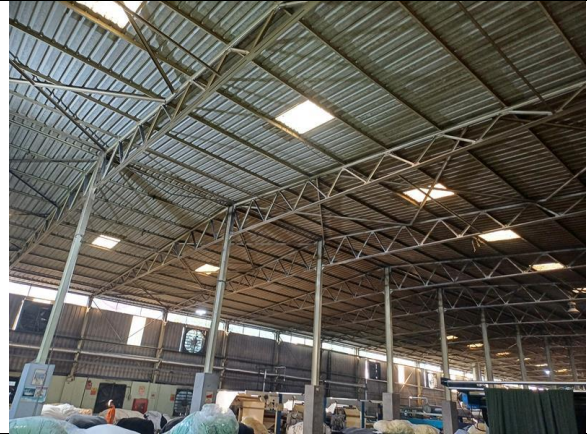
Observation-31: Lack of design report. (FAL 42- Dyeing Finishing)

Description: As per BNBC, every building or structure designed shall have its design documents prepared following the provision of Section 1.9.1. During inspection, the design report was not available on site.

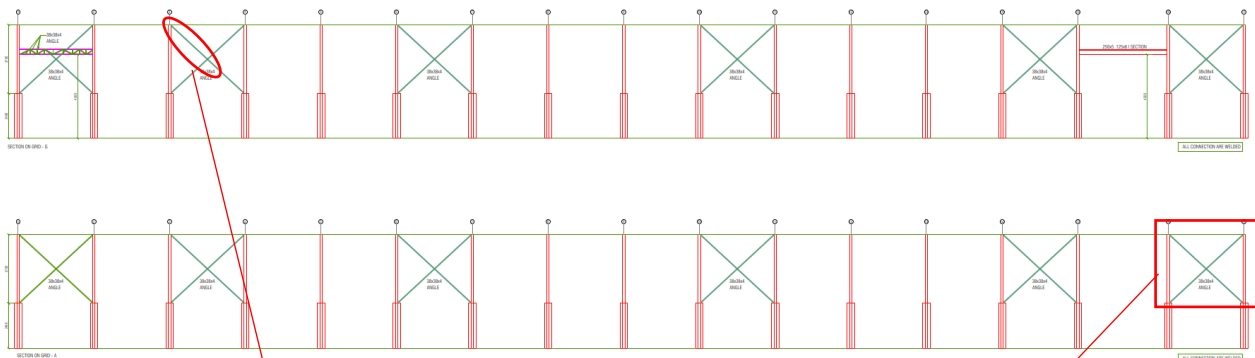
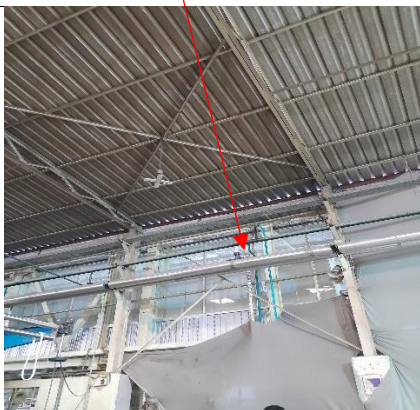
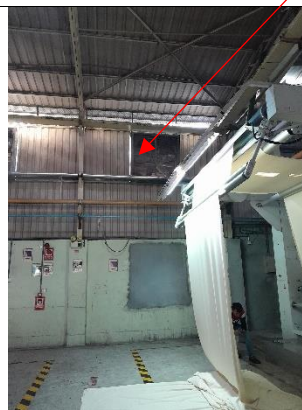
Observation-32: Discrepancies in as-built drawings. (FAL 42- Dyeing Finishing)

Description: During the inspection, mismatches were found in the vertical bracing layout between the onsite condition and the as-built drawing. The building engineer is required to survey the full structure and produce accurate as-built drawings.

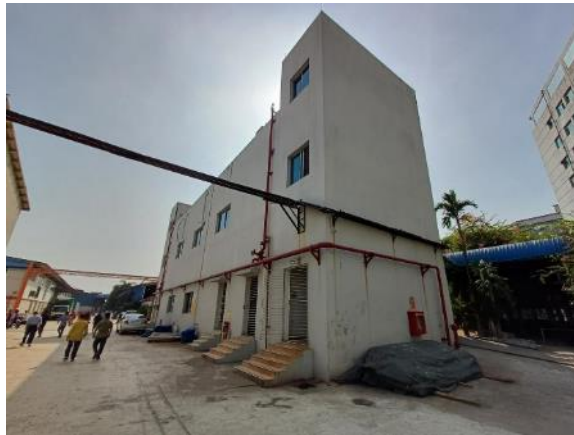
Observation-33: Lack of design report (FAL-43).

Description: As per BNBC, every building or structure designed shall have its design documents prepared following the provision of Section 1.9.1. The design documents shall include as-built drawings, material test reports, a load plan and a design report which shall be prepared in compliance with section 1.9.1, part-6 of BNBC.

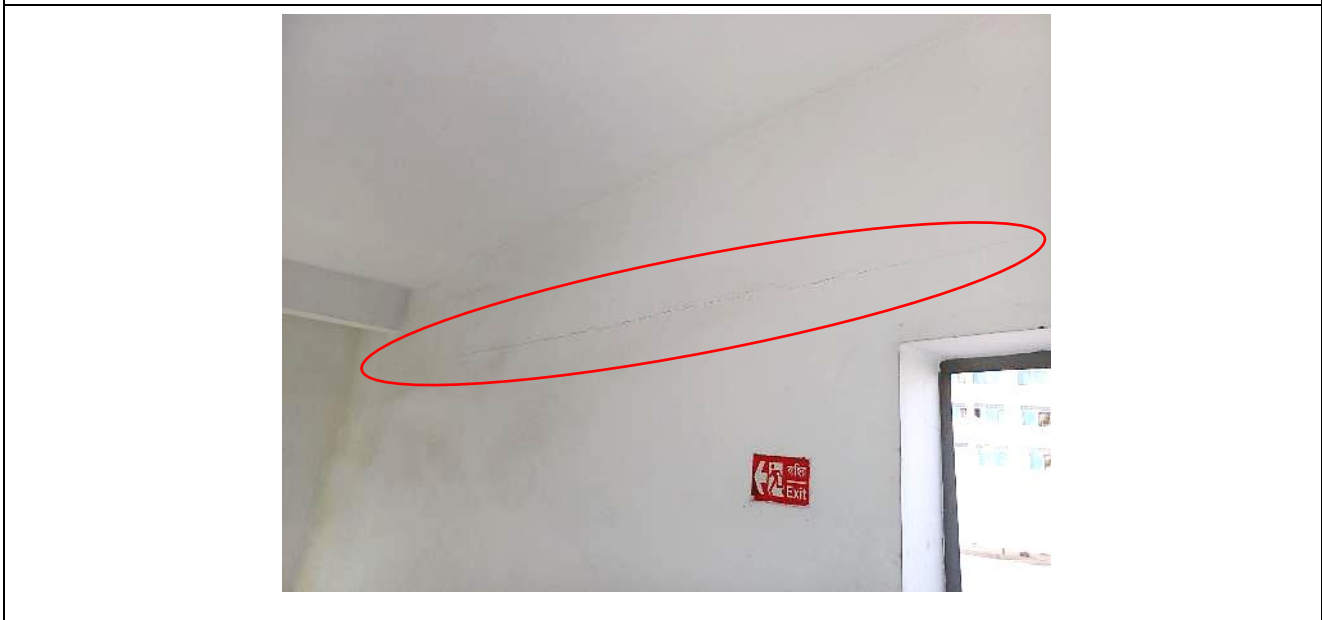
Observation-36: Cracks in brick wall of stairs at roof (FAL-43).

Description: Crack found on the brick wall of stair at roof. Building engineer is required to identify the reason of crack, take necessary remedial measure to repair the wall accordingly.

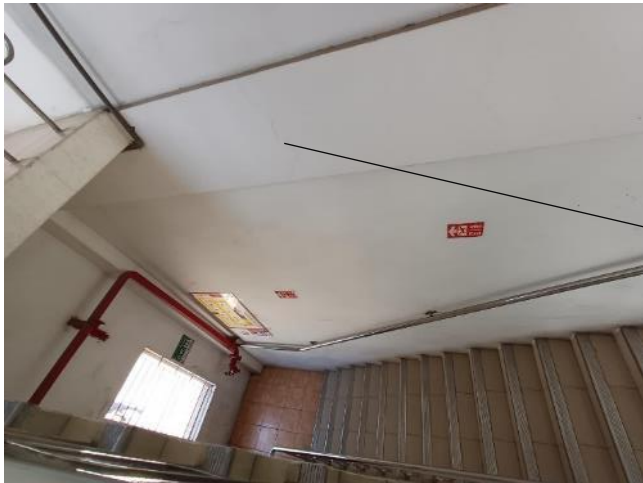
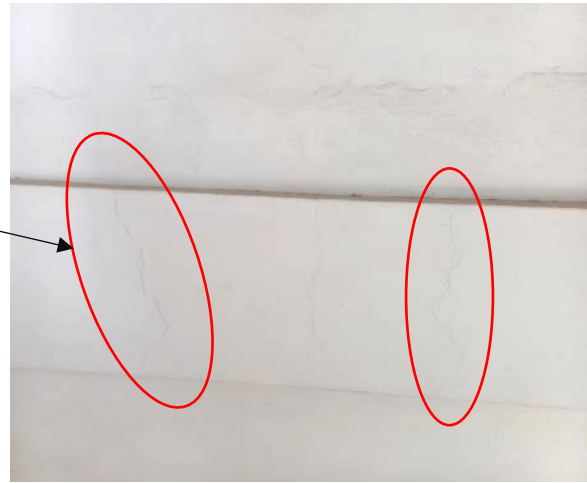
Observation-37: Cracks in beam of stairs at roof (FAL-43).

Observations: Cracks found on floor beam of stair at roof. Factory is required to identify the reason of crack, prepare crack investigation report, and take necessary remedial measure to repair the crack as per the suggestion of building engineer.

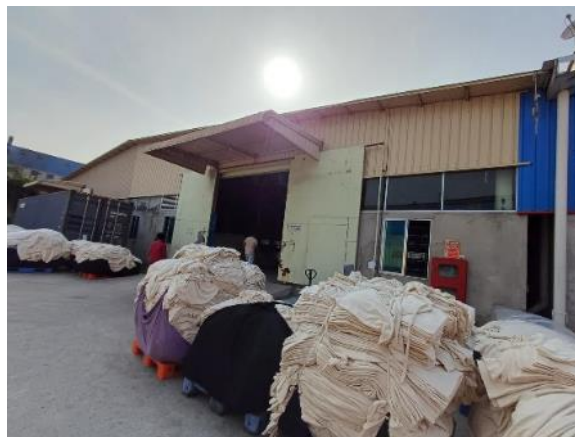
Observation-38: Lack of design report (FAL-44).

Description: As per BNBC, every building or structure designed shall have its design documents prepared in accordance with the provision of Section 1.9.1. The design documents shall include as-built drawings, material test reports and a design report which shall be prepared in compliance with section 1.9.1, part-6 of BNBC.

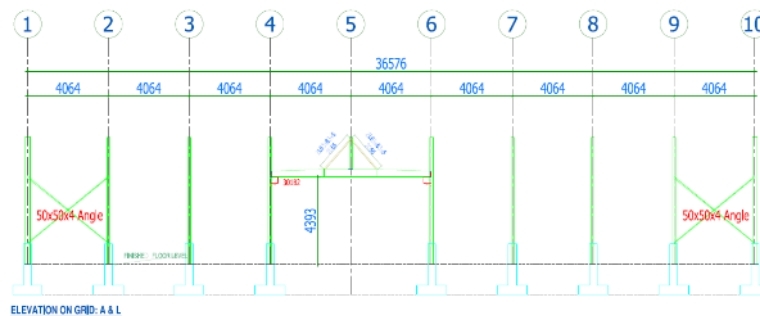
Misalignment of steel truss

Description: According to the on-site condition, steel truss is connected to steel columns along both directions. The steel truss alignment is not straight along short direction. In as built structural drawing, truss is not shown in the short direction both in plan and elevation. The building engineer is required to prepare accurate as-built drawings based on actual site condition.

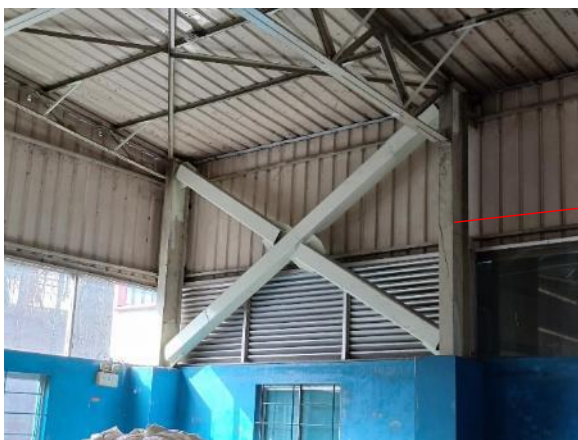
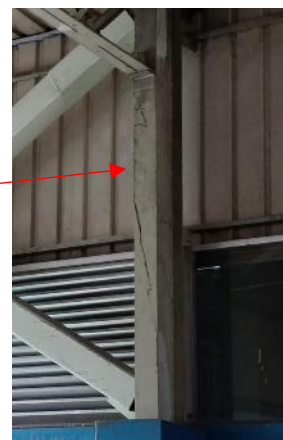
Observation-40: Distorted Steel Column (FAL-44).

Description: Steel column of GL 9-K found distorted. Factory is required to identify the reason of crack, prepare investigation report, and take necessary remedial measure to repair the crack as per the suggestion of building engineer.

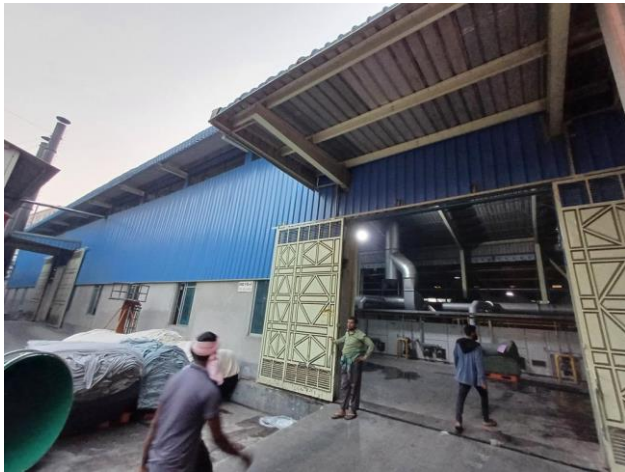
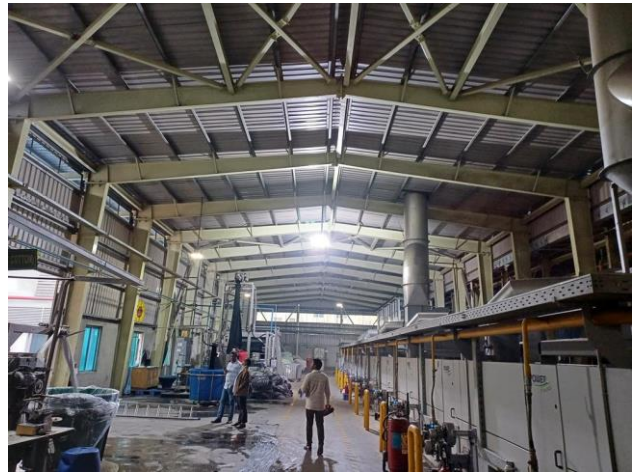
Observation-41: Lack of design documents (FAL-45).

Description: As per BNBC, every building or structure designed shall have its design documents prepared in accordance with the provision of Section 1.9.1. During the inspection, the design report and soil test report were not available on site.

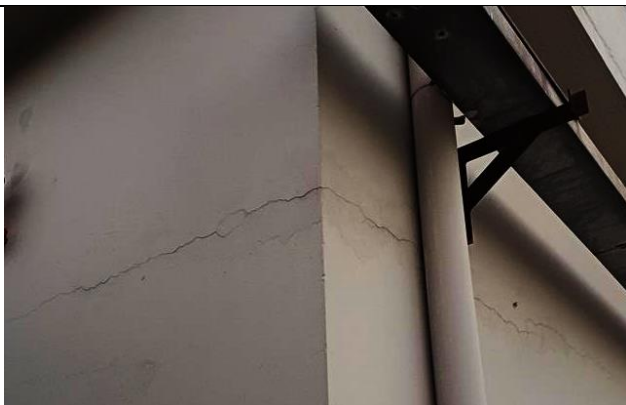
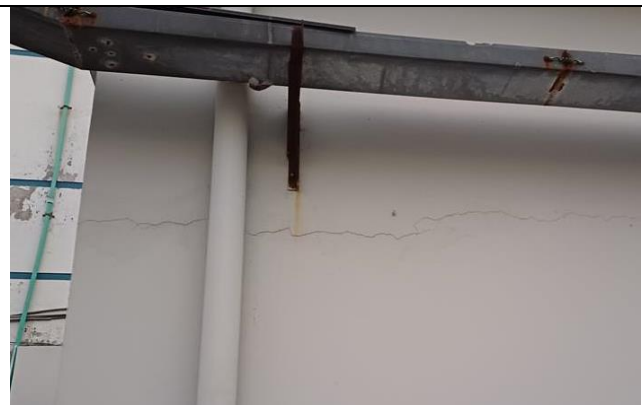
Observation-42: Horizontal crack on brick wall (FAL-46).

Description: During inspection, horizontal cracks were observed on the brick wall. The building engineer is required to identify the reason for the crack, take necessary remedial measure to repair the cracks accordingly.

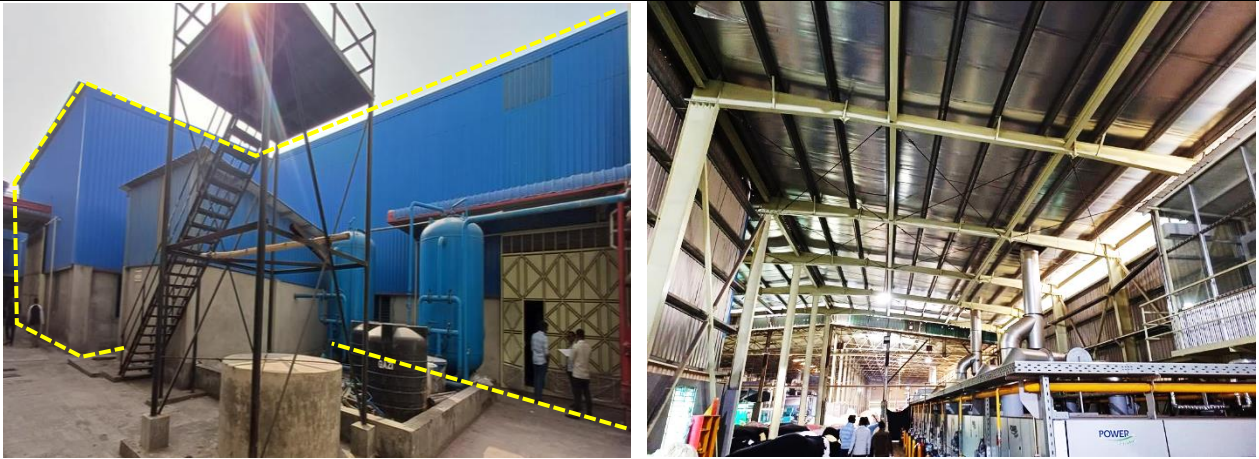
Observation-44: Lack of design documents (FAL-47).

Description: As per BNBC, every building or structure designed shall have its design documents prepared in accordance with the provision of Section 1.9.1. During the inspection, the design report and soil test report were not available on site.
