Fakir Apparels Ltd. (Extension)

A-127-131,135-138,142-145, B-501-503, BSCIC Hosiery Ind. Estate, Fatullah, Narayanganj
(23.622441, 90.480205)

14 November 2023 & 1 January 2024

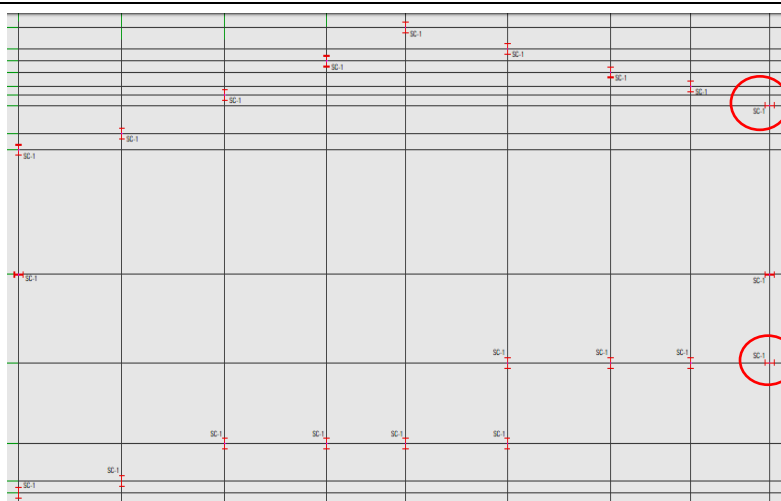
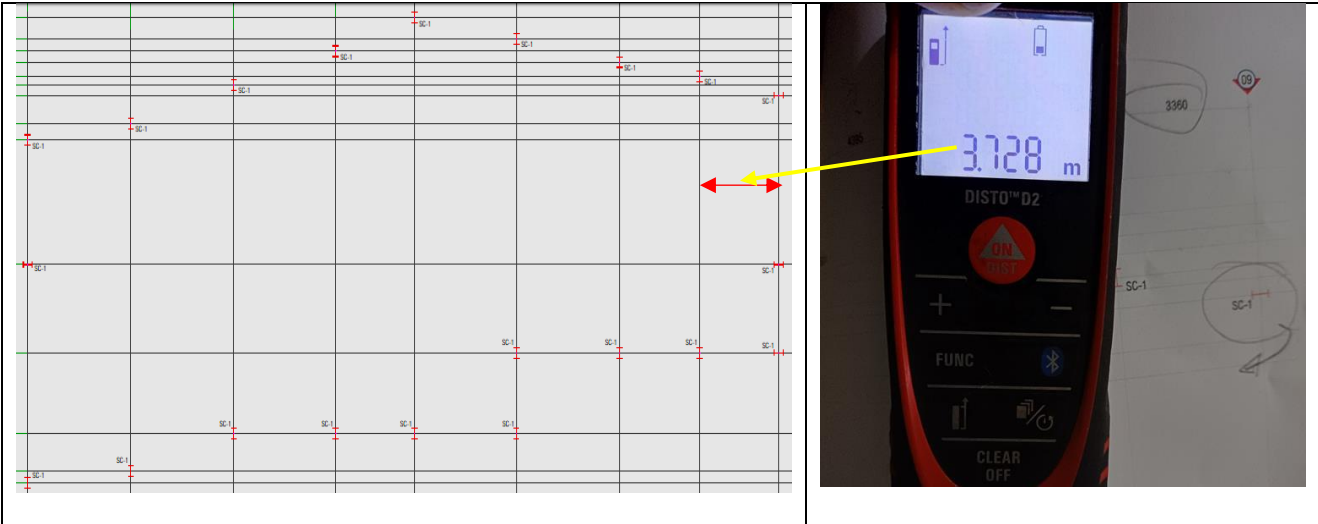
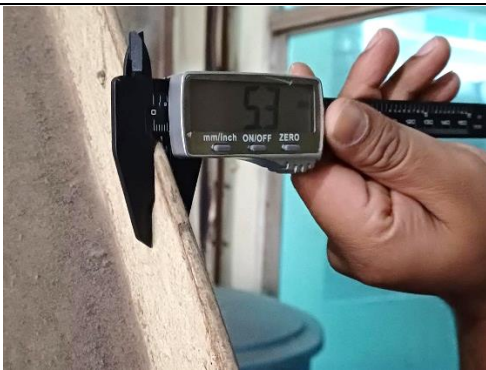
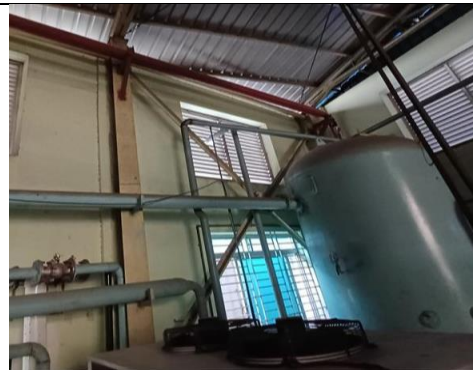
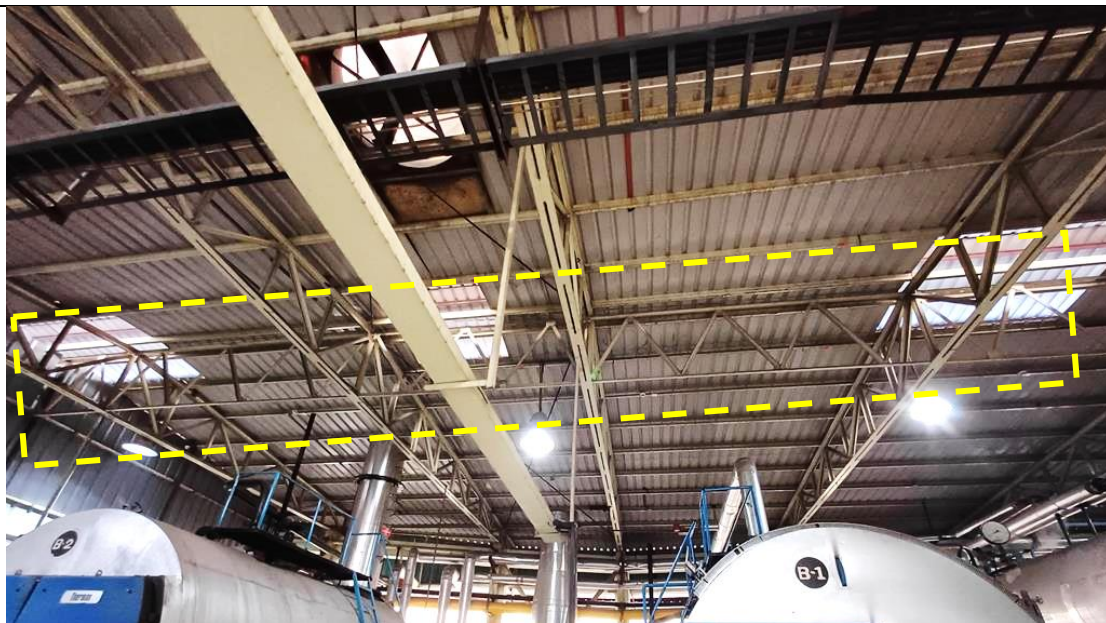
Observation-45: Discrepancies in as-built drawing (FAL-48).

Orientation mismatch - marked columns

Marked grid dimension was observed 3.728 m instead of 3.36 m

The thickness of wall bracing was found 5.3 mm instead of 6 mm

No drawing of truss in the long direction

Description: During the inspection, mismatches (column orientation, wall bracing size, grid dimension, no drawing of truss in a long direction) were observed. The building engineer is required to survey the whole structure and produce as-built drawings as per actual site conditions.

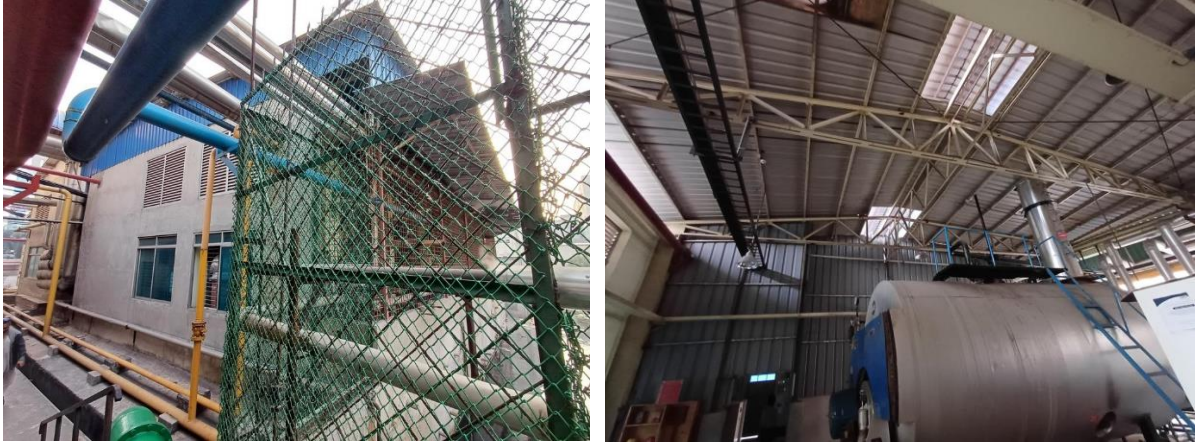
Observation-46: Lack of design documents (FAL-48).

Description: As per BNBC, every building or structure designed shall have its design documents prepared following the provision of Section 1.9.1. During the inspection, the design report and soil test report were not available on site.

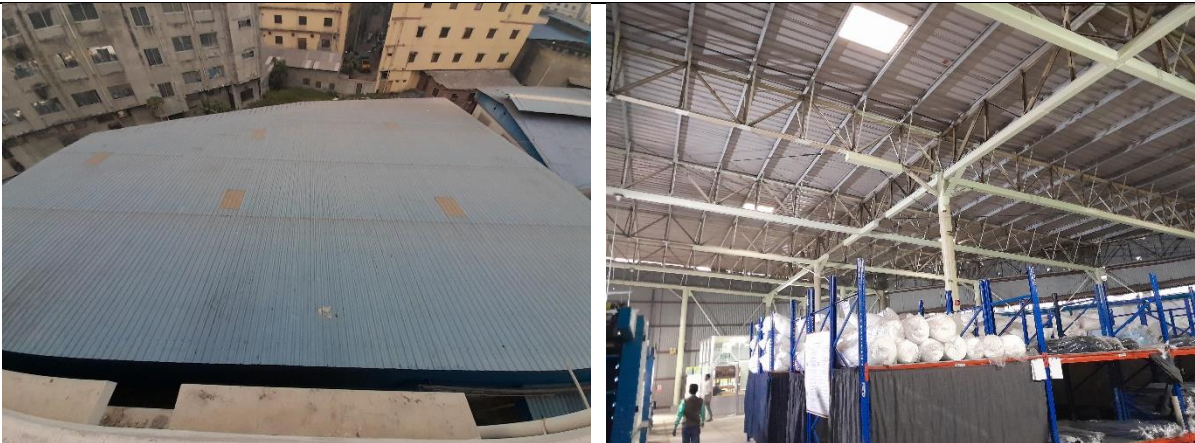
Observation-47: Lack of design report. (FAL 49- Warehouse)

Description: As per BNBC, every building or structure designed shall have its design documents prepared following the provision of Section 1.9.1. The factory carried out retrofitting on the roof system in 2021. However, during the inspection, the design report was not available on-site.

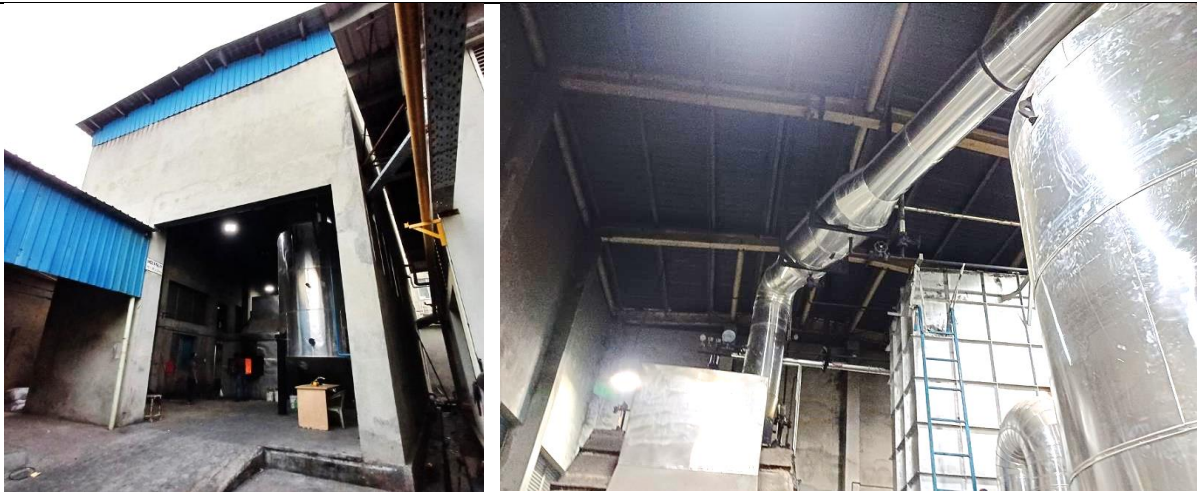
Observation-49: Lack of design documents (FAL-51).

Description: As per BNBC, every building or structure designed shall have its design documents prepared following the provision of Section 1.9.1. During the inspection, the design report and soil test report were not available on site.

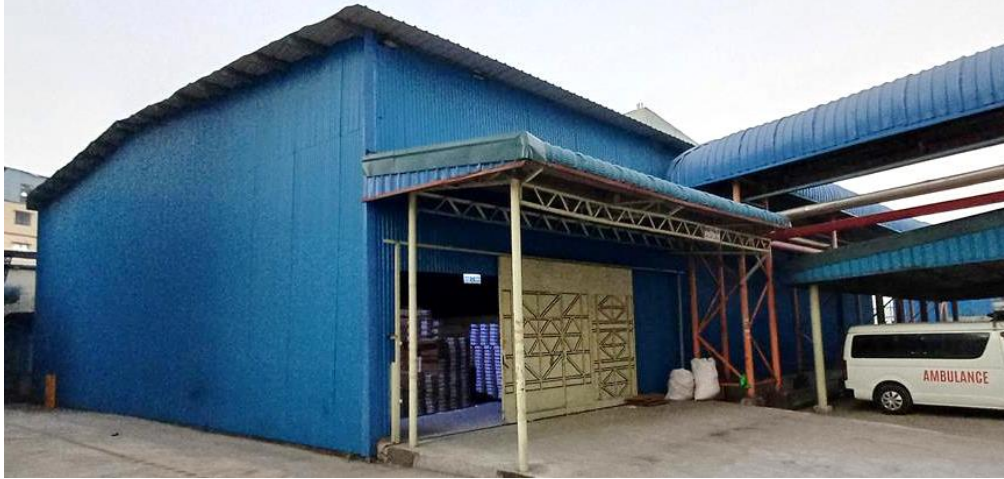
Observation-50: Lack of design documents (FAL-52).

Description: As per BNBC, every building or structure designed shall have its design documents prepared following the provision of Section 1.9.1. During the inspection, the design report and soil test report were not available on site.

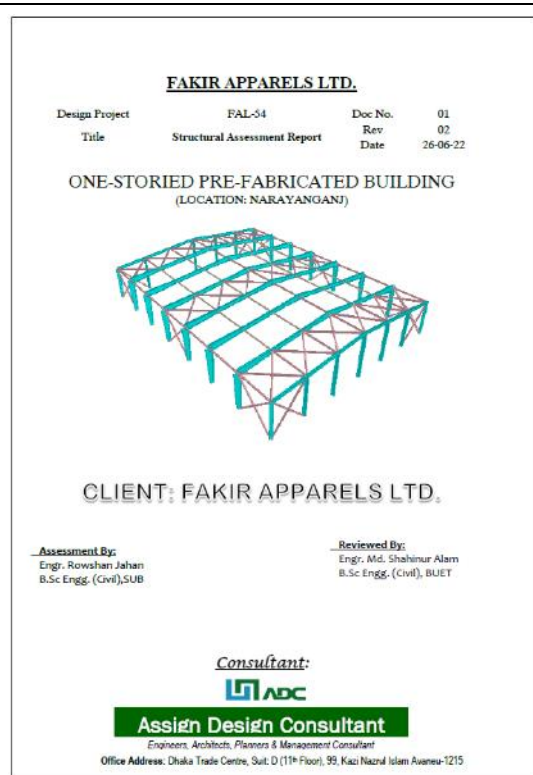
Observation-51: Inconsistency in design report (FAL-54).

Description: In the design report, steel connections, concrete members, and foundation adequacy checks are not provided. The building engineer is required to update the design report based on in-situ material strength, sub-surface condition and software-based analysis. Submit it to the RSC for review.

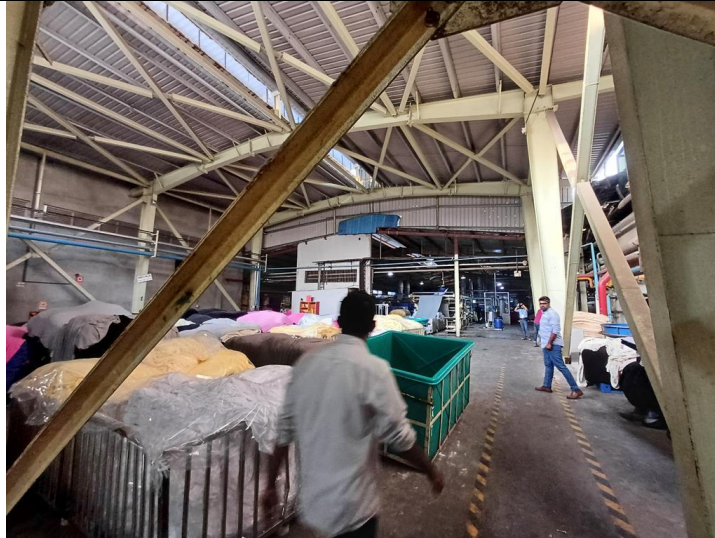
Observation-52: Lack of design documents (FAL-55).

Description: As per BNBC, every building or structure designed shall have its design documents prepared following the provision of Section 1.9.1. During the inspection, the design report and soil test report were not available on site.

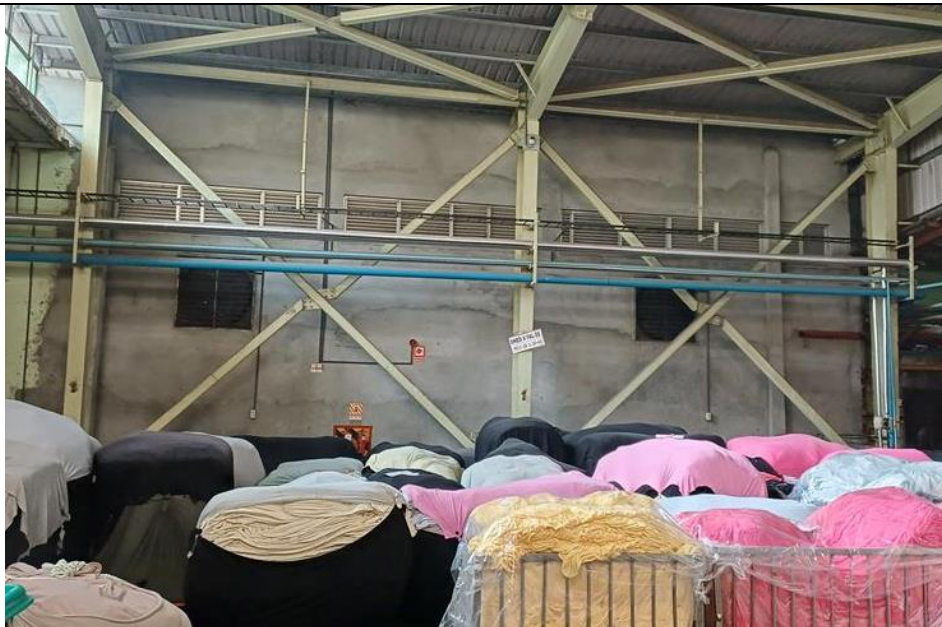
Observation-53: Misalignment of wall bracing (FAL-55).

Description: During the inspection, misalignment of wall bracing was observed. The building engineer is required to check the effect of misalignment of wall bracing or reinstall the bracing properly.

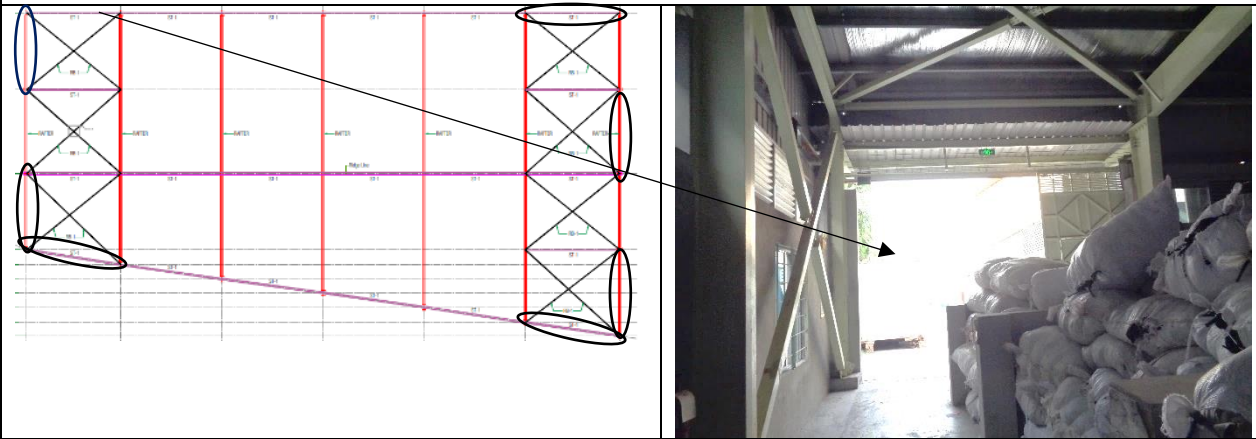
Observation-54: Bracing system is not symmetric (FAL-56, Wastage Shed)

Description: The bracing system of the shed is not symmetric. The building engineer is required to check the lateral stability of the shed.
