# Four Brothers Fashion (Extension)

Dhaka Uddan, Beribadh, Mohammadpur, Dhaka

22 April 2024

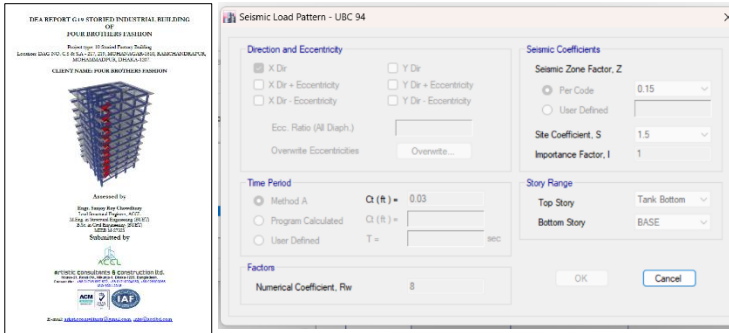
The factory has performed a Detailed Engineering Assessment (DEA) for the building. The structure has been considered as an Intermediate Moment Resisting Frame (IMRF) system ( $R=S$ ). However, in the report, adequate information and calculations have not been provided to support the framing system as IMRF.

A building engineer is required to revise the DEA documents based on the above observations and submit to RSC for further review.

| Serial No | Observation | Action Plan | Timeline |
|---|---|---|---|
| 1 | Inconsistencies in prepared Detail Engineering Assessment (DEA). | Building engineers is required to survey the whole structure and prepare accurate as-built drawings. | within 6 weeks |
| 2 | Inconsistencies in prepared Detail Engineering Assessment (DEA). | Building engineers is required to revise the Detail Engineering Assessment (DEA) based on design/in-situ material strength, loading and actual site condition. Submit DEA to RSC for further review. | within 6 weeks |

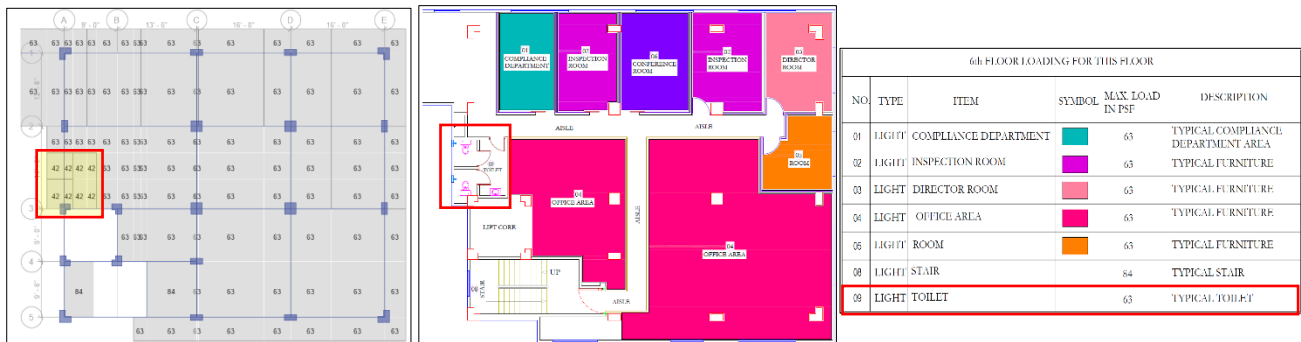
The assignment of the floor loading do not match between FEA model and load plan. Floor live load has been considered 3kPa for the toilet zone but in FEA model 2kPa has been assigned.

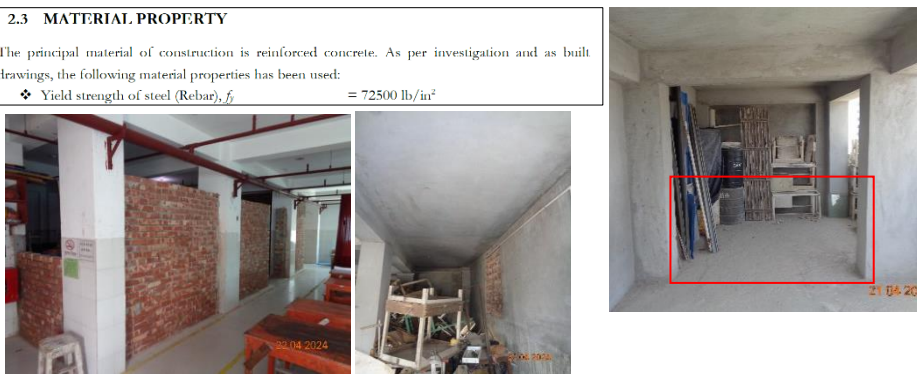
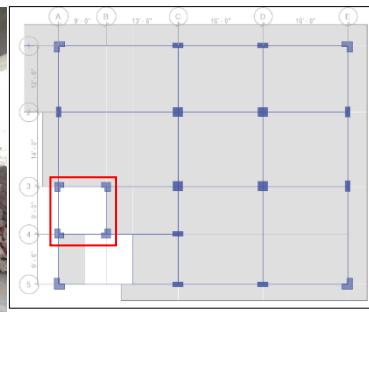
In the DEA, the tensile strength of the re-bar has been considered 500MPa but no test report is available. During the inspection, the floor layout plan was found mismatch with the provided as-built architectural drawing. Newly brick wall have been constructed on floors that are not shown in the drawing. The opening of the lift core has been shown in the floor layout and assigned in the FEA model, but at the site lift core opening was not found. A Cantilever slab was found which has not been shown in the architectural drawing.

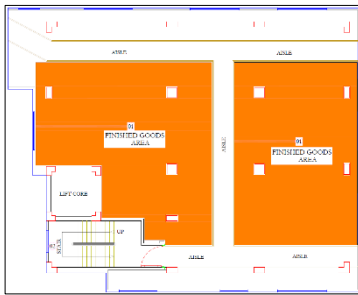
Posted load plan 5kPa at 3rd and 4th floor

6kPa required for storage

**Description:** During the inspection, storage was found on the 8th, 4th, 3rd and 1<sup>st</sup> floor. But in loading has been considered 3kPa in load plan. As per BNBC-2006, 6kPa live load needs to be considered for the storage area. The building engineer is required to update the floor load plan for storage areas, revise the Detail Engineering Assessment (DEA) report and submit to the RSC for further review.

| Serial No | Observation | Action Plan | Timeline |
|---|---|---|---|
| 4 | Load plan does not comply with BNBC requirement. | Revise the floor loading plan following BNBC requirement. | within 6 weeks |

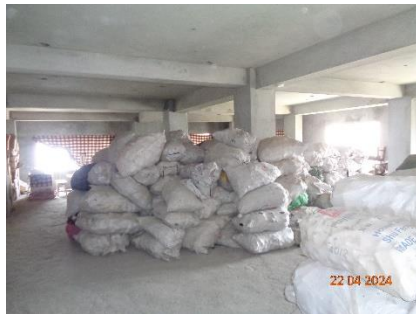
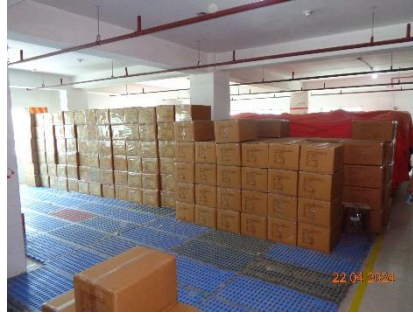
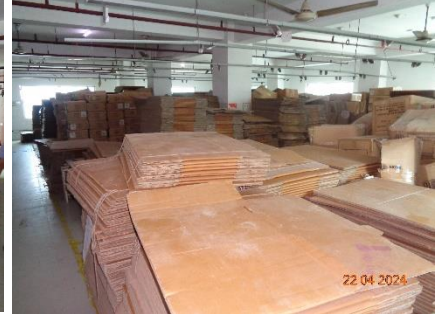
Storage found on the 8<sup>th</sup>, 4<sup>th</sup>, 3<sup>rd</sup> and 1<sup>st</sup> floor

| Serial No | Observation | Action Plan | Timeline |
|---|---|---|---|
| 5 | Load plan does not comply with BNBC requirement. | Implement the floor load management plan. | within 6 months |

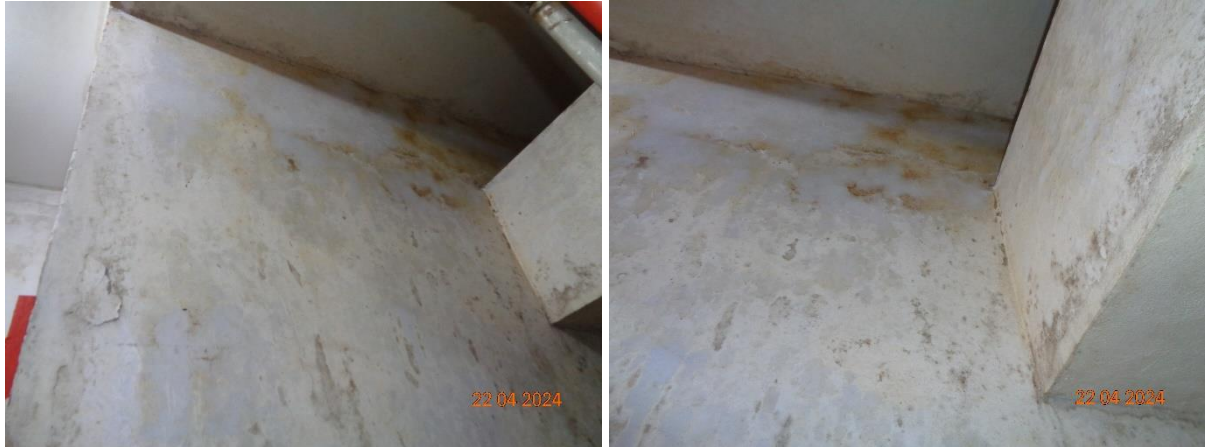
Seepage in RC wall of under-ground water reservoir

**Description:** Dampness was found at the RC wall of the under-ground water reservoir and overhead head water tank due to the seepage of moisture. The building engineer is required to investigate the extent of dampness and take necessary measures to prevent the dampness.

| Serial No | Observation | Action Plan | Timeline |
|---|---|---|---|
| 6 | Dampness in under-ground water reservoir and overhead water tank. | Building Engineer is required to investigate the reason of dampness and carry out suitable repair of dampness. | within 6 weeks |

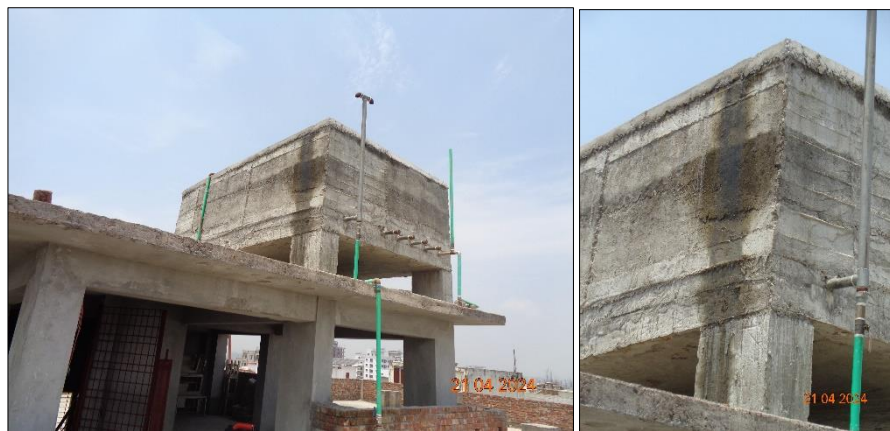
Seepage in RC wall of OHWT

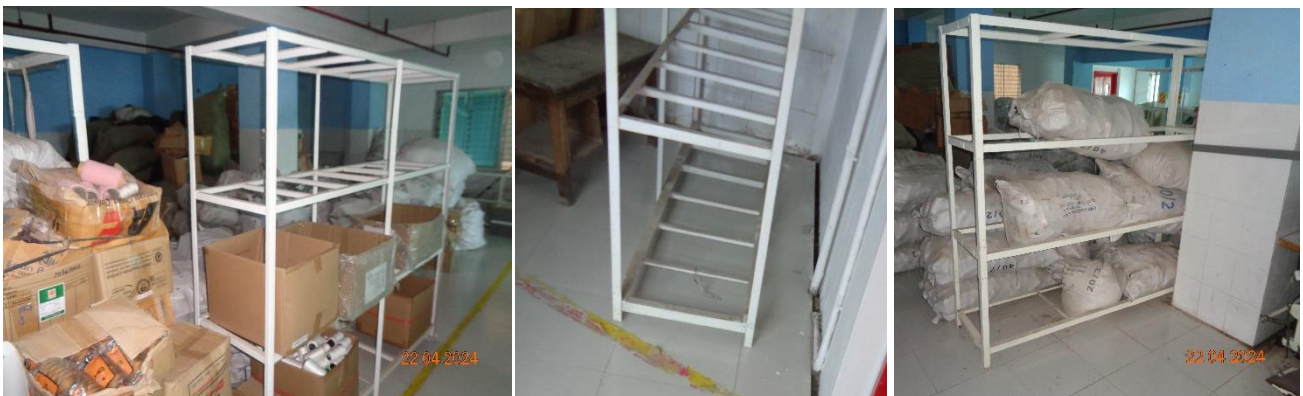
**Description:** Racks on different floors are not adequately anchored or braced to resist lateral (earthquake) forces. Building is required to adequately anchor and brace all non-structural elements to resist earthquake forces to comply with the BNBC.

| Serial No | Observation | Action Plan | Timeline |
|---|---|---|---|
| 7 | Non-structural elements not anchored or braced. | Building engineer is required to adequately anchor and brace all non-structural elements to resist earthquake forces to comply with the BNBC. | within 6 months |
