# Rong Rui Garments BD Ltd

Tapirbari, Tengra, Sreepur, Gazipur, 1740, Bangladesh  
(24.22678783, 90.42706390)

24 April 2024

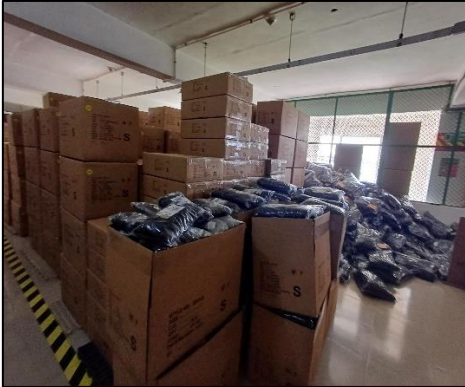
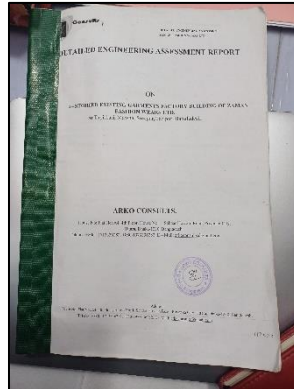
**Observation-1:** Stress in the columns exceeds the normal design limit. [Building-1 (Production Building)]

Loading condition

DEA Report

Core test result

**Description:** Cursory calculation indicates that stress in the column exceeds the normal design limit considering 3 kPa live load for the typical floor, 5 kPa for stairs, 1.5 kPa for the roof, and minimum concrete strength based on aggregate type.

Structural drawings, foundation information, and floor live load plans were not found on-site during the inspection.

A Detail Engineering Assessment (DEA) report was found on site where core test value was considered for this structure, but no test report was found.

The building engineer is required to prepare a complete DEA report based on in-situ material test report, updated as-built drawings, and live load plan.

| Item No. | Observation | Action Plan | Timeline |
|---|---|---|---|
| 1 | Stress in the column exceeds normal design limit. (Building-1 (Production Building)) | Verify in-situ material strength. | within 6 weeks |
| 2 | Stress in the column exceeds normal design limit. (Building-1 (Production Building)) | The building engineer is required to prepare a complete as-built drawing with foundation details. | within 6 weeks |
| 3 | Stress in the column exceeds normal design limit. (Building-1 (Production Building)) | As part of the Detail Engineering Assessment (DEA), the building engineer is required to review the design, load, and column stresses. | within 6 weeks |
| 4 | Stress in the column exceeds normal design limit. (Building-1 (Production Building)) | The building engineer is required to prepare a live load plan for all floor plates. | within 6 weeks |
| 5 | Stress in the column exceeds normal design limit. (Building-1 (Production Building)) | Carry out suggested remedial works. | within 6 months |

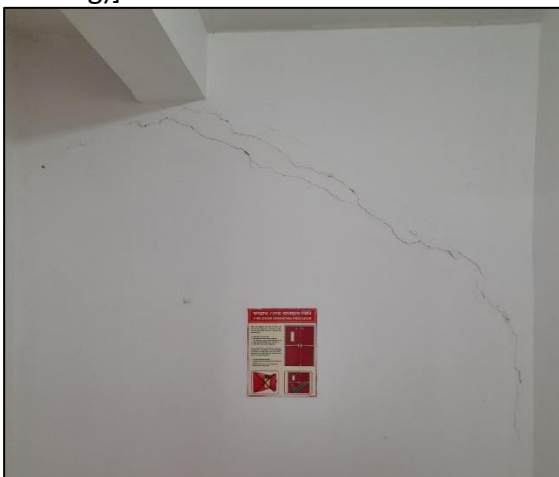
**Observation-2:** Crack on the brick wall and slab soffit on the 3<sup>rd</sup> floor. [Building-1 (Production Building)]

Crack on a brick wall (stair zone of 3<sup>rd</sup> floor)

**Description:** Cracks were found on the brick wall (stair zone) and several locations on the 3<sup>rd</sup>-floor slab soffit.

The building engineer is required to identify the reason for the crack and take necessary remedial measures to repair the wall and slab accordingly.

| Item No. | Observation | Action Plan | Timeline |
|---|---|---|---|
| 6 | Crack on the brick wall and 3rd-floor slab soffit. (Building-1 (Production Building)) | The building engineer is required to identify the reason for the crack and take necessary remedial measures to repair the wall and slab accordingly. | within 6 weeks |

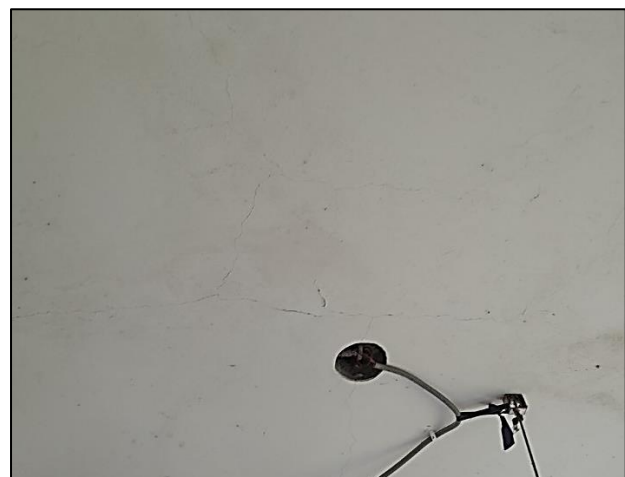
Crack on slab soffit (3<sup>rd</sup> floor)

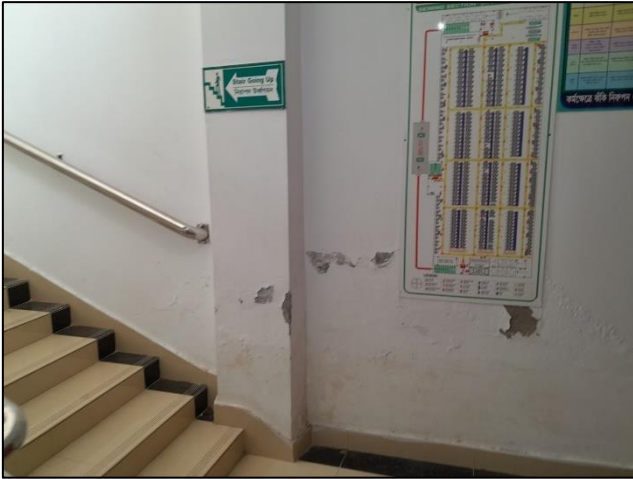
**Observation-3:** Dampness in several locations. [Building-1 (Production Building)]

Dampness on wall

**Description:** Dampness found on the peripheral wall and beam (stair zone). The building engineer is required to identify the source of dampness and take remedial measures to repair the wall accordingly.

| Item No. | Observation | Action Plan | Timeline |
|---|---|---|---|
| 7 | Dampness in several locations. (Building-1 (Production Building)) | The building engineer is required to identify the source of dampness and take remedial measures to repair the damp areas. | within 6 months |

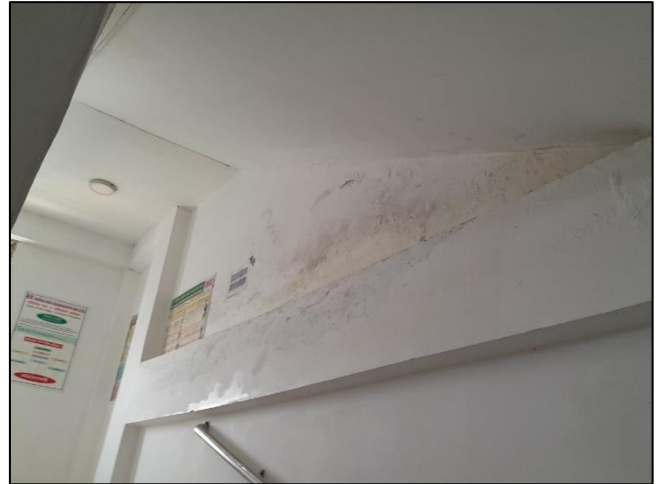
Dampness on beam

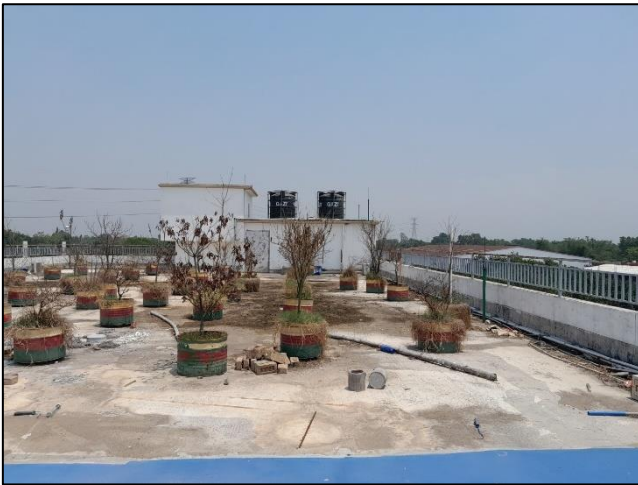
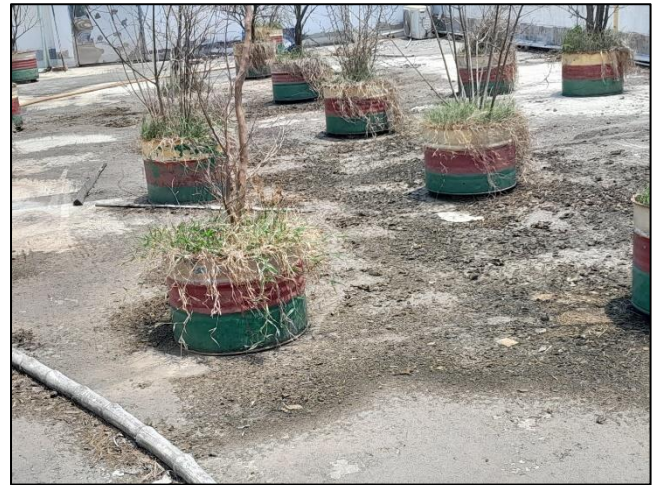
**Observation-4:** Poor roof drainage system. (Building-1 (Production Building))

Signage of water clogging

**Description:** Signage of water clogging found on the roof. The building engineer is required to improve the drainage system.

| Item No. | Observation | Action Plan | Timeline |
|---|---|---|---|
| 8 | Poor roof drainage system. (Building-1 (Production Building)) | The building engineer is required to improve the drainage system with adequate slope and drainage outlets. | within 6 months |

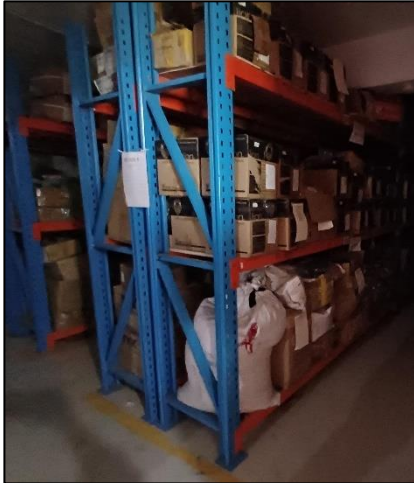
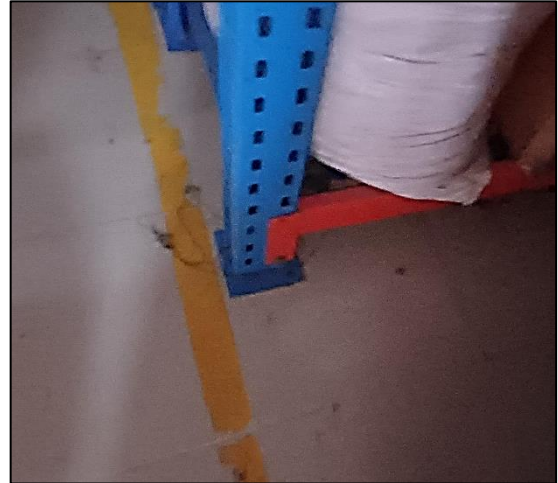
**Observation-5:** Non-structural elements found unbraced/not anchored. [Building-1 (Production Building)]

**Description:** Storage rack found within the building without braced/anchored. The building engineer is required to brace/anchor all non-structural elements.

| Item No. | Observation | Action Plan | Timeline |
|---|---|---|---|
| 9 | Non-structural elements found unbraced/not anchored. (Building-1 (Production Building)) | The building engineer is required to brace/anchor all non-structural elements. | within 6 months |

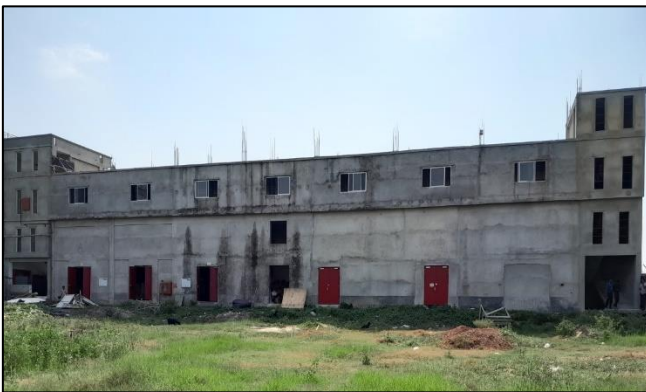
Building-2 (Utility Building)

**Observation-6:** Lack of design documents. [Building-2 (Utility Building), Building-3 (Fire Control Building)]

**Description:** As per BNBC, every building or structure designed shall have its design documents prepared by the provision of Section 1.9.1. The design documents shall include as-built drawings and a design report which shall be prepared in compliance with section 1.9.1, part 6 of BNBC.

During the inspection, as-built drawings, foundation detail, the design report and live load plan were not available on site. The building engineer is required to prepare a detailed engineering Assessment based on in-situ material strength & software-based analysis including a live load plan, and as-built drawing and submit it to RSC for review.

| Item No. | Observation | Action Plan | Timeline |
|---|---|---|---|
| 10 | Lack of design documents. (Building-2 (Utility Building), Building-3 (Fire Control Building)) | Carry out Detailed Engineering Assessment (DEA) based on in-situ material strength & software-based analysis and submit to RSC for review. | within 6 weeks |
| 11 | Lack of design documents. (Building-2 (Utility Building), Building-3 (Fire Control Building)) | The building engineer is required to prepare a complete as-built drawing with foundation details. | within 6 weeks |

| 12 | Lack of design documents. (Building-2 (Utility Building), Building-3 (Fire Control Building)) | The building engineer is required to prepare a live load plan for all floor plates. | within 6 weeks |
| 13 | Lack of design documents. (Building-2 (Utility Building), Building-3 (Fire Control Building)) | Carry out suggested remedial works if required. | within 6 months |

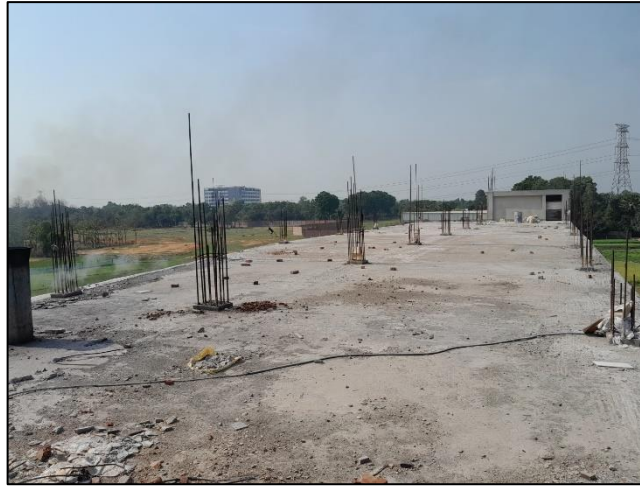
**Observation-7:** Falling Hazard at roof level. Building-2 (Utility Building)

**Description:** The parapet/railing was missing on the roof. The building engineer is required to provide parapet/railing at all locations of the roof to avoid possible falling hazards.

| 14 | Falling Hazard at roof level. Building-2 (Utility Building) | The building engineer is required to provide parapet/railing at all locations of the roof to avoid possible falling hazards. | within 6 weeks |

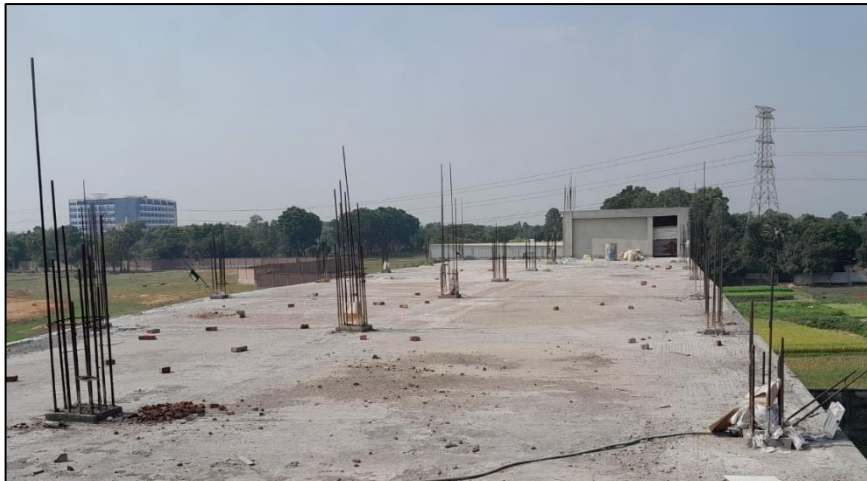
**Observation-8:** Exposed rebar on the roof. Building-2 (Utility Building)

**Description:** Exposed rebar left on the roof. The Building Engineer is required to provide rust-proof paint on exposed reinforcement to protect from corrosion.

| 15 | Exposed rebar on the roof. Building-2 (Utility Building) | The Building Engineer is required to provide rust-proof paint on exposed reinforcement to protect from corrosion. | within 6 months |

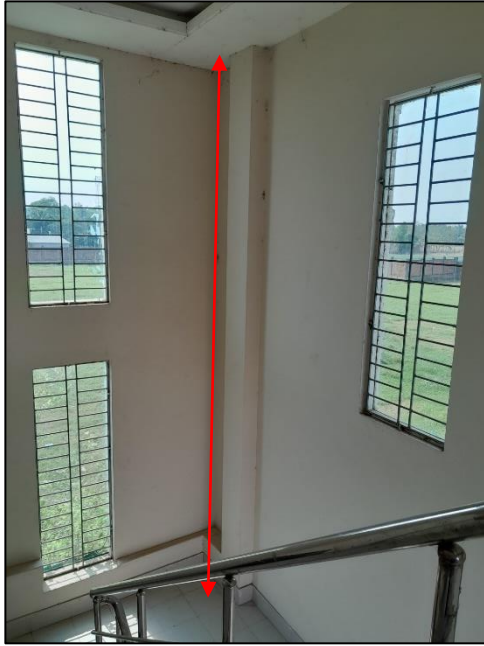
**Observation-9:** Columns appear to be slender. (Building-3 (Fire Control Building))

Column dimension: 250mm x 250mm

Unsupported length: 4.5m

Columns with high unsupported length

**Description:** Cursory calculation shows that slenderness in highlighted columns exceeds the normal design limit due to long unsupported lengths. The building engineer is required to adequacy check of the highlighted column considering the slenderness effect as part of DEA.

| 16 | Columns appear to be slender. (Building-3 (Fire Control Building)) | The factory engineer is required to carry out an adequacy check of the highlighted column considering the slenderness effect. | within 6 weeks |

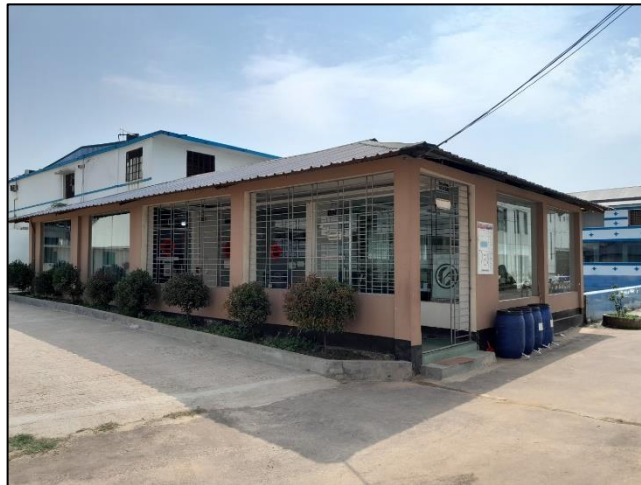
Shed:1 (Admin Building)

**Observation-10:** Lack of lateral stability. Shed:1 (Admin Building), Shed:2 (Generator and sub-station), Shed:3 (Bonded Warehouse))

**Description:** A lack of lateral load transfer media was observed in the structures. Also, no as-built structural drawings were available for the structures.

The building engineer is required to carry out an Engineering Assessment (EA) to check the lateral stability and adequacy of all structural elements of the structure based on in-situ material strength and software-based analysis which shall be prepared in compliance with section 1.9.1, part-6 of BNBC.

| 17 | Lack of lateral stability. Shed:1 (Admin Building), Shed:2 (Generator and sub-station), Shed:3 (Bonded Warehouse)) | The building engineer is required to prepare a complete as-built drawing with foundation details. | within 6 weeks |
| 18 | Lack of lateral stability. Shed:1 (Admin Building), Shed:2 (Generator and sub-station), Shed:3 (Bonded Warehouse)) | The building engineer is required to carry out an Engineering Assessment (EA) to check the lateral stability and adequacy of all structural elements of the structure based on in-situ material strength and software-based analysis which shall be prepared in compliance with section 1.9.1, part-6 of BNBC. | within 6 weeks |
| 19 | Lack of lateral stability. Shed:1 (Admin Building), Shed:2 (Generator and sub-station), Shed:3 (Bonded Warehouse)) | Carry out suggested remedial works if required. | within 6 months |

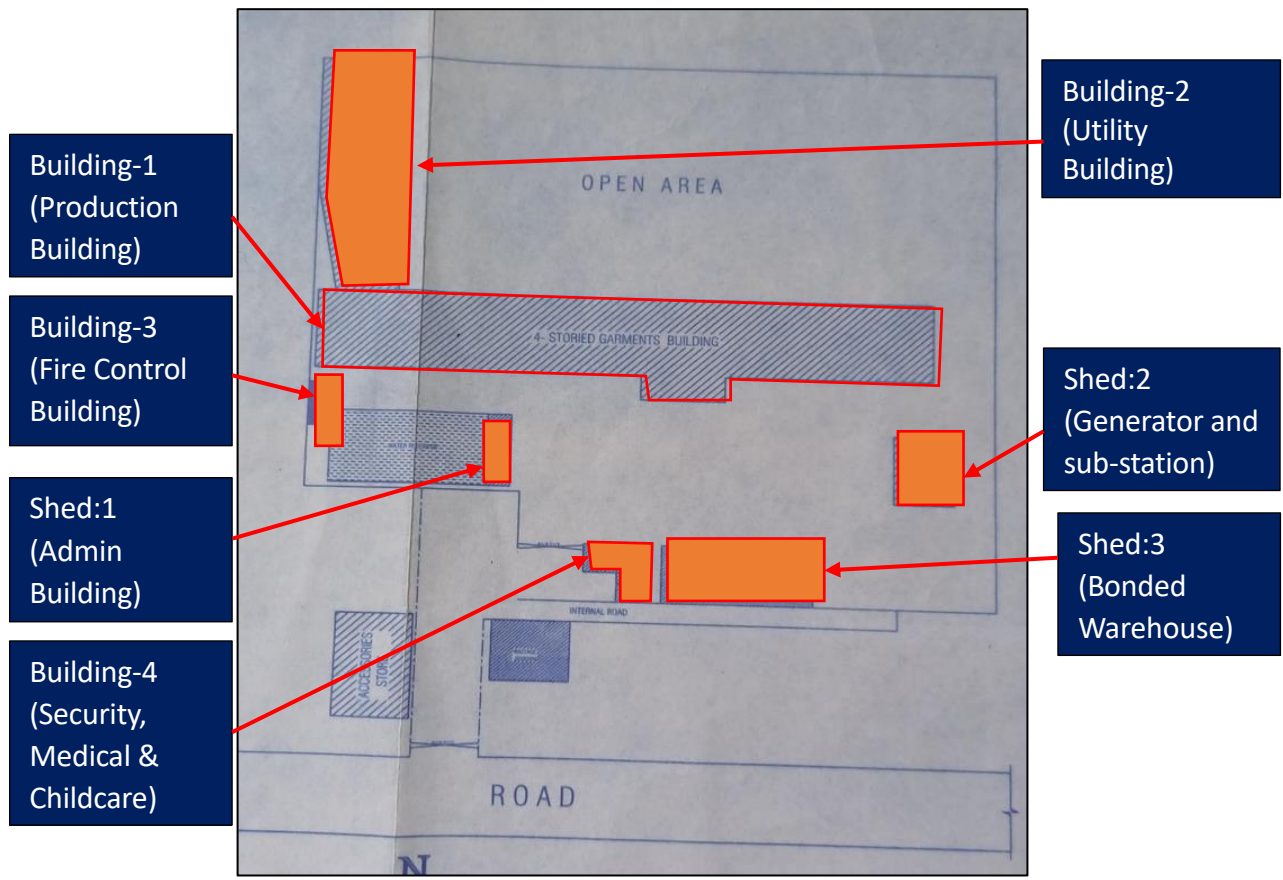
**Observation-11:** Lack of Geotechnical investigation report. (Building-2 (Utility Building), Building-3 (Fire Control Building), Building-4 (Security, Medical & Childcare), Shed-1 (Admin Building), Shed:2 (Generator and sub-station), Shed:3 (Bonded Warehouse))

**Description:** During the inspection, a geotechnical investigation report was not found for Building-2 (Utility Building), Building-3 (Fire Control Building), Building-4 (Security, Medical & Childcare), Shed-1 (Admin Building), Shed:2 (Generator and sub-station), Shed:3 (Bonded Warehouse). The geotechnical engineer is required to conduct the geotechnical investigation and prepare a geotechnical investigation report for all these structures.

| 20 | Lack of Geotechnical investigation report. (Building-2 (Utility Building), Building-3 (Fire Control Building), Building-4 (Security, Medical & Childcare), Shed-1 (Admin Building), Shed:2 (Generator and sub-station), Shed:3 (Bonded Warehouse)) | The geotechnical engineer is required to prepare a geotechnical investigation report covering all these structures. | within 6 weeks |
