# AMC Knit Composite Ltd. (Extension)

5508, Baniar Chala, Bhabanipur, Gazipur Sadar, Gazipur  
(24.160098, 90.410616)

24 April 2024

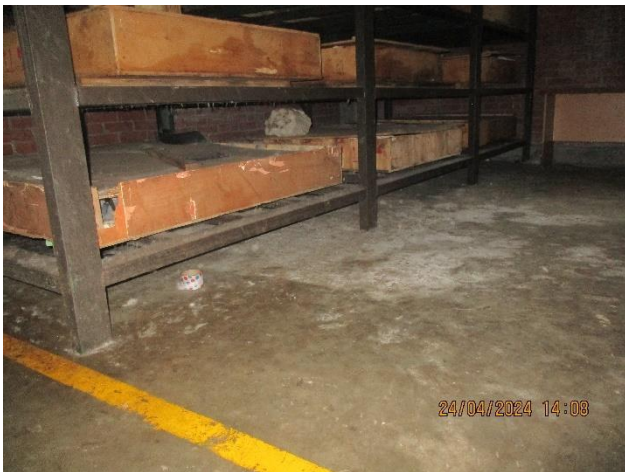
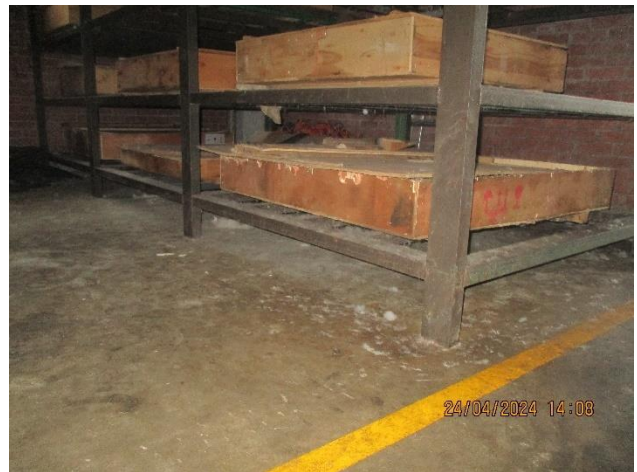
### Observation-02: Non-structural elements found unbraced/not anchored. (Production Building)

**Description:** Non-structural elements suspended from, attached to, or resting atop the structure shall be adequately anchored and braced to resist earthquake forces. Factory is required to brace/anchor all non-structural elements (storage racks).

| Serial No | Observation | Action Plan | Timeline |
|---|---|---|---|
| 4 | Non-structural elements found unbraced/not anchored. (Production Building) | Factory is required to brace/anchor all non-structural elements. | within 6 months |

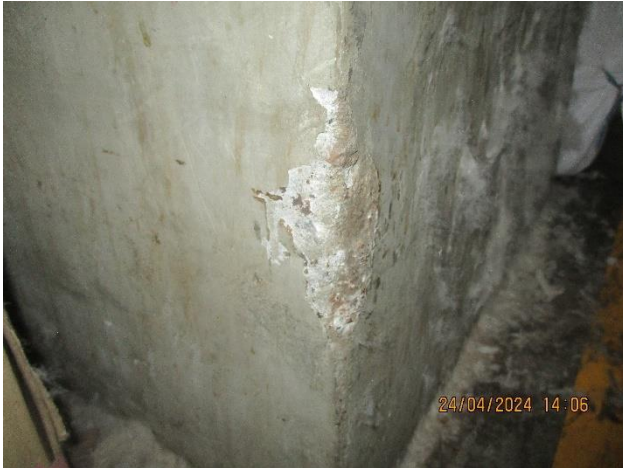
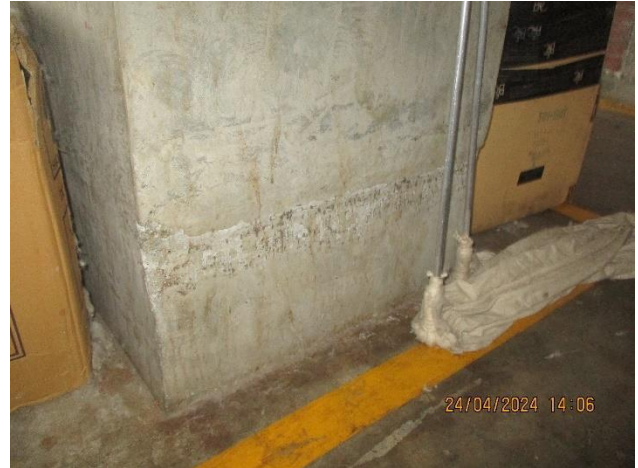
**Observation-03:** Column Susceptible to trolley impact. (Production Building)

**Description:** Columns are susceptible to trolley impact on different floor levels. Building engineer is required to take necessary action to prevent the trolley impact in the columns.

| Serial No | Observation | Action Plan | Timeline |
|---|---|---|---|
| 5 | Column Susceptible to trolley impact. (Production Building) | Building engineer is required to take necessary action to prevent the trolley impact in the columns. | within 6 months |

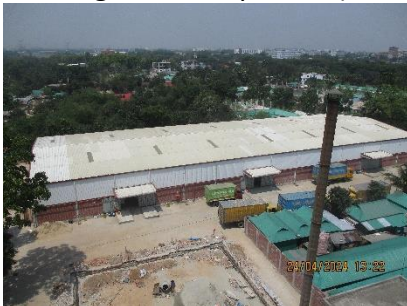
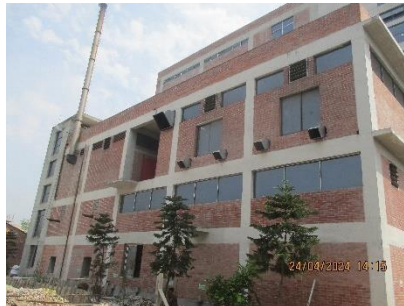
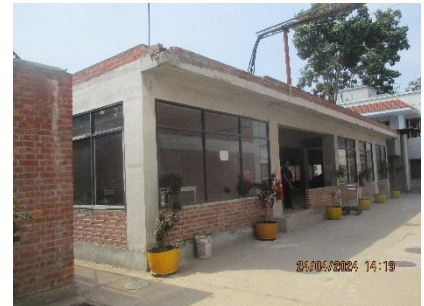
**Observation-04:** Building permit from local authority not available. (Yarn store shed, Utility Building, Fire Pump Room)

**Description:** During the inspection, a building permit from the local authority was not available for the Yarn store shed, Utility Building, and Fire Pump Room. The factory authority is required to collect building permits from the local authority for these buildings.

| Serial No | Observation | Action Plan | Timeline |
|---|---|---|---|
| 6 | Building permits from the local authority not available. (Yarn Store Shed, Utility Building, Fire Pump Room) | Factory authority is required to collect building permits from local government authority for the building. | within 6 months |

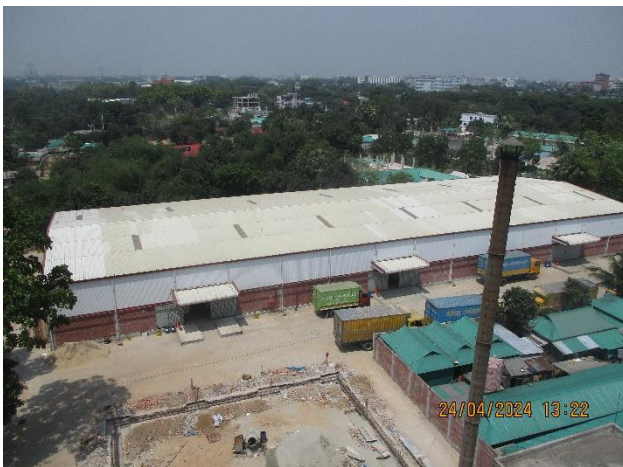
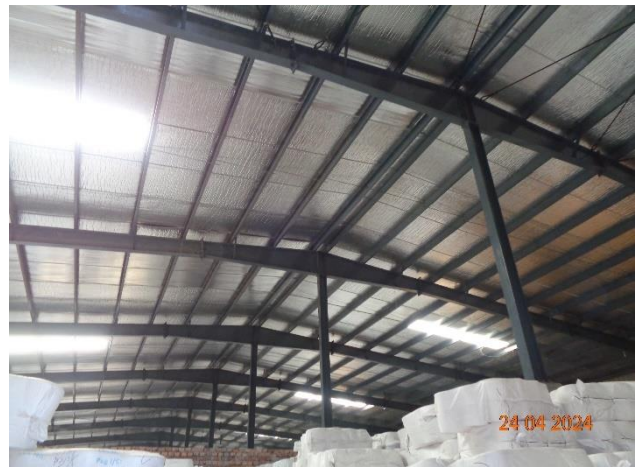
**Observation-05:** Lack of lateral stability system. (Yarn Store Shed)

**Description:** Load transfer media is not provided along the long direction. Therefore, the lateral stability system of the shed is apparently incomplete.

The building engineer is required to check the stability system of the existing structure and prepare design documents (including as-built drawings, design report, and material test reports) in compliance with section 1.9.1 (part-6, BNBC).

| Serial No | Observation | Action Plan | Timeline |
|---|---|---|---|
| 7 | Lack of lateral stability system. (Yarn Store Shed) | The building engineer is required to check the stability system of the existing structure and prepare design documents (including as-built drawings, design report, and material test reports) in compliance with section 1.9.1 (part-6, BNBC). | within 6 weeks |
| 8 | Lack of lateral stability system. (Yarn Store Shed) | Carry out the suggested remedial works. | within 6 months |

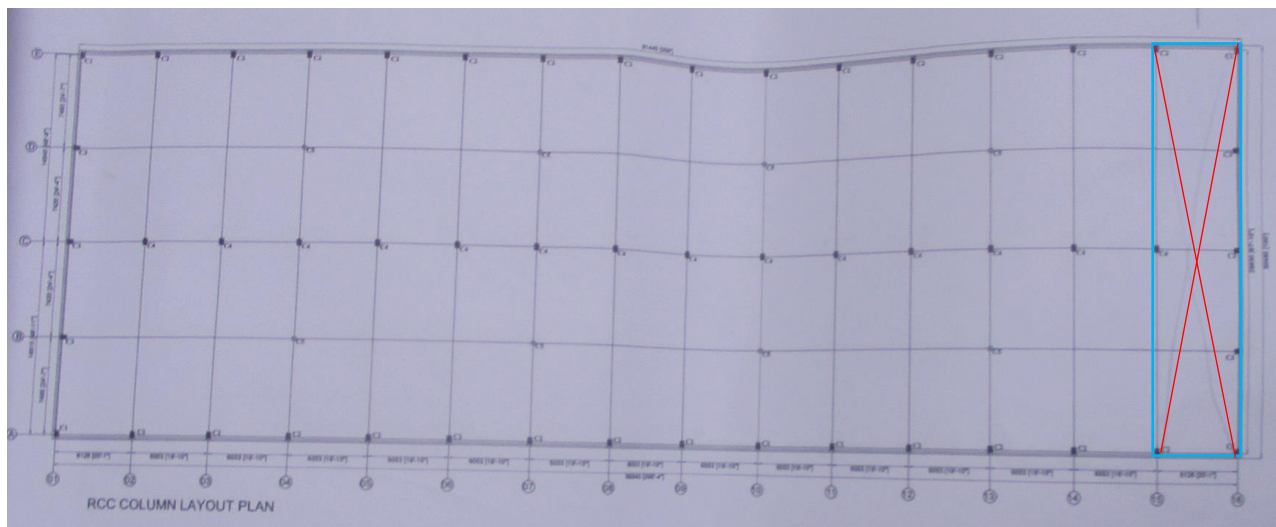
## Observation-06: Discrepancy with working drawings. (Yarn Store Shed)

**Description:** During the inspection, the factory provided a set of working drawings (RC part) for the Yarn store shed. But the end bay (grid 15-16) has not been constructed as per the drawing (marked area).

Building engineer is required to survey the structures and update the as-built drawings as per the actual site condition.

| Serial No | Observation | Action Plan | Timeline |
|---|---|---|---|
| 9 | Discrepancy with working drawings. (Yarn Store Shed) | The building engineer is required to survey the whole structure and revise the as-built drawing as per actual site condition. | within 6 weeks |

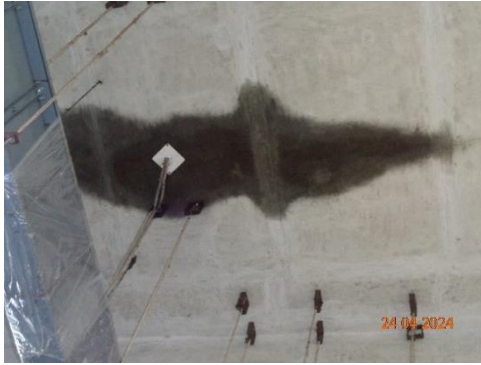
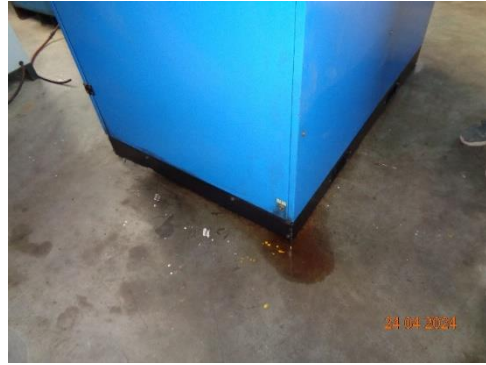
**Observation-08:** Intrusion of oil through the 1<sup>st</sup> floor slab. (Utility Building)

**Description:** Oil Intrusion through ceiling of 1<sup>st</sup> was observed due to oil leakage from tank. Building engineer is required to investigate the reason of intrusion in RC slab and repair the slab with proper method.

| 13 | Intrusion of oil through the 1st floor slab. (Utility Building) | The building engineer is required to investigate the reason for oil intrusion into the RC slab and repair the slab with the proper method. | within 6 weeks |

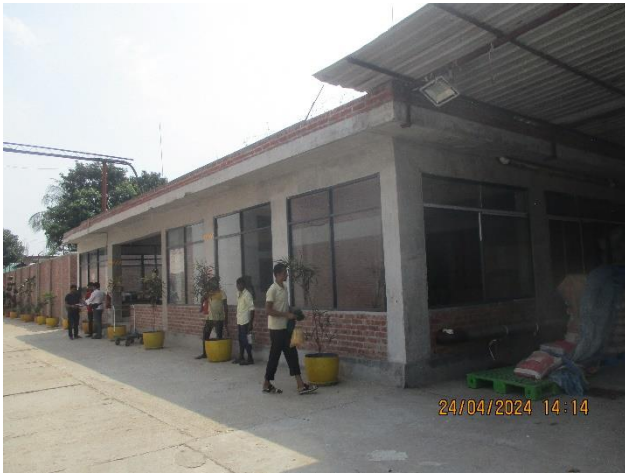
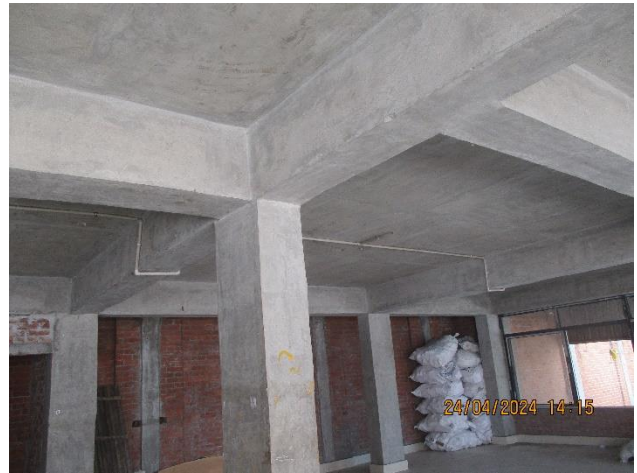
**Observation-09:** Lack of design documents. (Fire Pump Room)

**Description:** As per BNBC, every building or structure designed shall have its design documents prepared in accordance with the provision of Section 1.9.1. The design document shall include a design report and a set of structural drawings, which shall be prepared in compliance with sections 1.9.1.1 and 1.9.1.2 as per BNBC.

At the time of inspection, design documents (design report, structural drawings, and material test reports) were not available, which are required to be prepared in compliance with section 1.9.1 (part 6, BNBC). However, the provided as-built drawings do not indicate the site condition.

| 14 | Lack of design documents. (Fire Pump Room) | The building engineer is required to survey the structure and prepare accurate as-built drawings. | within 6 weeks |
| 15 | Lack of design documents. (Fire Pump Room) | The building engineer is required to prepare design documents (including design reports, structural drawings, and material test reports) in compliance with section 1.9.1 (part 6, BNBC). | within 6 weeks |
| 16 | Lack of design documents. (Fire Pump Room) | Carry out the suggested remedial works. | within 6 months |

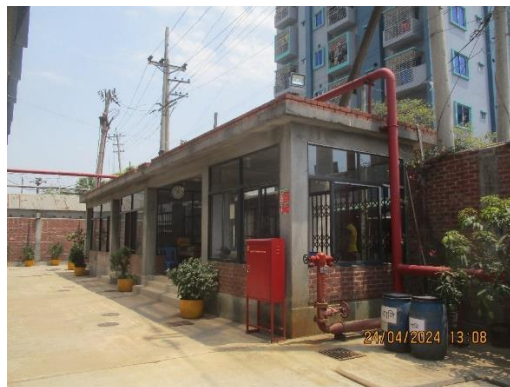
**Observation-10:** Lack of as-built drawing. (Security Building)

**Description:** The as-built drawings of the Security Building were not available on site. The building engineer is required to prepare the as-built drawing of the structure.

| 17 | Lack of as-built drawing. (Security Building) | The building engineer is required to prepare as-built drawings. | within 6 weeks |
