# Masco Industries Ltd. (Composite Unit)

221-223 Khartail, Shataish Road, Tongi, Gazipur.  
(23.9212132N), (90.3870028E)

3<sup>rd</sup> November, 2015

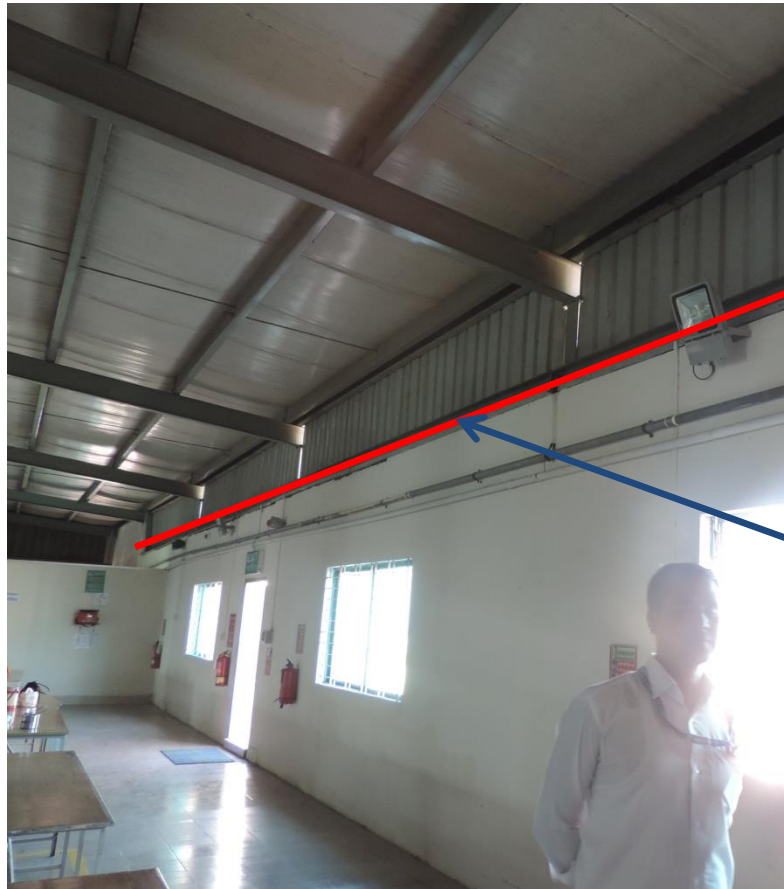
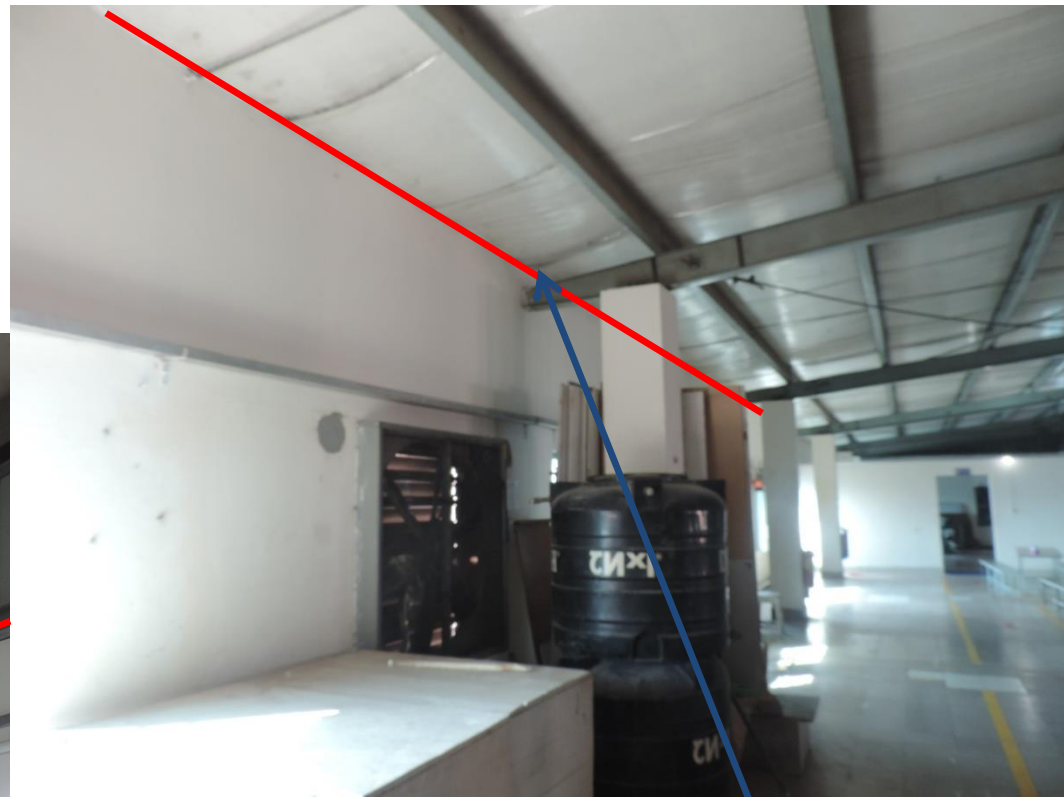
Lack of head restraint to external wall. The walls currently appear to cantilever from the floor slab

**ITEM 3:** Stability of external wall on the 8th Floor

| Item No. | Observation | Recommended Action Plan | Recommended Timeline |
|---|---|---|---|
| 7 | Stability of external wall on the 8th Floor | Engineer to access by calculation the stability of the external walls to the 8th floor, in particular the head restrain of the wall | 6-weeks |
| 8 | Stability of external wall on the 8th Floor | Implement the recommendations from the above assessment | 6-months |

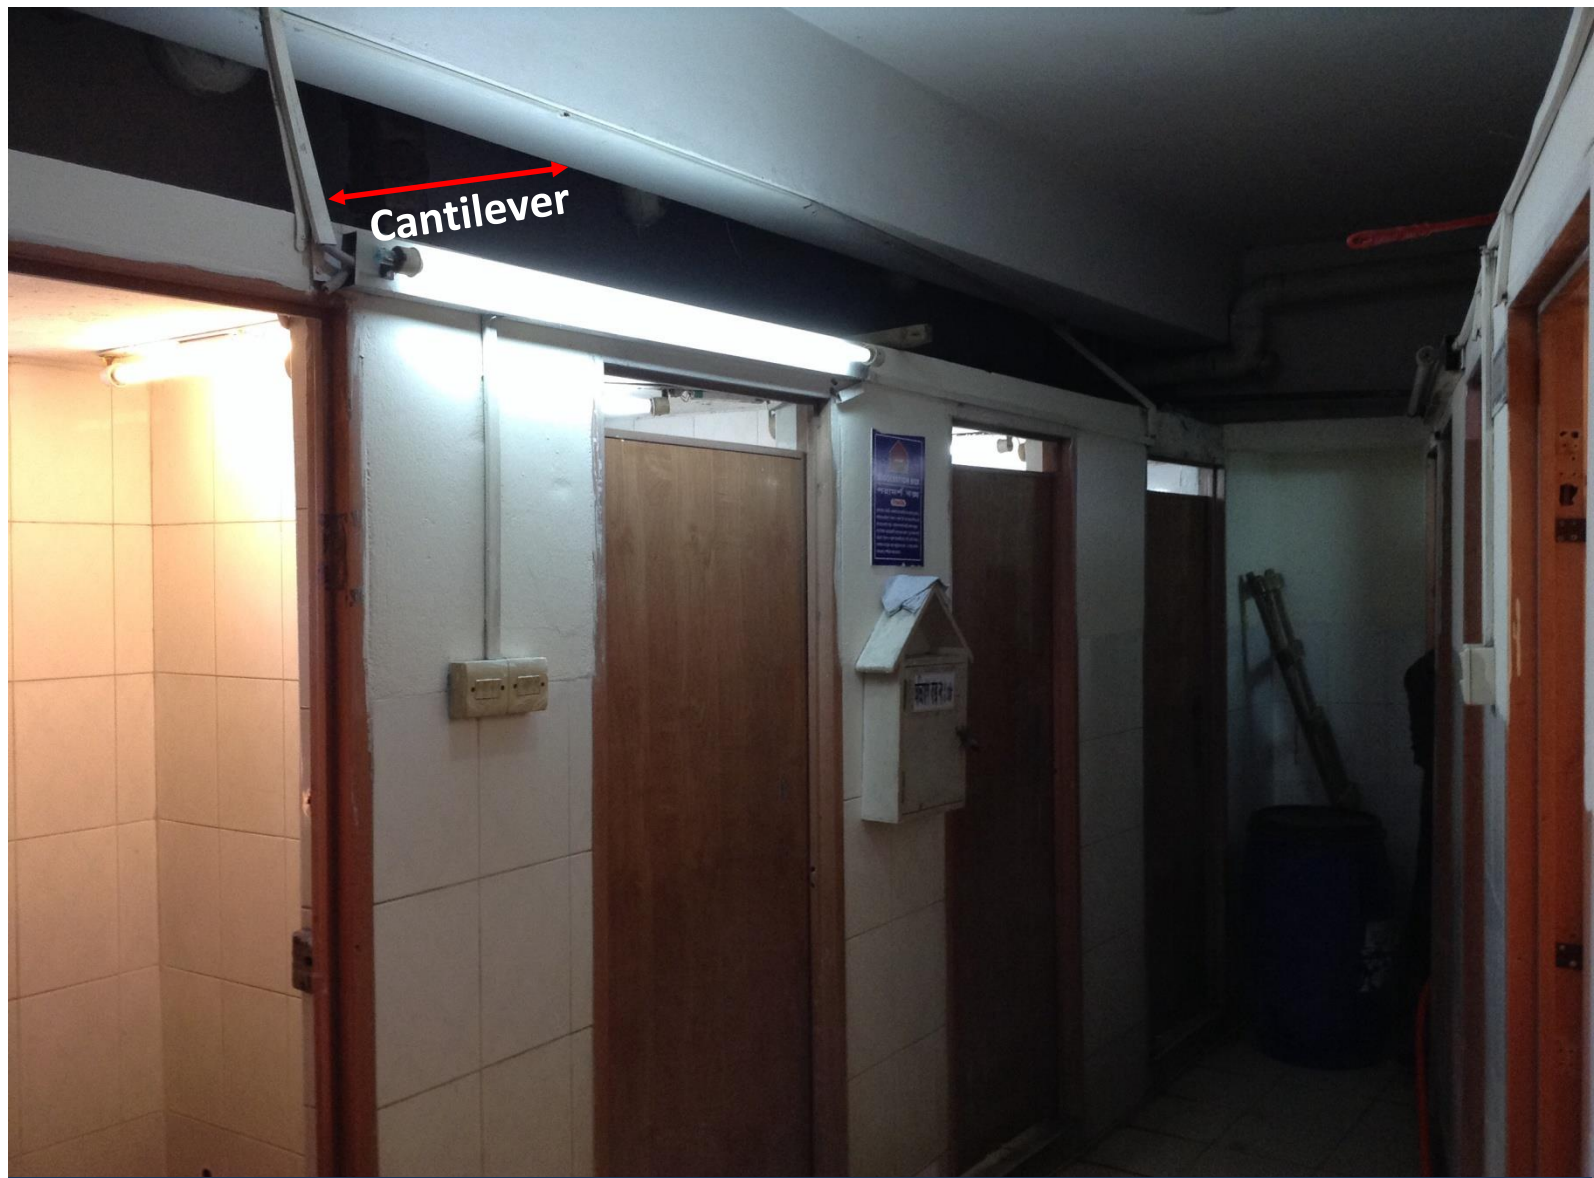
Toilets are on cantilever slab

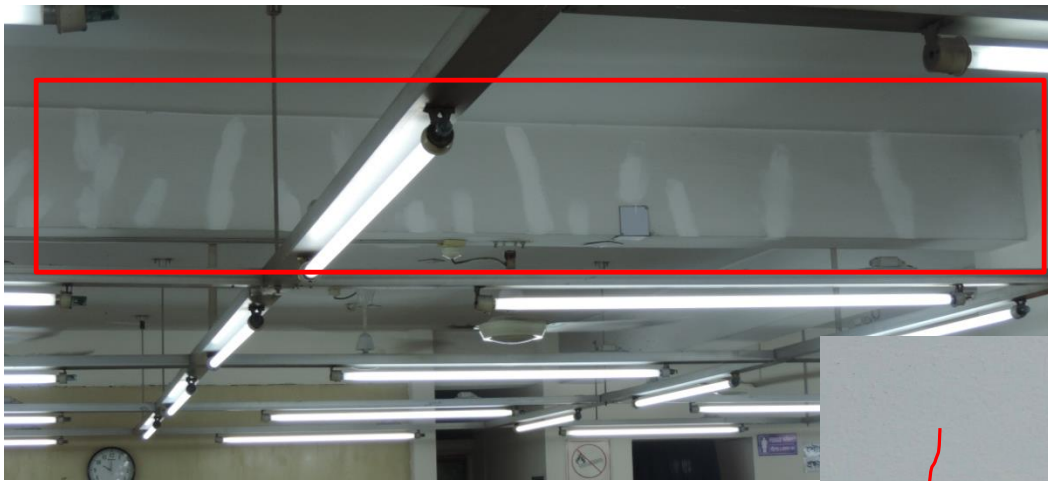
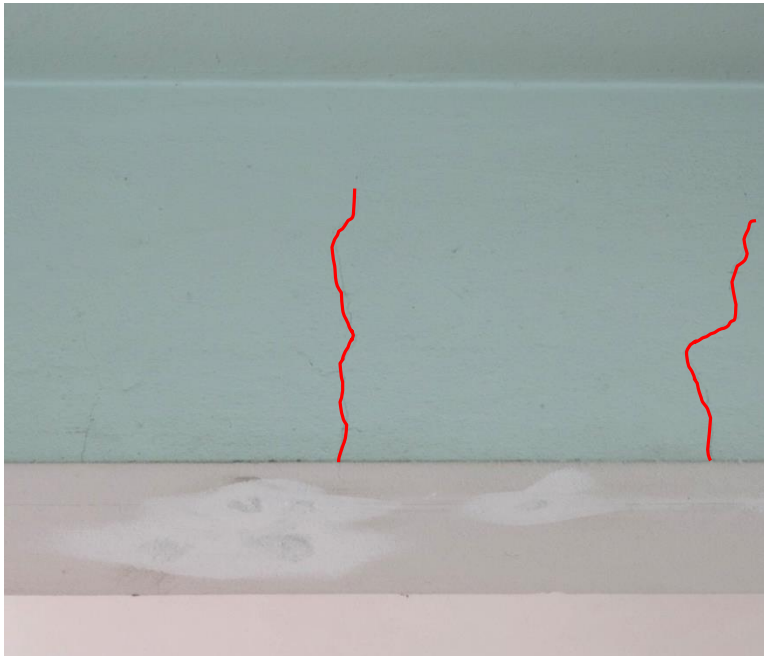
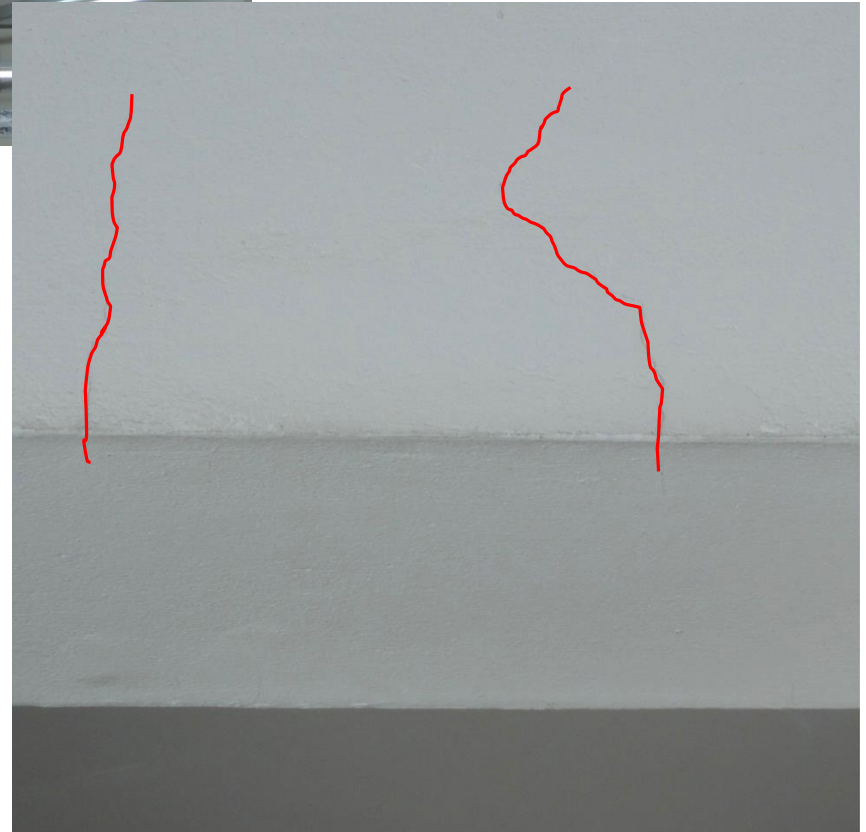
Cracking noted on downstand beams over the 3<sup>rd</sup> 6<sup>th</sup> and 7<sup>th</sup> floor

**ITEM 4:** Cracking noted on downstand beams over the 3<sup>rd</sup> 6<sup>th</sup> and 7<sup>th</sup> floor

| Item No. | Observation | Recommended Action Plan | Recommended Timeline |
|---|---|---|---|
| 9 | Cracking noted on downstand beams over the 3rd 6th and 7th floor | The Engineer to carry out investigation into the cracking noted on the downstand beams. | 6-weeks |
| 10 | Cracking noted on downstand beams over the 3rd 6th and 7th floor | Reduce loading or carry out remedial actions as required from the above study. | 6-months |

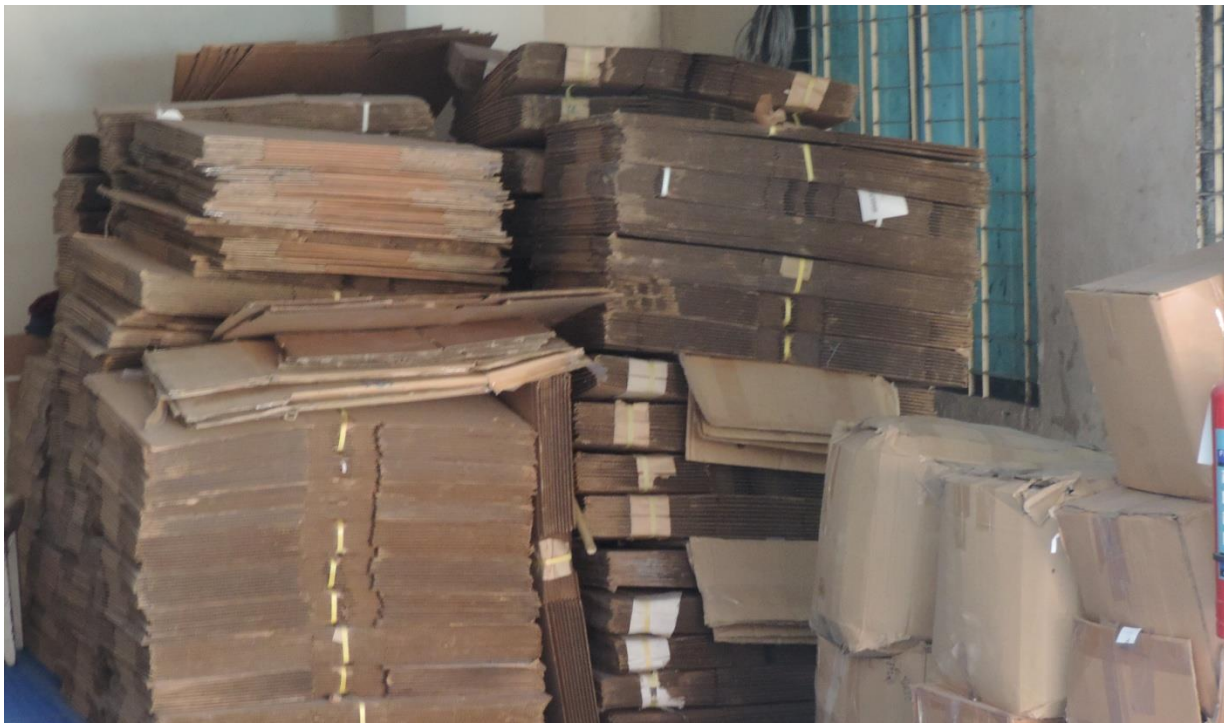
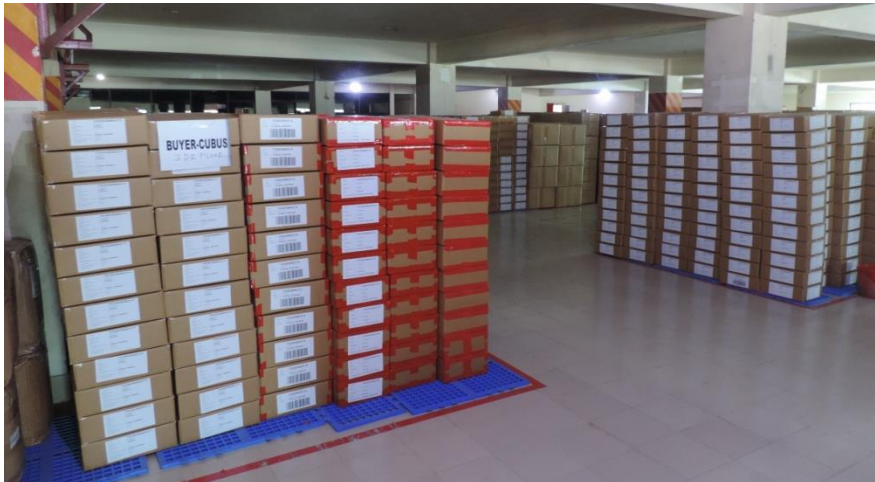
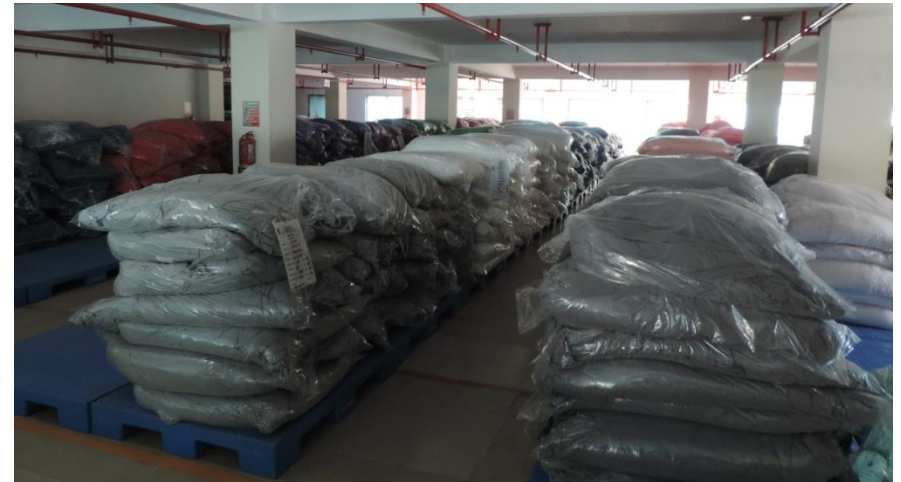
Heavy loading on 1st and 2nd floor plates

**ITEM 5:** Heavy loading on 1<sup>st</sup> and 2<sup>nd</sup> floor plates

| Item No. | Observation | Recommended Action Plan | Recommended Timeline |
|---|---|---|---|
| 11 | Heavy loading on 1st and 2nd floor plates | The floor slabs to be accessed by calculation by the engineer to carry the substantial storage loading from the storage of fabric and other materials. | 6-weeks |
| 12 | Heavy loading on 1st and 2nd floor plates | Produce and actively manage a loading plan for all floor plates within the factory giving consideration to floor capacity and column capacity | 6-weeks |
| 13 | Heavy loading on 1st and 2nd floor plates | Remove all uncontrolled loading | 6-weeks |

| Item No. | Observation | Recommended Action Plan | Recommended Timeline |
|---|---|---|---|
| 14 | Heavy loading on 1st and 2nd floor plates | Reduce the loading in accordance with the above study | 6-months |

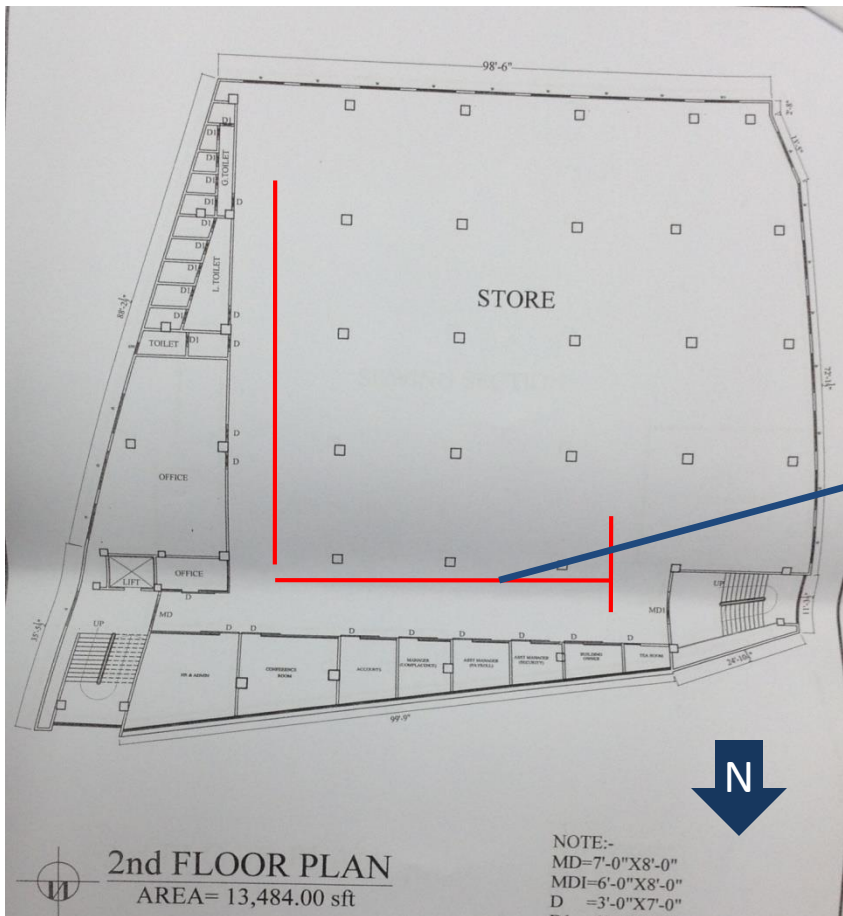
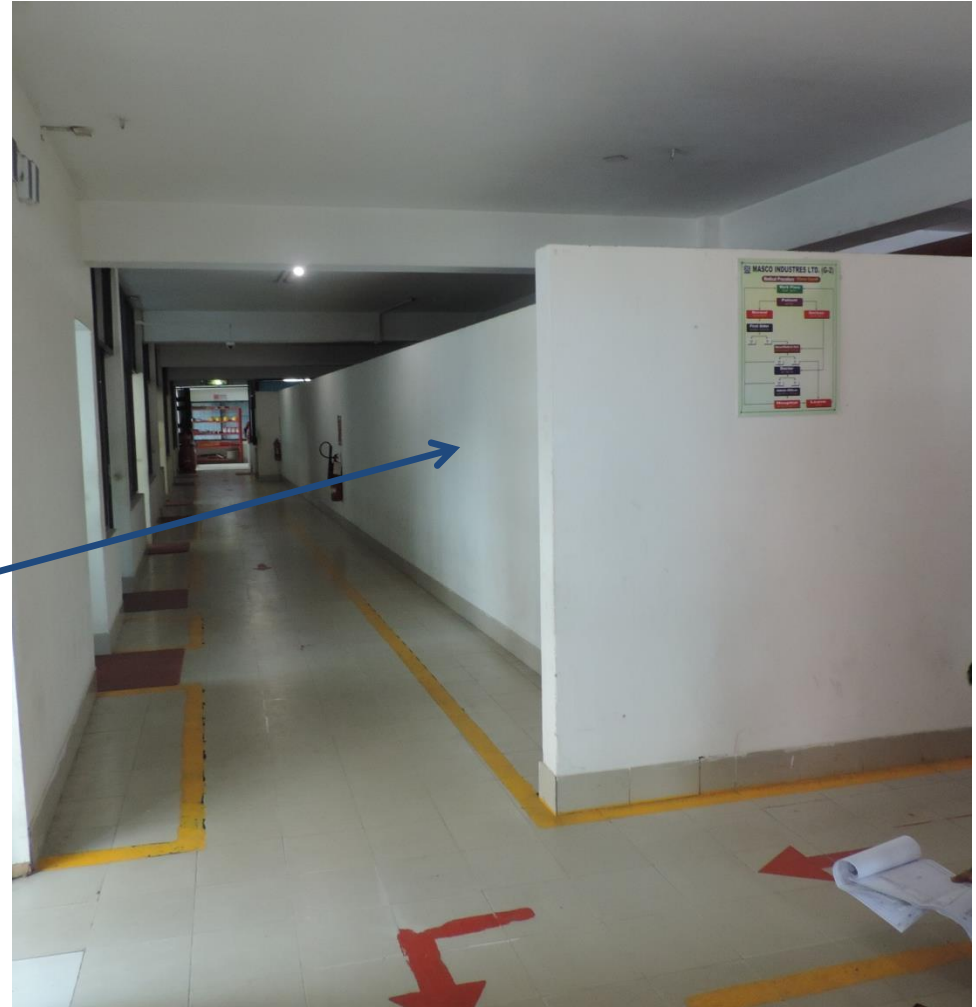
Observations – 6

Minor difference between layout drawings and as built

**ITEM 6:** Minor difference between layout drawings and as built

| Item No. | Observation | Recommended Action Plan | Recommended Timeline |
|---|---|---|---|
| 15 | Minor difference between layout drawings and as built | Building engineer to update the as-built drawings to reflect the newly built walls on the 2nd floor | 6-months |

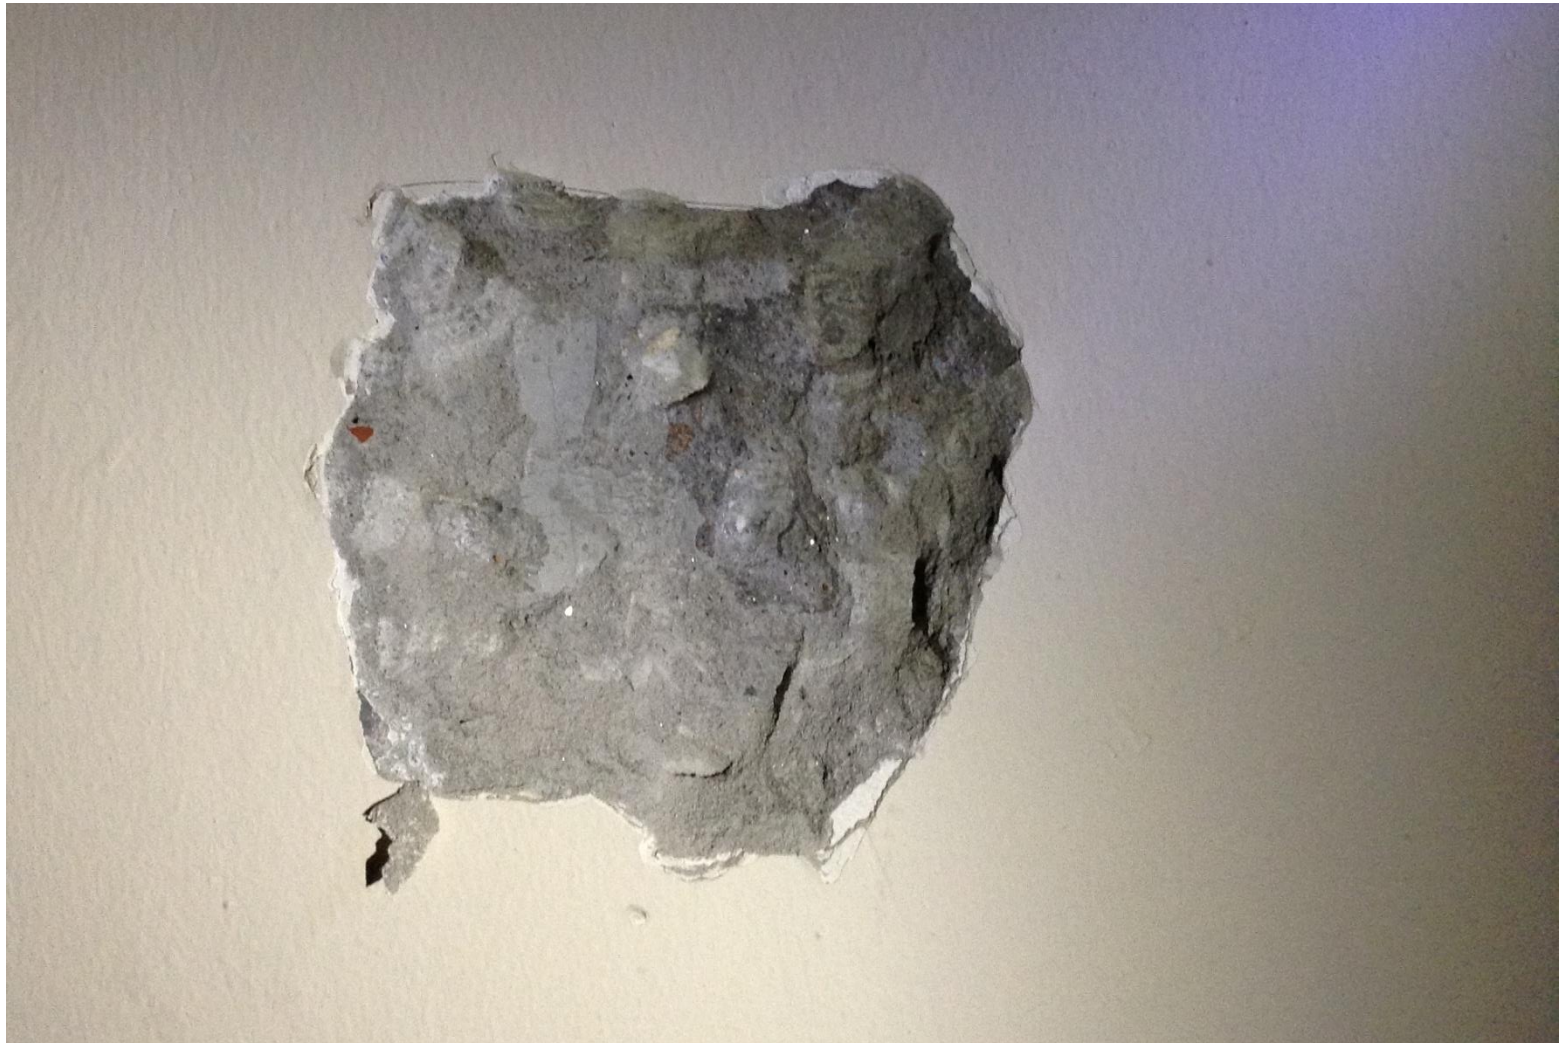
Stone chips observed in column
