Square Apparels Limited (Extension)

Mamarishpur, Mallikbari, Bhaluka, Mymensingh

25 April 2024

1. Building Information

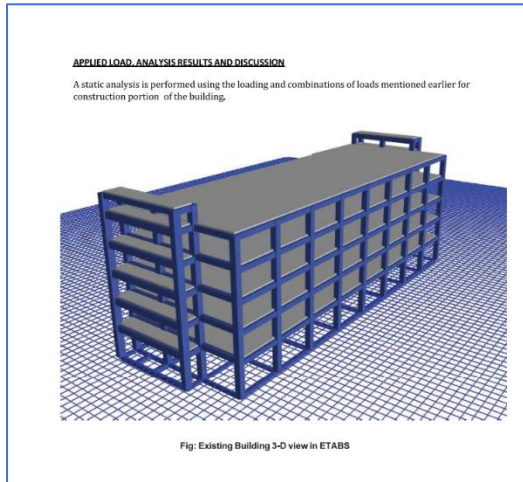
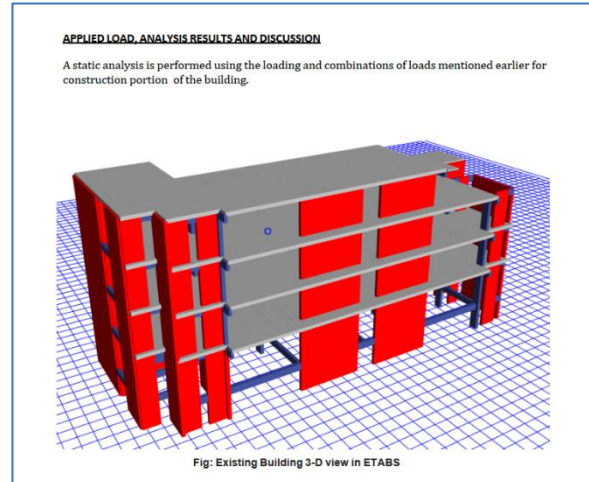
Observation-1: The design report required to be reviewed against lateral loading in detail. (Warehouse Building, Administration Building)

Description: A design report has been prepared for the five-storied Warehouse Building and partially four-storied Administration Building. The structural design report needs to be reviewed against lateral loading.

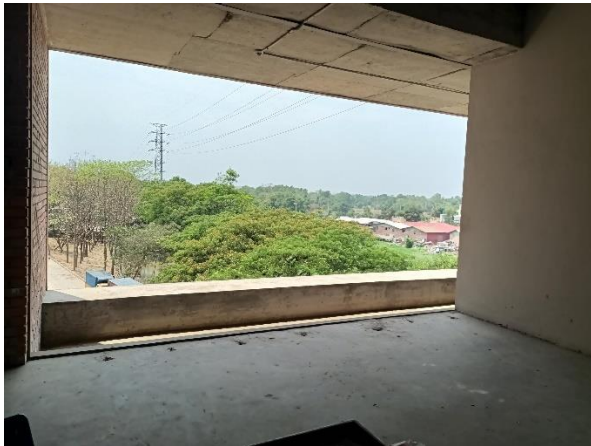
Observation-2: Falling hazard risk. (Warehouse Building, Administration Building)

Description: Falling hazard risk was observed on different floors of the Warehouse Building and Administration Building. The building engineer is required to provide sufficient protection/barrier to mitigate the risk

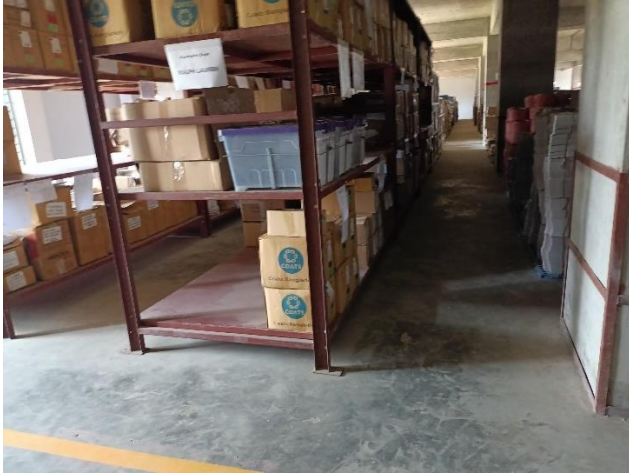
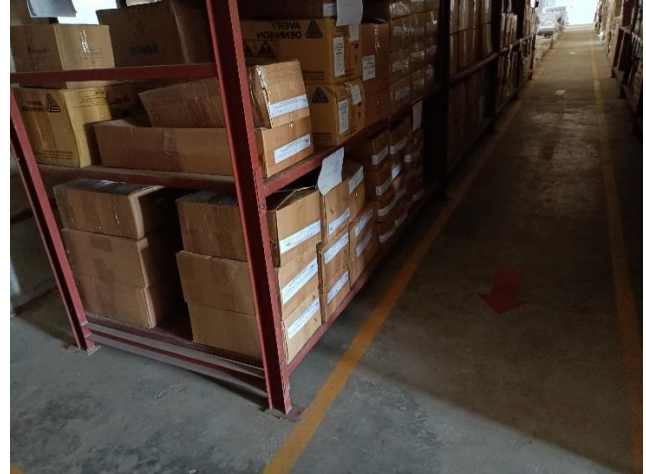
Observation-3: Unbraced storage racks. (Warehouse Building)

Description: Unbraced storage racks were found on different floors. The factory needs to brace/anchor all storage racks to avoid falling hazards during earthquake.

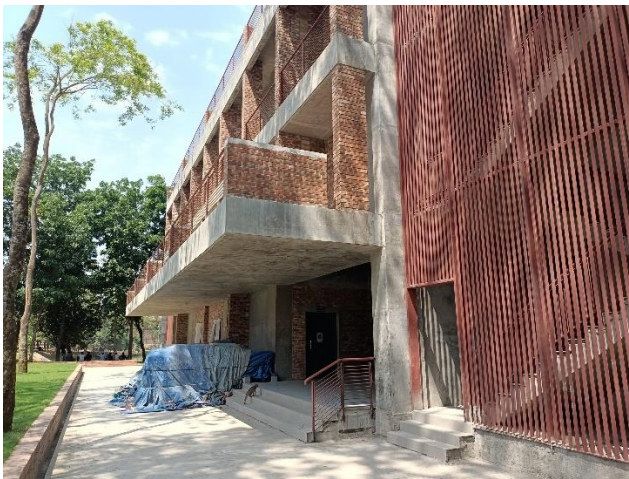
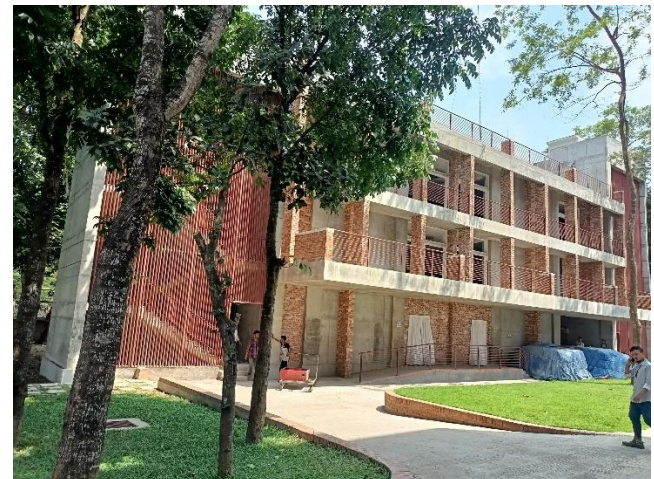
Observation-4: Large cantilever on 1st floor. (Administration Building)

Description: Almost a 3 m large cantilever was found on the 1st floor of the building. The building engineer is required to check the adequacy & deflection limit of the cantilever slab.

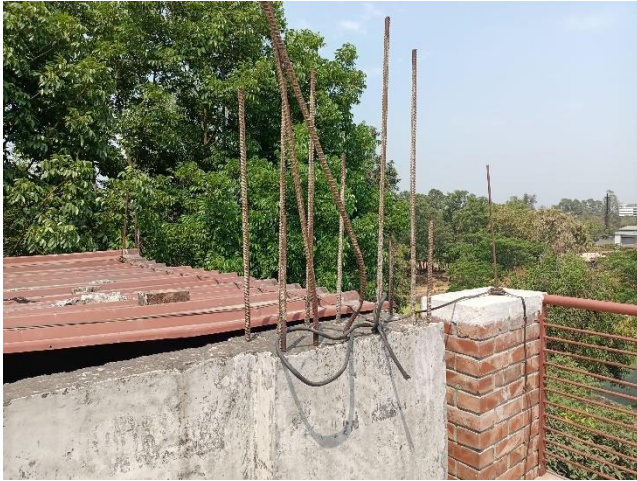
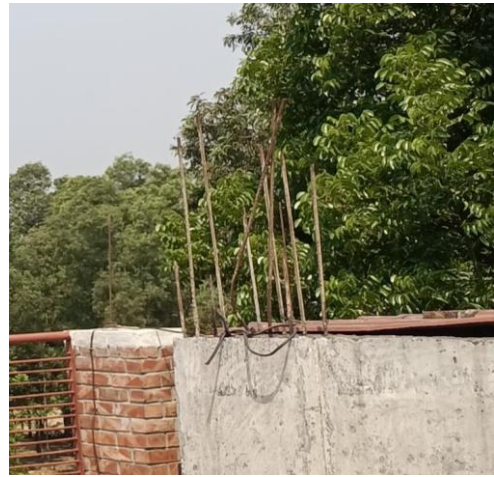
Observation-5: Corrosion on exposed reinforcement. (Administration Building)

Description: Corrosion was observed on exposed rebars on the column. The building engineer is required to provide rust-proof coating on exposed rebars to protect from corrosion.

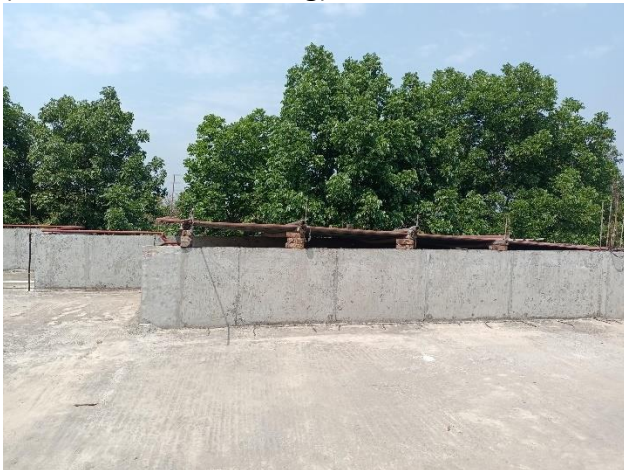
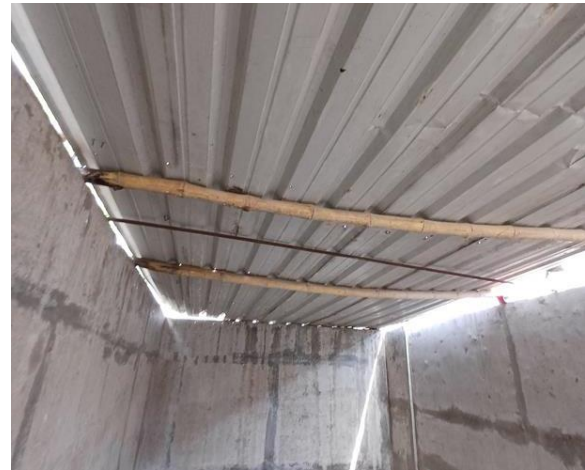
Observation-6: Inadequate connection on lightweight stair roof against uplift forces. (Administration Building)

Description: An inadequate connection was observed on the lightweight stair roof. The building engineer is required to check the connection adequacy of the lightweight roof against the uplift pressure of the wind. Also, suggest suitable repair methods.
