YORK FASHION LTD.

Plot# S-12 & 13, BSCIC Industrial Area, Baburhat, Chandpur-3602
(23.2592634N, 90.7004539E)

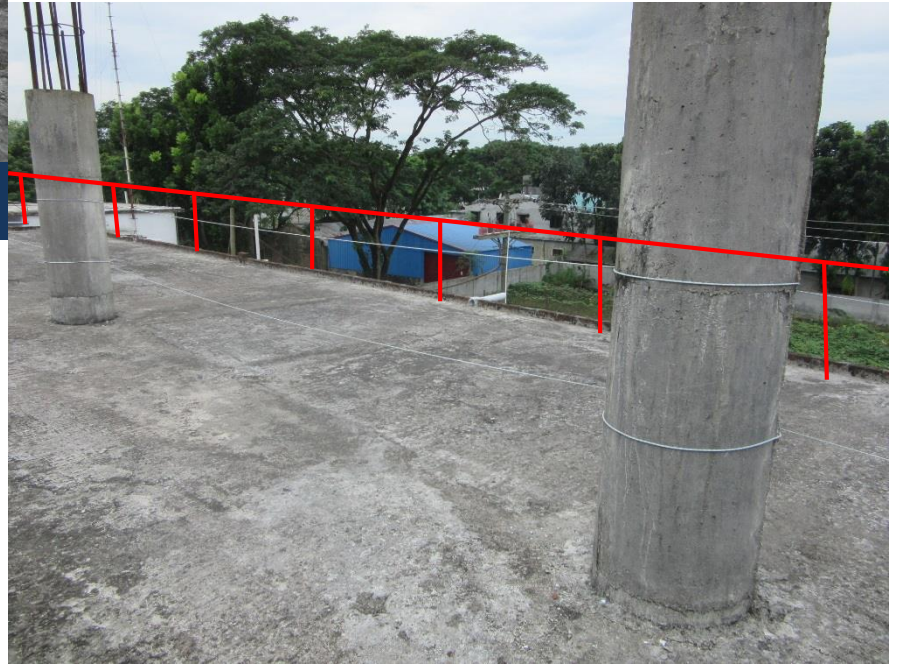
Observations – Main building

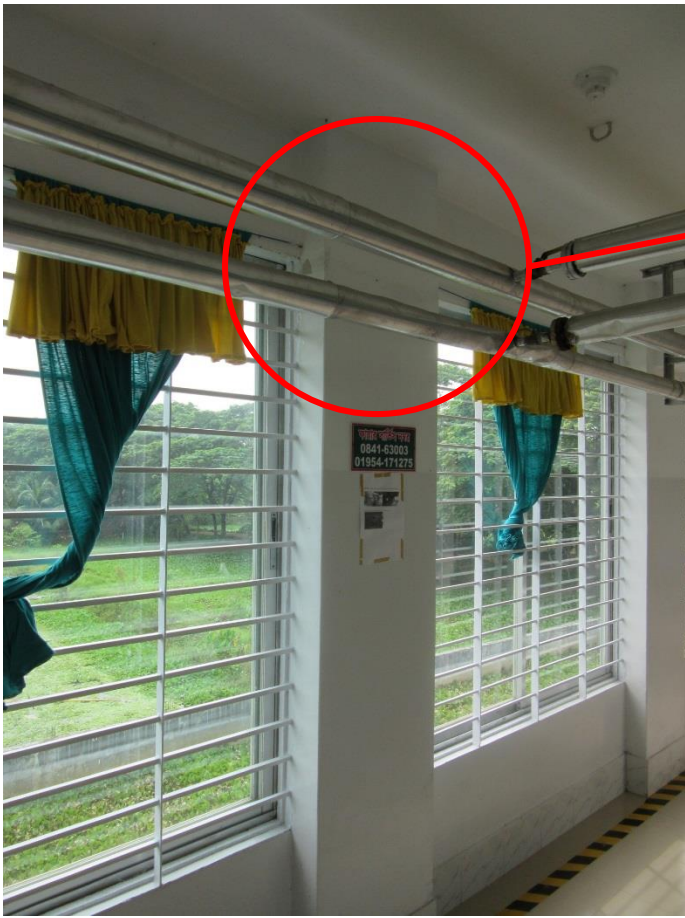
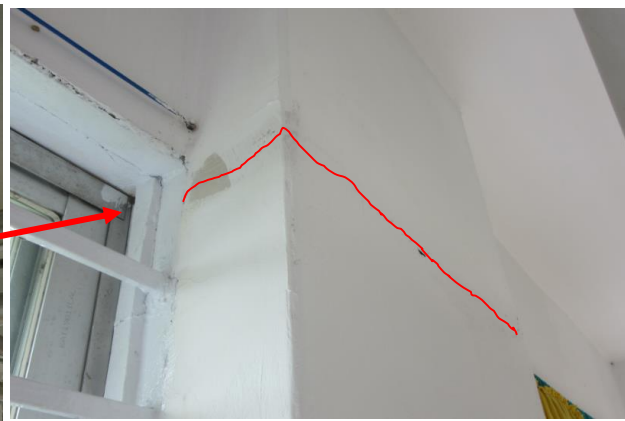
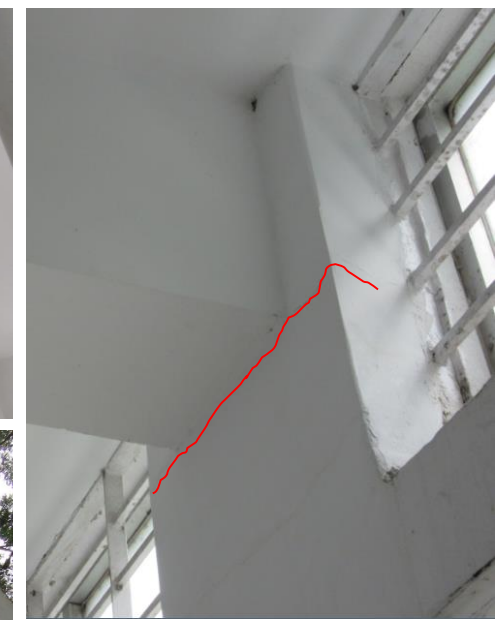
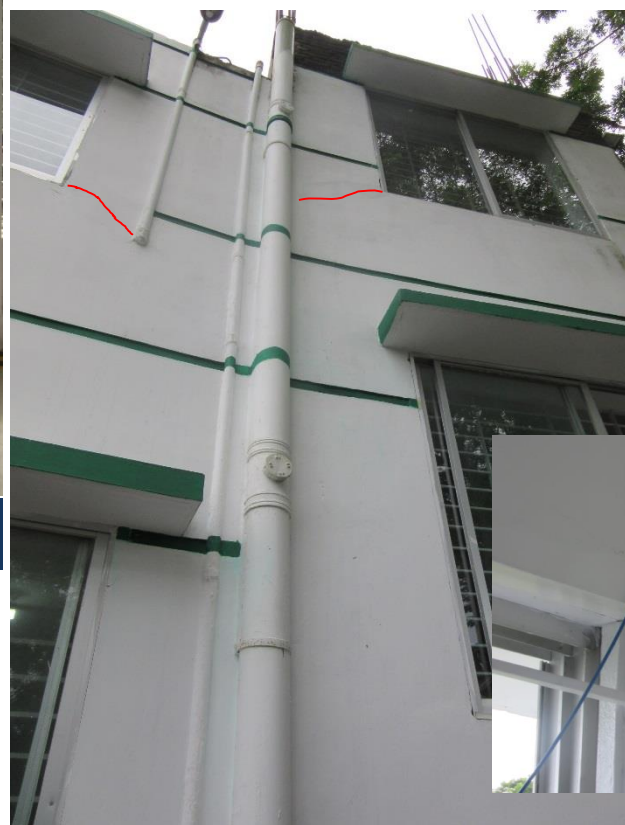
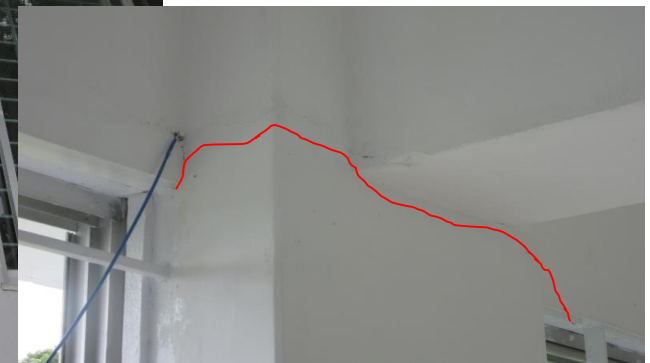
Cracks in the brick facade walls

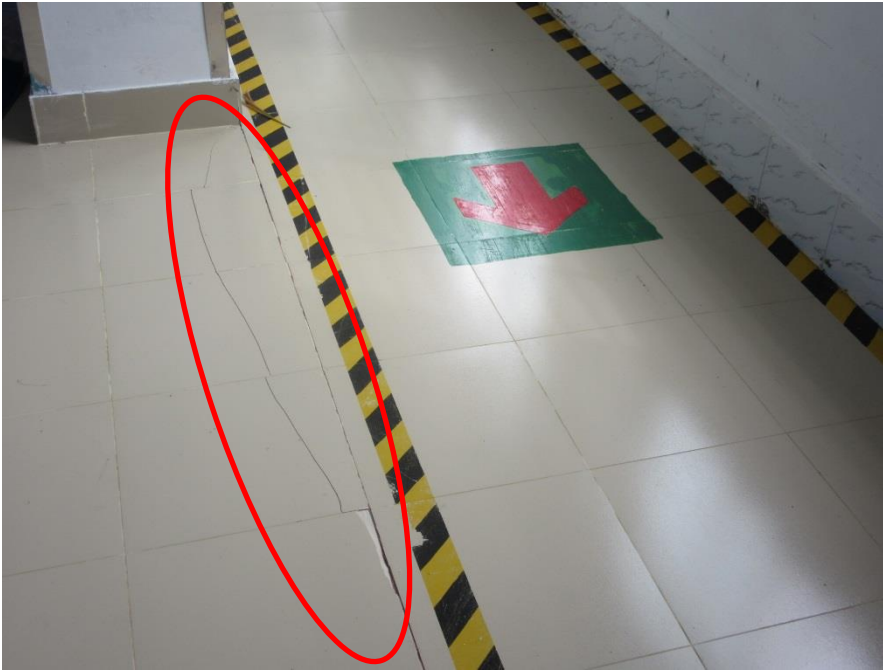
Cracks on the ground floor – internal, South.

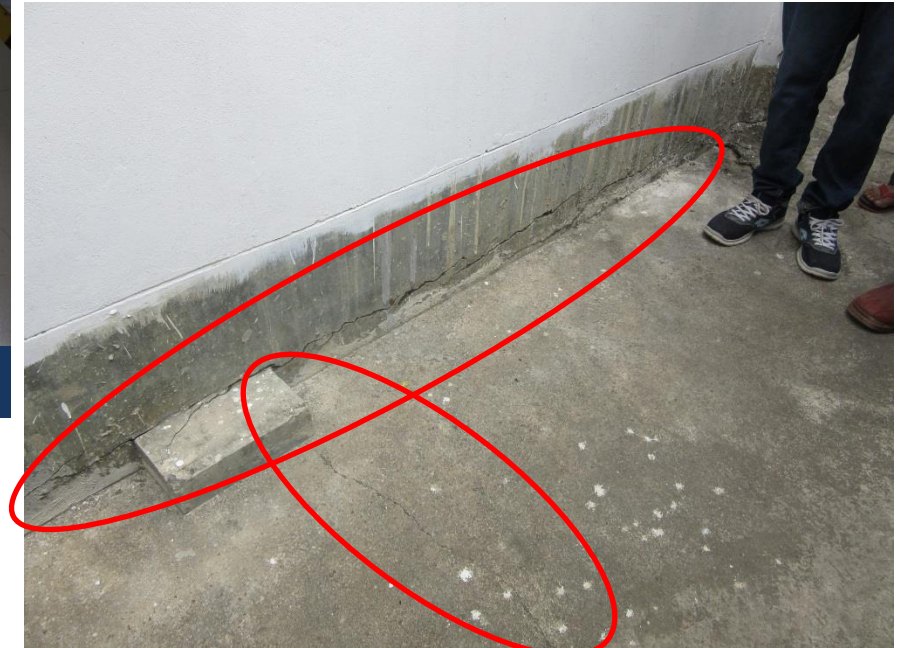
Cracks on the pavement – external, South.

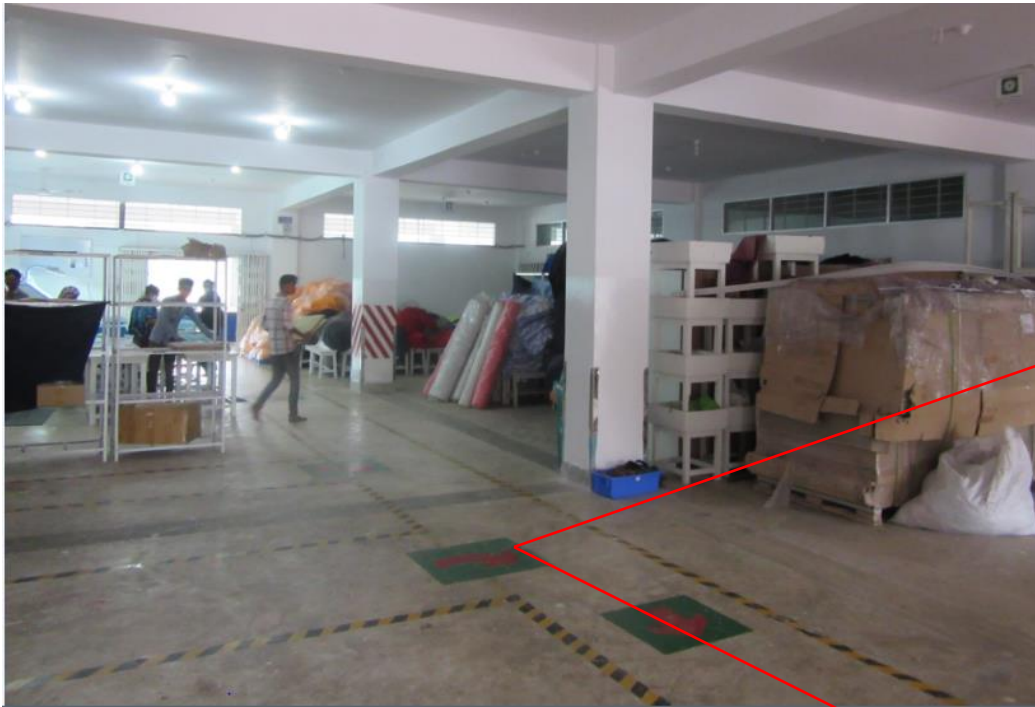
Cracks on the ground floor – inside, Loading Area and Raw Material Room.

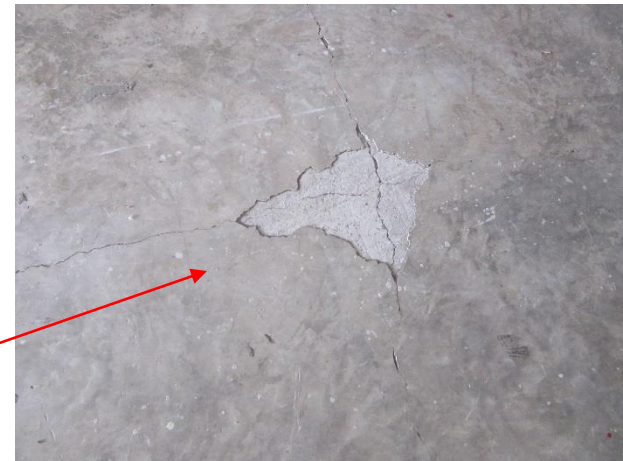
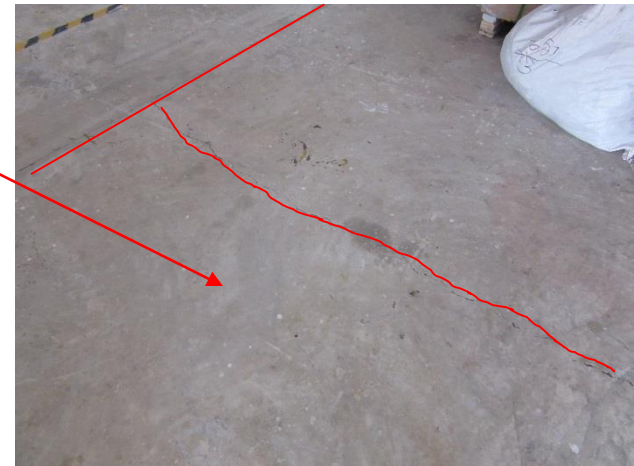
Observations – Main building

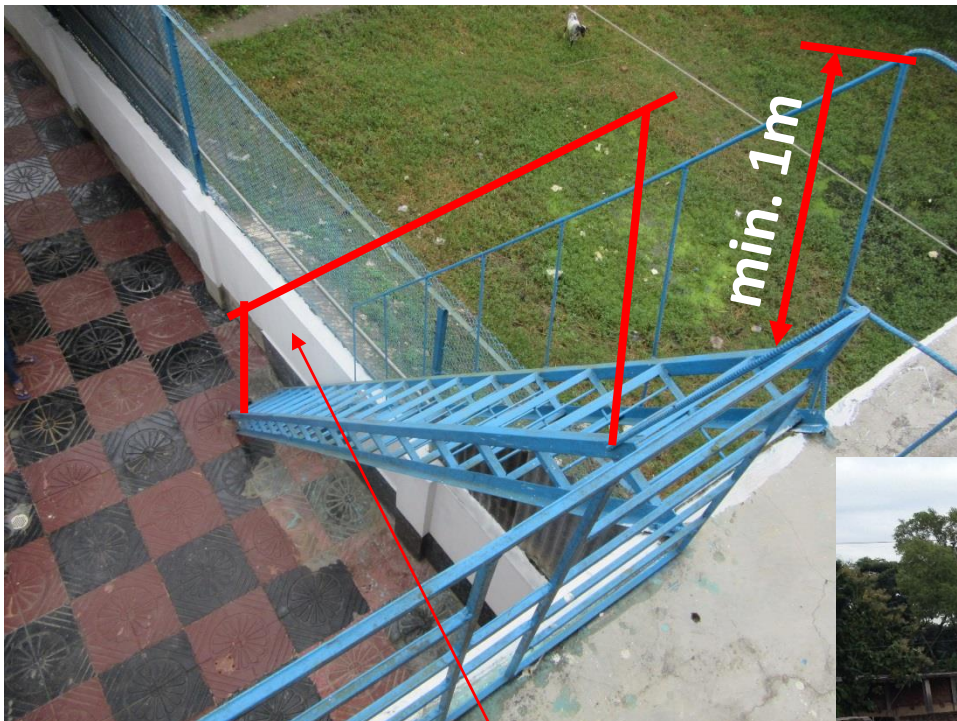
Observations – Utility building

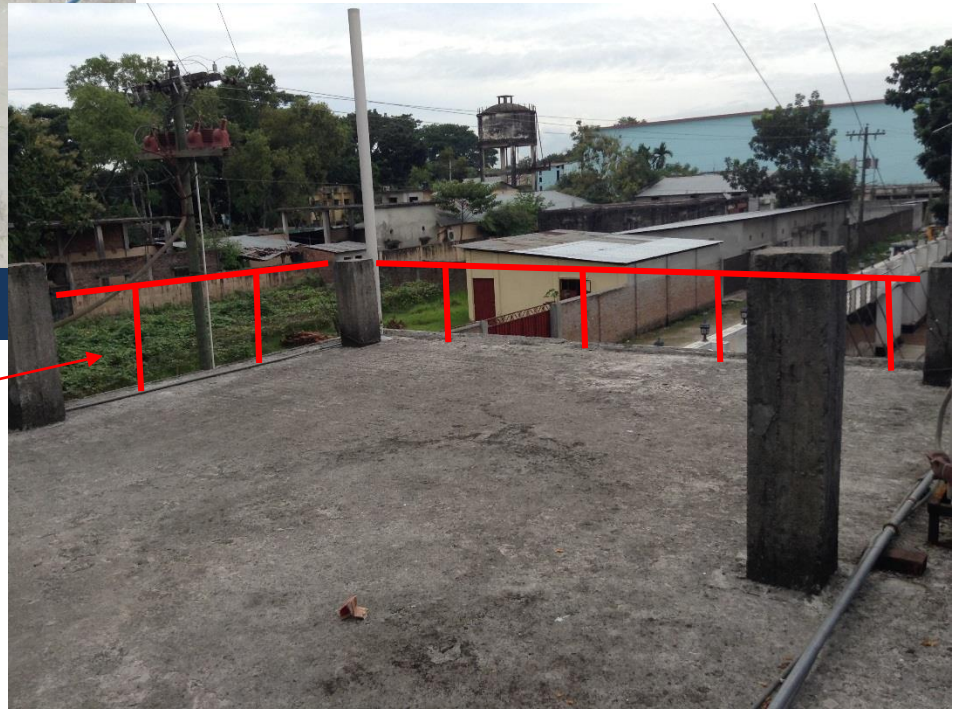
Lack of parapets or fall restraints
