# Probridhi Apparels Ltd (Extension)

Kawya, Chonnapara, Sreepur, Gazipur

28 April 2024

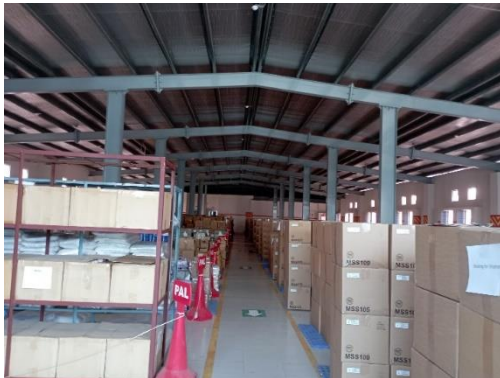
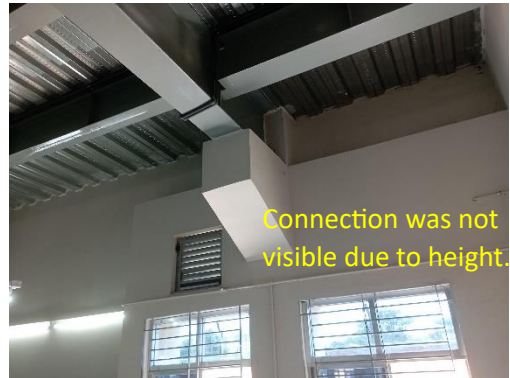
### Observation-1: Lack of lateral stability (Main Building-2).

**Description:** Tie beam is provided along the periphery only but no-load transfer media is provided for the internal frame. Besides, roof bracing is not provided. The building engineer is required to check the lateral stability of the structure. Also, verify and check the connection adequacy of corbel/steel rafter.

| Observation | Action Plan | Timeline |
|---|---|---|
| Lack of lateral stability (Main Building-2). | The building engineer is required to check the lateral stability of the structure. Also, verify and check the connection adequacy of corbel/ steel rafter. | within 6 weeks |
| Lack of lateral stability (Main Building-2). | Implement remediation work if required. | within 6 months |

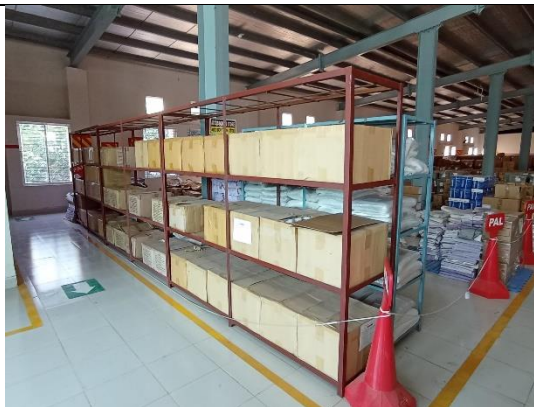
### Observation-2: Non-structural elements found not anchored/braced (Main Building-2).

**Description:** Non-structural elements found not anchored/braced. The building engineer is required to brace/anchor all nonstructural elements including storage racks within the factory.

| Observation | Action Plan | Timeline |
|---|---|---|
| Nonstructural elements found not anchored/braced (Main Building-2). | The building engineer is required to anchored/braced all nonstructural elements. | within 6 weeks |

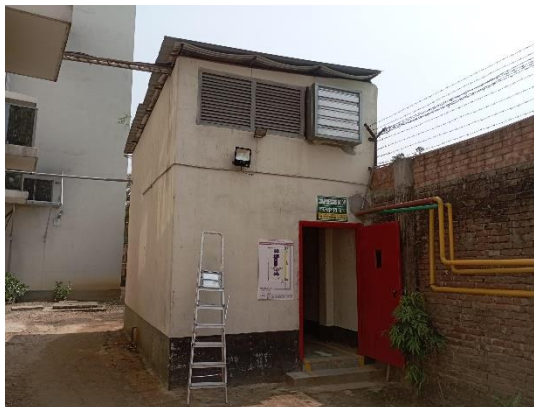
### Observation-3: Lack of as-built drawing (Compressor Room)

**Description:** At the time of inspection as-built drawing was not available for the structure. The building engineer is required to produce as-built drawing.

| Observation | Action Plan | Timeline |
|---|---|---|
| Lack of as-built drawing (Compressor Room) | The building engineer is required to produce as-built drawing. | within 6 weeks |
