Arrival Fashion Limited (Extension)

Colomesshor, Board Bazar, P.O: National University, P.S: Gazipur, Bangladesh

28 April 2024

Observation-1: Inconsistencies in design documents. (Production Building 2)

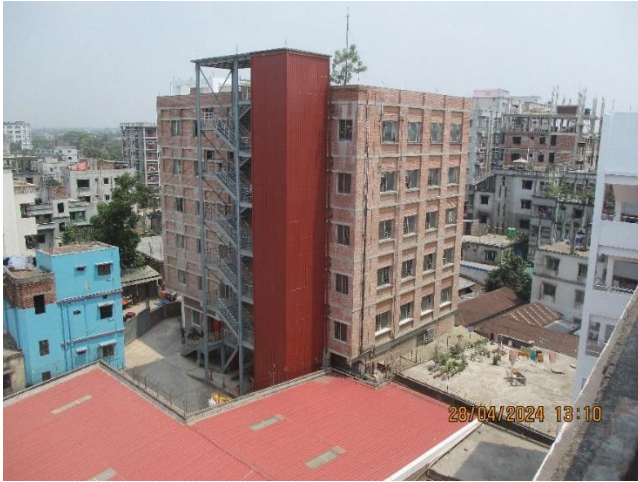
Adjacent external steel stair

Description: The adequacy of the Mat foundation and slabs was not incorporated in the provided engineering assessment (EA) report. Also, an adjacent external steel stair connects with the main building. However, no evaluation of steel stair was provided in the engineering assessment.

Description: In the assessment report, intermediate moment resisting frame (IMRF, R=8) was considered without proper justification. The building engineer is required to recheck the design parameters and update the design documents accordingly. Also, the building engineer is required to incorporate all types of adequacies checks in the EA report and submit it to the RSC for review.

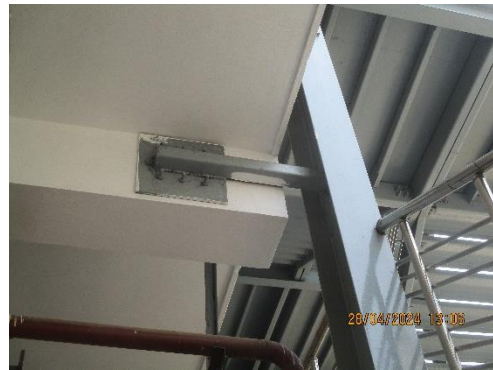
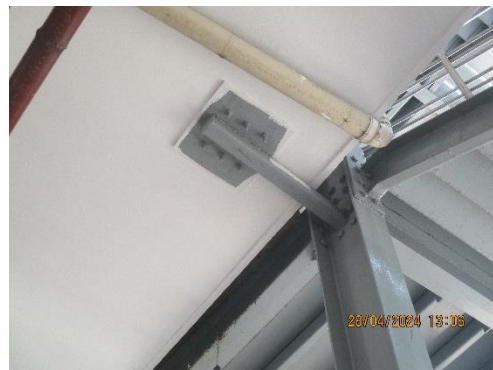
Connection with the main building

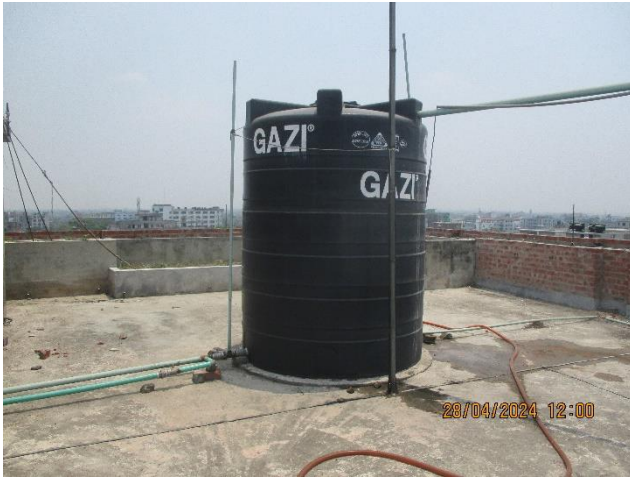
Unbraced water tanks on roof

Description: Non-structural elements suspended from, attached to, or resting atop the structure shall be adequately anchored and braced to resist earthquake forces. The factory is required to brace/anchor all non-structural elements (PVC water tanks, storage racks etc.).

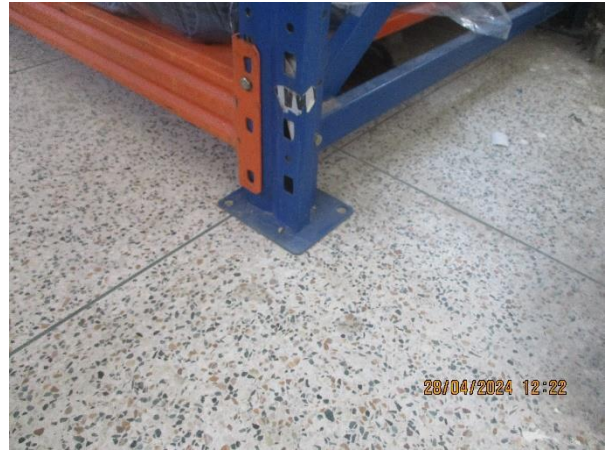
Unbraced racks on the floor
