# Universe Knitting Garments Ltd. (Unit- 1)

Jamgora Chourasta, Ashulia Road, Savar  
23.936590N, 90.290692E

4<sup>th</sup> November 2015

# Observations

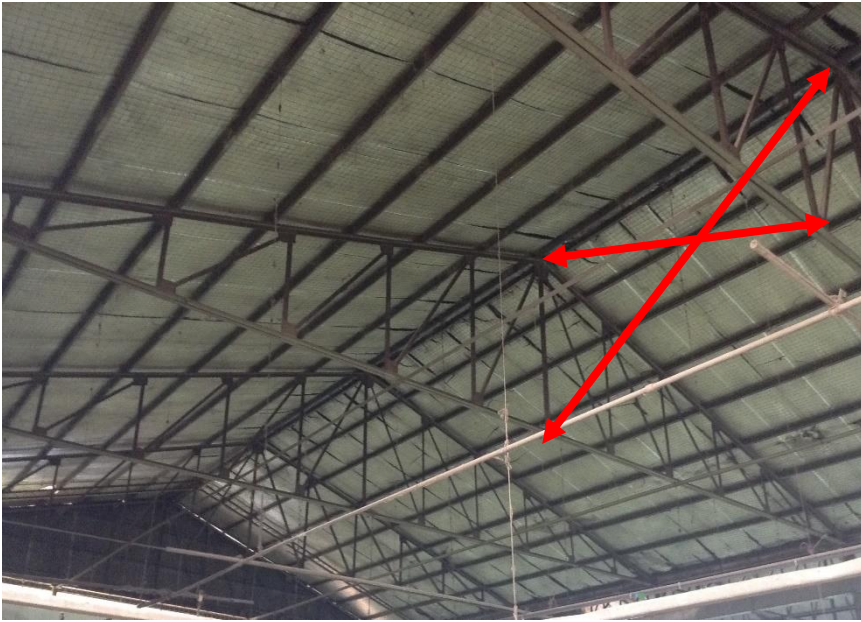
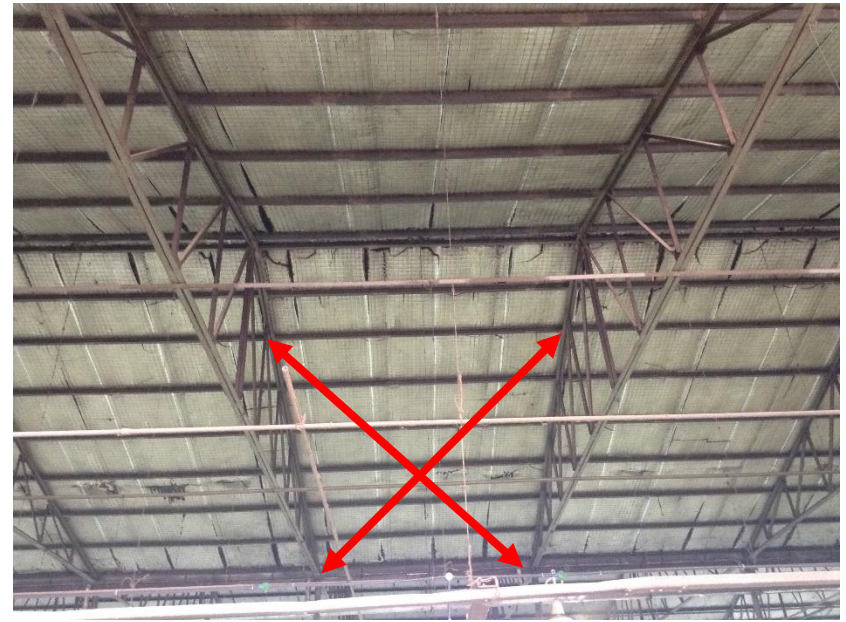
# Lack of Vertical and Horizontal Bracing on Main Production Shed

**Lack of Vertical and Horizontal Bracing on Main Production Shed**

**ITEM 1:** Lack of lateral stability in production building.

Item No.	Observation	Recommended Action Plan	Recommended Timeline
1	Stability of the structure needs to be verified by the Building engineer	Building Engineer to verify lateral stability of the structure.	6-weeks
2	Stability of the structure needs to be verified by the Building engineer	Building Engineer to check, collect information and complete structural drawings and documentation as soon as possible.	6-months
3	Non engineered roof structure	Engineer to review the roofs and make recommendations as to how the roofs are to be brought up to standards	6-weeks
4	Non engineered roof structure	Carry out remedial actions as required	6-months

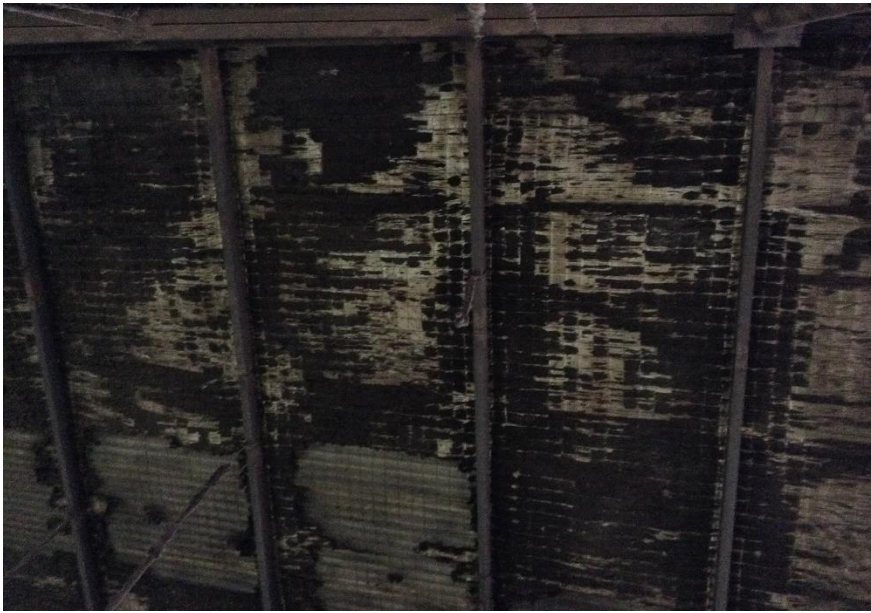
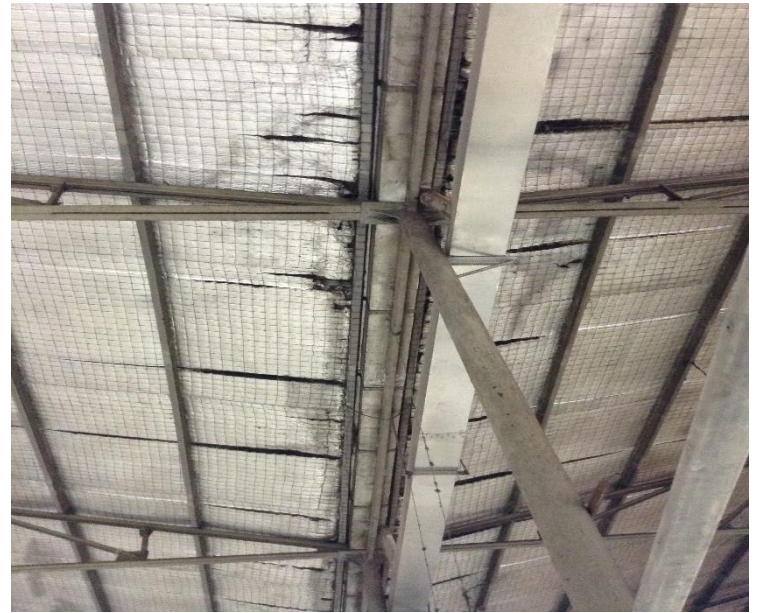
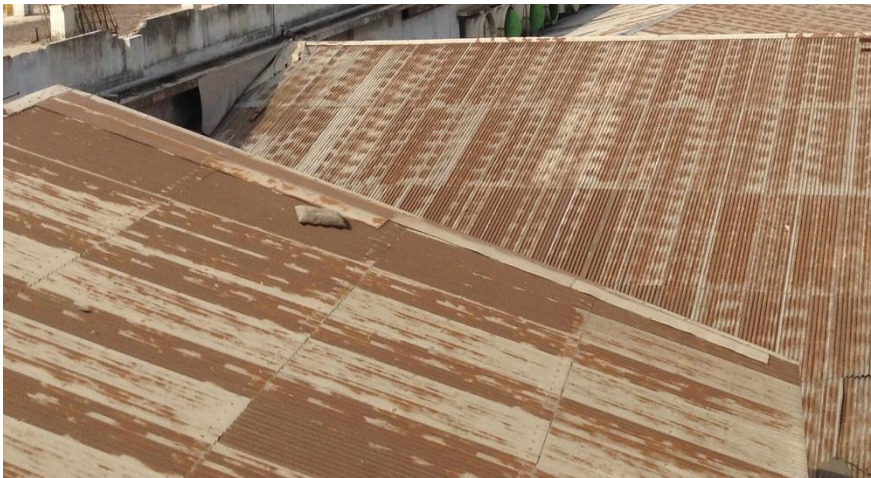
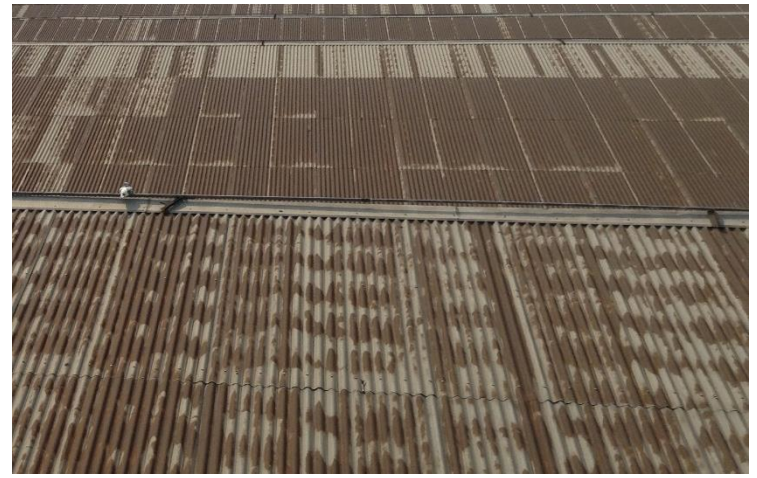
# Poor Roof Insulation and Corrosion on Roof

Poor Roof Insulation and Corrosion on Roof

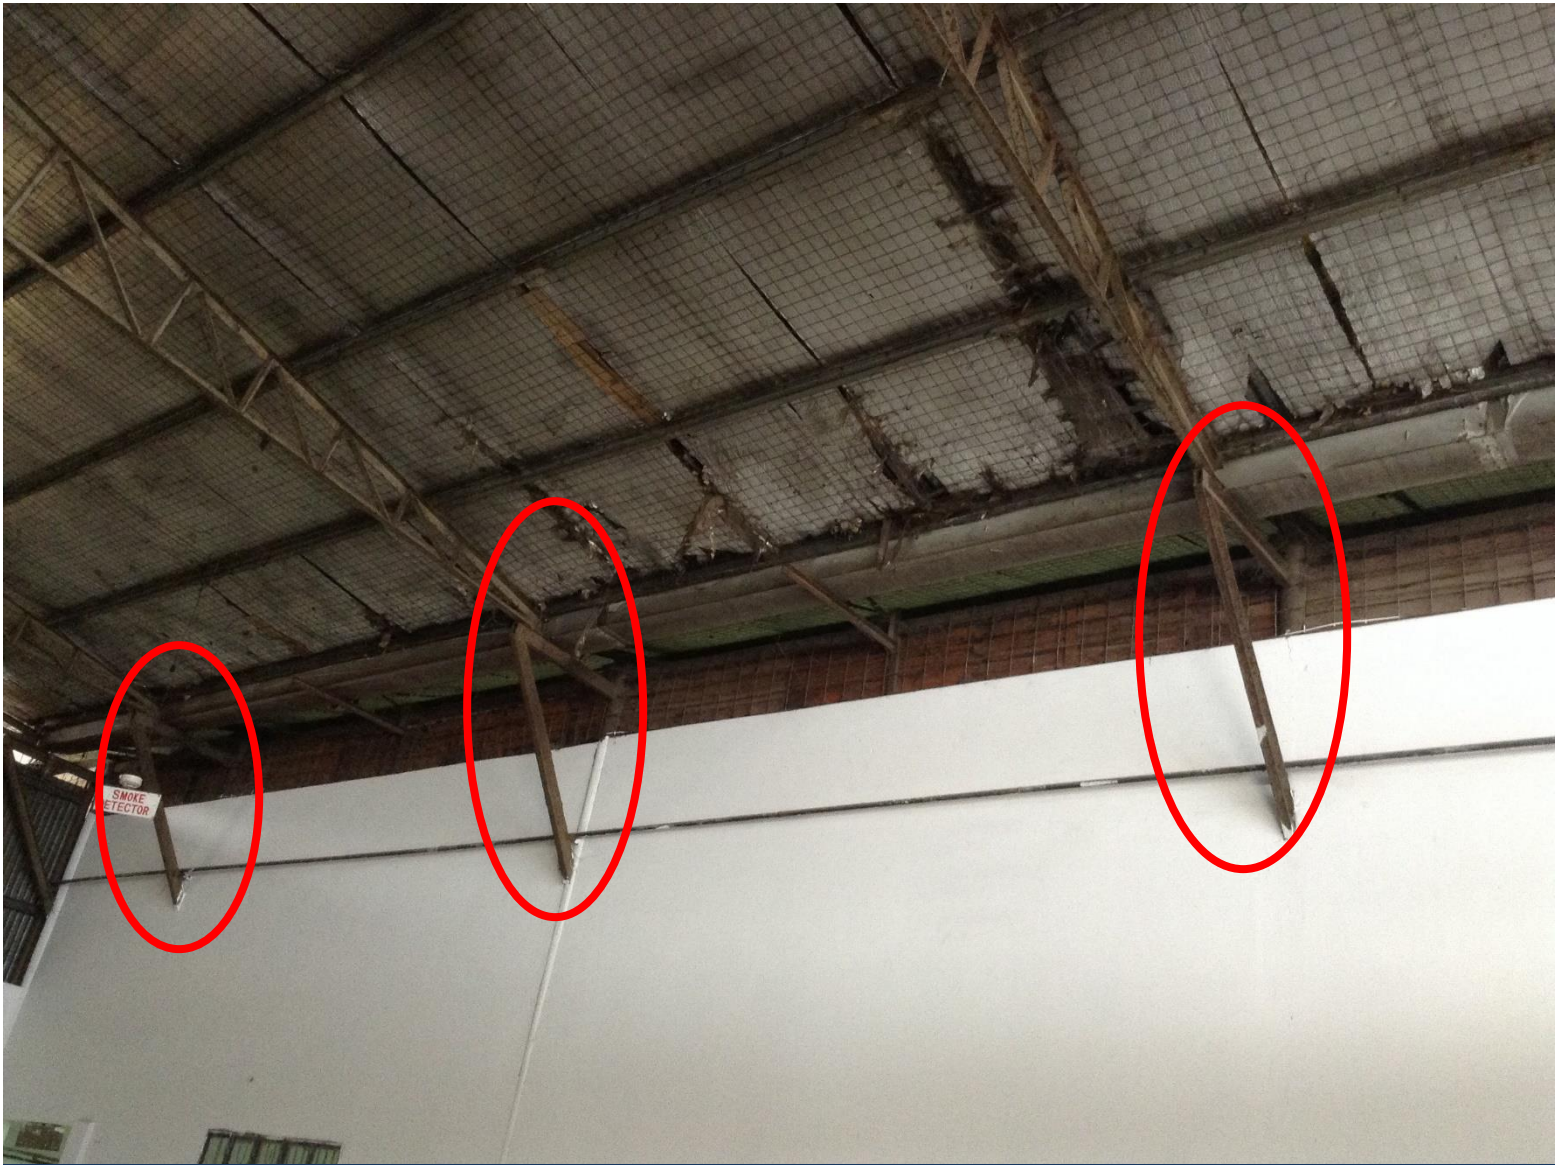
# Non-Engineered Truss Connection in Warehouse

**Non-Engineered Connection of Roof Truss in Warehouse**

**ITEM 2:** Non engineered roof connections in warehouse.
