Lantabur Apparels Ltd Taqwa Fabrics Ltd & Libas Knitwear.

Kewa, Boherarchala, Gila Beraeed, Sreepur.
(24.19605675N), (90.40638176E)

4th November, 2015

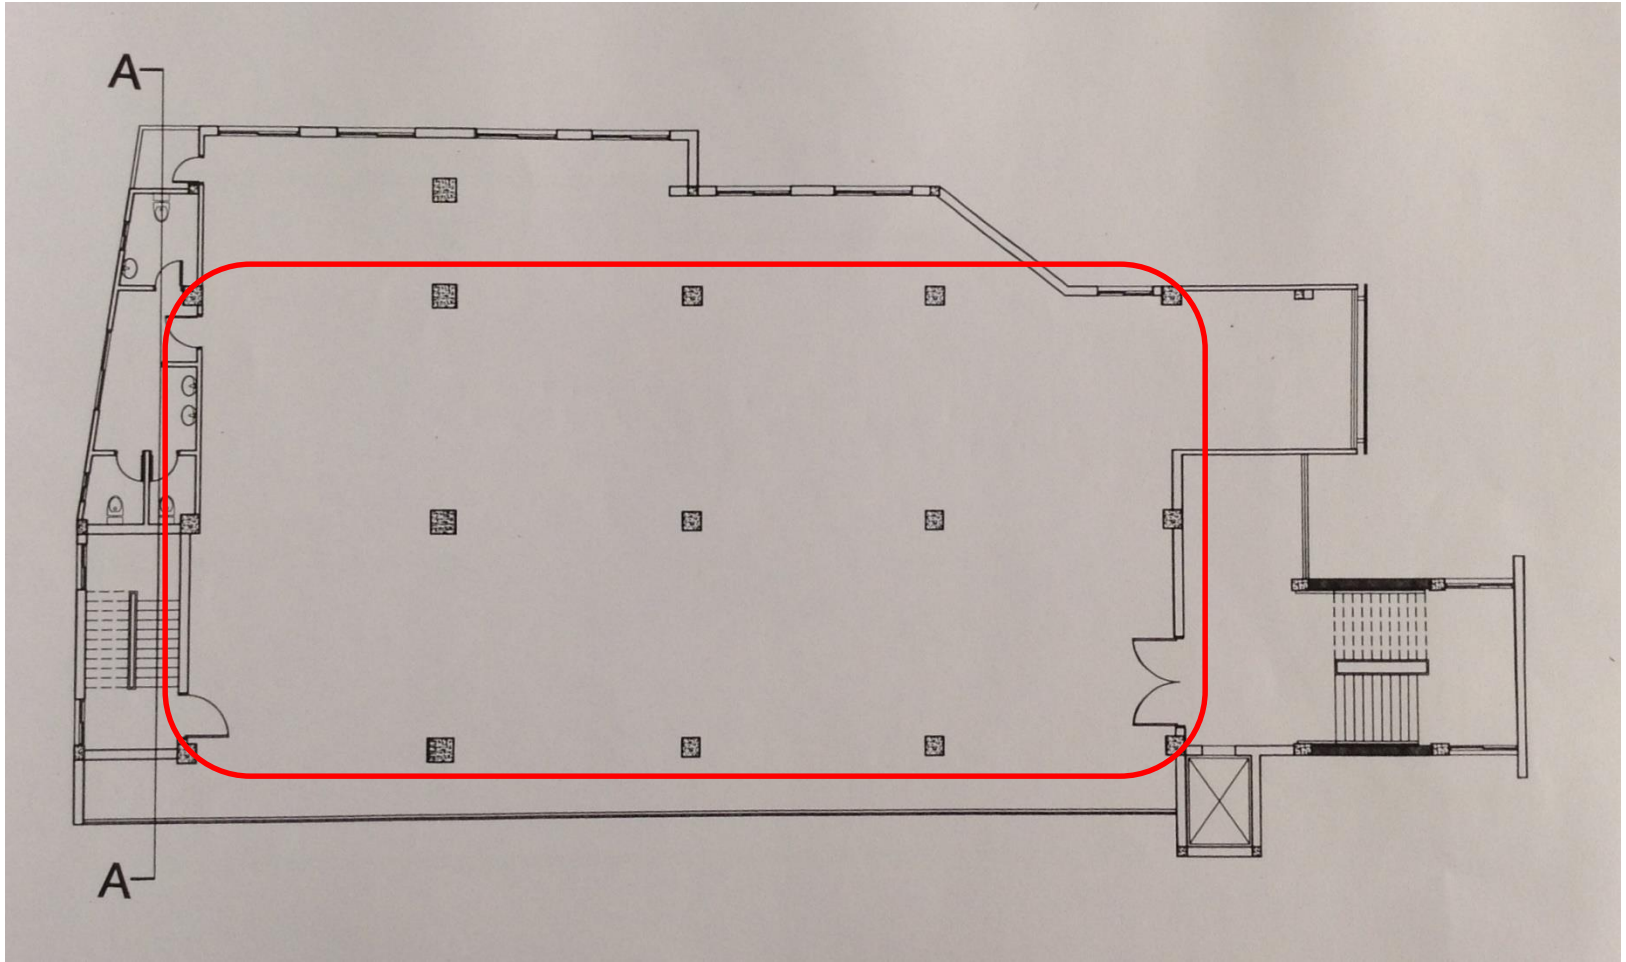
Ground floor columns appear to be overstressed with their working loads

- Item 1:** Ground floor Columns appear to be stressed in excess of normal design limits and require review
- Item 2:** Ground floor Large wall panels appear to be slender
- Item 3:** Toilets and 250mm thick external walls build on large cantilever average 1.75m
- Item 4:** Water tank on drawing to be constructed on roof slab

Item No.	Observation	Recommended Action Plan	Recommended Timeline
1	Building 1 External Columns adjacent to the cantilevers appear to be stressed in excess of normal design limits and require review	Factory Engineer to review design, loads and columns stresses in the columns based design check to loading set out in BNBC-2006.	6-weeks
2	Building 1 External Columns adjacent to the cantilevers appear to be stressed in excess of normal design limits and require review	Factory Engineer to verify insitu concrete strength by taking 100mm diameter cores from 4 brick aggregate columns . Verify grade of steel reinforcement used.	6-weeks
3	Building 1 External Columns adjacent to the cantilevers appear to be stressed in excess of normal design limits and require review	No further construction should proceed until the above study is completed	6-weeks
4	Building 1 External Columns adjacent to the cantilevers appear to be stressed in excess of normal design limits and require review	Carry out any remedial actions arising form the above study.	6-months

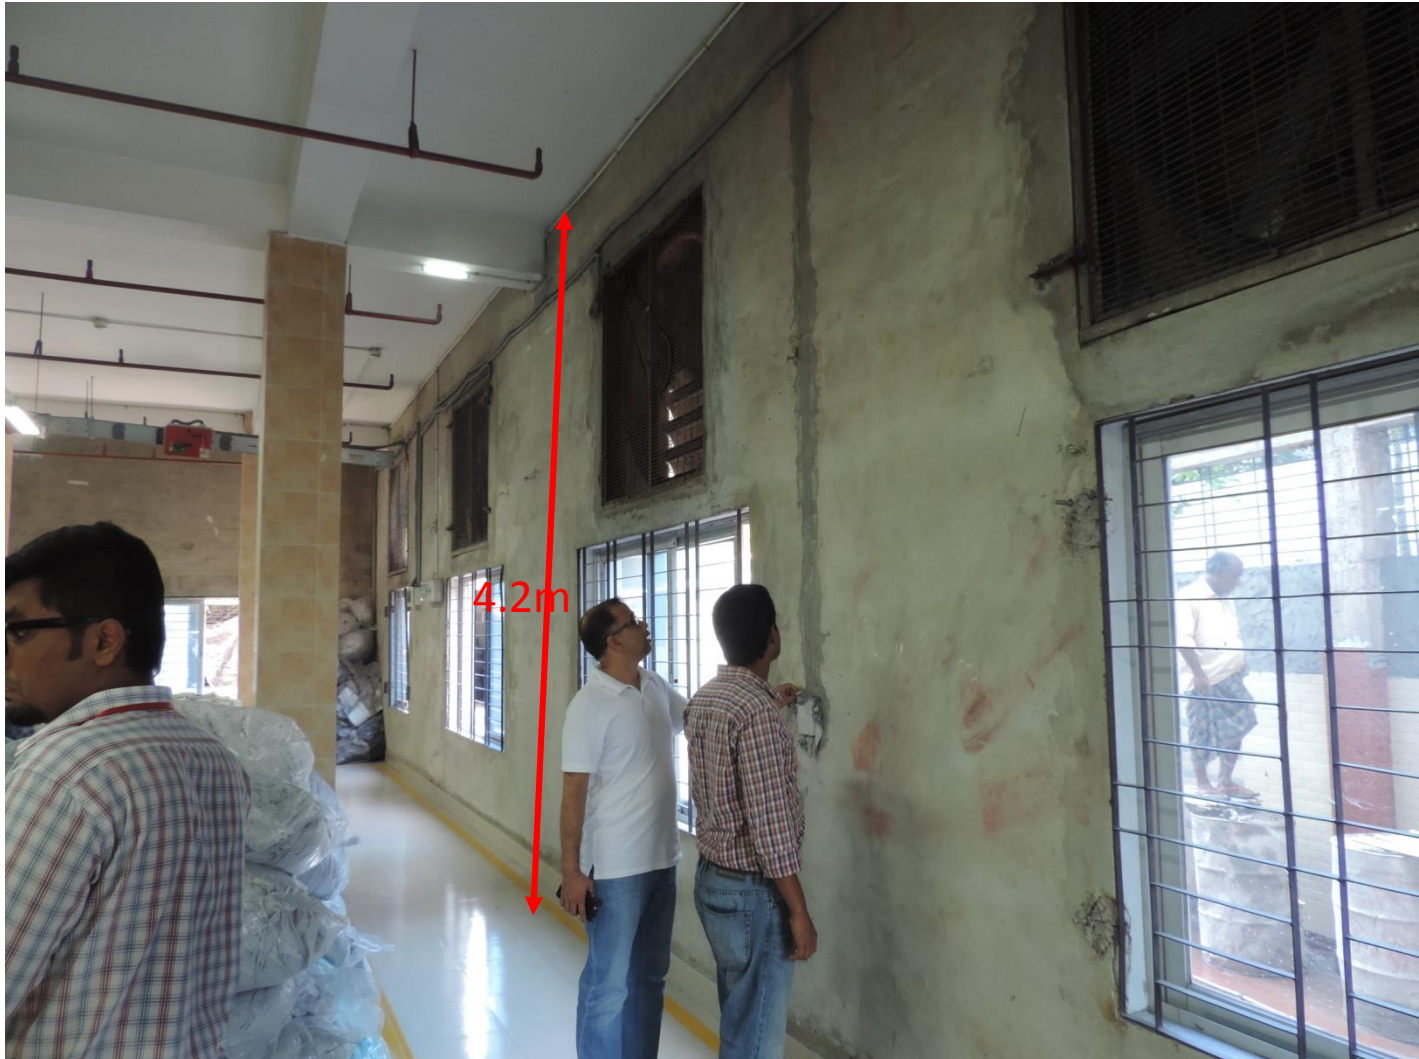
Ground floor large wall panels appear to be slender

Item No.	Observation	Recommended Action Plan	Recommended Timeline
5	Building 1 Ground floor Large wall panels appear to be slender	Design engineer to review by calculation the capacity of the large brick wall panels to resist the wind and other lateral loads	6-weeks
6	Building 1 Ground floor Large wall panels appear to be slender	Carry out any remedial actions from the above review	6-months
7	Building 1 Toilets and 250mm thick external walls build on large cantilever average 1.75m	Building Engineer to review by calculation the loads on the cantilevers and their ability to carry these loads	6-weeks
8	Building 1 Toilets and 250mm thick external walls build on large cantilever average 1.75m	Carry out such remedial actions as maybe required from the above study	6-months
9	Building 1 Water tank on drawing to be constructed on roof slab	The water tank on the roof needs to form part of the review for the heavily loaded edge columns. (refer to Item 1).	6-weeks

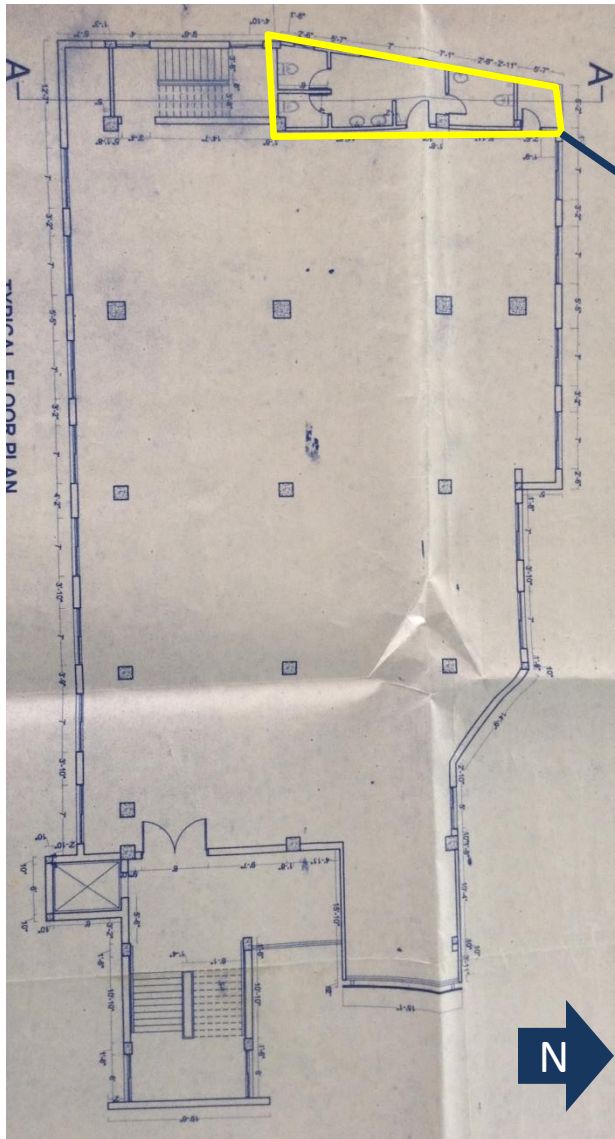
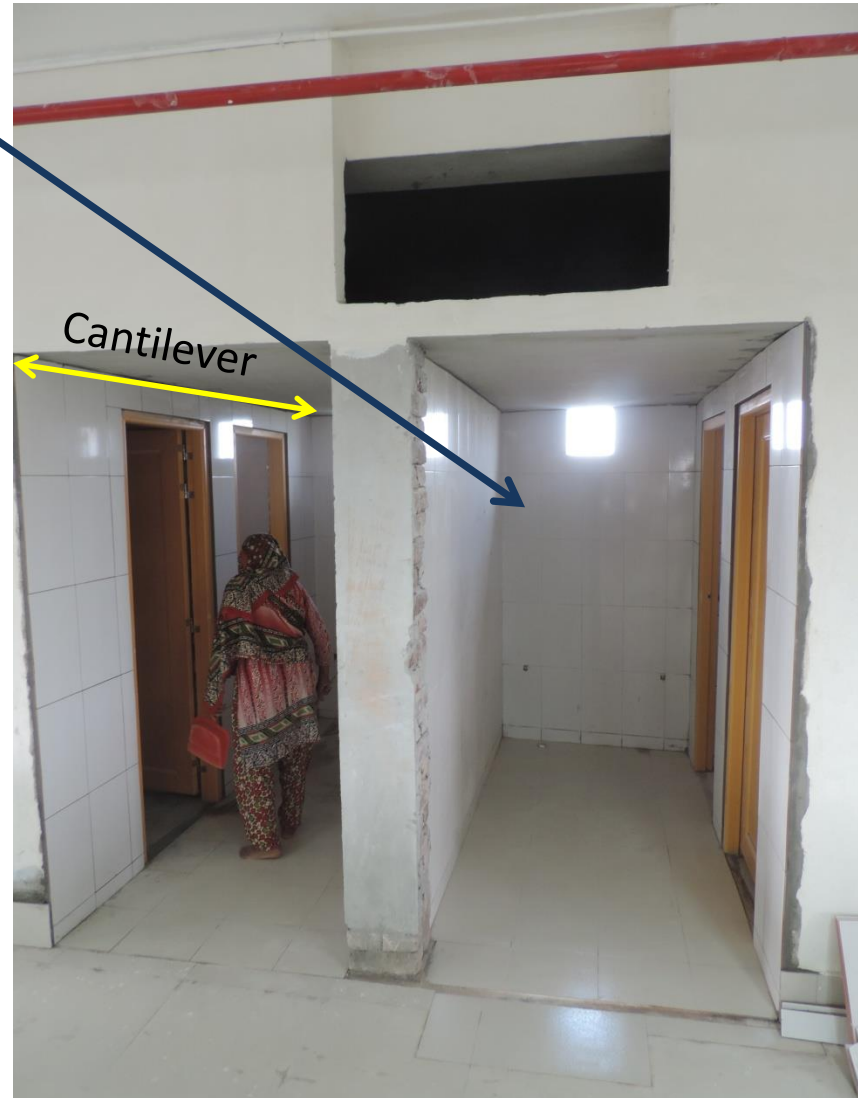
Toilets are on cantilever

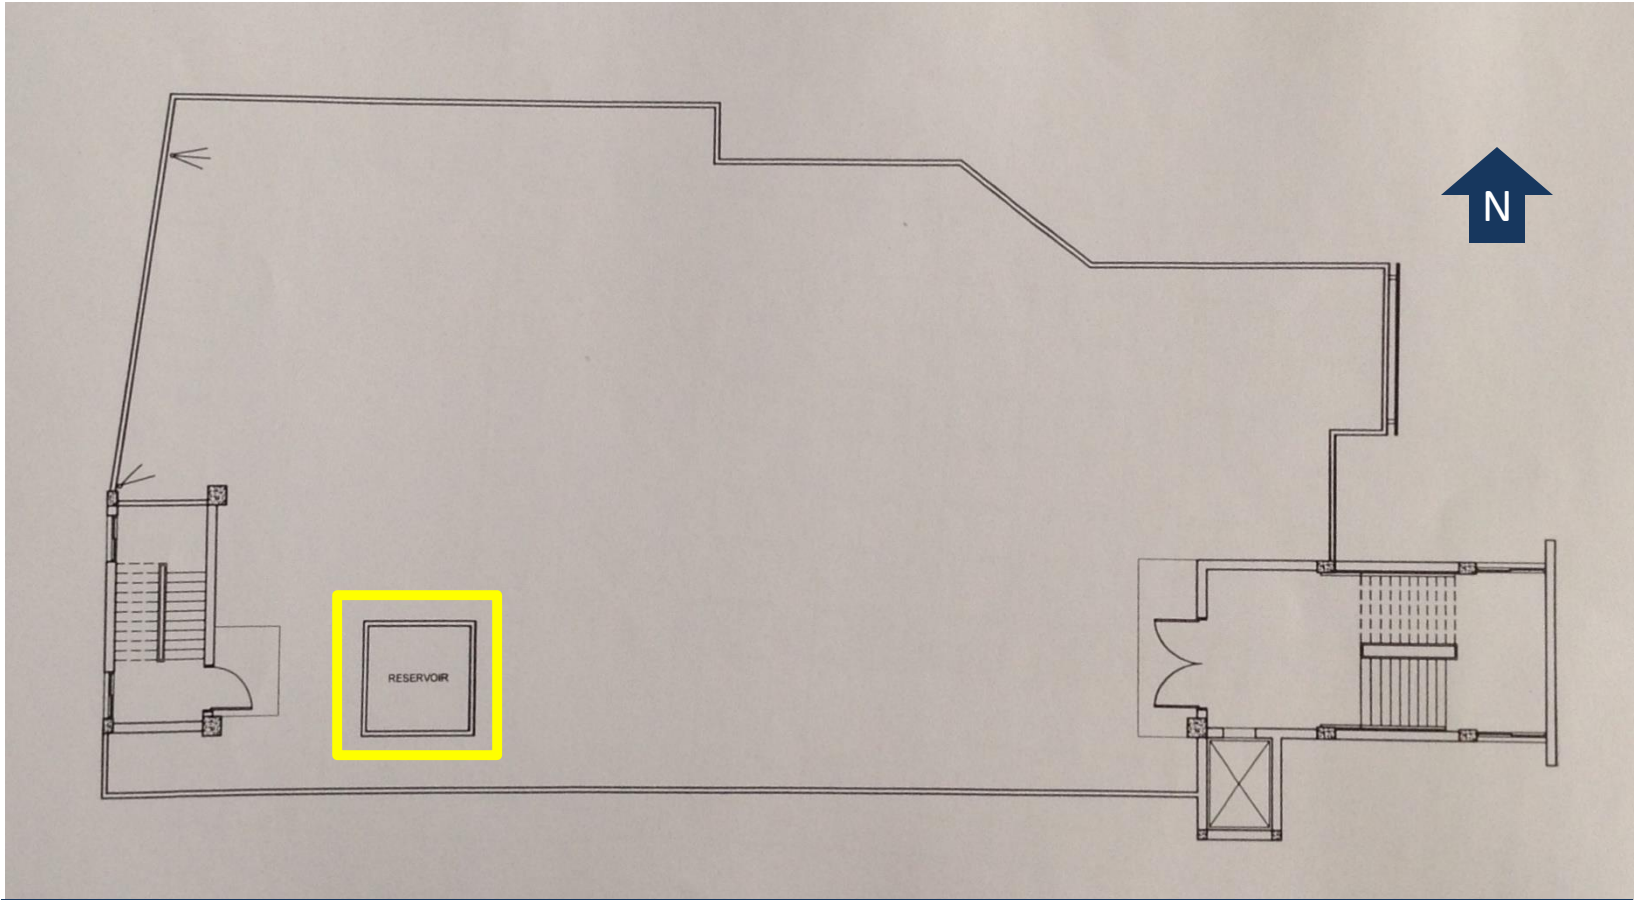
Water tanks on drawings to be constructed on roof slab

10	Building 1 Water tank on drawing to be constructed on roof slab	Construction of the tank to be put on hold until such time the column capacities have been justified.	6-weeks

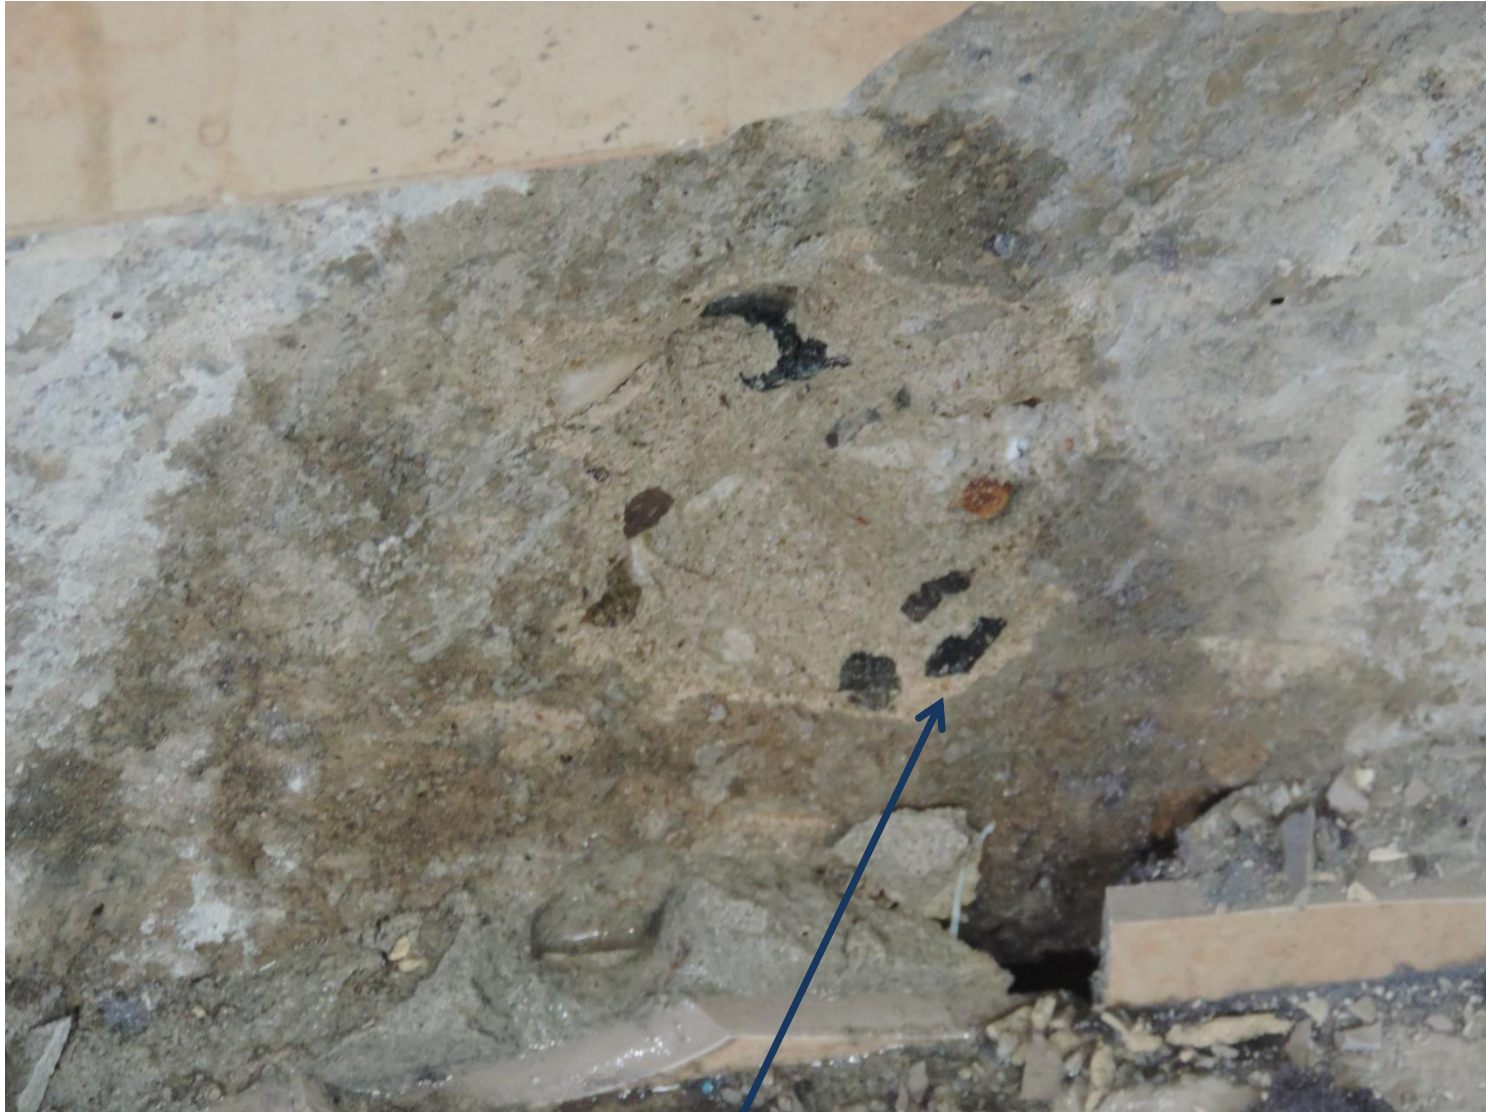
Stone chips observed at ground floor column

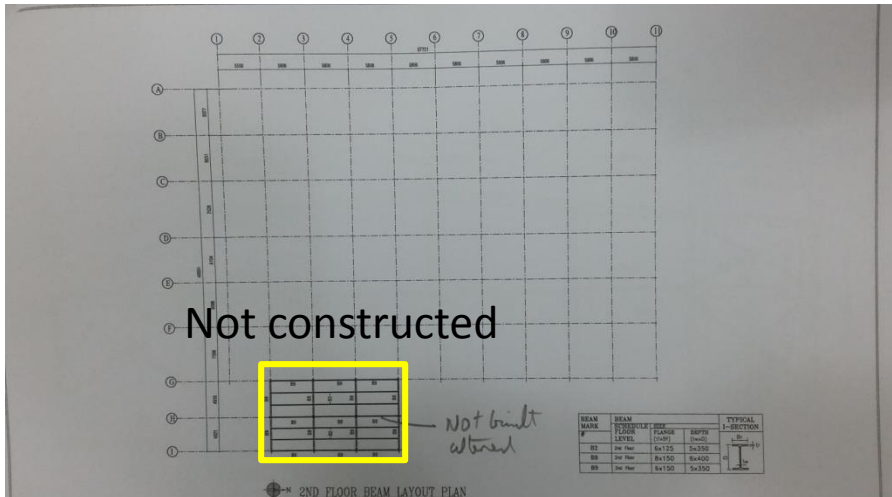
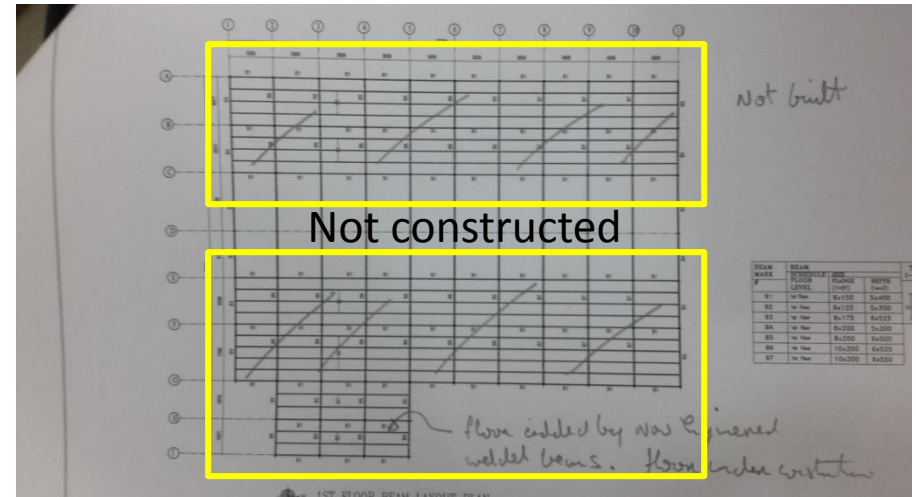
Structural drawing is different from as constructed building

Item No.	Observation	Recommended Action Plan	Recommended Timeline
11	Shed 1 Structural drawings different from as-constructed building	Engineer to revise drawings to reflect the as-built structure and to include any remedial works following this review	6-weeks
12	Shed 1 Non Engineered lean-to structure under construction as add-on to main shed	Engineer to review by calculation the non-engineered structure currently under construction. Engineer to propose alternations to make the design conform with code requirement or instruct its removal.	6-weeks
13	Shed 1 Non Engineered lean-to structure under construction as add-on to main shed	No further works to be carried out on this structure until after the Engineering review	6-weeks
14	Shed 1 Non Engineered lean-to structure under construction as add-on to main shed	Carry out the remedial works from the above study	6-months

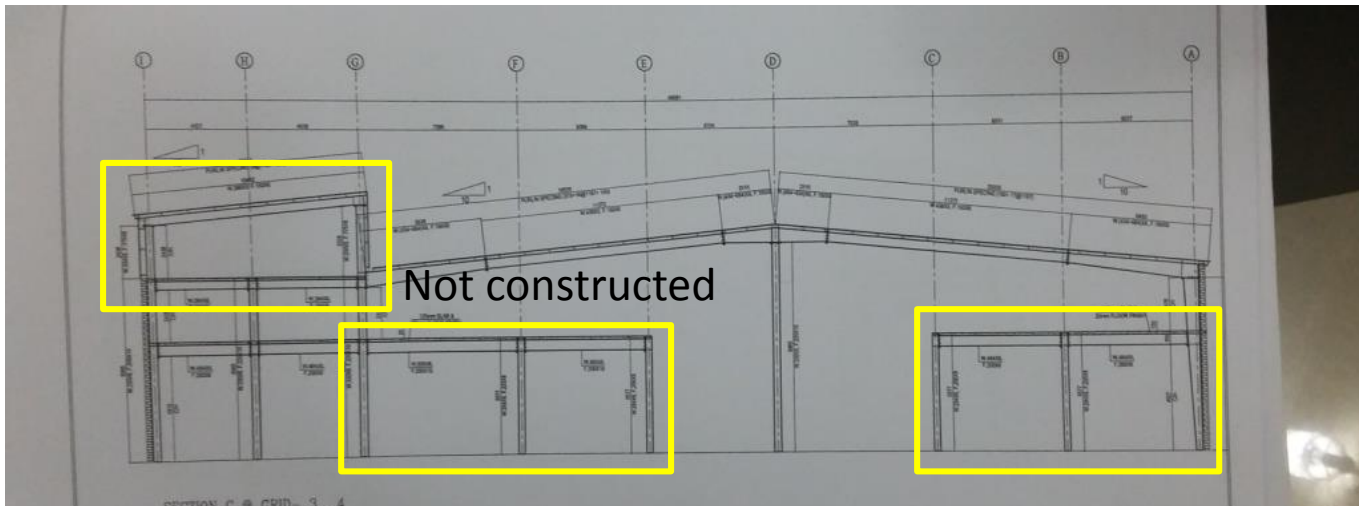
Structural drawing is different from as constructed building

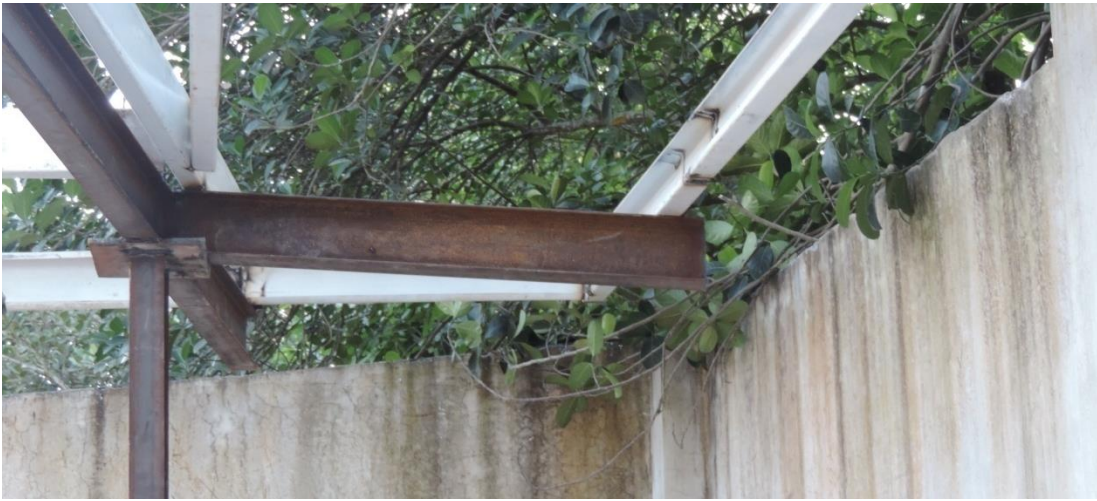
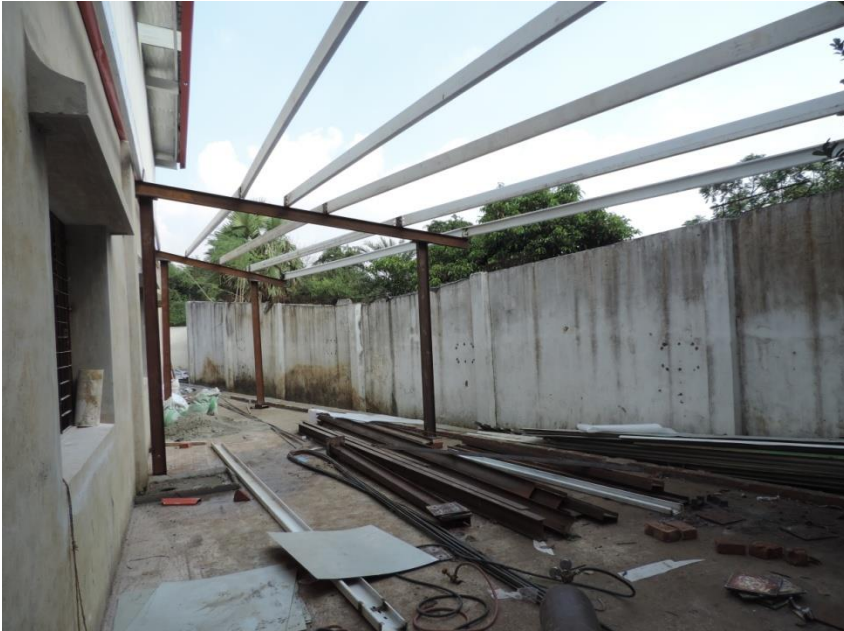
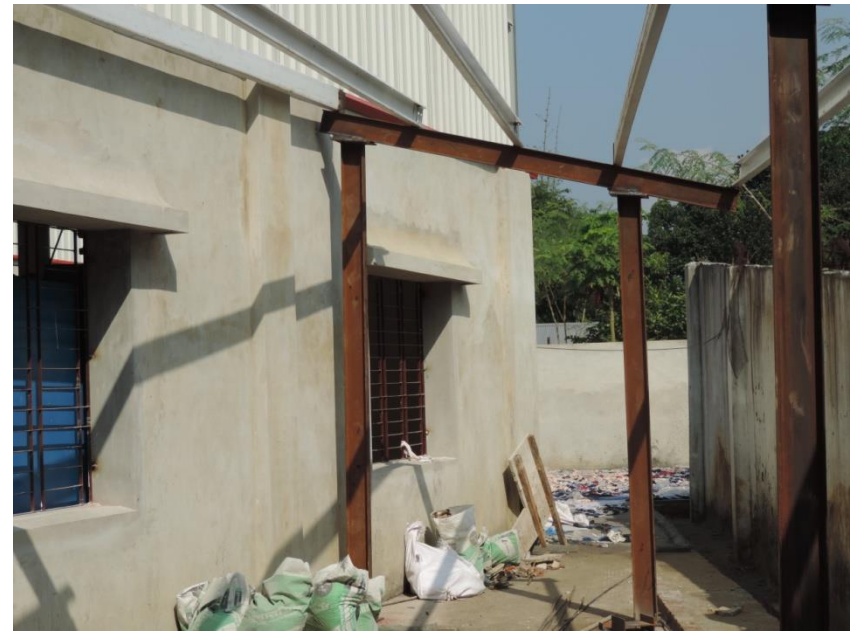
Non Engineered lean-too structure under construction as add-on to main shed

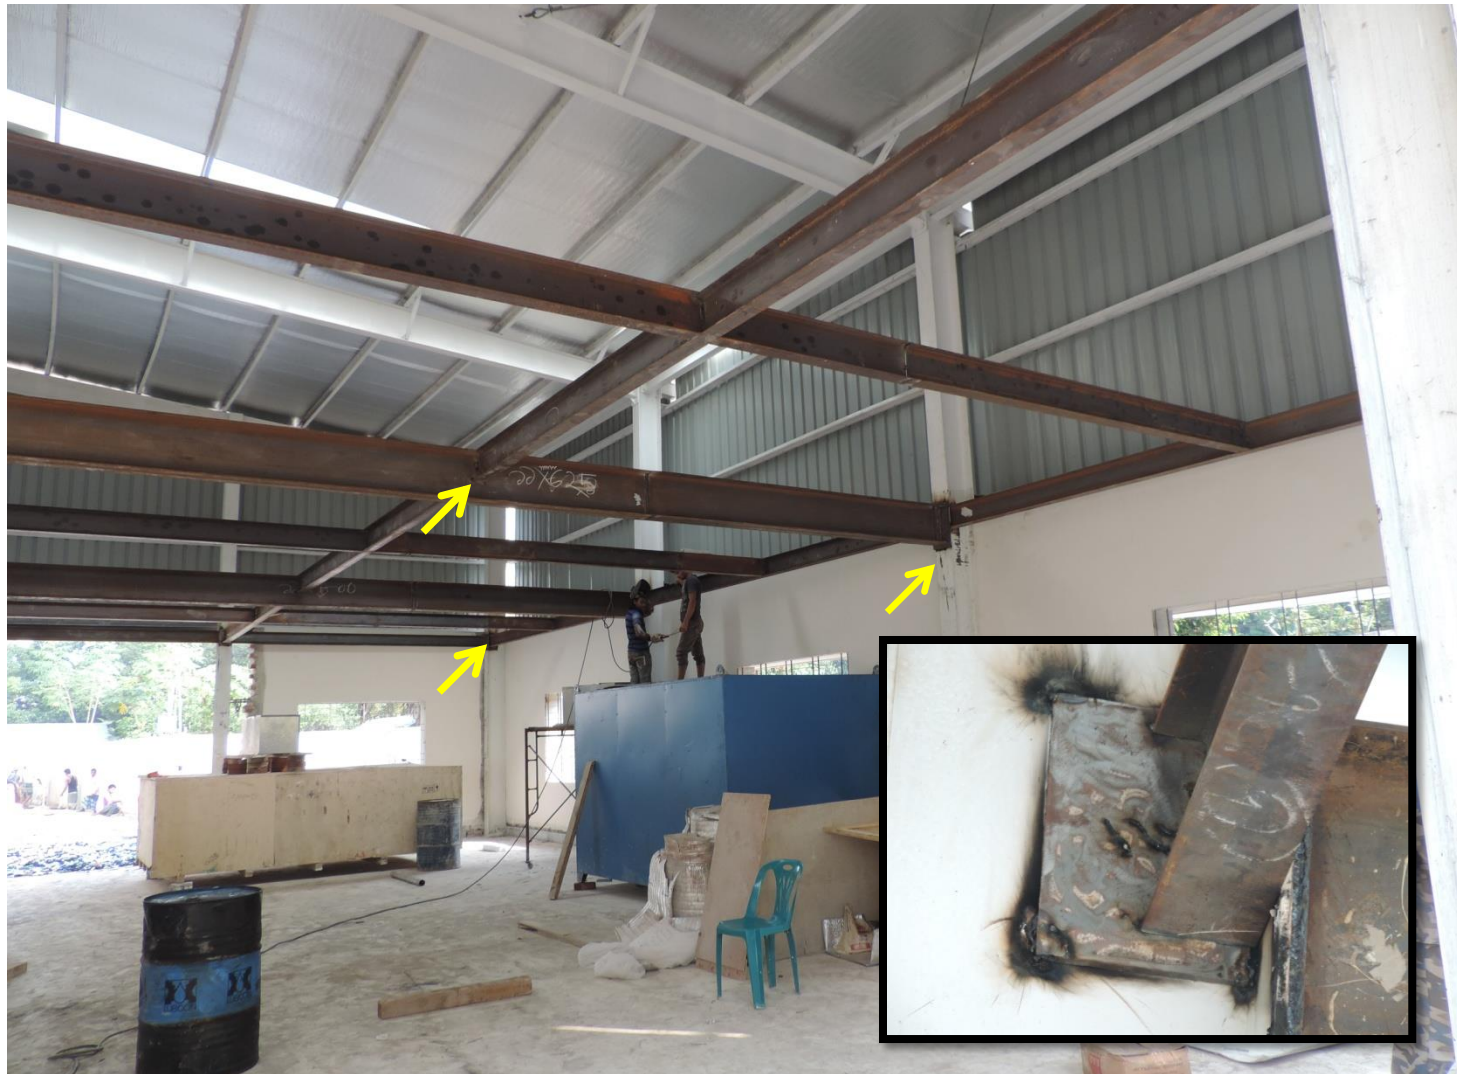
Non engineered connections to mezzanine floor. On site welding

Item No.	Observation	Recommended Action Plan	Recommended Timeline
15	Shed 1 Non – engineered connections to mezzanine floor. On site welding	Engineer to review by calculation the non-engineered structure currently under construction. Engineer to propose alternations to make the design conform with code requirement in particular the member connections.	6-weeks
16	Shed 1 Non – engineered connections to mezzanine floor. On site welding	No further works to be carried out on this structure until after the Engineering review	6-weeks
17	Shed 1 Non – engineered connections to mezzanine floor. On site welding	Carry out the remedial works from the above study	6-months
18	Shed 1 Portal 2 to 5 have no moment connection with column. (ability to act as a portal)	Engineer to review by calculation the ability of the above frames to act as portals in particular its ability to resist lateral loading.	6-weeks
19	Shed 1 Portal 2 to 5 have no moment connection with column. (ability to act as a portal)	Carry out the remedial works from the above study	6-months

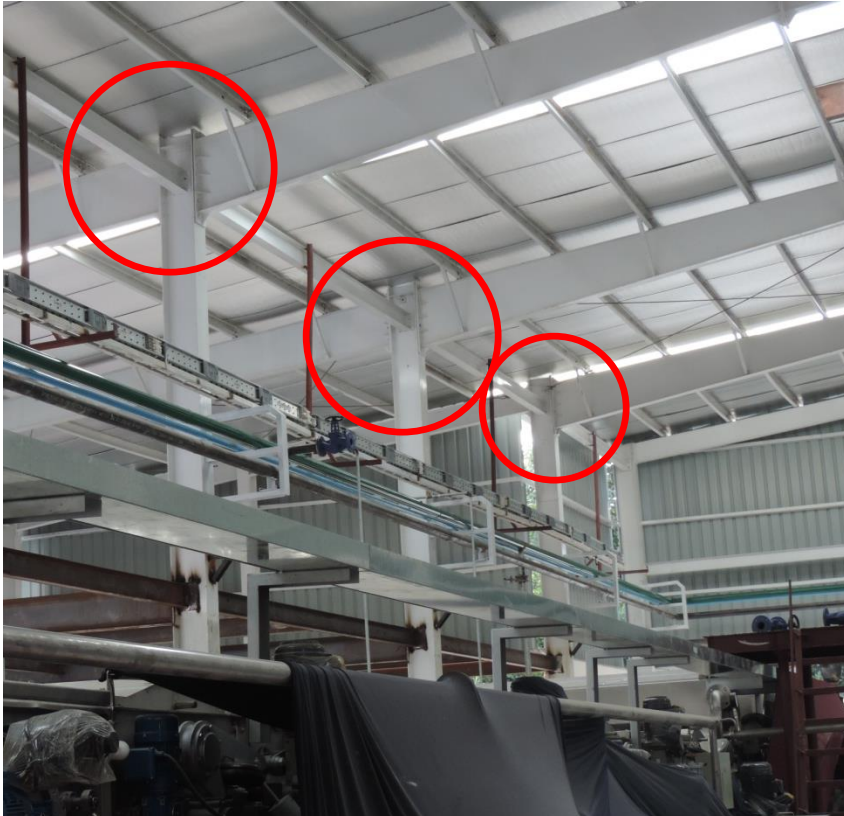
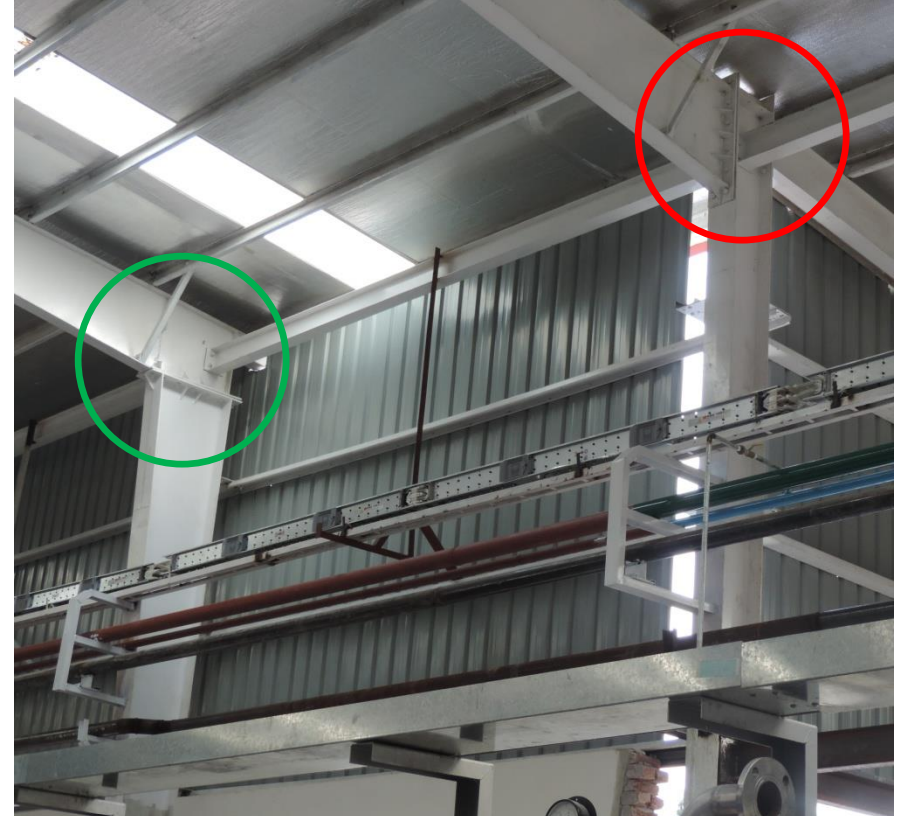
Portal 2 to 5 have no moment connection with column. (ability to act as a portal)

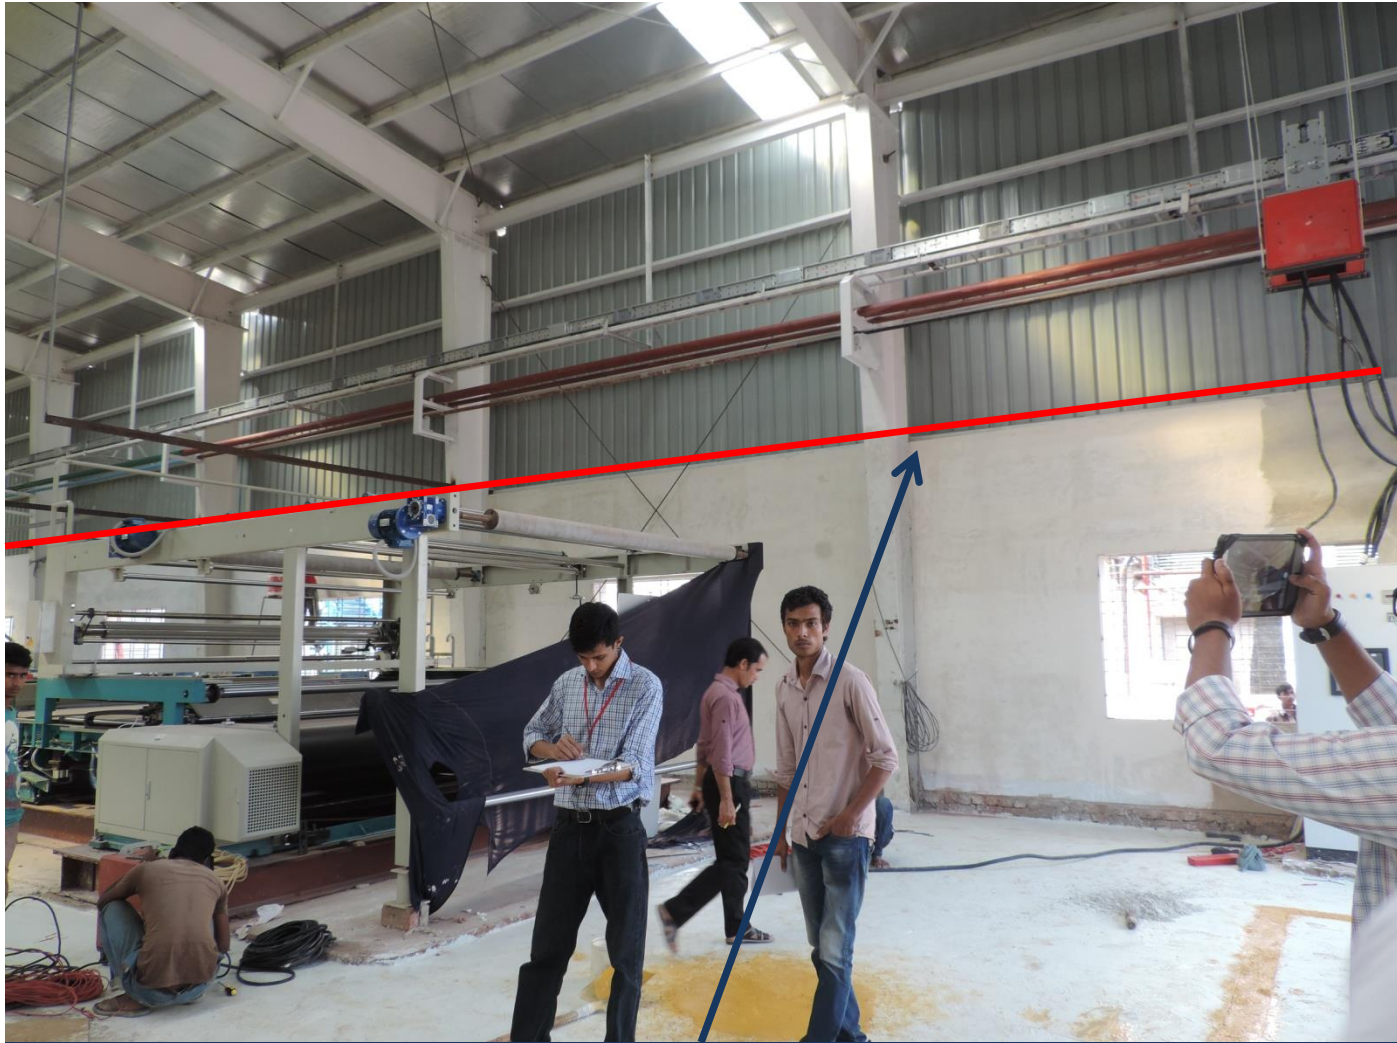
Lack of head restraint to masonry infill wall panels

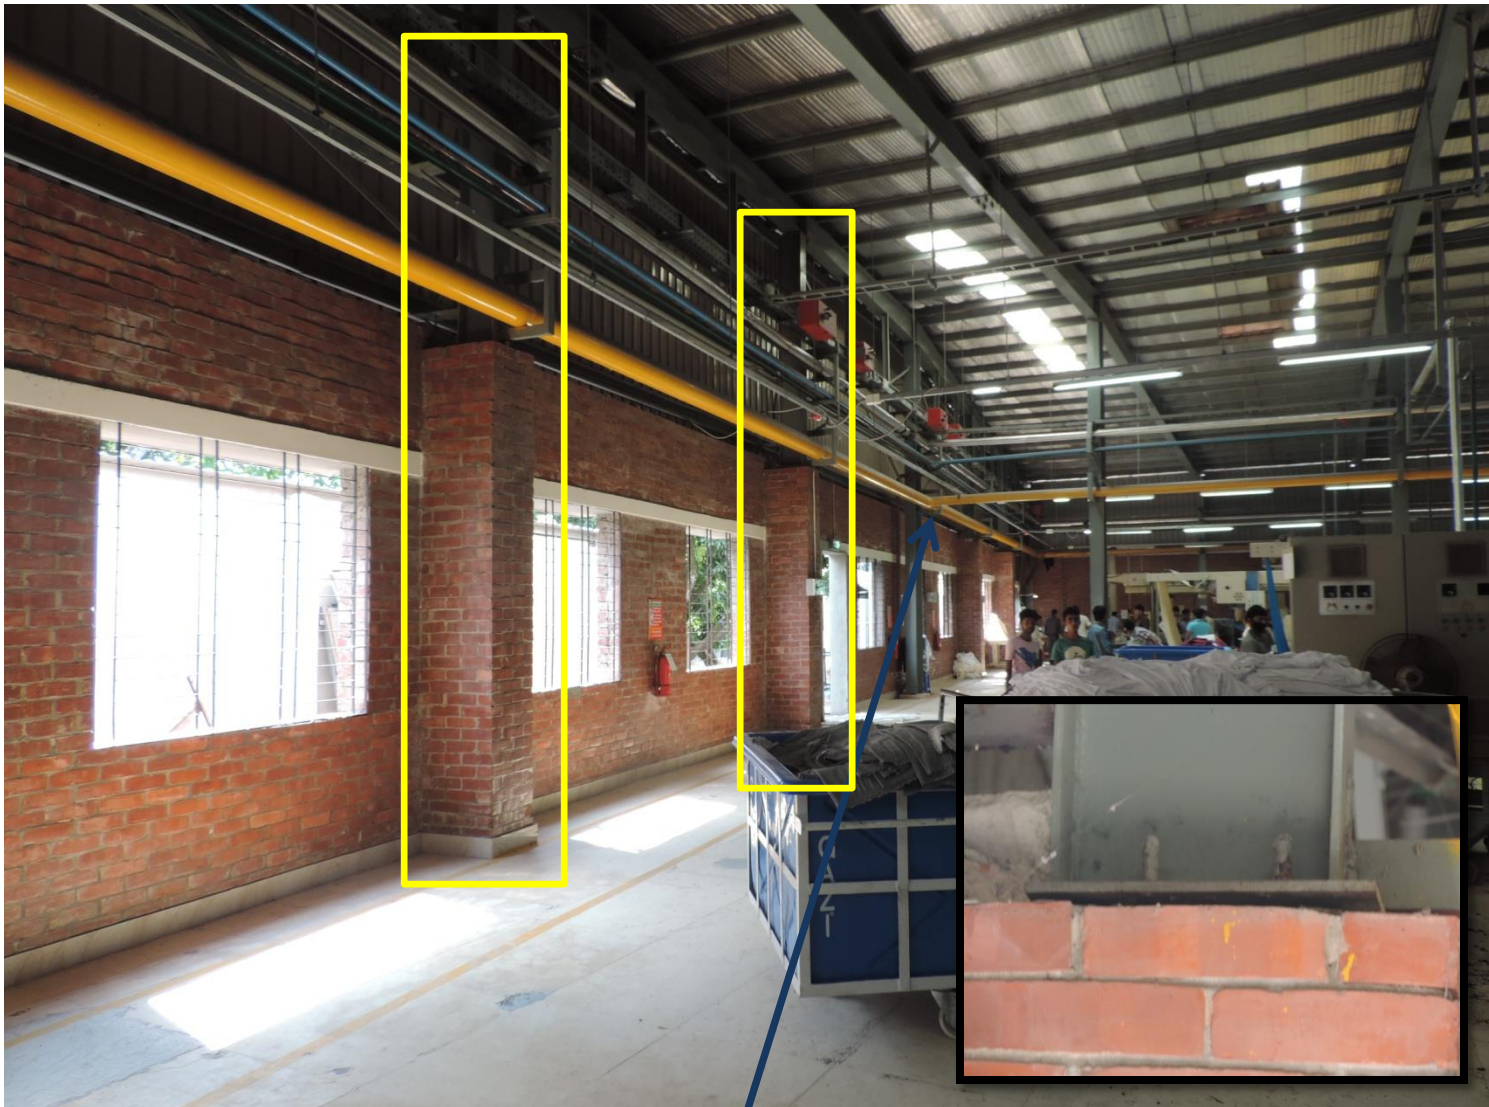
Gable columns constructed half height in concrete

25	Shed 2 Gable columns constructed half height in concrete	Carry out the remedial works from the above study	6-months

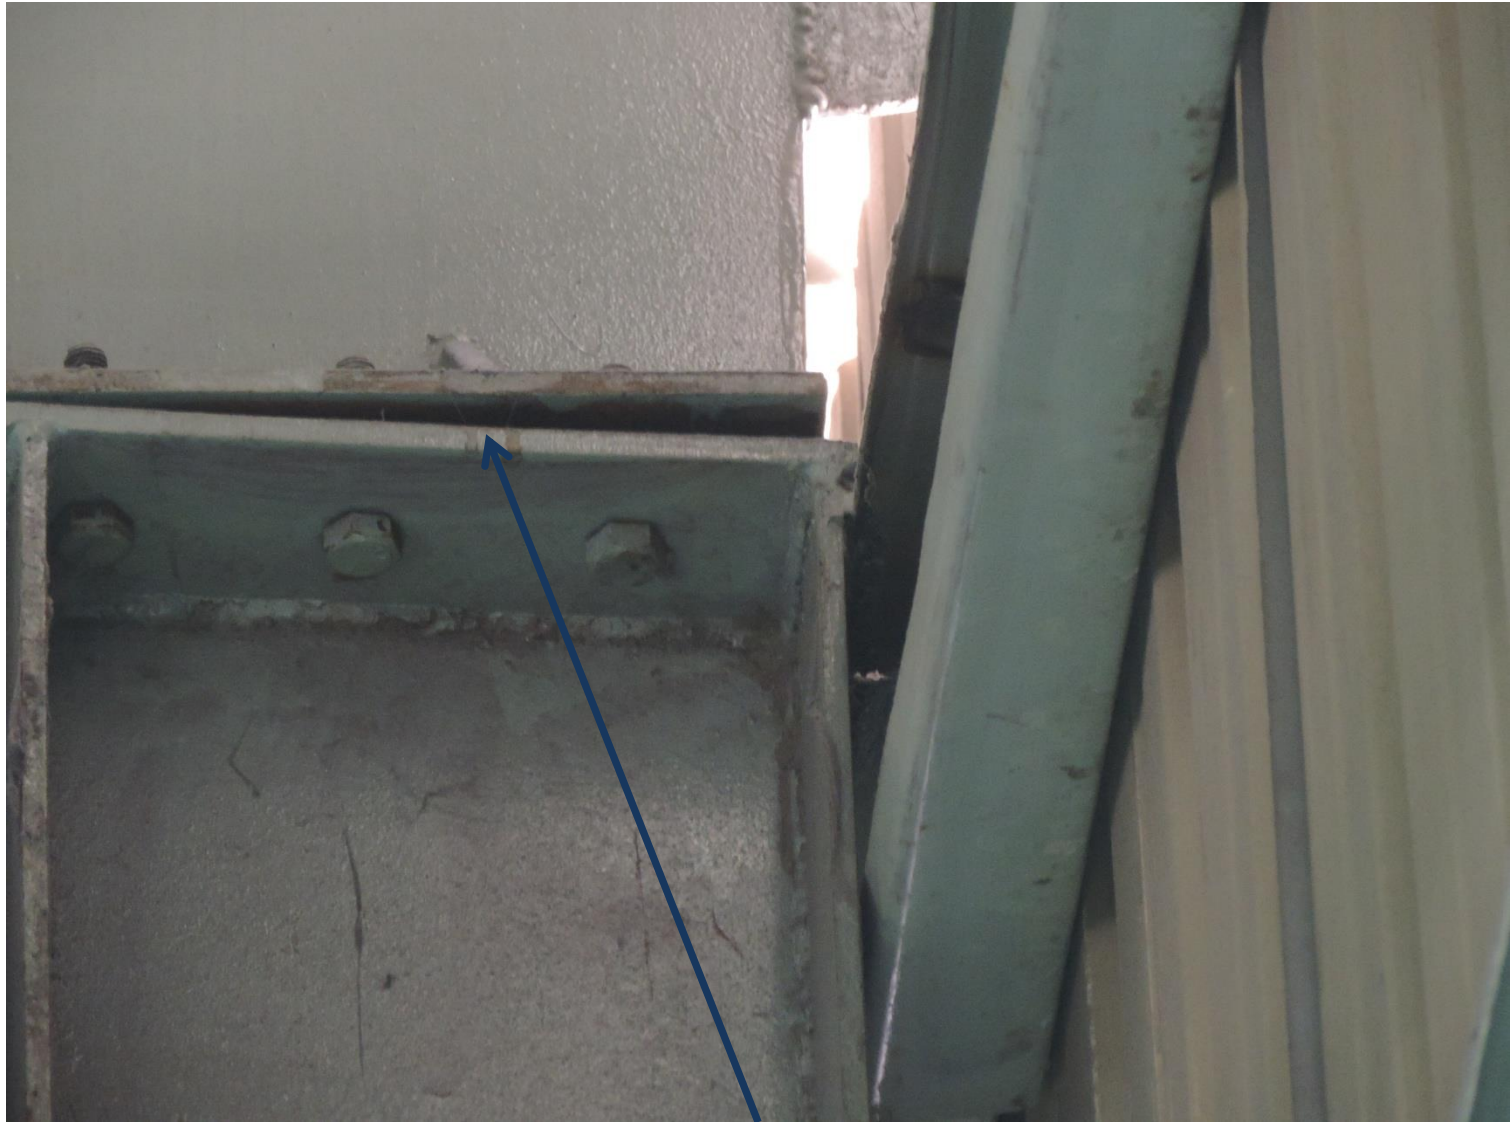
Open moment joint in portal 10

Item No.	Observation	Recommended Action Plan	Recommended Timeline
26	Shed 2 Open moment joint in portal 10	Engineer to review the joint as-built on site and propose remedial works	6-weeks
27	Shed 2 Open moment joint in portal 10	Carry out the remedial works from the above study	6-months
28	Shed 2 Missing bottom flange plates to rafter splices portal 02	Engineer to review the splice connections and propose remedial work to correct the splice joint	6-weeks
29	Shed 2 Missing bottom flange plates to rafter splices portal 02	Carry out the remedial works from the above study	6-months
30	Shed 2 Gable masonry wall has no head restraint	Engineer to review the capacity of the wall panels without head restraint to resist lateral loading and make suitable recommendations on remedial works	6-weeks
31	Shed 2 Gable masonry wall has no head restraint	Carry out the remedial works from the above study	6-months

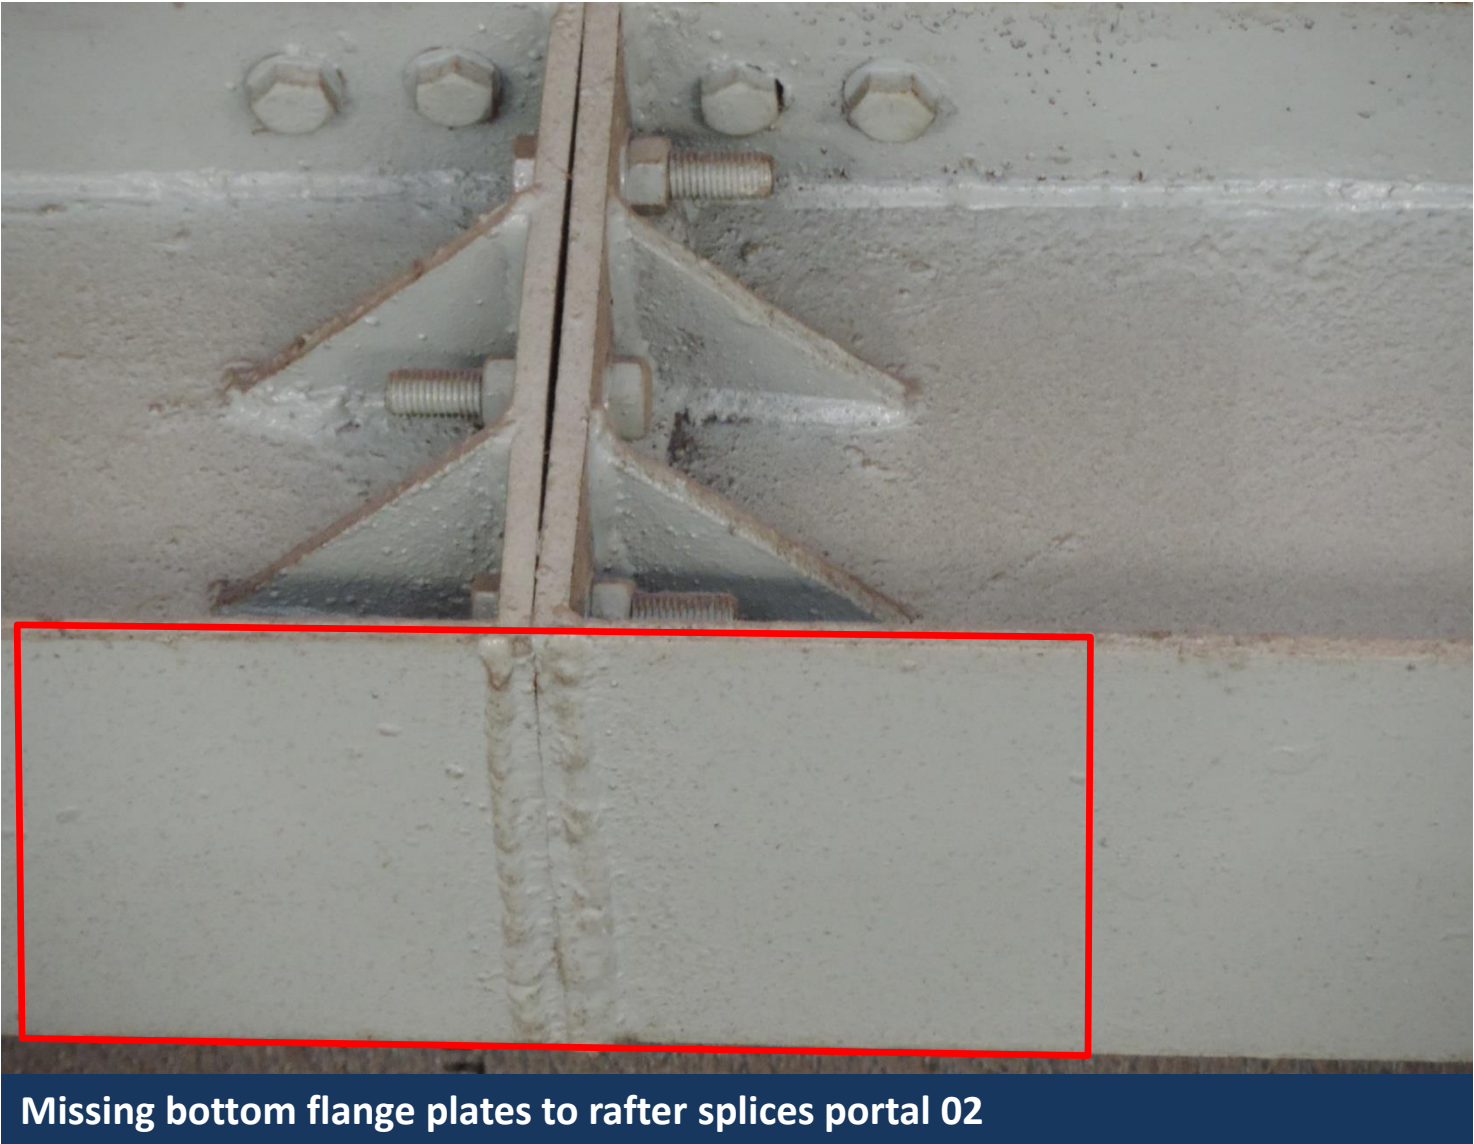
Missing bottom flange plates to rafter splices portal 02
