Lantabur Apparels Ltd Taqwa Fabrics Ltd & Libas Knitwear.

Kewa, Boherarchala, Gila Beraeed, Sreepur.
(24.19605675N), (90.40638176E)

4th November, 2015

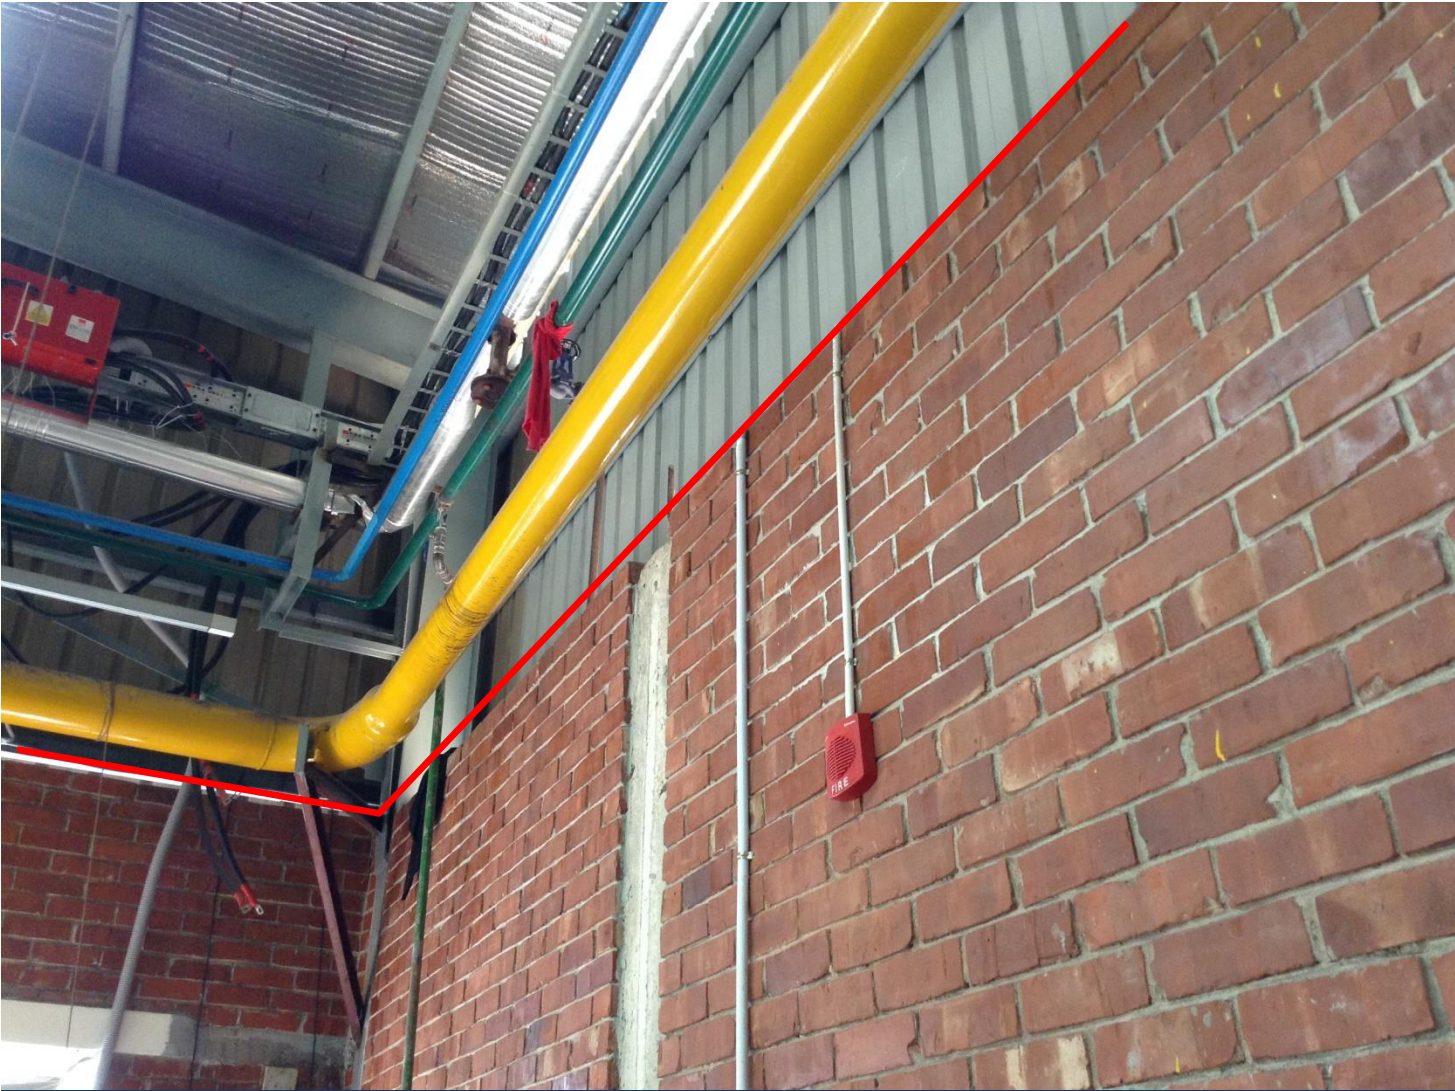
Gable masonry wall has no head restraint

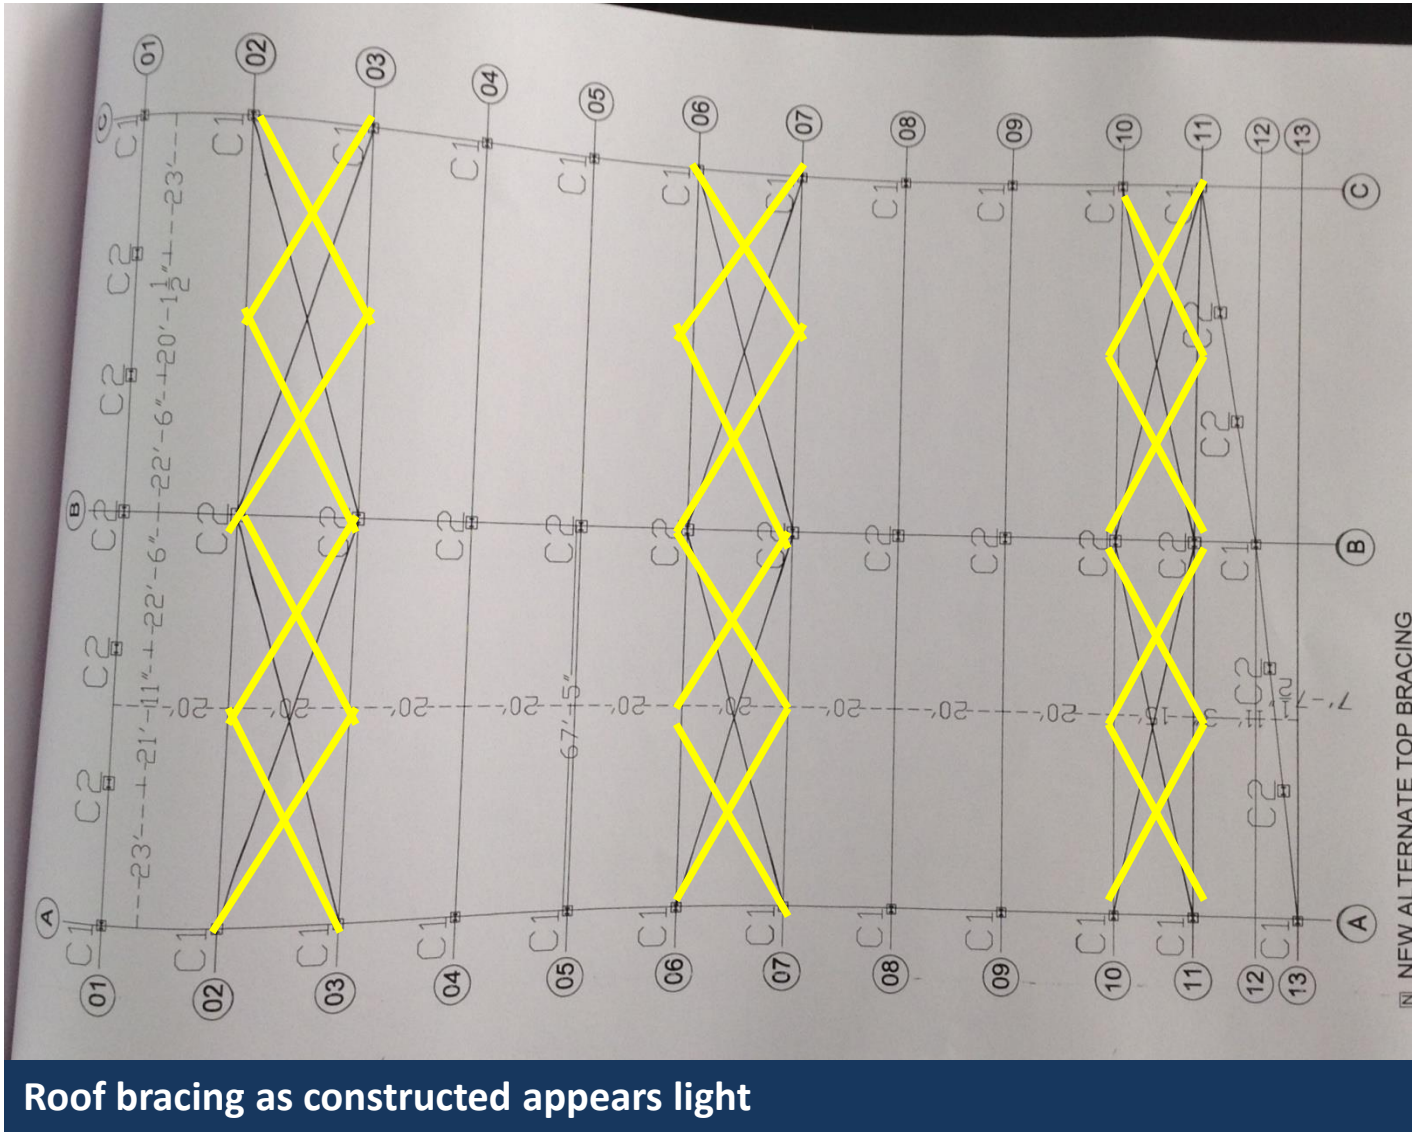
Roof bracing as constructed appears light

Item No.	Observation	Recommended Action Plan	Recommended Timeline
32	<p style="text-align: center;">Shed 2</p> <p>Roof bracing as constructed not as shown on drawings. (appears light)</p>	<p>Engineer to review the as-built roof bracing by calculation to resist lateral loading to the gable.</p>	<p style="text-align: center;">6-weeks</p>
33	<p style="text-align: center;">Shed 2</p> <p>Roof bracing as constructed not as shown on drawings. (appears light)</p>	<p>Update drawing to show as built</p>	<p style="text-align: center;">6-weeks</p>
34	<p style="text-align: center;">Shed 2</p> <p>Roof bracing as constructed not as shown on drawings. (appears light)</p>	<p>Carry out the remedial works from the above study</p>	<p style="text-align: center;">6-months</p>
